Caerus Piceance LLC
N36NWB
Location # 334967

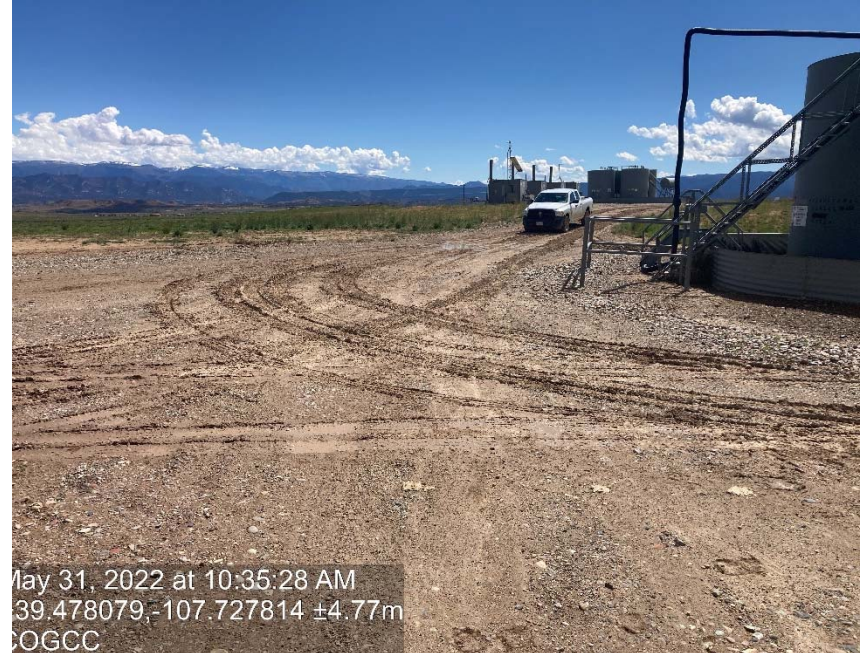
**location and Lack of stabilization/ compaction/
degradation**

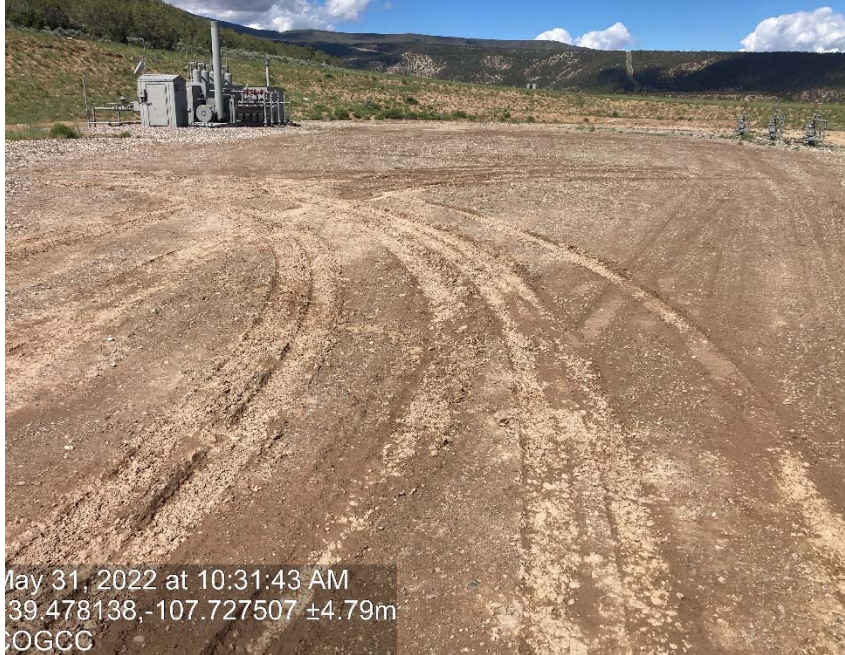
Lack of stabilization/ compaction/ degradation

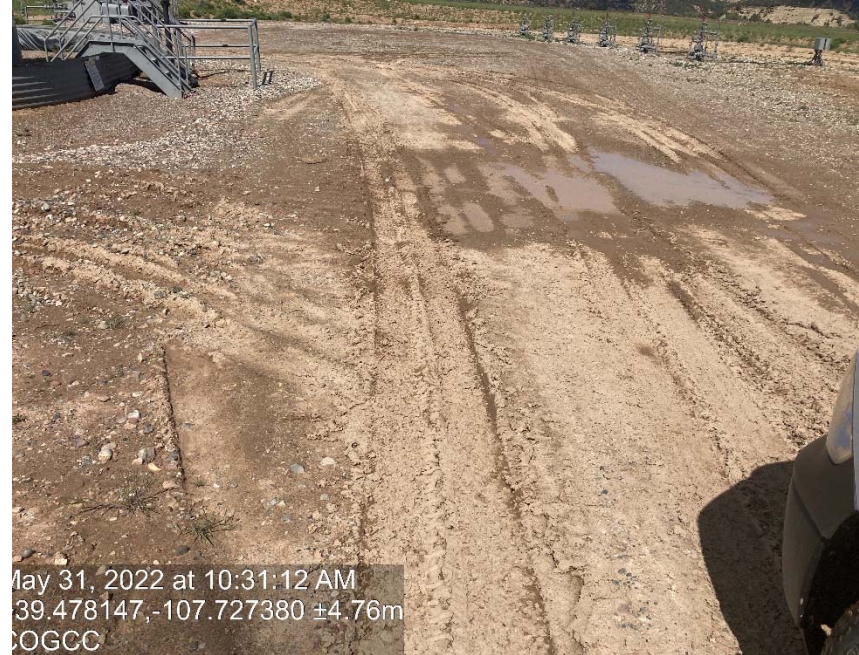
Lack of stabilization/ compaction/ degradation

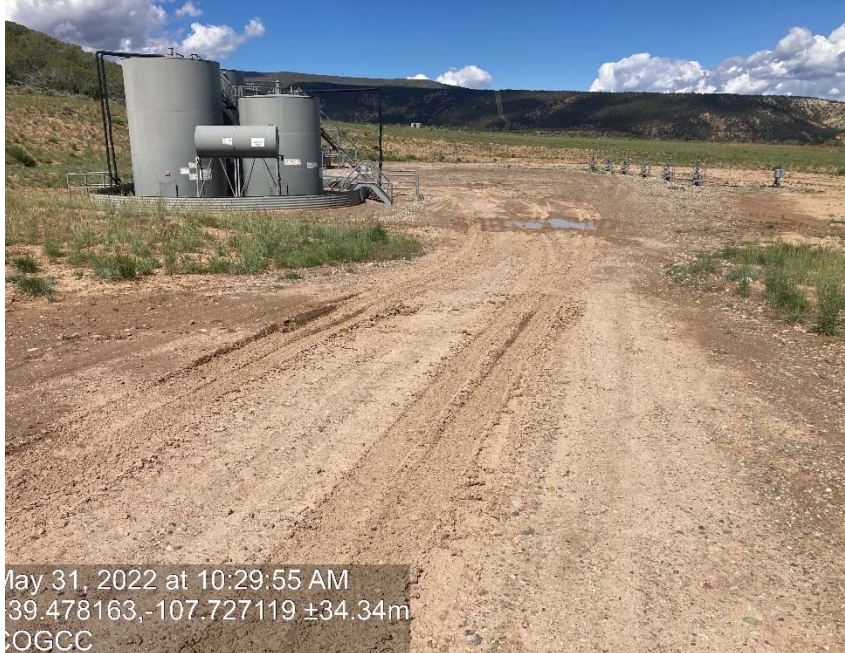
Lack of stabilization/ compaction/ degradation

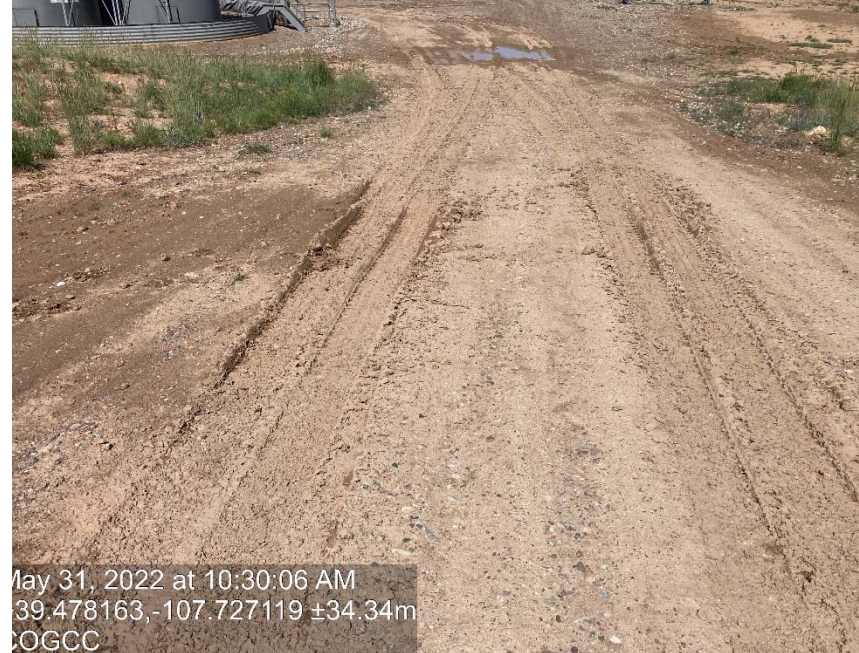
Lack of stabilization/ compaction/ degradation

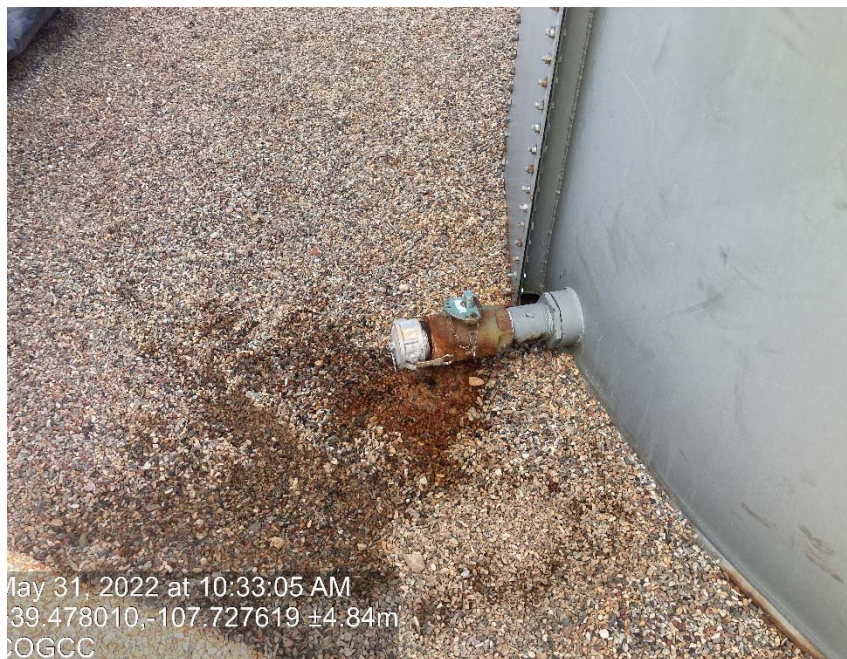
Valve leaking

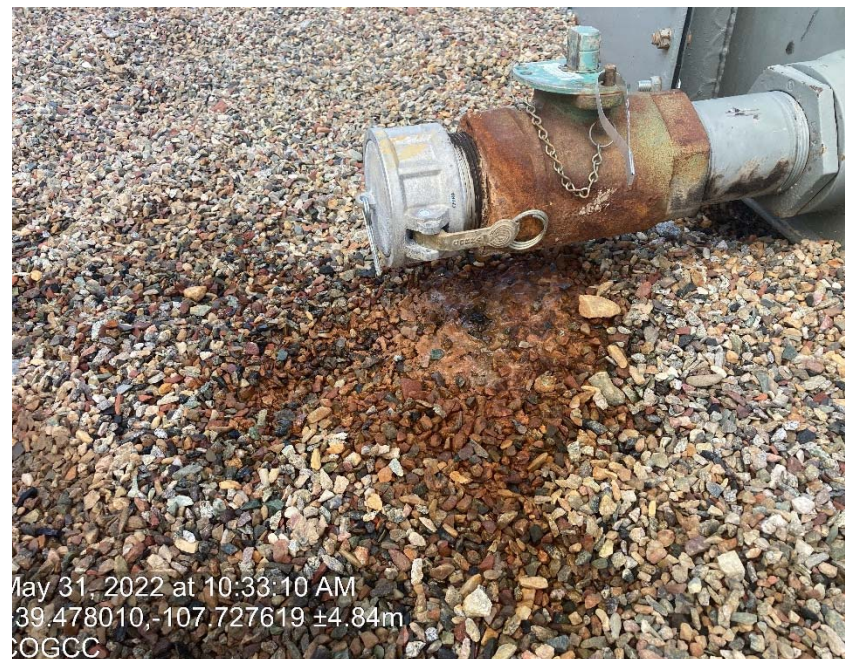
Valve leaking
