Site Inspection Report

Site: MARIE GERHART 9
06/02/2022

SITE INSPECTION REPORT

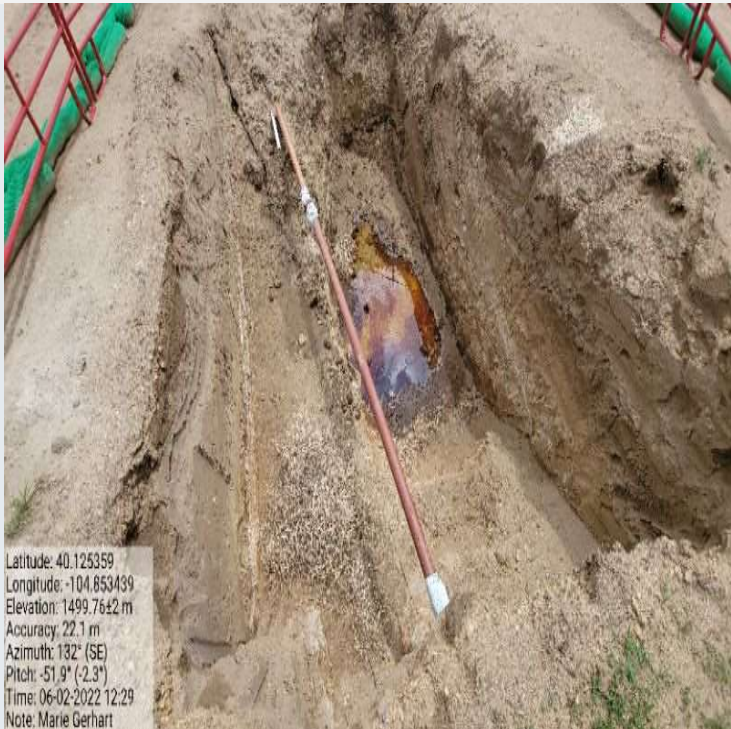
Remediation Activity Checklist	
	Photo
Question: Open excavation? Approximate size (Length x Width x Depth, ft) Response: Yes Notes: 24x12x8

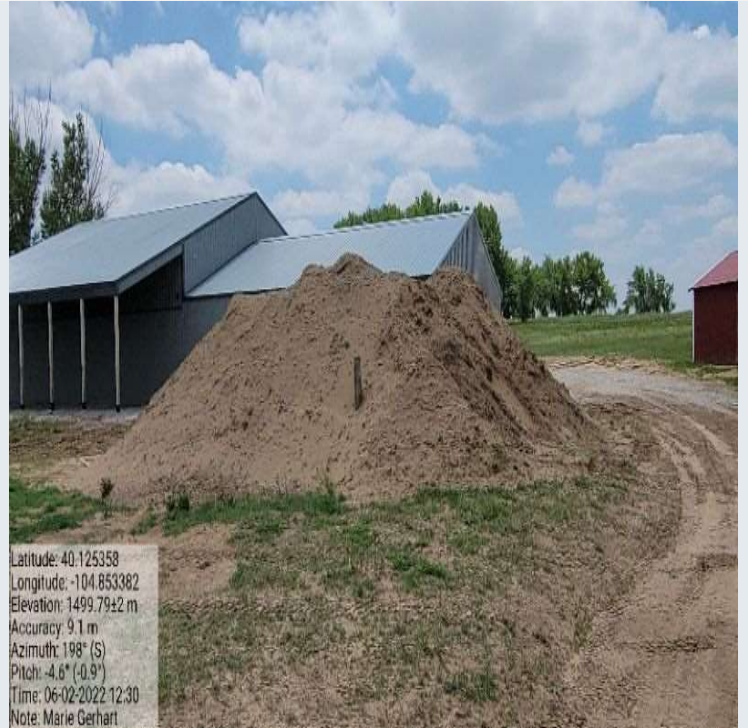
Question: Stockpiled waste and approximate volume (cubic yards)

Response: Yes

Notes: 85

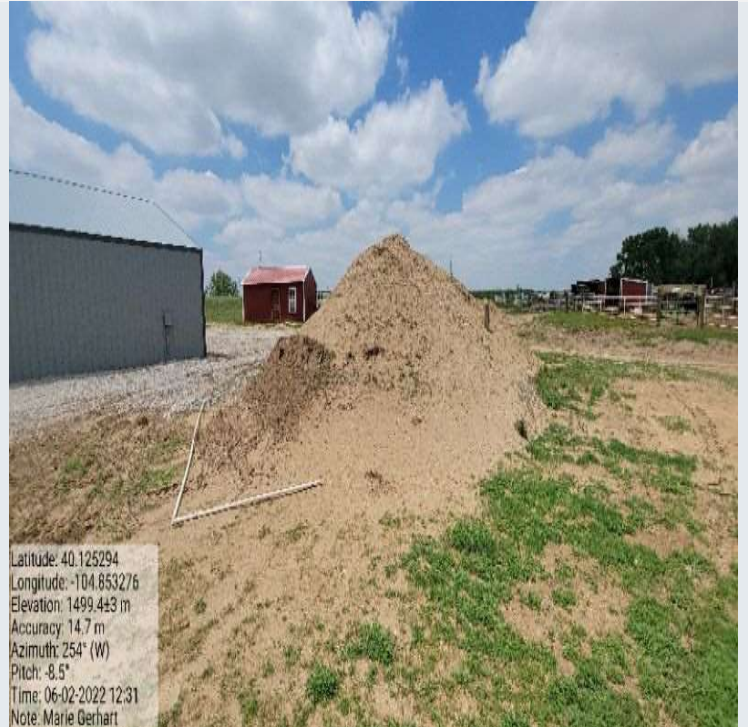
Question: Stockpiled waste and approximate volume (cubic yards)

Response: No Change

Notes: No liner

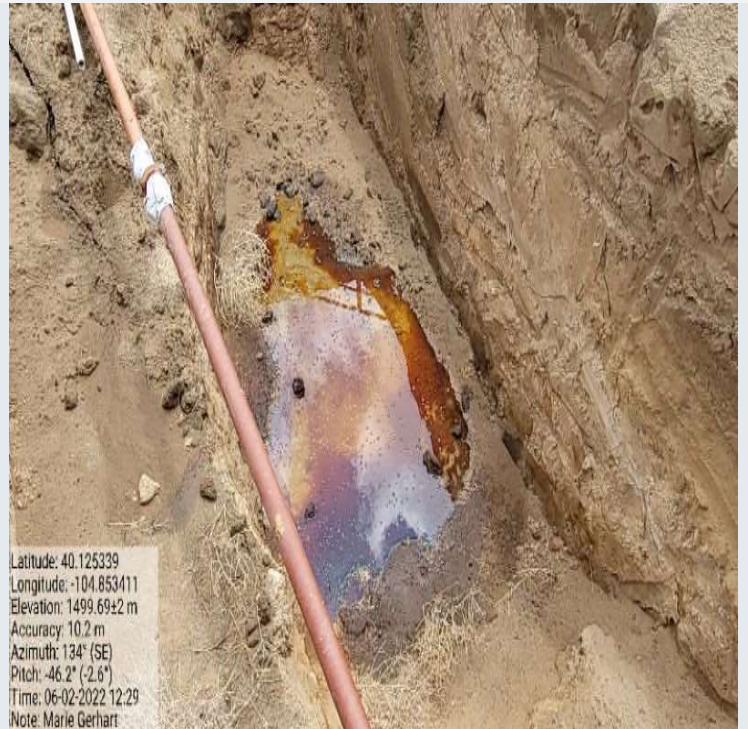
Photo
Question: Groundwater present? (Depth, ft) Note: Free product/Sheen Response: No Notes: Stormwater within excavation

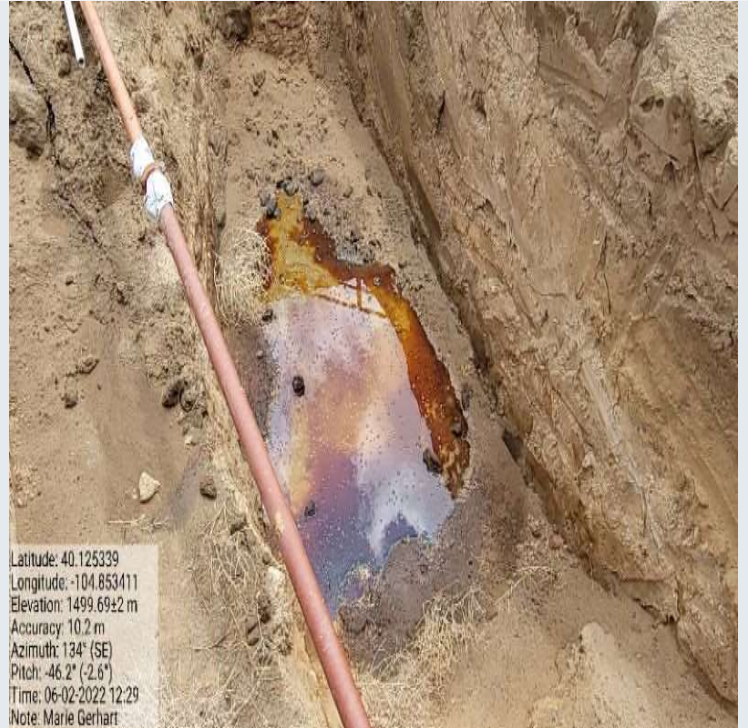
Question: Ground surface appears clean (no evidence of new equipment leaks, oil leaks, spills, or releases)?

Response: No

Notes: Product floating on rainwater within excavation

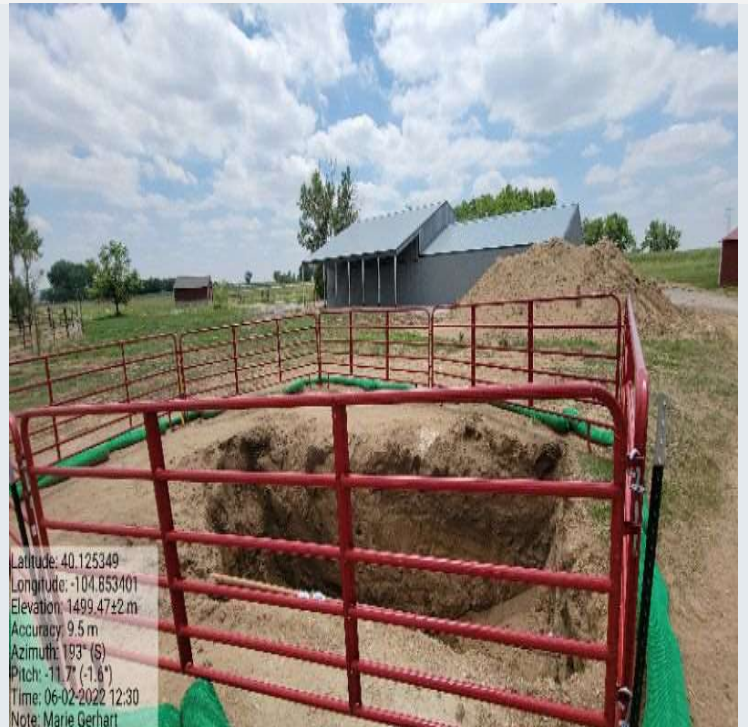
Question: Open excavation properly fenced/covered (in accordance with Rule 913.b.(5)B.i.)?

Response: Yes

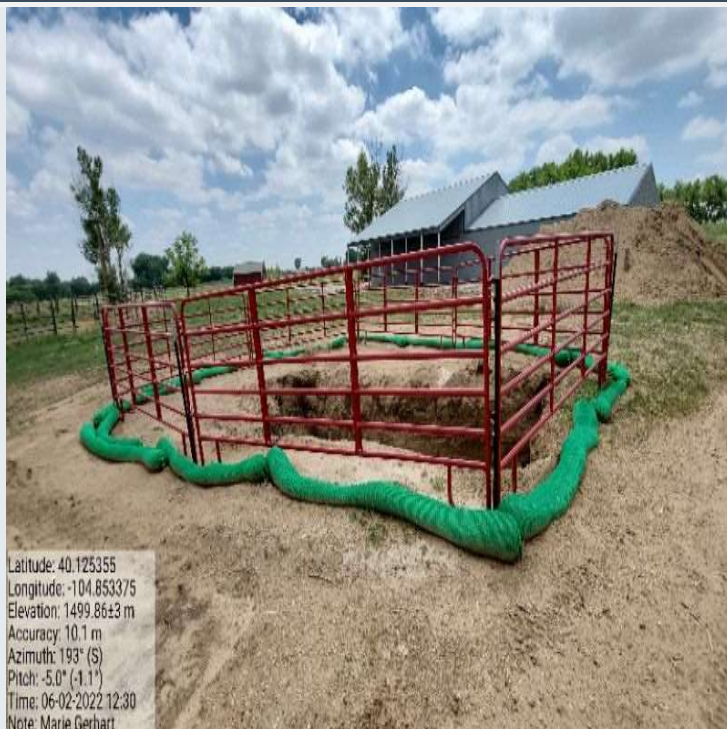
Question: Open excavation properly fenced/covered (in accordance with Rule 913.b.(5)B.i.)?

Response: Yes

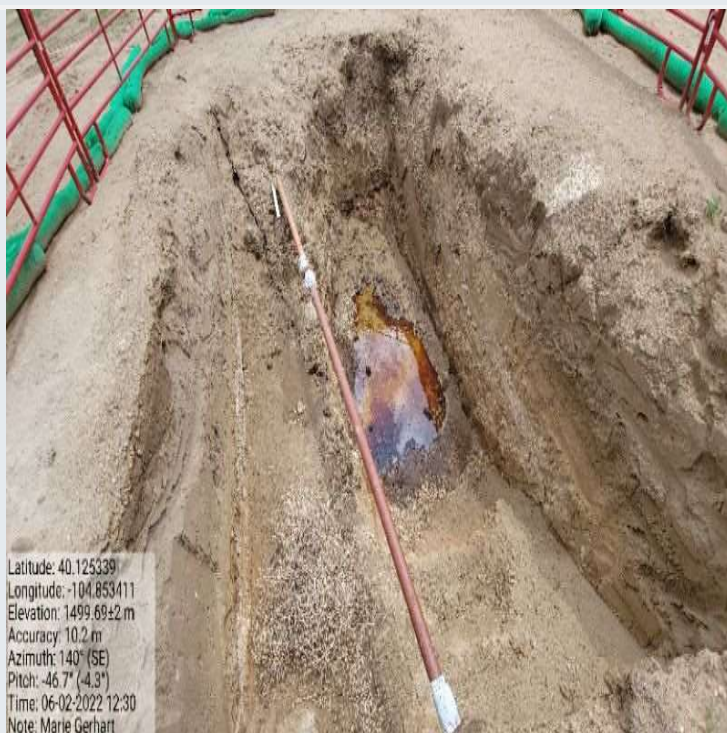
Question: Exposed buried/underground flowlines?

Response: Yes

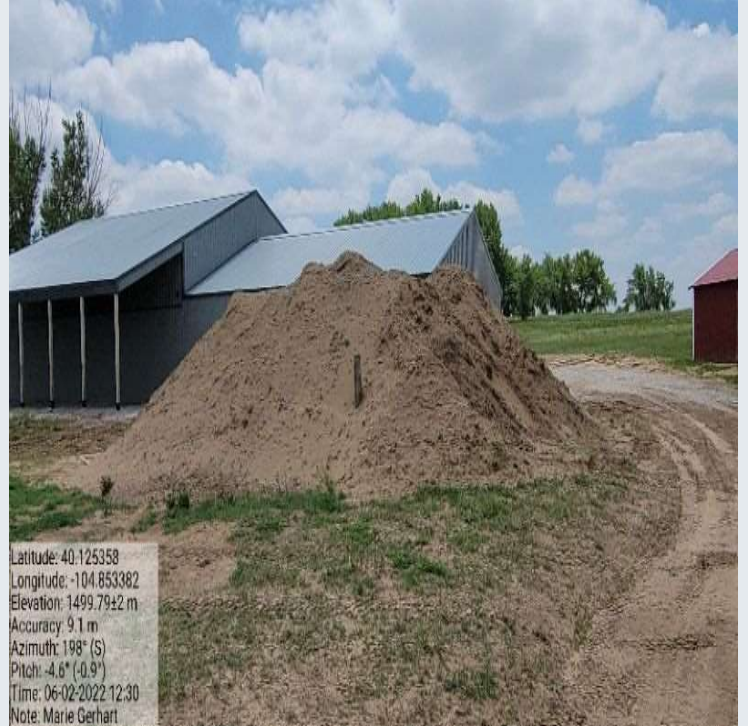
Stormwater Checklist	
	Photo
Question: Evidence of pollutants being discharged off-site? Response: No Notes: Potential threat	No Photo

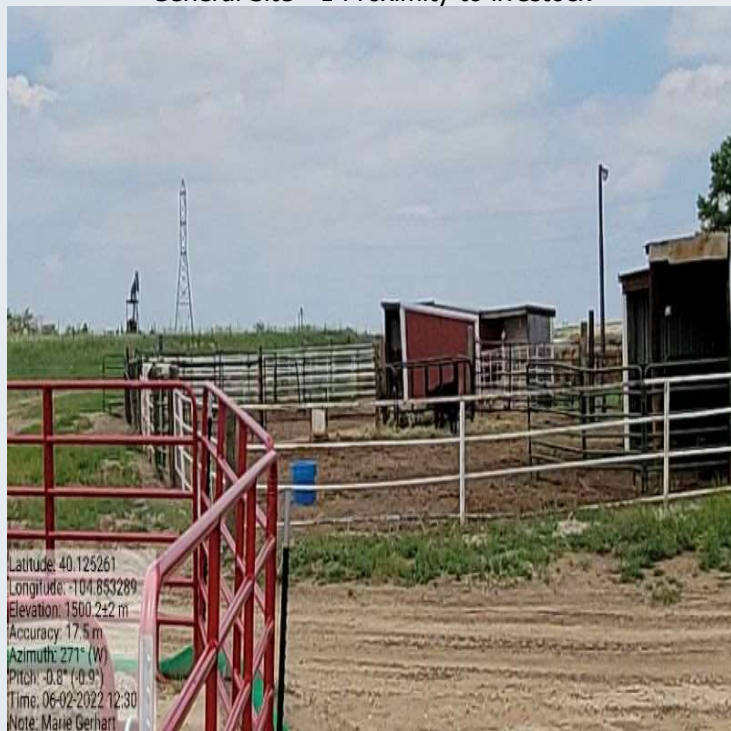
General Site - 1 Proximity to livestock
