Final Reclamation Inspection

Operator: PDC ENERGY INC - 69175

Location ID: 307211

Inspection Photos
Location Name: Ryan 25-BU
Location ID: 307211

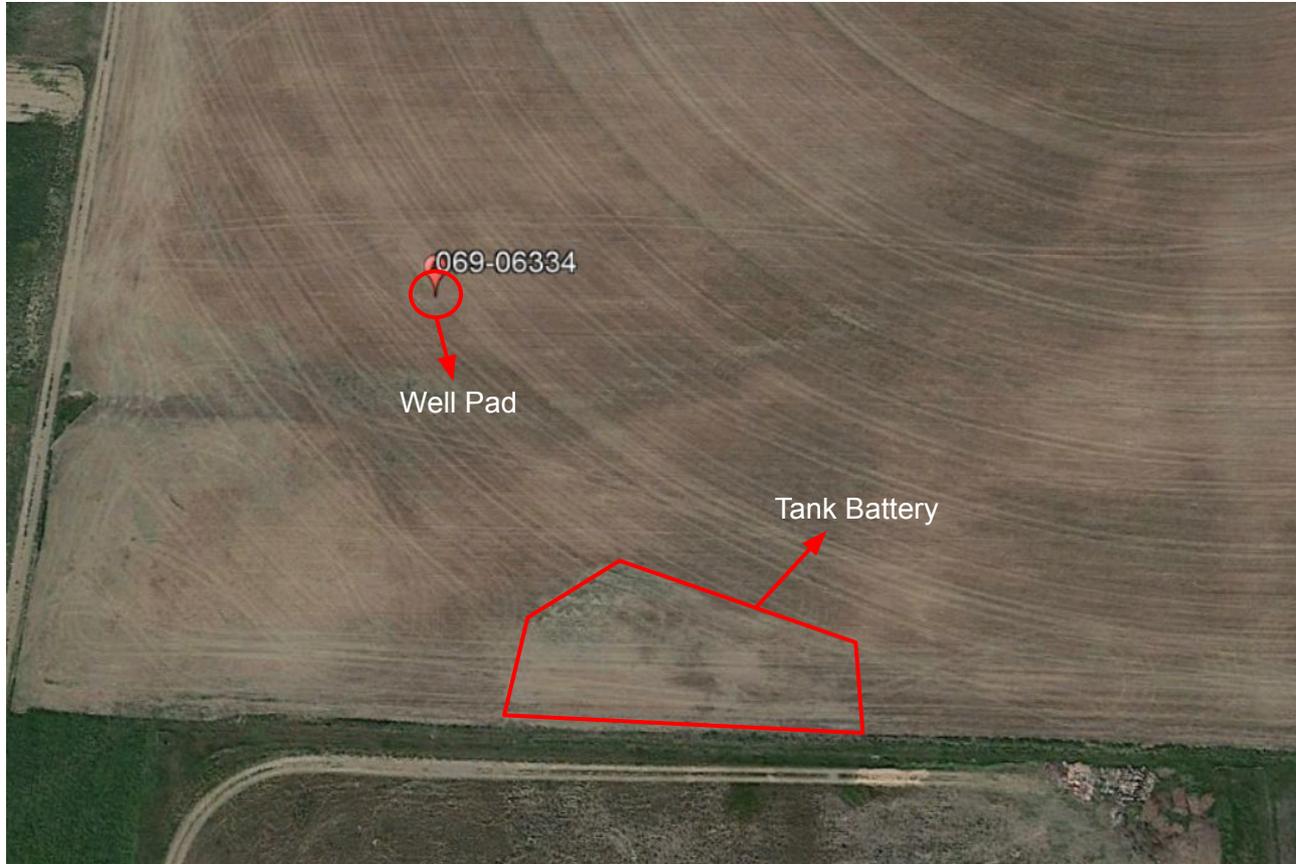
Photo 1. 2021 aerial imagery of the well pad and tank battery.

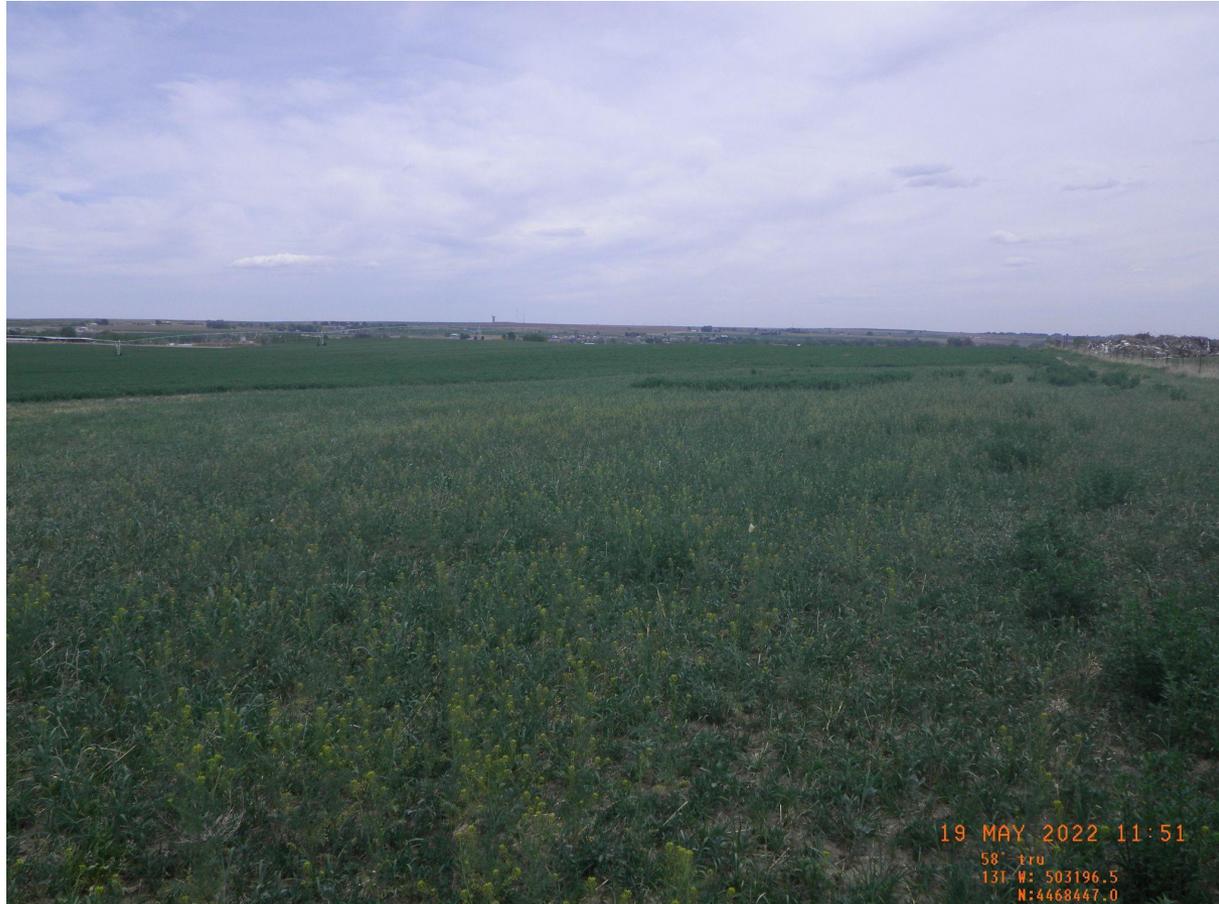
Photo 2. Overview photo of the tank battery taken at ground level from the western edge looking east.

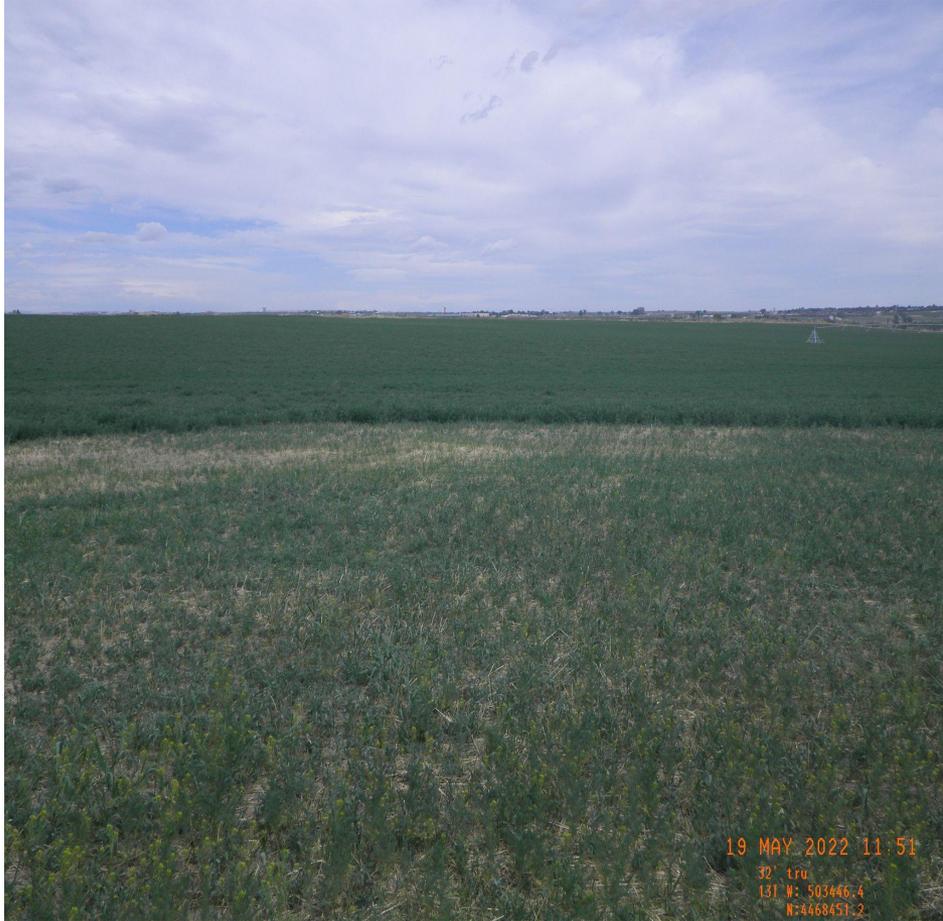
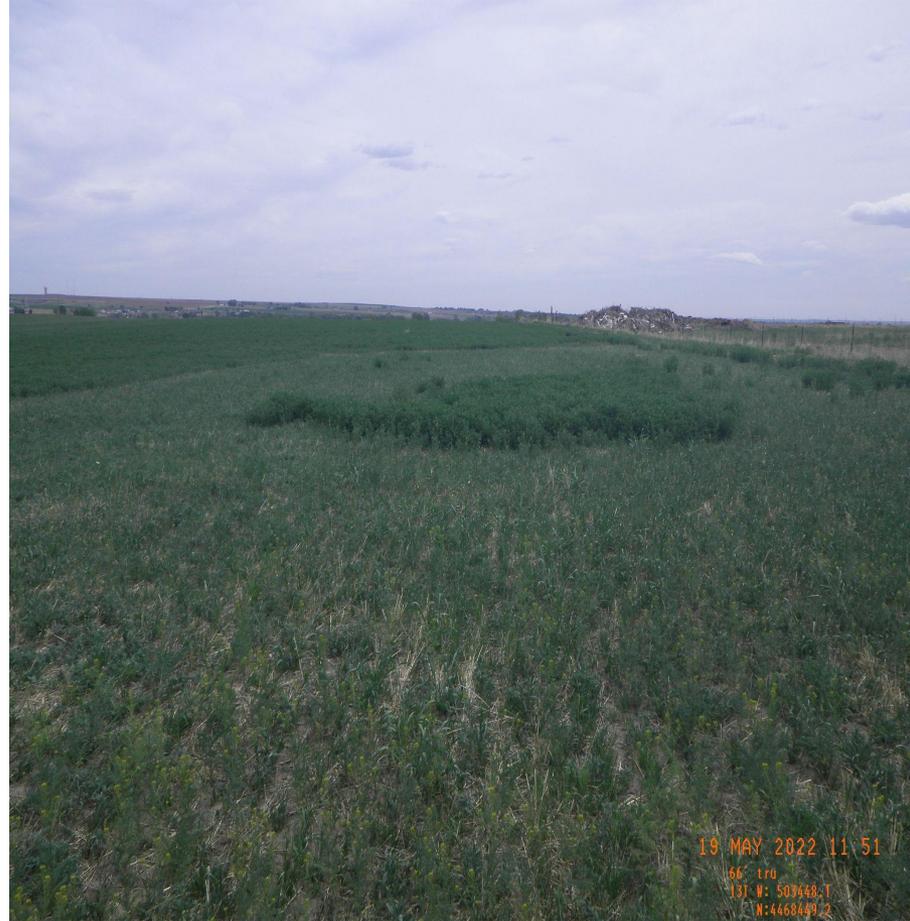
Photo 3. Cardinal photos taken from the middle of the tank battery. Left photo facing north, right photo facing east.

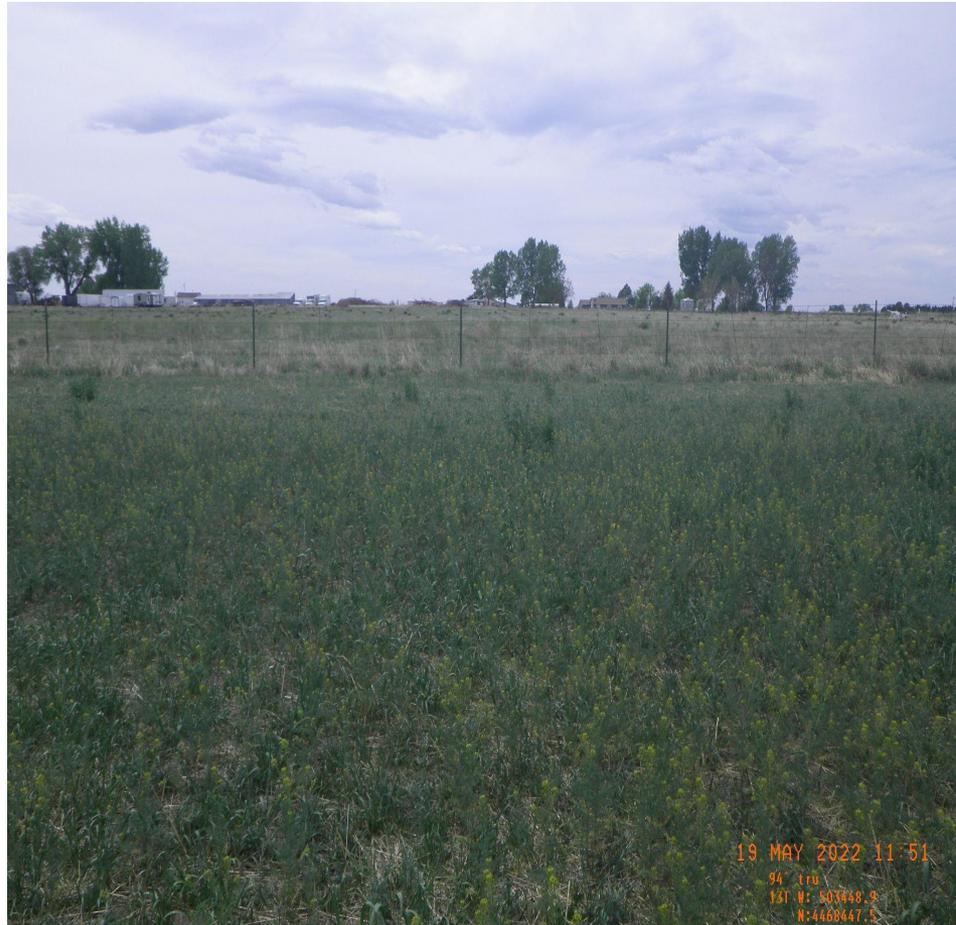
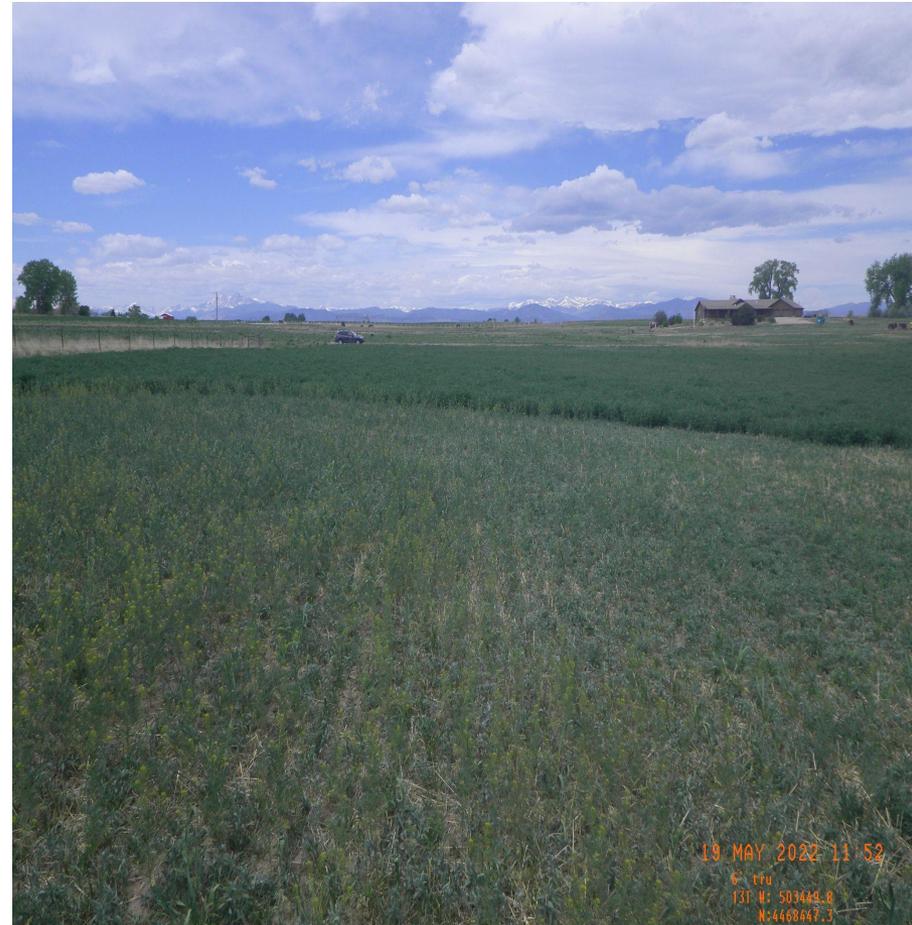
Photo 4. Cardinal photos taken from the middle of the well pad. Left photo facing south, right photo facing west. Note: evidence of drill row seeding and desirable species observed during inspection. Tank battery will remain in process until alfalfa has re-established or crop field has been repurposed and site can be re-inspected.

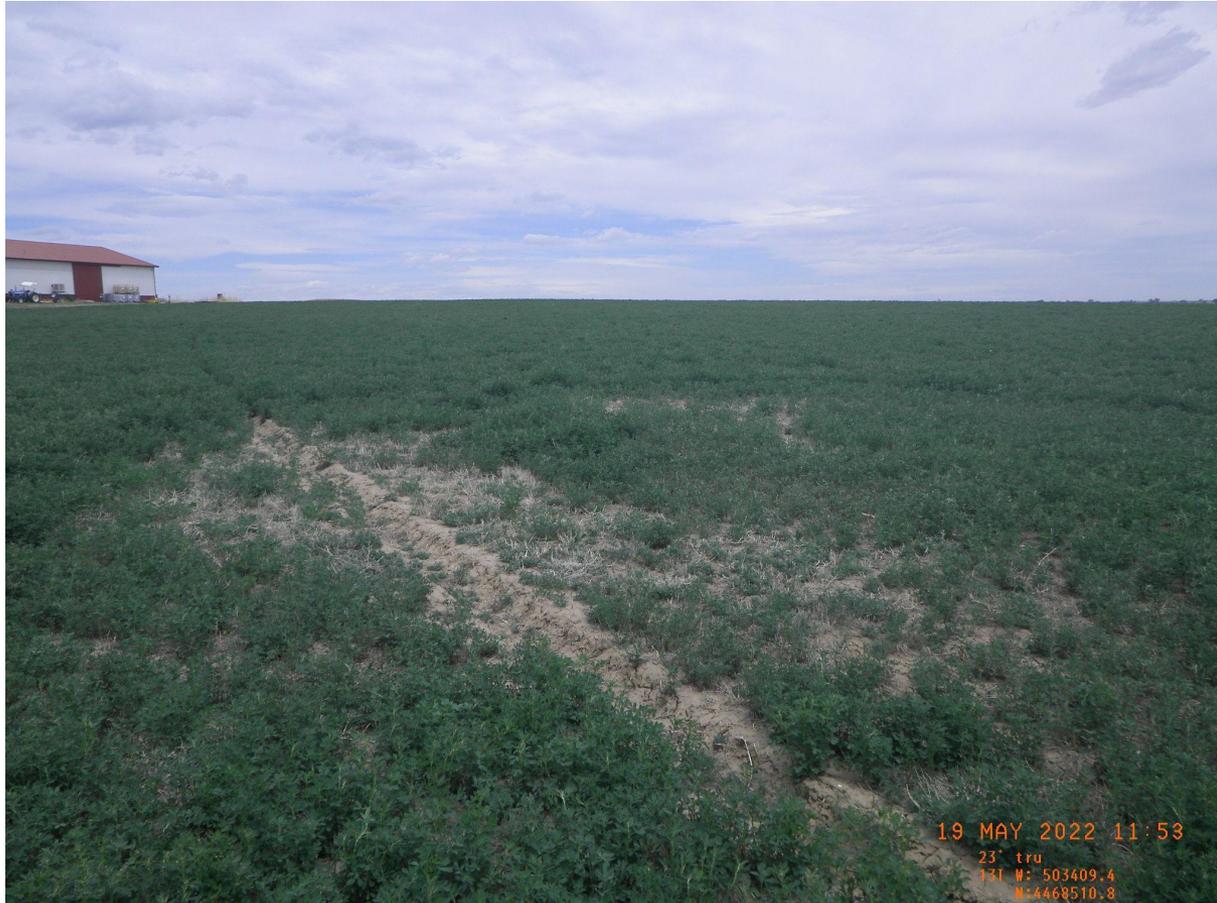
Photo 5. Overview photo of the well pad taken at ground level from the southern edge looking north. Note: well pad does shows stunted alfalfa crop and does not appear consistent with reference area (see photo 6).

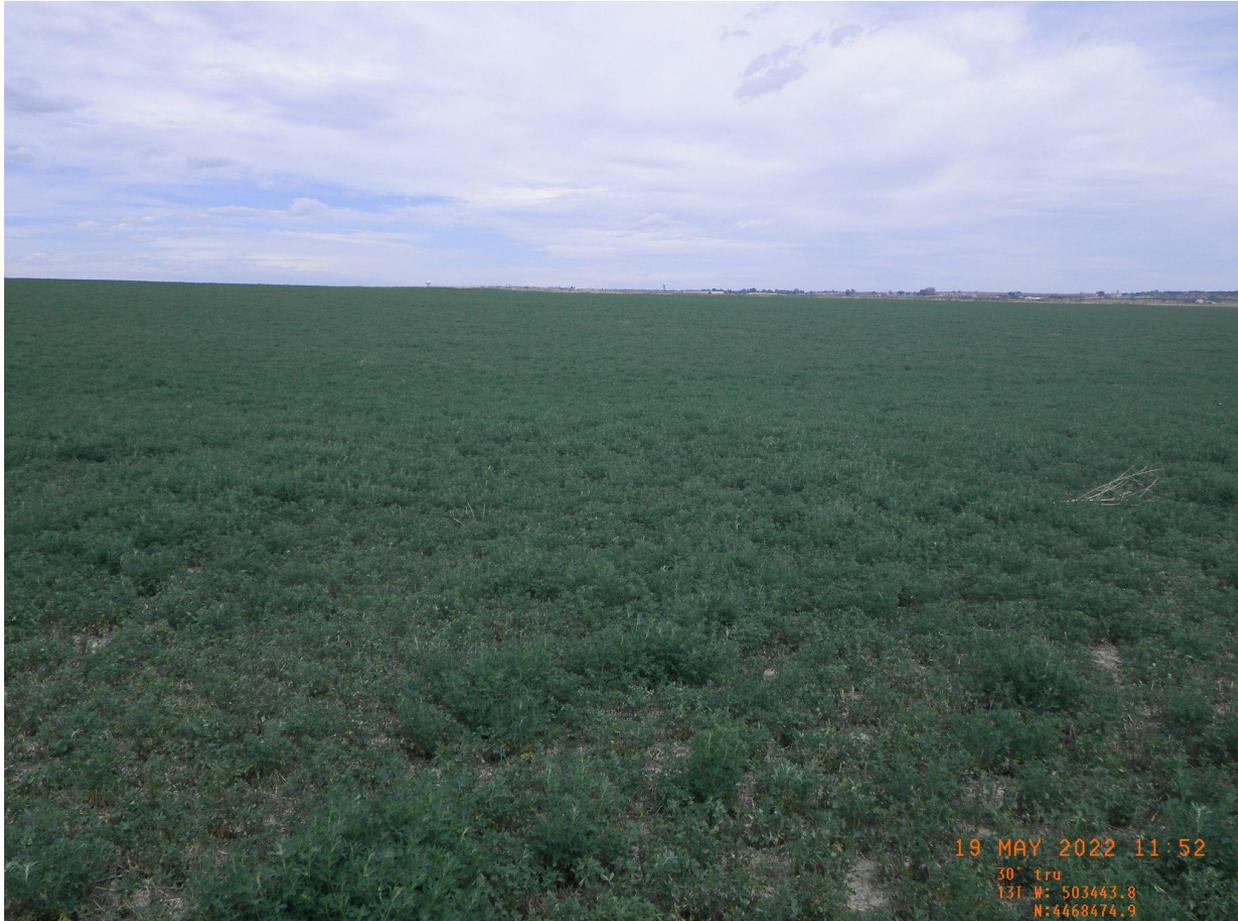
Photo 5. Reference area.
