Inspection Photos
Location Name: Champlin HER 2-8
Location ID: 320245

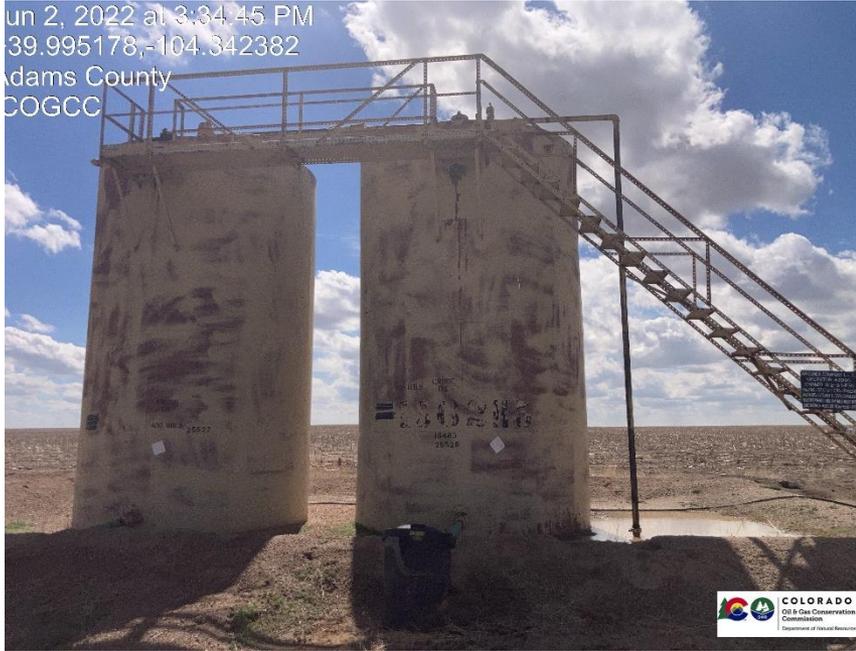
Pic 1 tanks

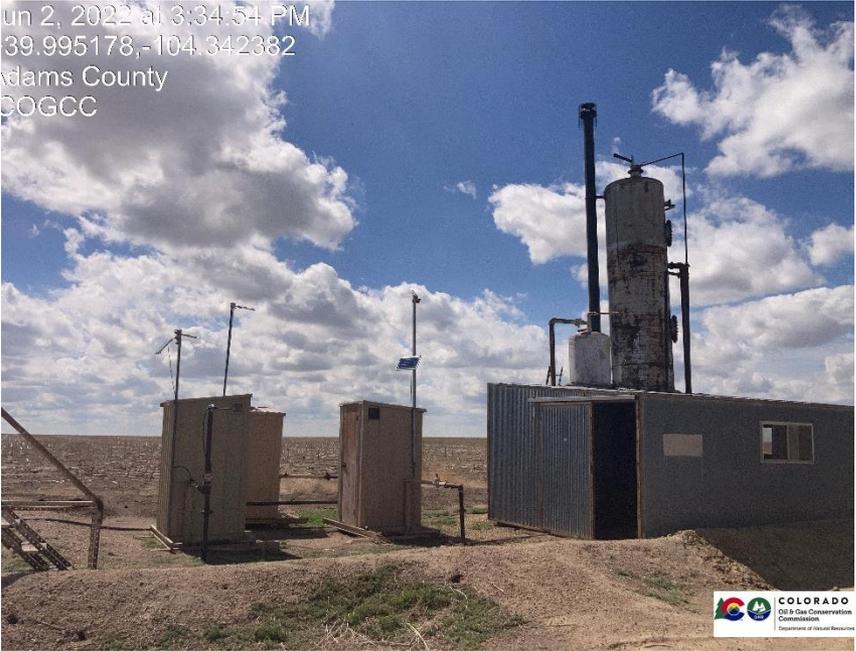
Pic 2 gas meter run separators

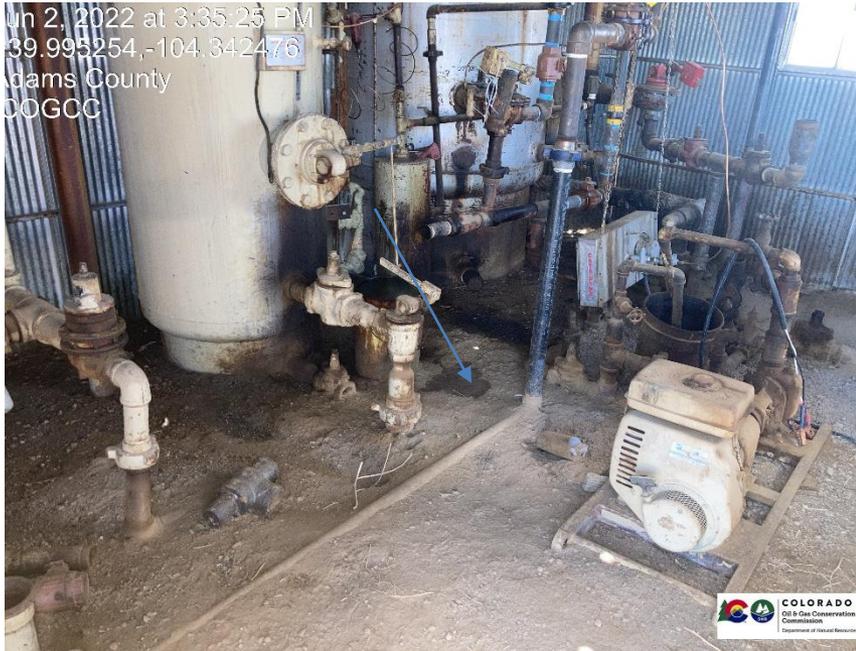
Pic 3 stined soil in separator house

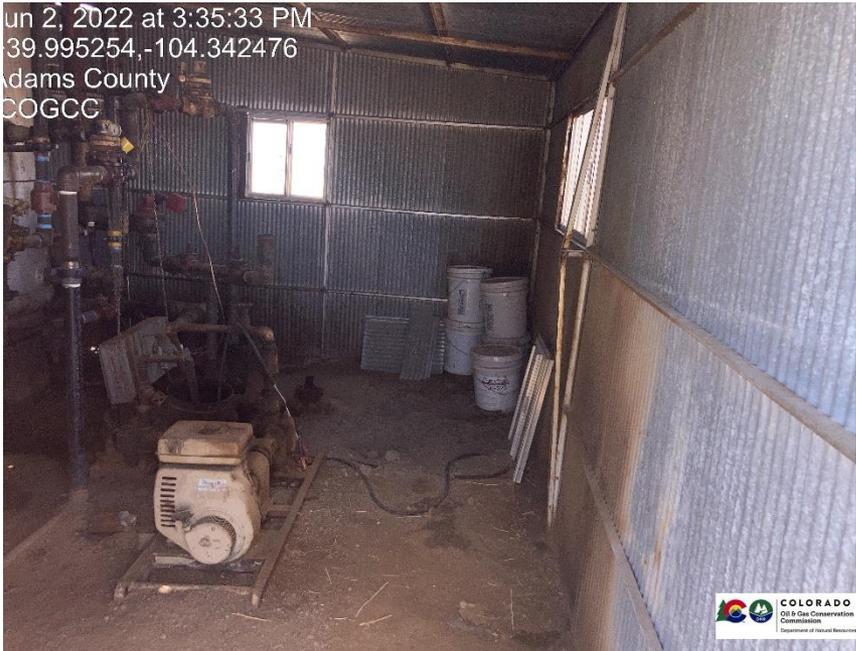
Pic 4 trash stored in separator house

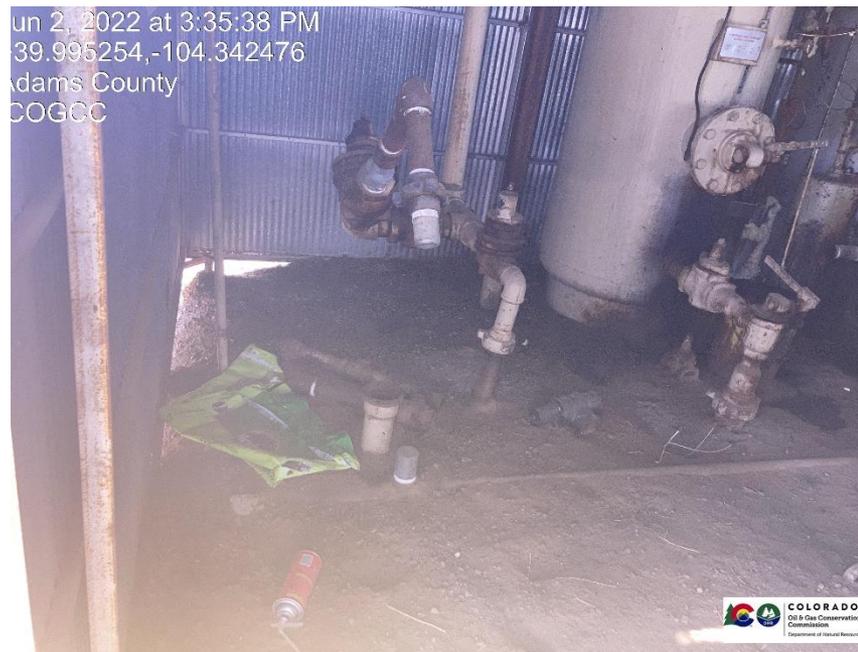
Pic 5 trash and stained soil in separator house

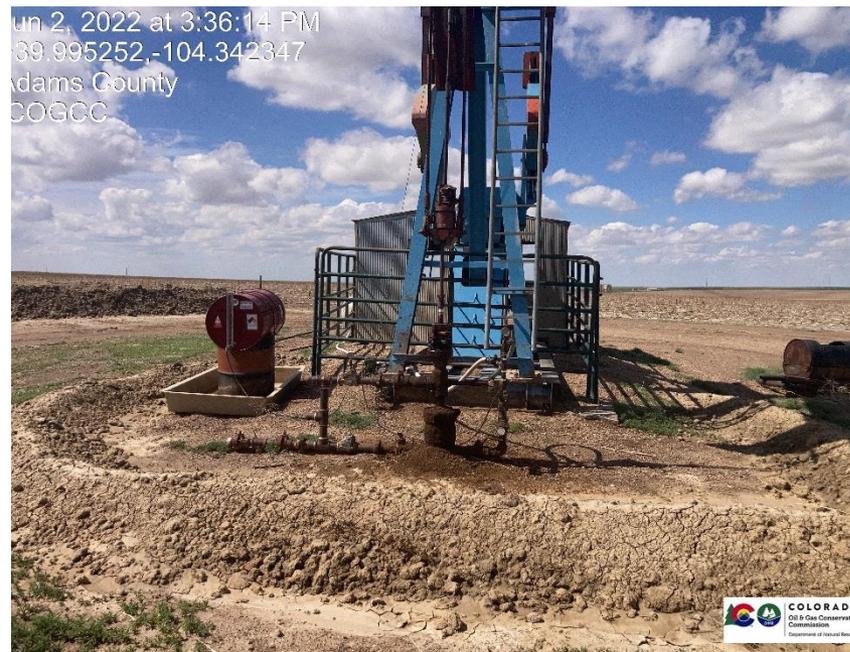
Pic 6 Mechanical issue / stained soil by well head

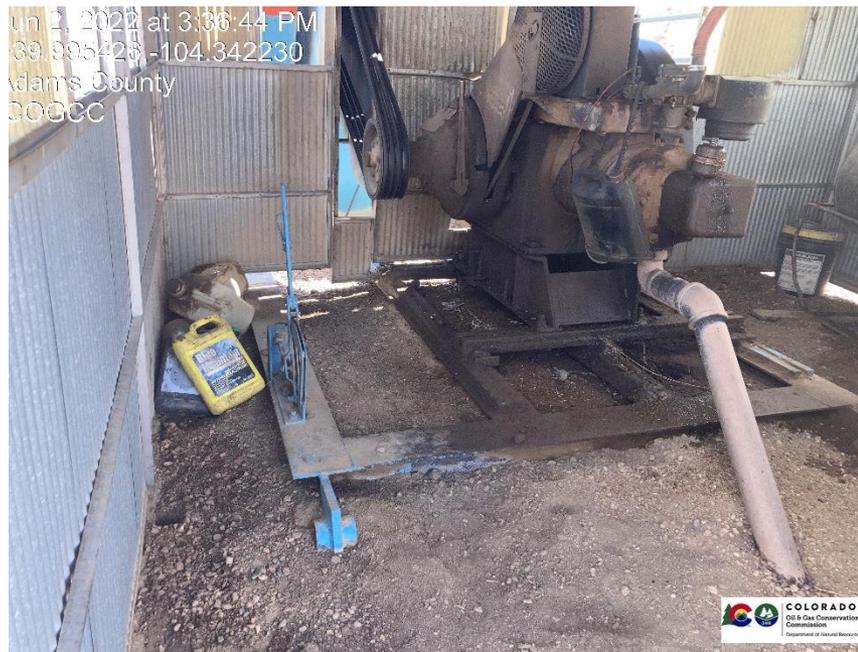
Pic 7 stained soil / mechanical issue / trash stored in motor house

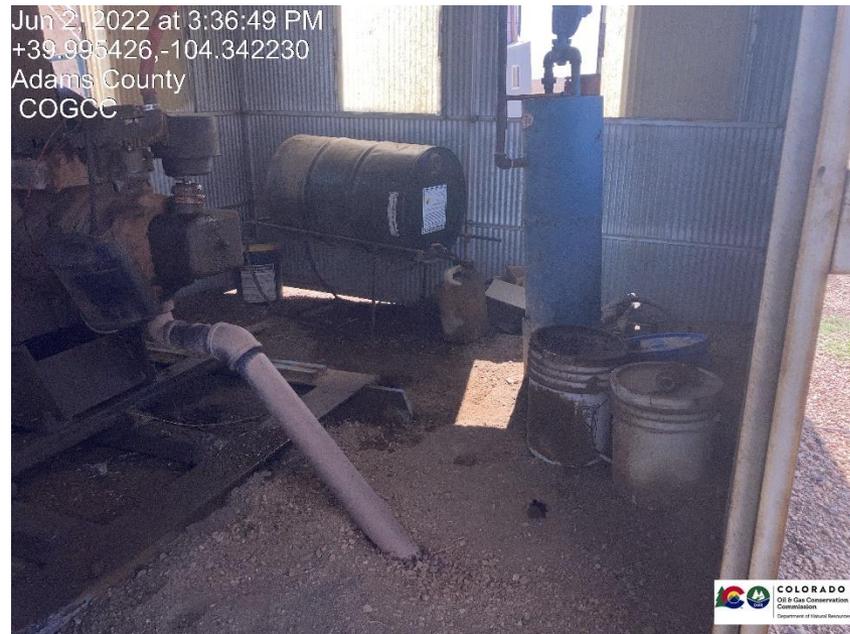
Pic 8 stained soil / mechanical issue / trash stored in motor house

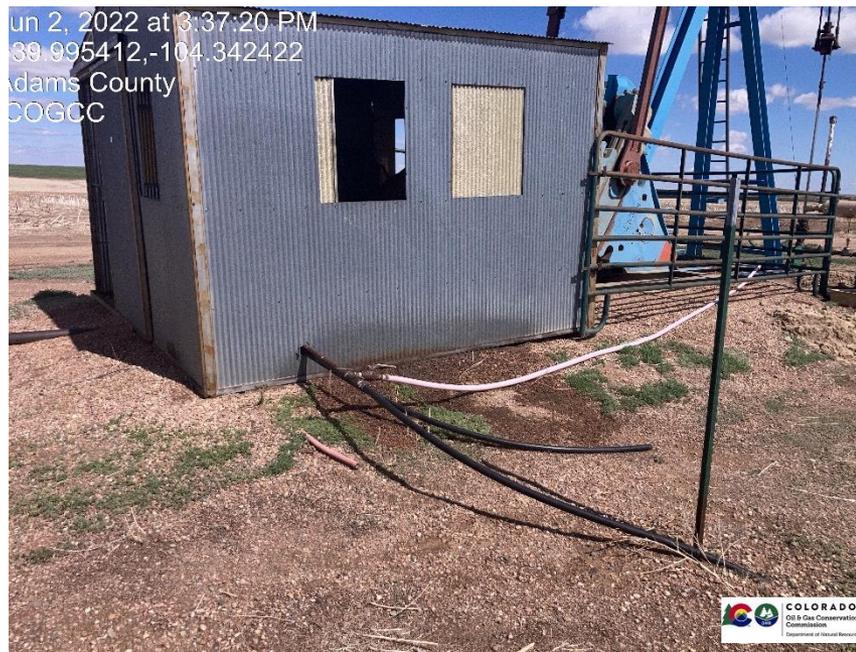
Pic 9 chemical tank leak, stained soil visible on outside of motor house, no containment used on chemical tank(s)

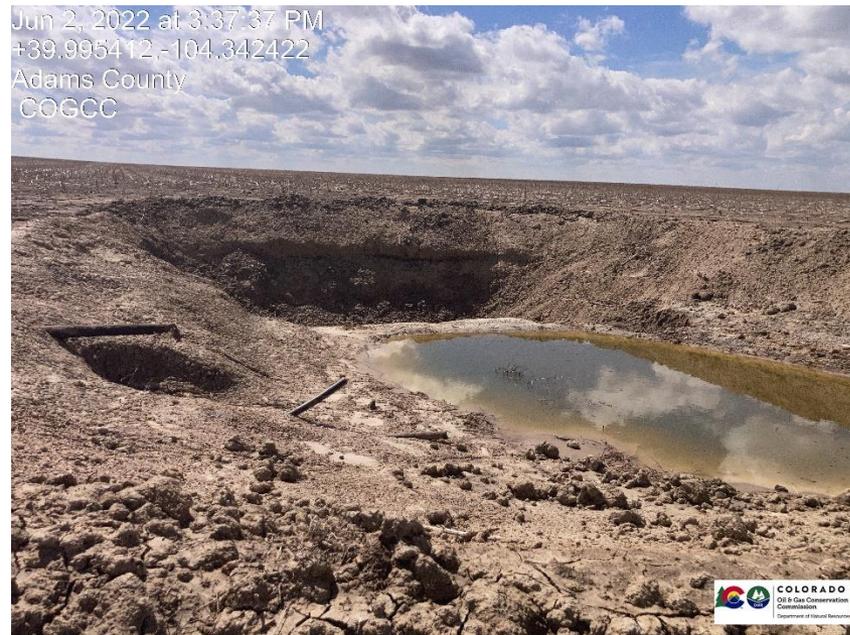
Pic 10 pit

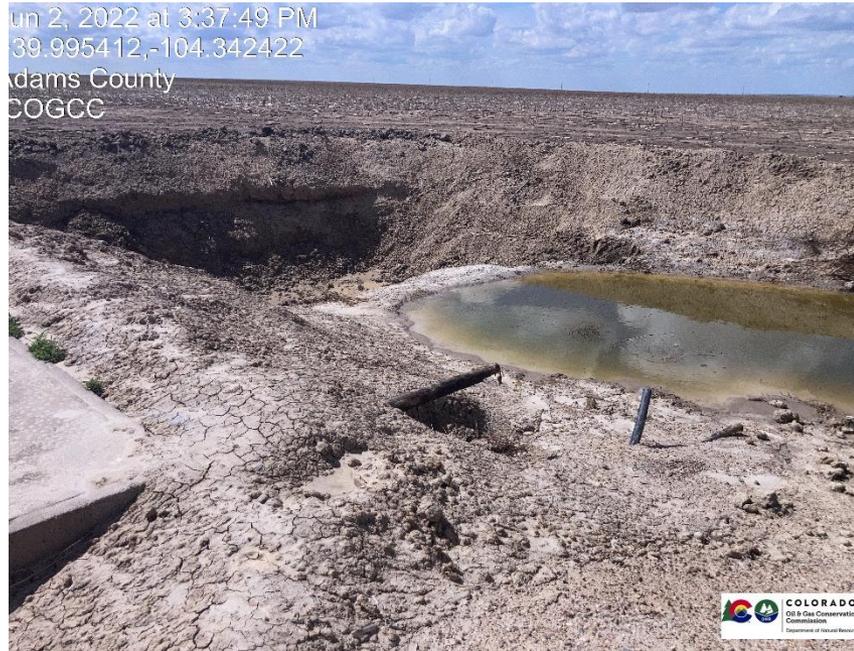
Pic 11 pit
