# Inspection Photos

May 31, 2022

Location Name: Shideler-66S92W /32SWNE

Inspection Document #: 702800290

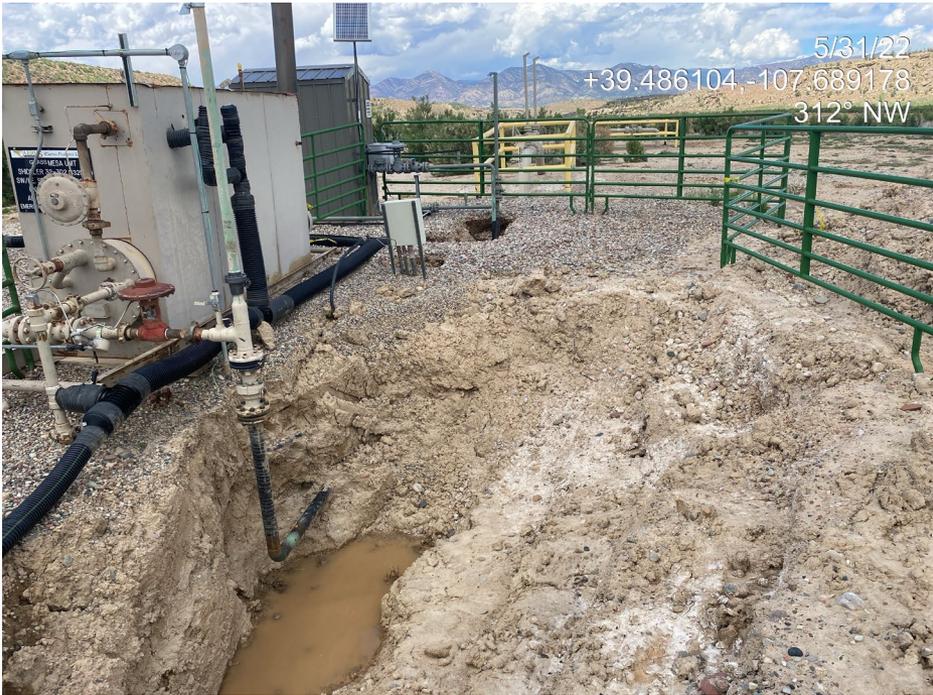
**Photo 1.** Photo taken from the separator at the northeast of the Location shows fence panels completely enclosing an excavation.

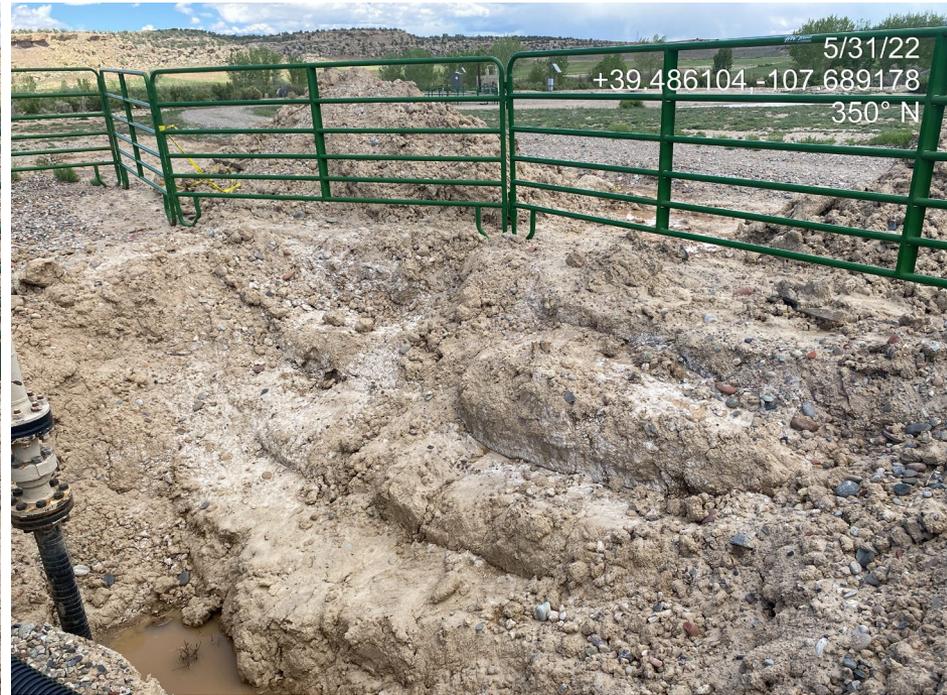
**Photo 2.** Photo taken from the separator at the northeast of the Location shows fence panels completely enclosing an excavation. Photo also shows the sides of the excavation are gently sloped and stepped to allow for egress.

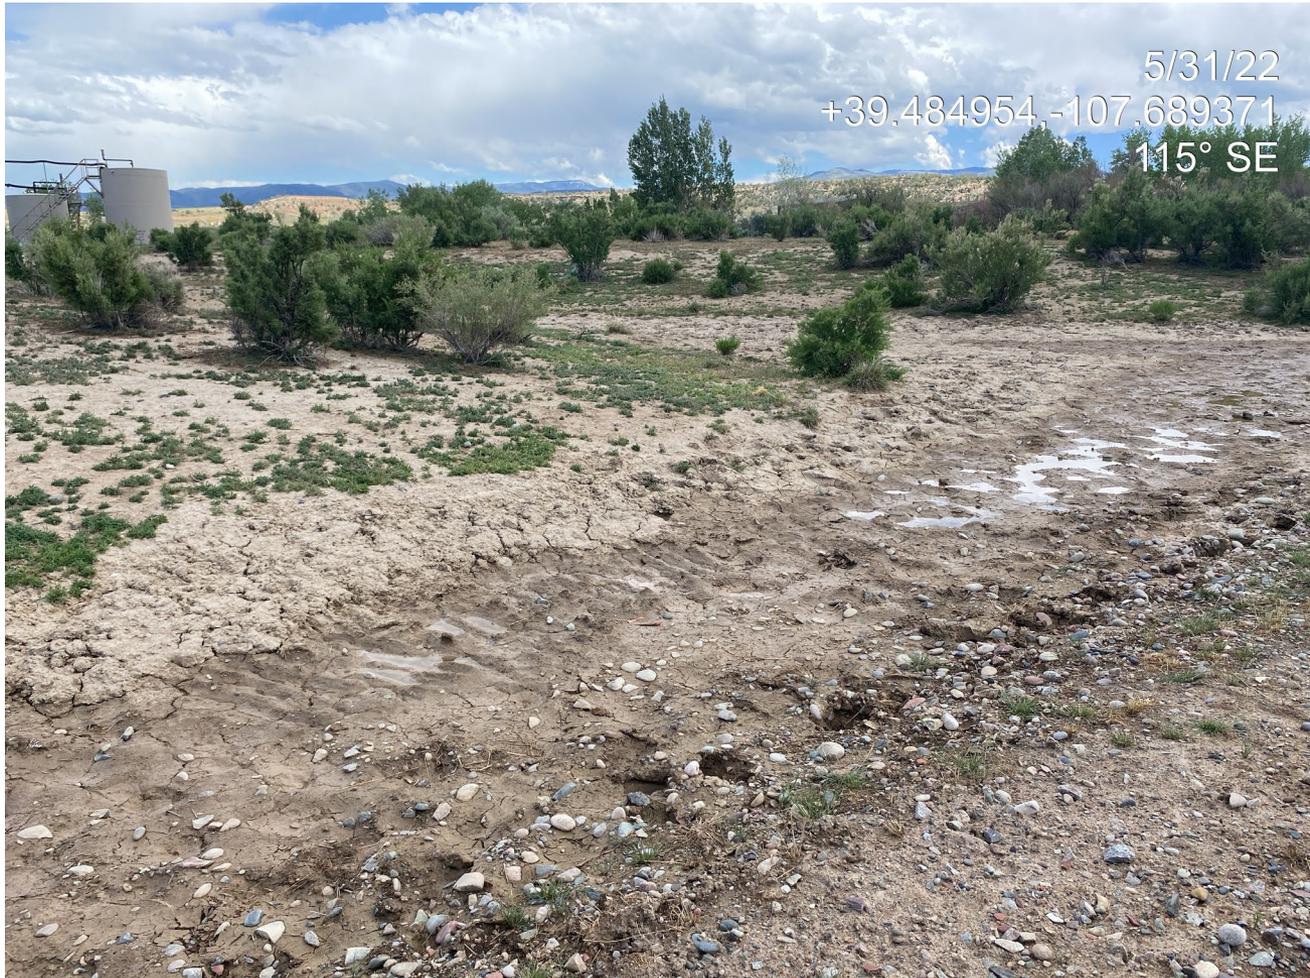
**Photo 3.** Photo taken from the southeast of the Location shows where a guy line anchor has been removed.

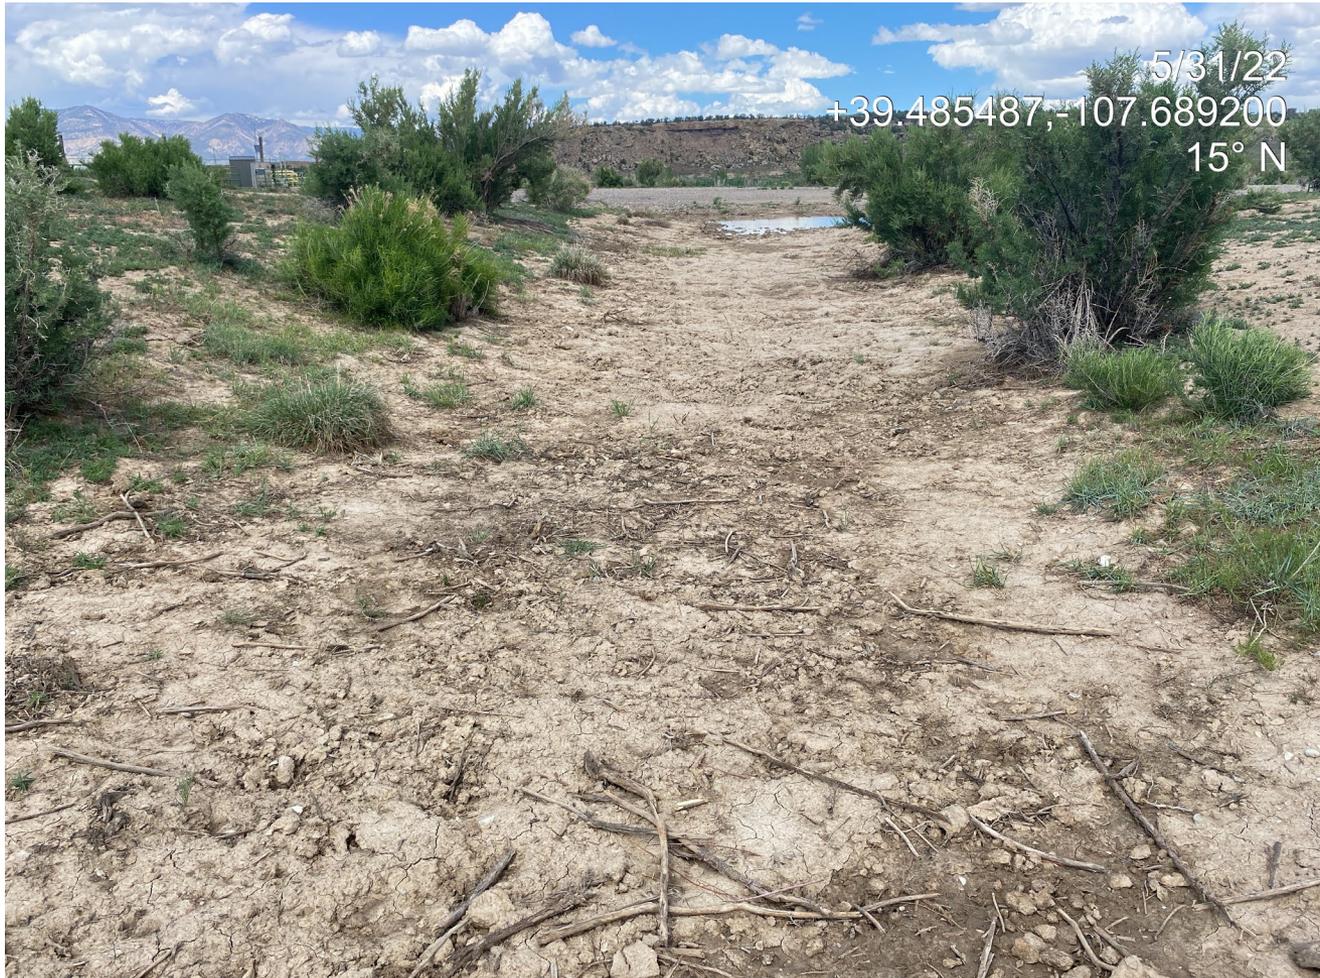
**Photo 4.** Photo taken from the ditch to the east of the Location shows where Noxious salt cedar plants have been removed.

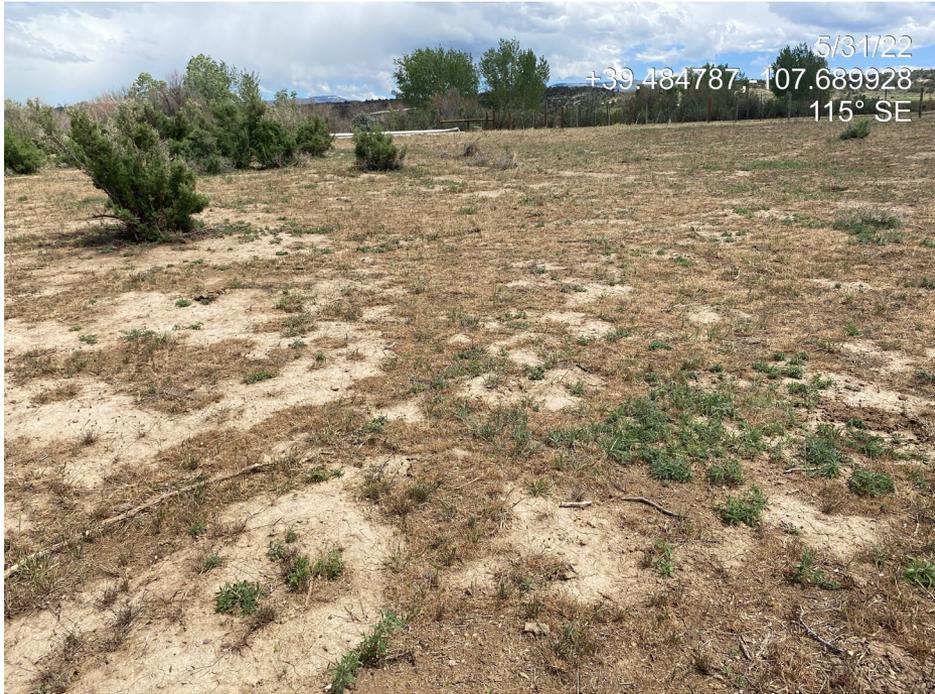
**Photo 5.** Photo taken from the south of the Location shows interim area shrub interspaces dominated by bare ground and undesirable plant species/weeds.

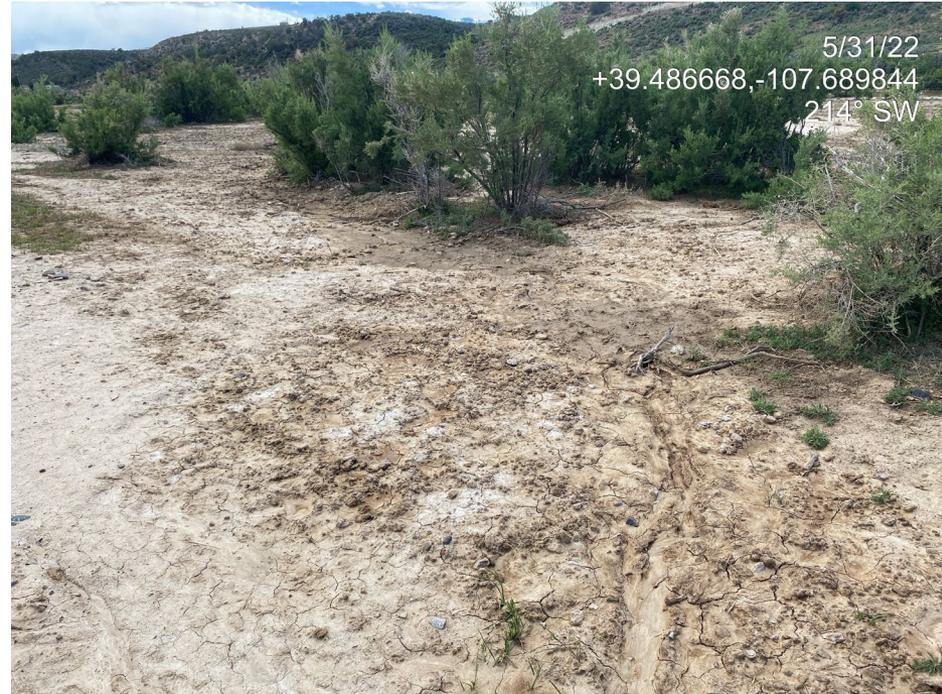
**Photo 6.** Photo taken from the north of the Location shows where erosion was raked. Erosion continues at the site, as no control measures were implemented to stabilize soils.

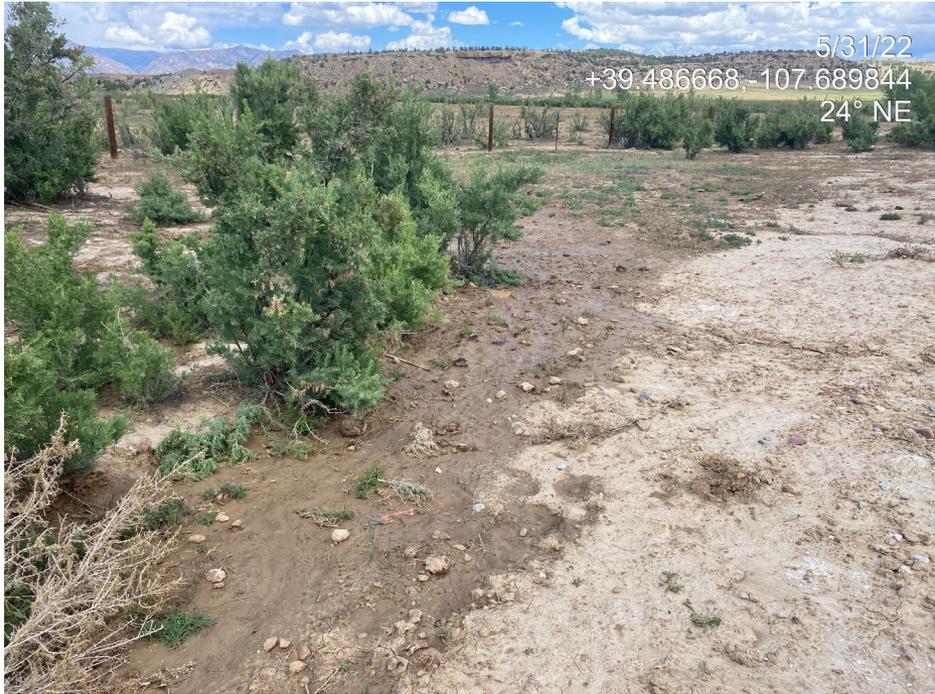
**Photo 7.** Refer to Photo 6 comments.

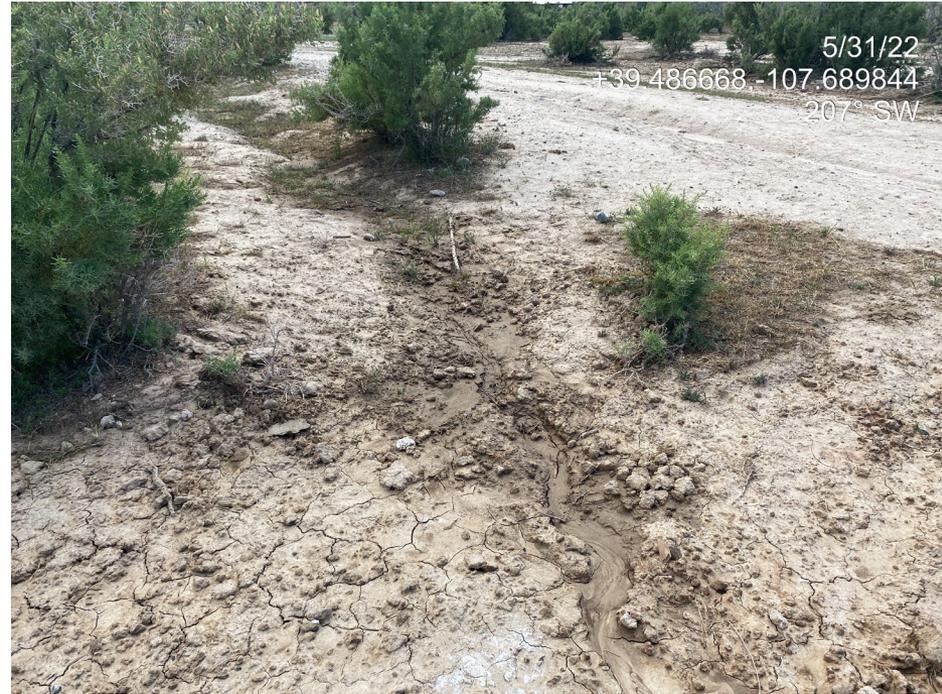
**Photo 8.** Refer to Photo 6 comments.
