## **ATTACHMENT B**

## TANK BATTERY DECOMMISSIONING FORM

<b>SITE NAME:</b> Brant HZ Facility							<b>DATE:</b> 6/2/2022	<b>REM. PROJECT #:</b>	<b>WEATHER:</b> Sunny 70's
<b>SITE DIRECTIONS:</b> From HWY 7 and Riverdale Road travel south 3/10 of a mile to location							<b>CLIENT:</b> PDC - Cheyenne		
<b>LEGALS AND LAT/LONG:</b>							<b>TASMAN PERSONNEL:</b> Sam Anderson		
<b>SOIL TYPES:</b> Clayey Sand - SC							<b>SURFACE GRADIENT:</b> Southeast		
SOIL SAMPLING							FACILITY INFRASTRUCTURE		
Date/Time	Soil Sample ID	PID (ppm)	Visual	Olfactory	Photo?	Grab or Lab Sample?	EQUIPMENT		Quantity
							Above Ground Storage Tank (AST)		
6/2/2022 10:40	GS01 @ 0-6"	3.4	HC Staining	Slight HC Odor	Yes	Grab	Buried or Partially Buried Vessel		
6/2/2022 10:42	GS02 @ 0-6"	0.8	No Staining	No Odor	Yes	Grab	Separator		
6/2/2022 10:44	GS03 @ 0-6"	11.5	HC Staining	Slight HC Odor	Yes	Grab	Emission Control Device (ECD)		
6/2/2022 10:46	GS04 @ 0-6"	0.4	No Staining	No Odor	Yes	Grab	Dump Line

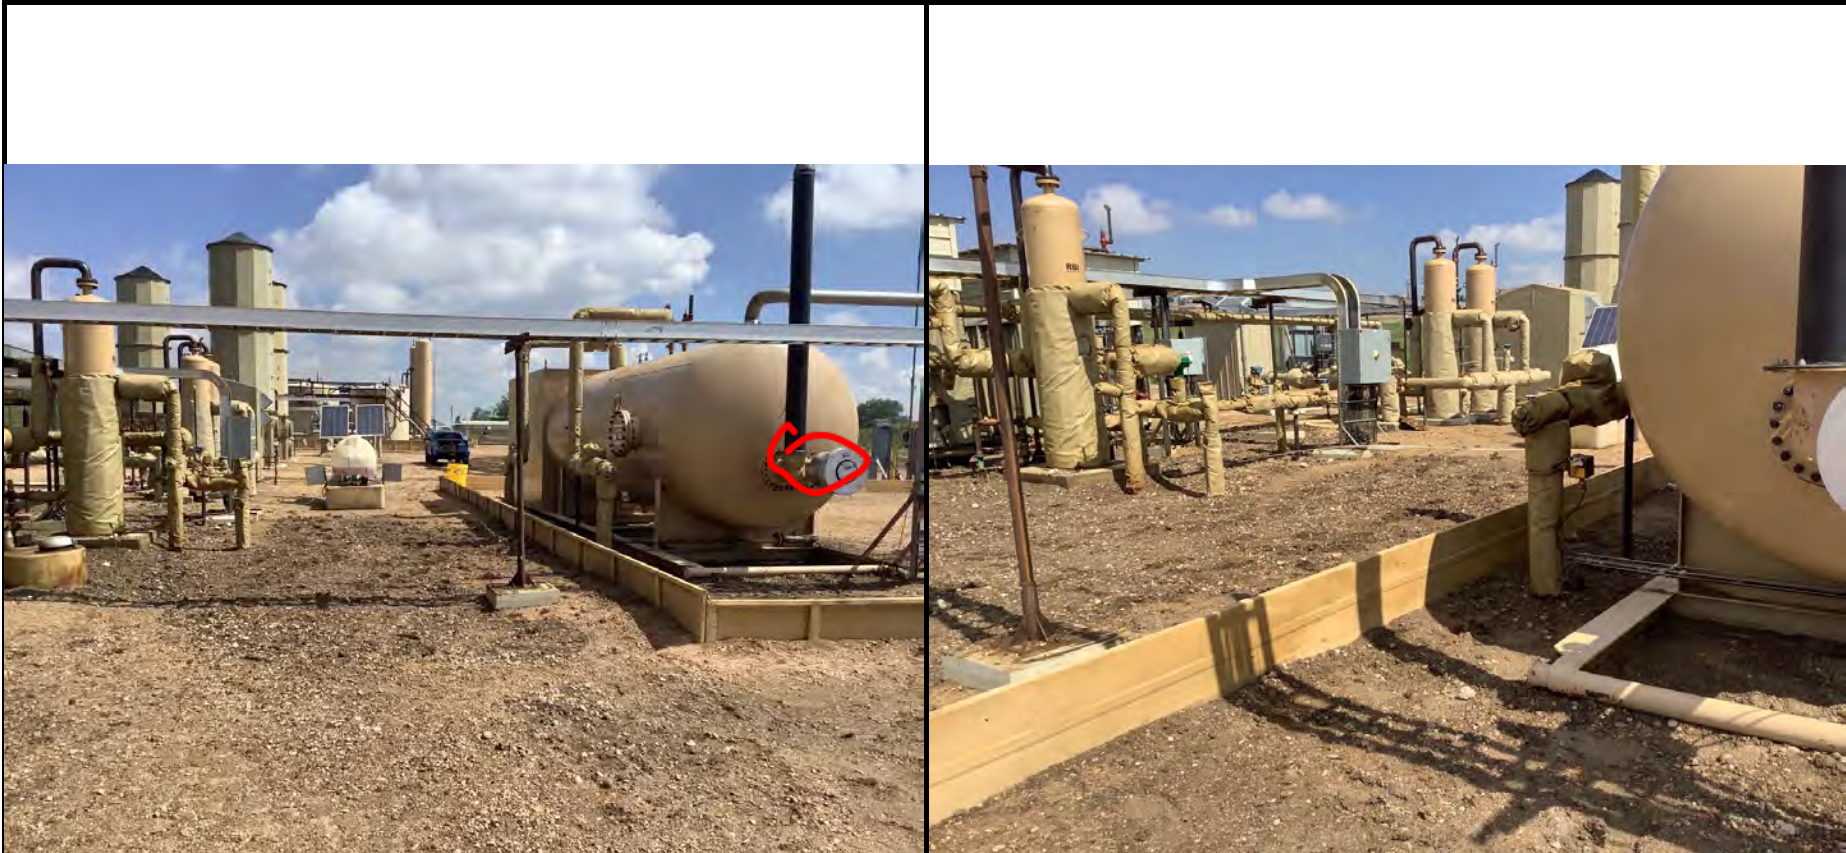
<b>Equipment ID:</b>		<b>Equipment Type:</b>	
<b>Material:</b>	<b>Volume:</b>	<b>Contents:</b>	
<b>Notes/Conditions:</b> Point of release

<b>Equipment ID:</b> Release area		<b>Equipment Type:</b>	
<b>Material:</b>	<b>Volume:</b>	<b>Contents:</b>	
<b>Notes/Conditions:</b>

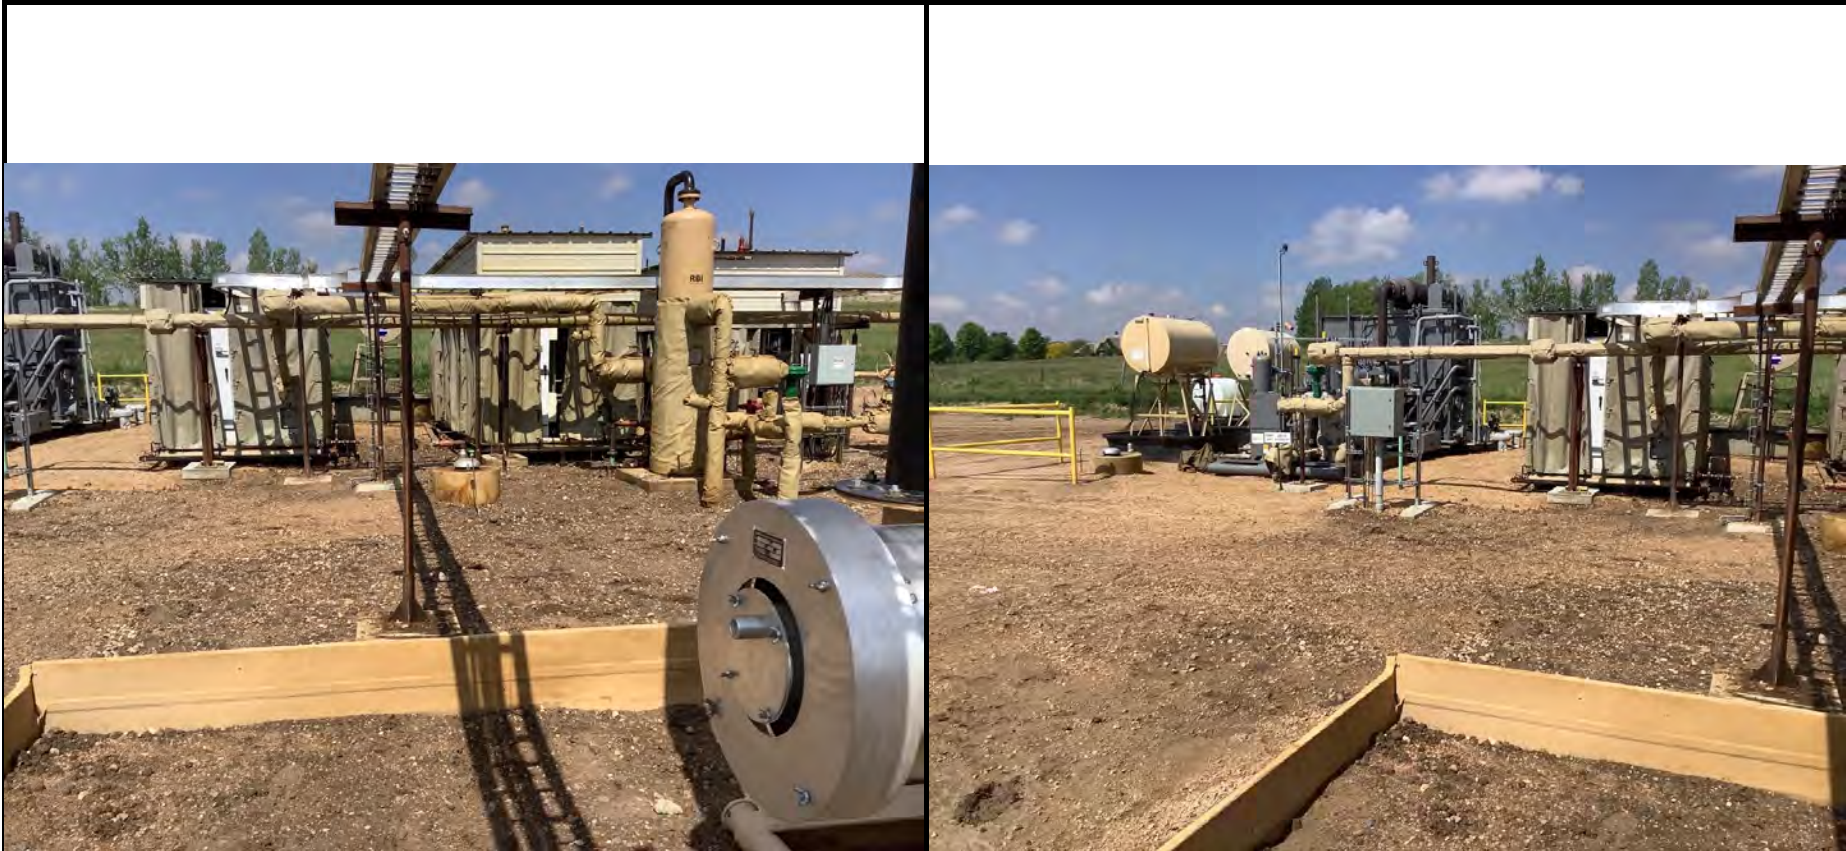
<b>Equipment ID:</b>		<b>Equipment Type:</b>	
<b>Material:</b>	<b>Volume:</b>	<b>Contents:</b>	
<b>Notes/Conditions:</b> Western view of release area

<b>Equipment ID:</b>		<b>Equipment Type:</b>	
<b>Material:</b>	<b>Volume:</b>	<b>Contents:</b>	
<b>Notes/Conditions:</b> Standing at point of release - showing south western view

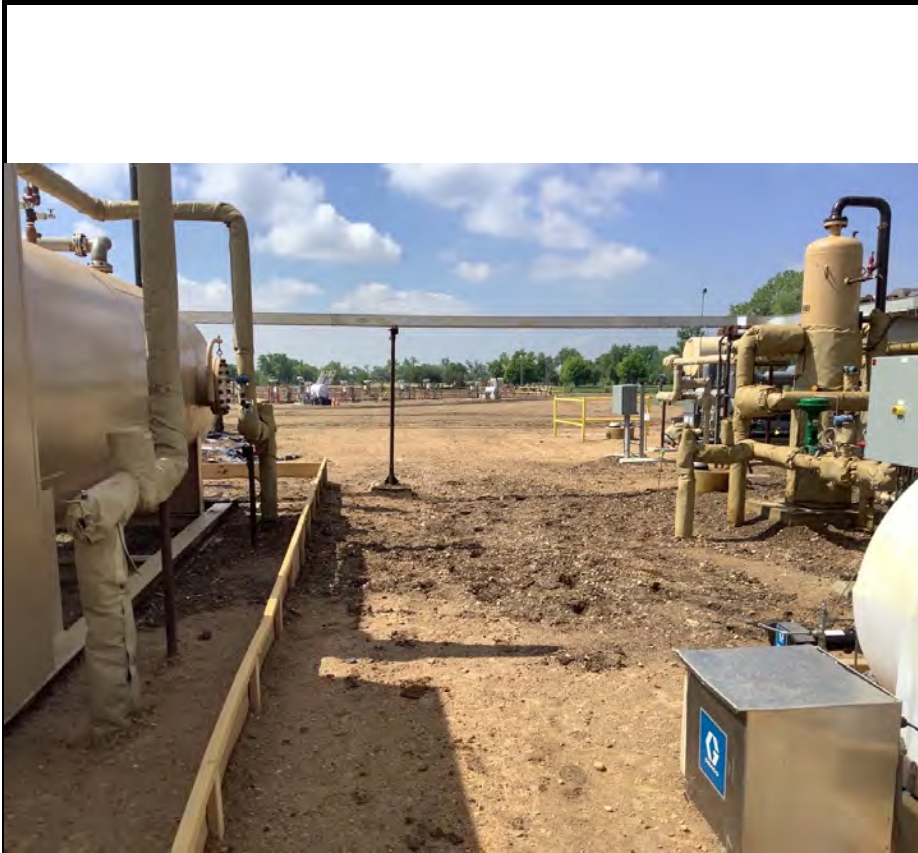
<b>Equipment ID:</b>		<b>Equipment Type:</b>	
<b>Material:</b>	<b>Volume:</b>	<b>Contents:</b>	
<b>Notes/Conditions:</b> Standing at north end of separator viewing release area to the south

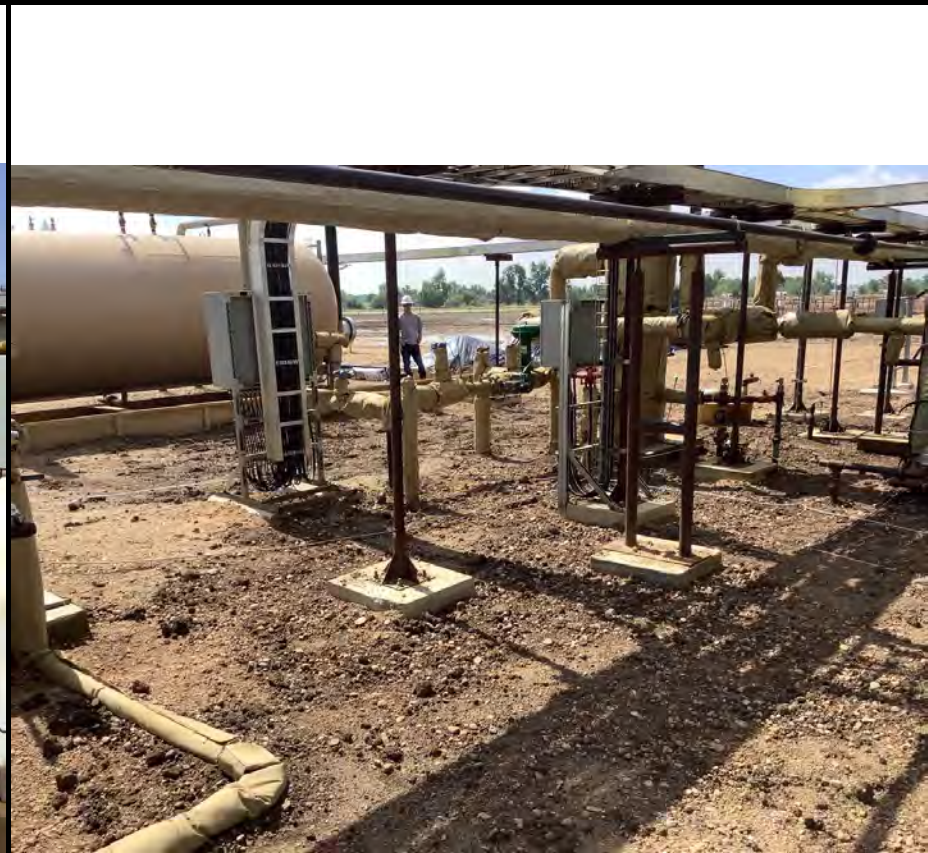
<b>Equipment ID:</b>		<b>Equipment Type:</b>	
<b>Material:</b>	<b>Volume:</b>	<b>Contents:</b>	
<b>Notes/Conditions:</b> Standing at NW corner of release area showing separator release and release area

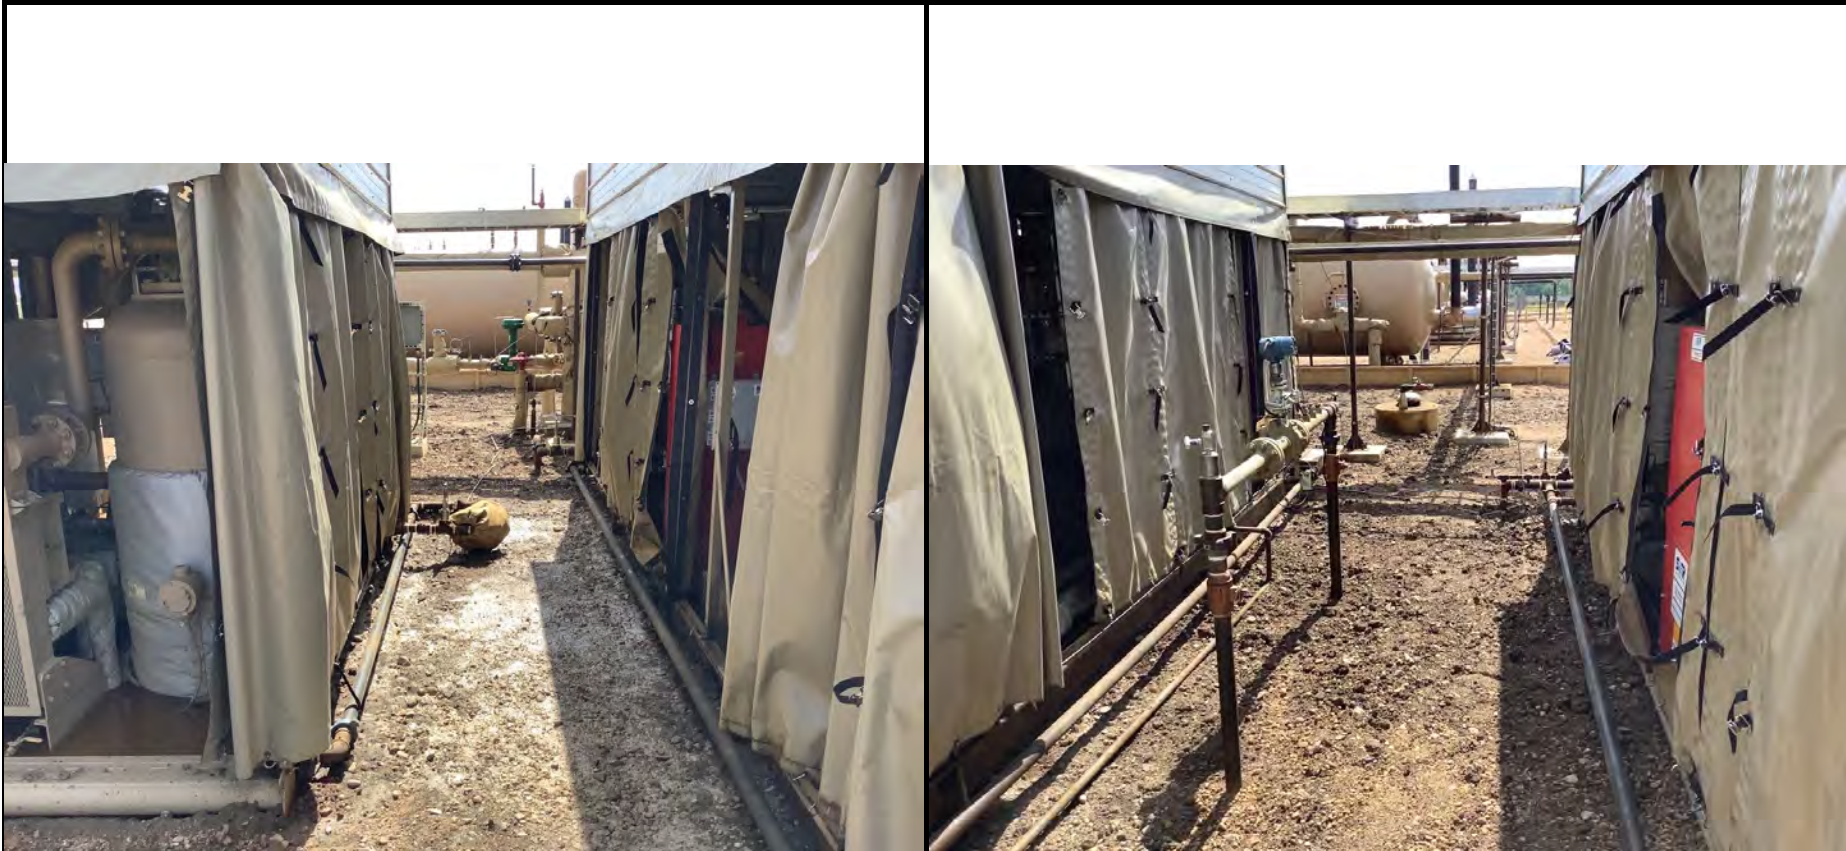
<b>Equipment ID:</b>		<b>Equipment Type:</b>		<b>Equipment ID:</b>		<b>Equipment Type:</b>	
<b>Material:</b>	<b>Volume:</b>	<b>Contents:</b>		<b>Material:</b>	<b>Volume:</b>	<b>Contents:</b>	
<b>Notes/Conditions:</b> Standing at western extent of release area showing pooled water between infrastructure				<b>Notes/Conditions:</b> Standing at south western extent of release showing release point and release between infrastructure

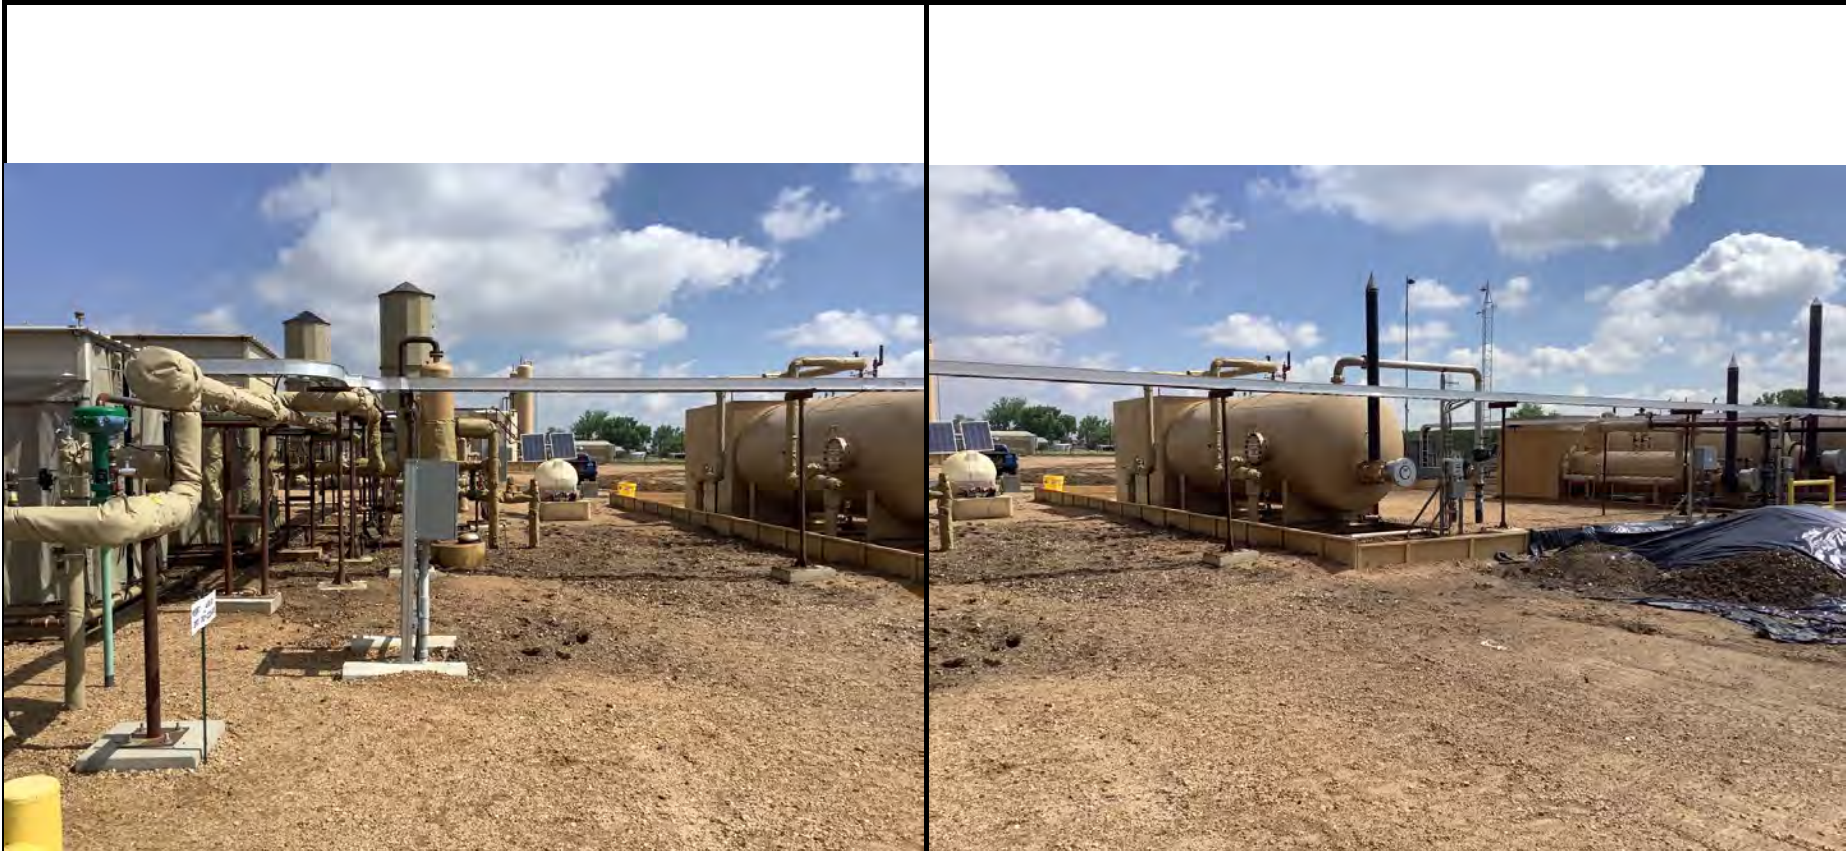
<b>Equipment ID:</b>		<b>Equipment Type:</b>		<b>Equipment ID:</b>		<b>Equipment Type:</b>	
<b>Material:</b>	<b>Volume:</b>	<b>Contents:</b>		<b>Material:</b>	<b>Volume:</b>	<b>Contents:</b>	
<b>Notes/Conditions:</b> South western corner of release area and entire release extent				<b>Notes/Conditions:</b> Release point and half of stock pile

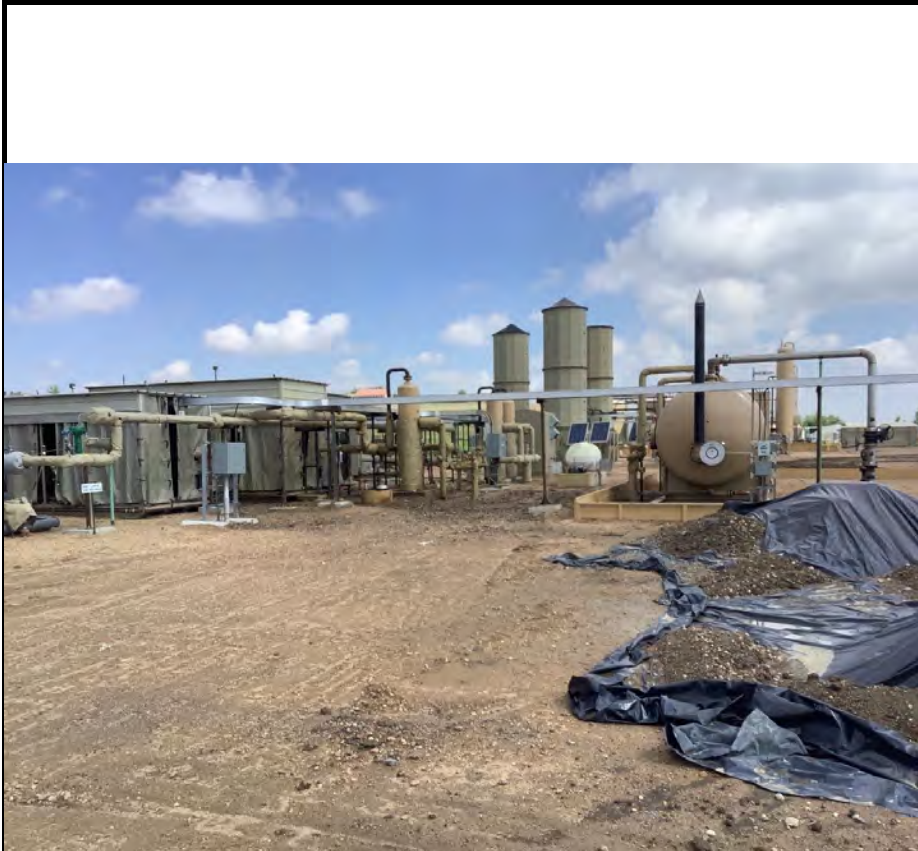
<b>Equipment ID:</b>		<b>Equipment Type:</b>	
<b>Material:</b>	<b>Volume:</b>	<b>Contents:</b>	
<b>Notes/Conditions:</b> Stockpiled release area material

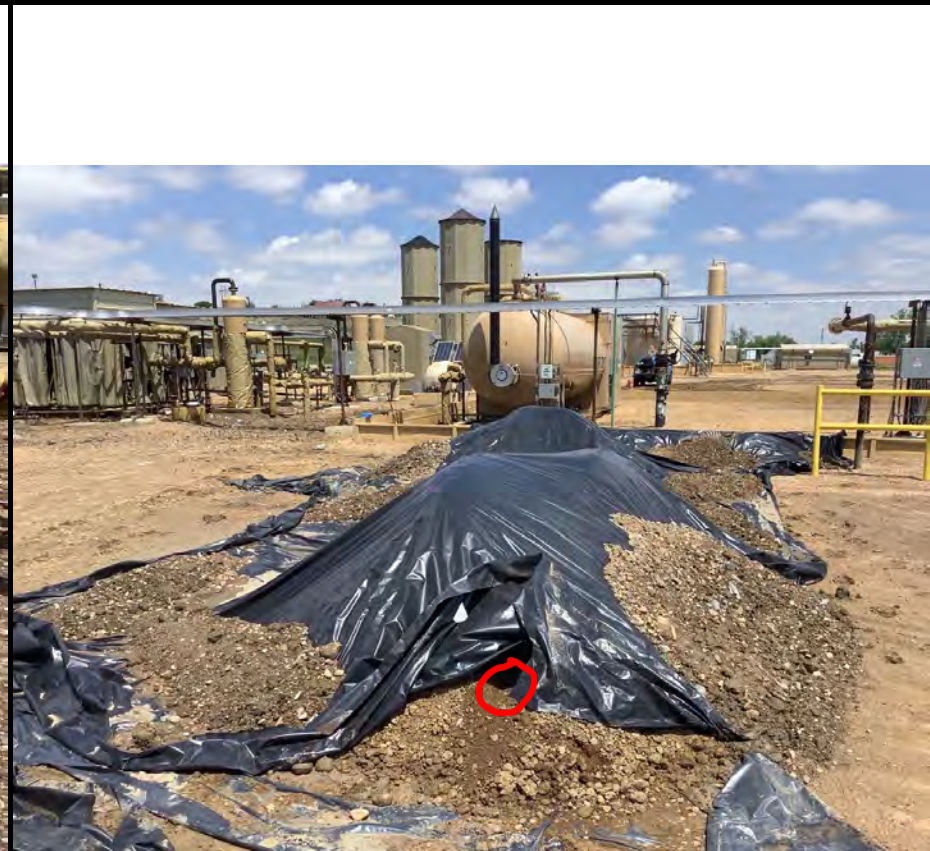
<b>Equipment ID:</b> SS01		<b>Equipment Type:</b>	
<b>Material:</b>	<b>Volume:</b>	<b>Contents:</b>	
<b>Notes/Conditions:</b> Waste characterization sample from removed and piled source material

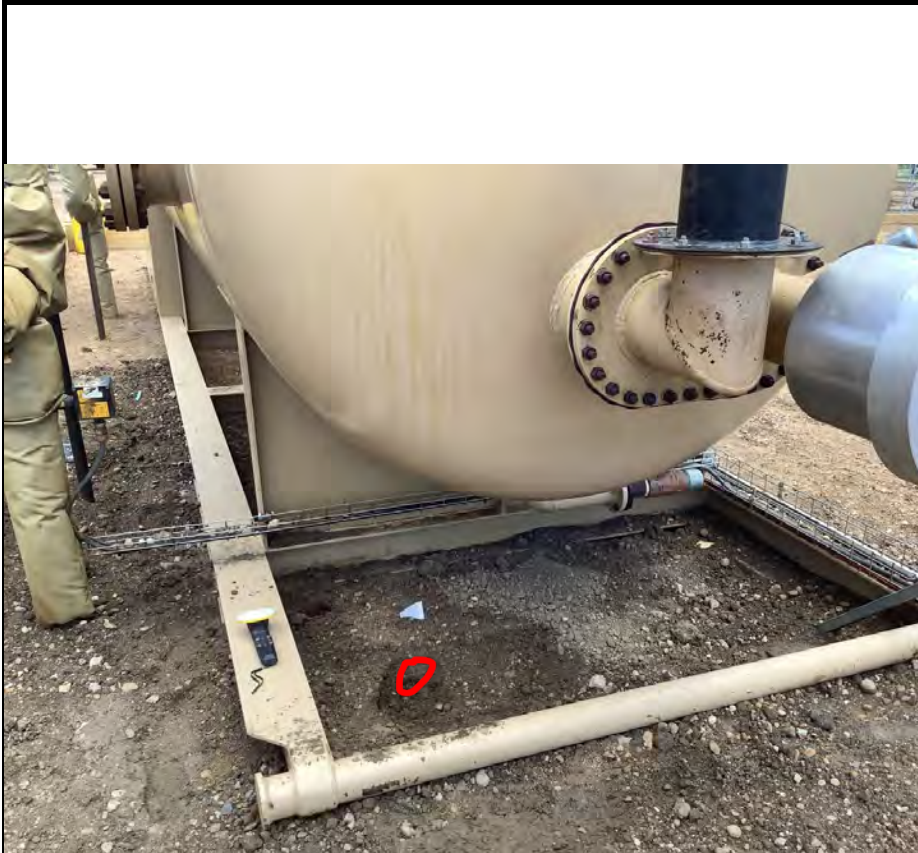
<b>Equipment ID:</b> SS02		<b>Equipment Type:</b>	
<b>Material:</b>	<b>Volume:</b>	<b>Contents:</b>	
<b>Notes/Conditions:</b> Under release point

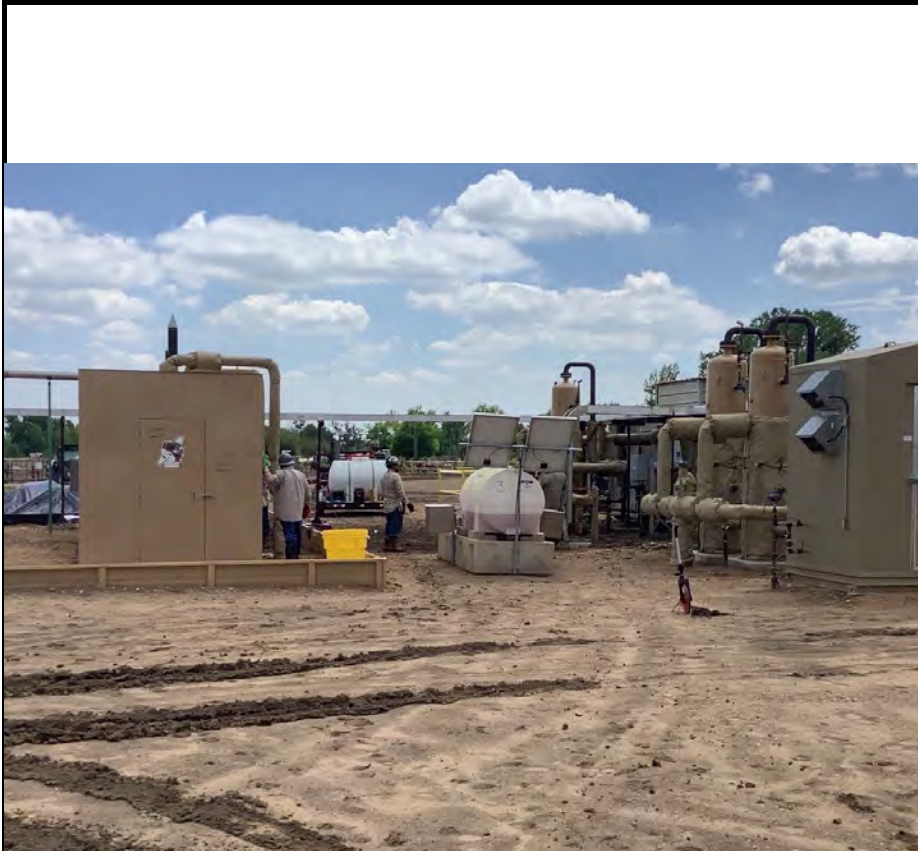
<b>Equipment ID:</b>		<b>Equipment Type:</b>	
<b>Material:</b>	<b>Volume:</b>	<b>Contents:</b>	
<b>Notes/Conditions:</b> Cleaning crew

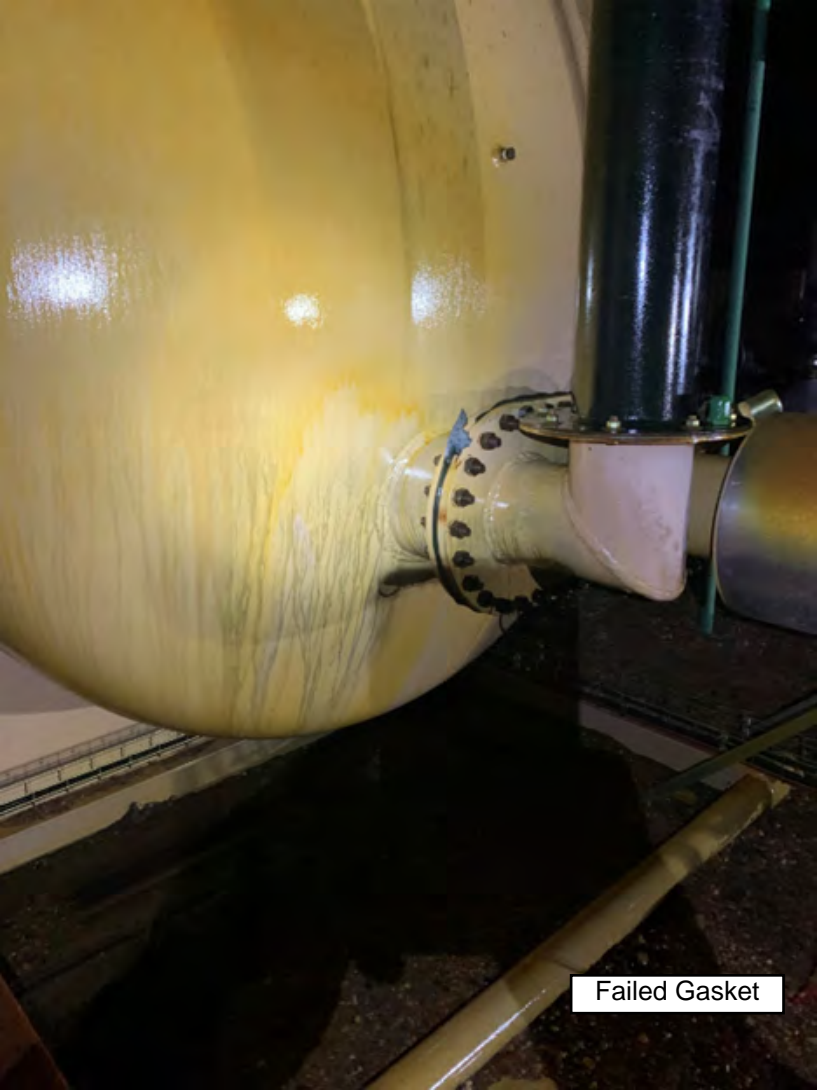
Failed Gasket

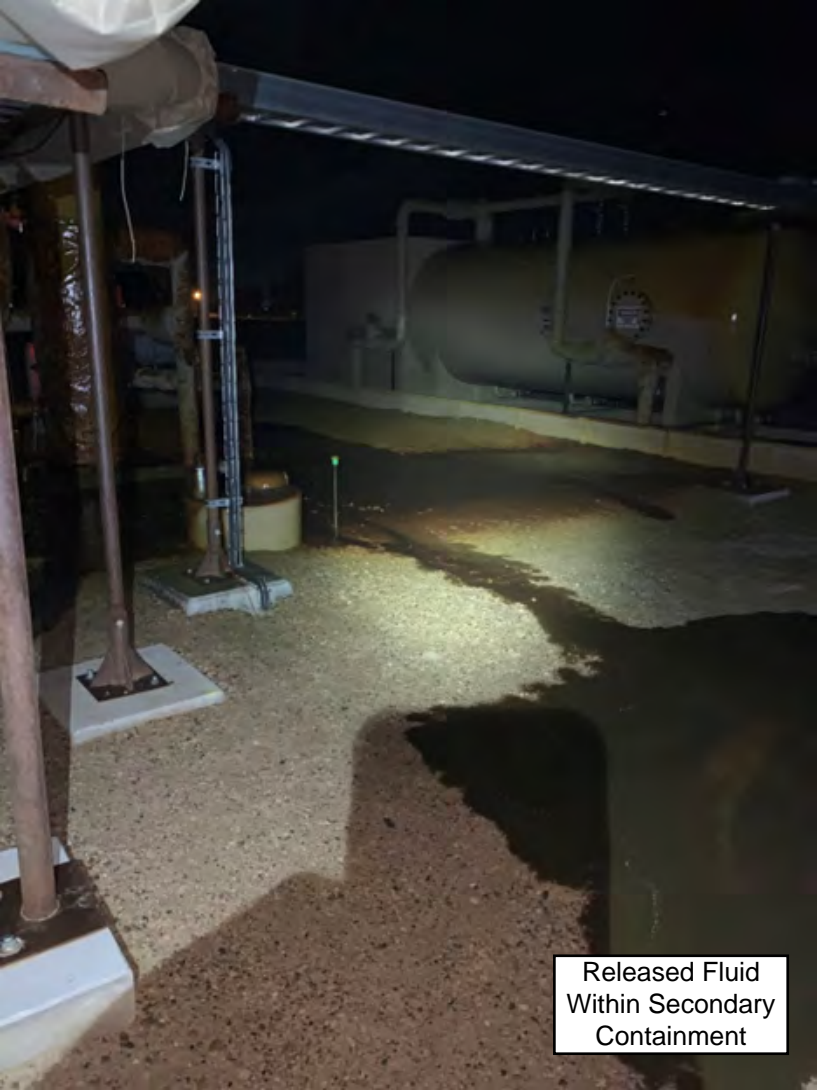
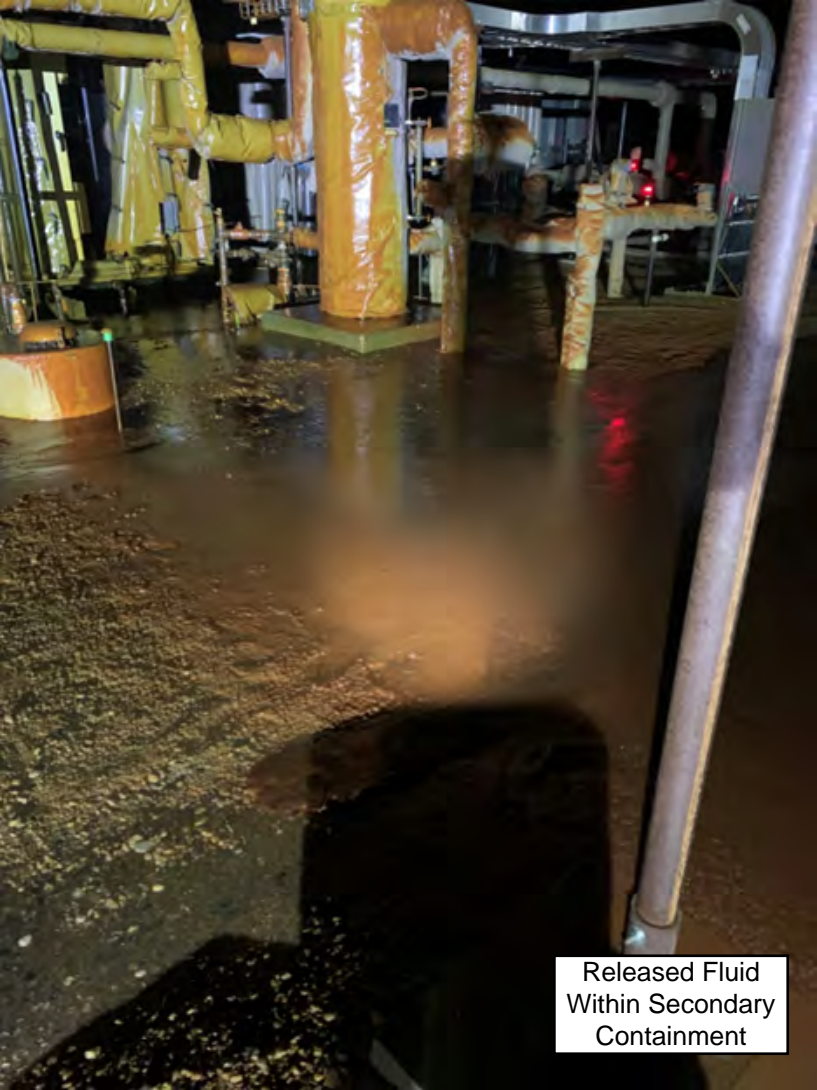
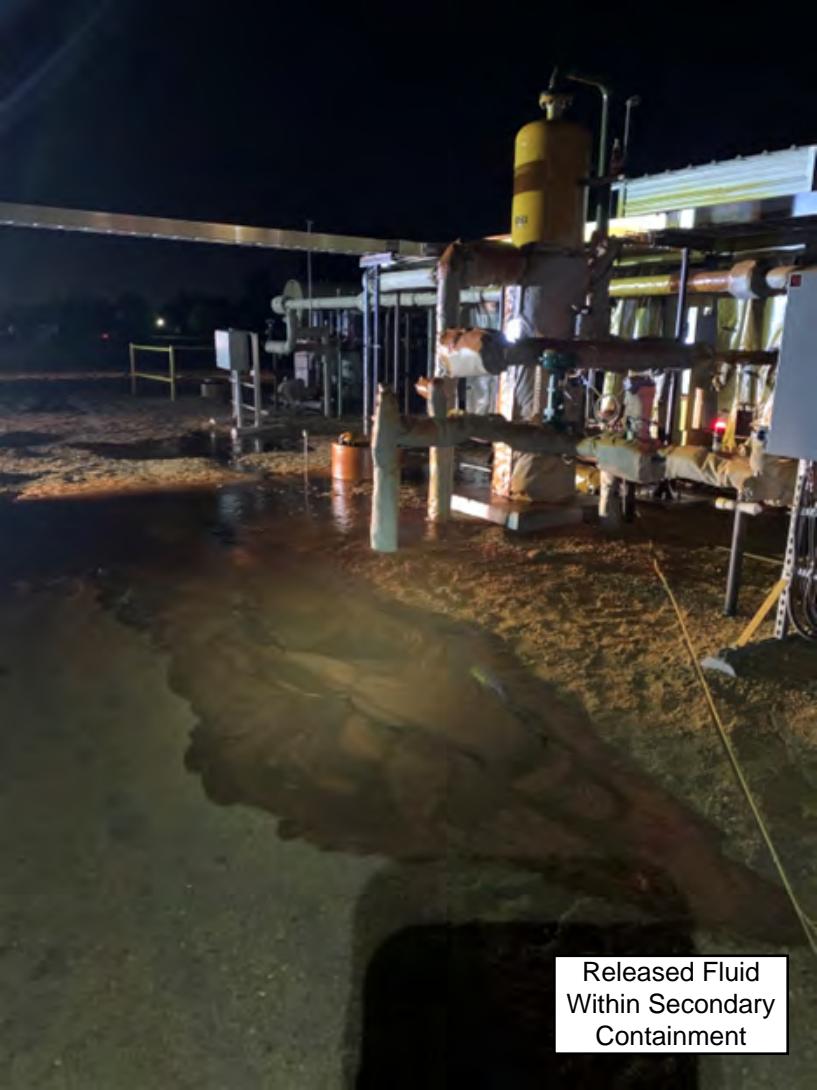
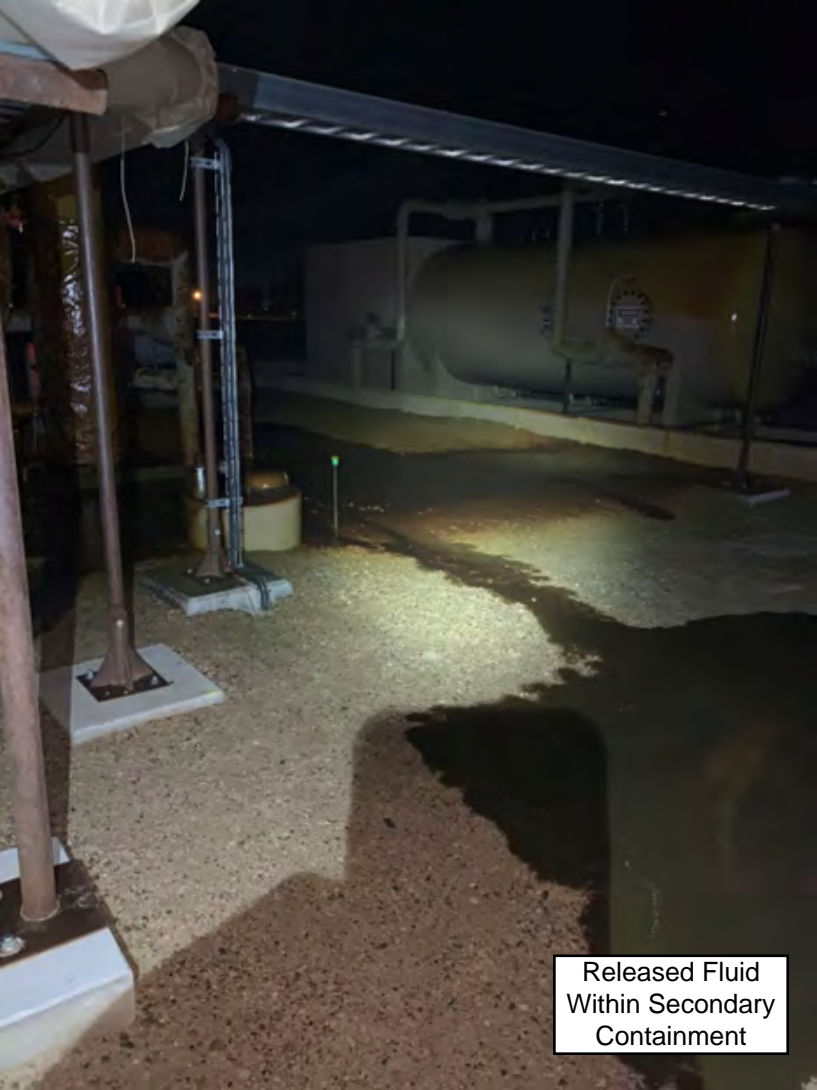
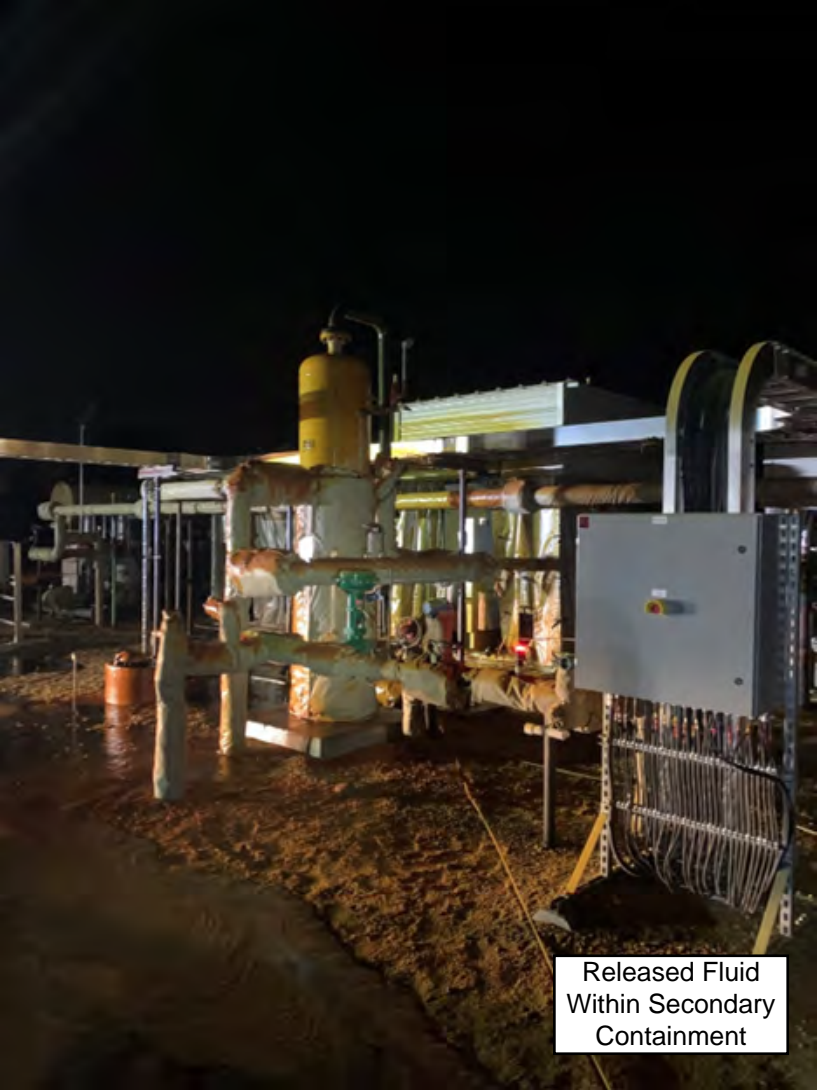
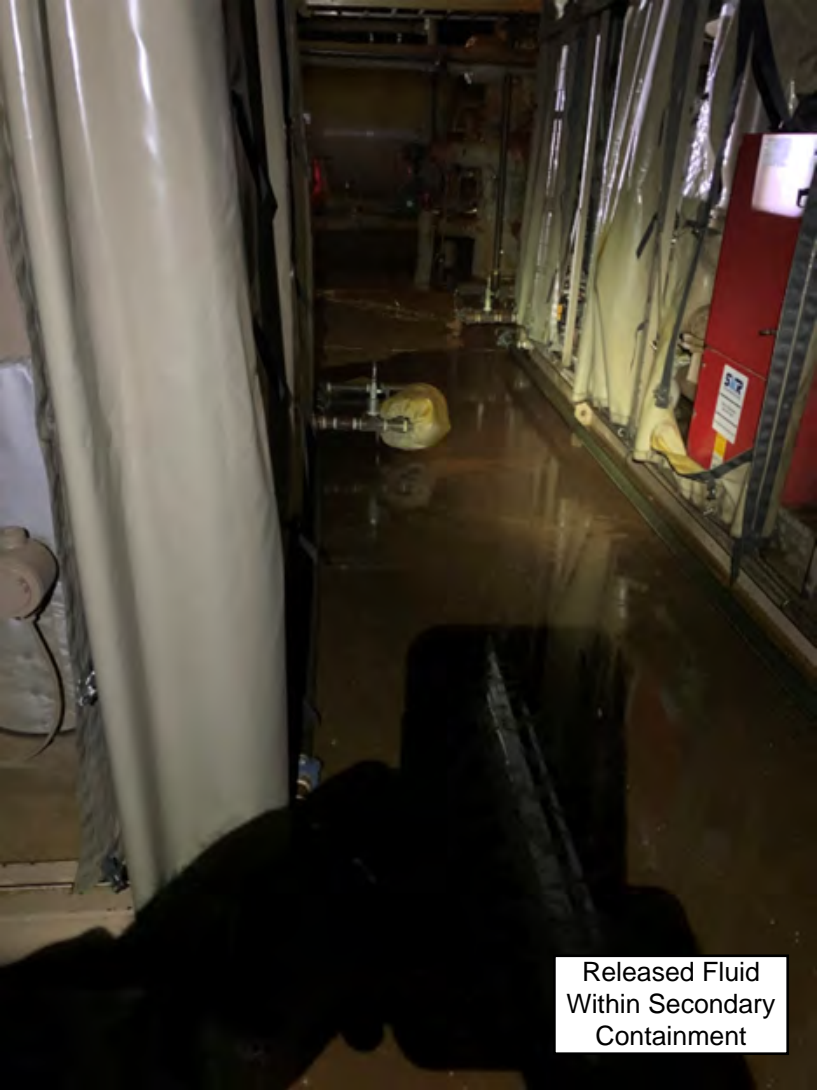
Released Fluid  
Within Secondary  
Containment
