# Inspection Photos

API: 055-06196

Operator: EVERGREEN NATURAL RESOURCES

Inspection Date: 6/7/2022

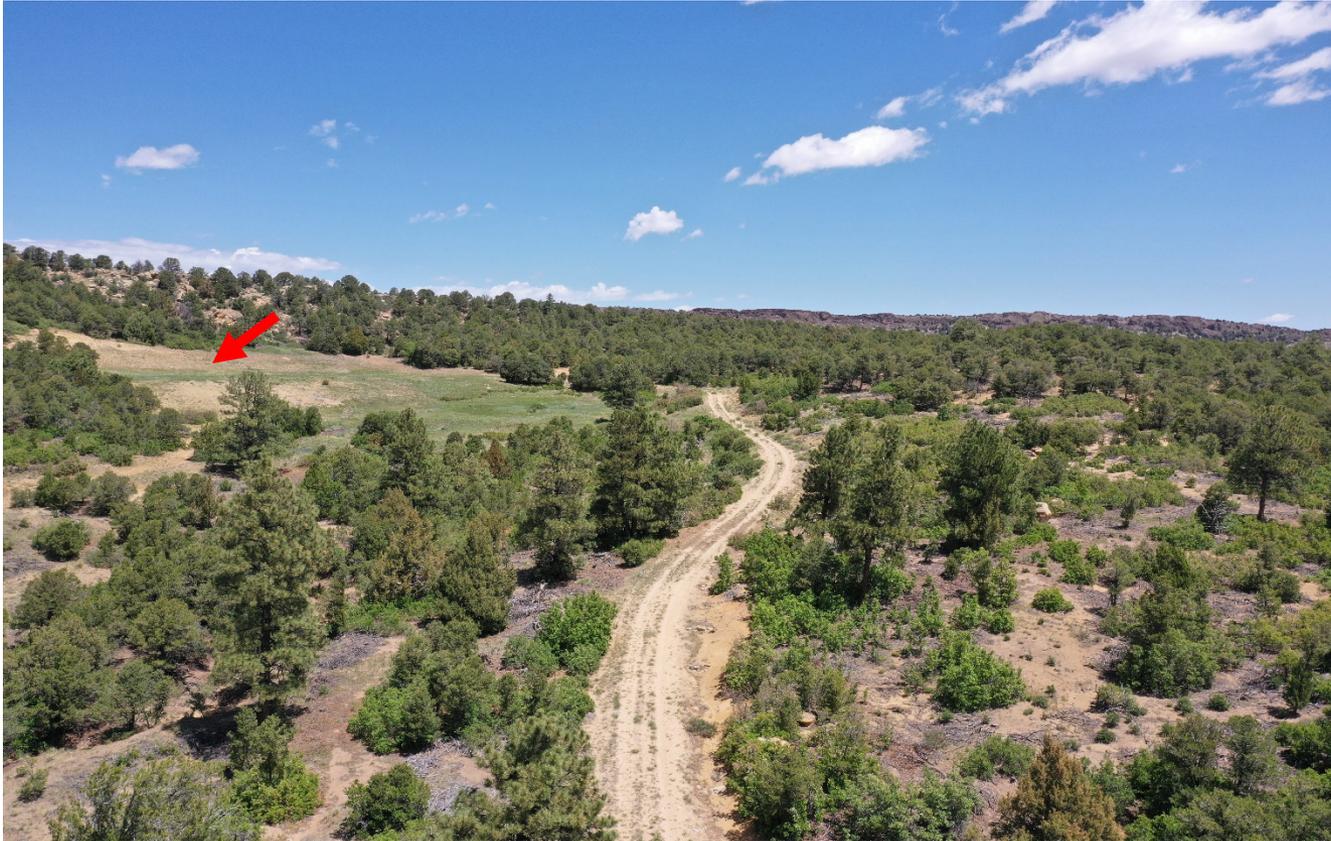
**Photo 1.** Drone aerial photo facing north along the former access road. The road was not recontoured and reclaimed but continues on past the location. Location shown at red arrow.

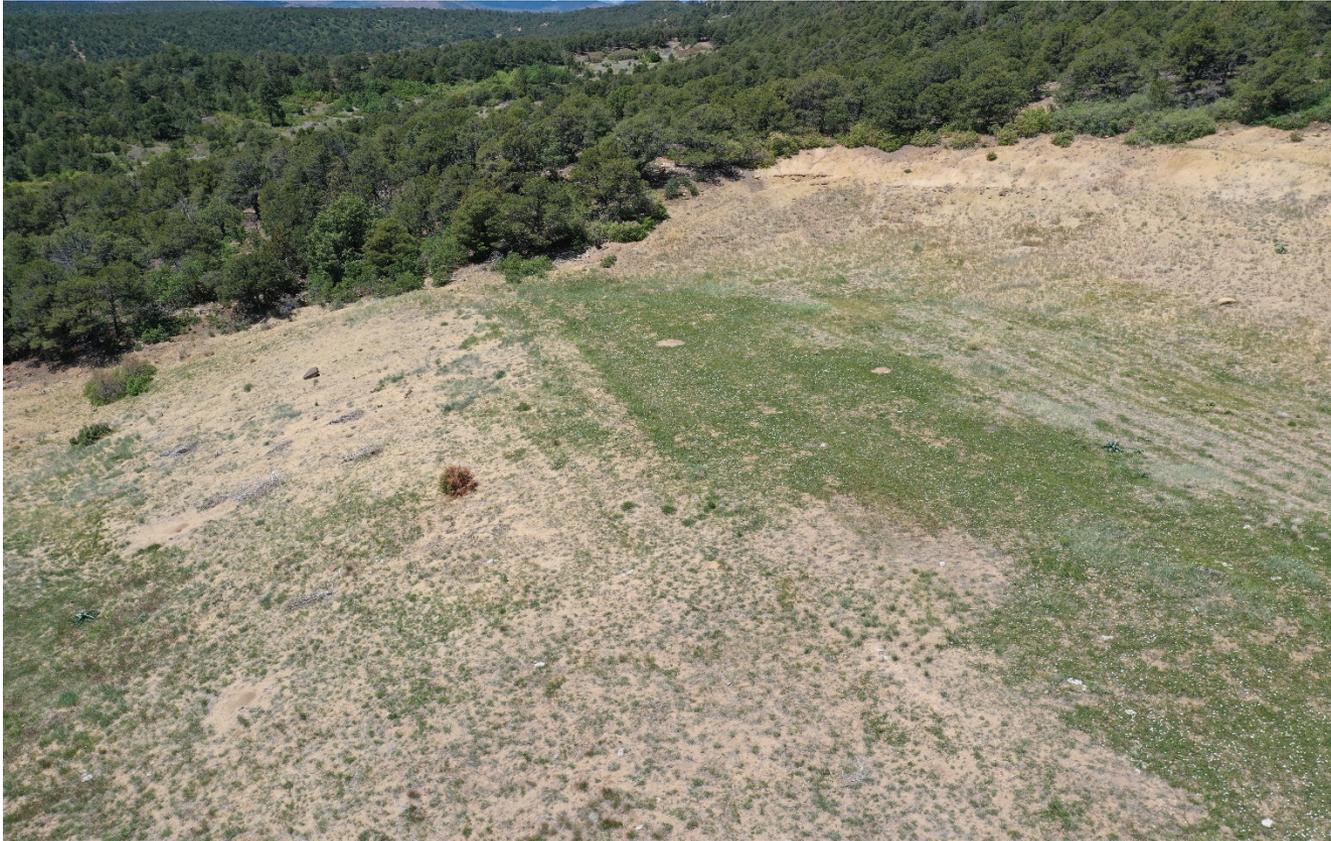
**Photo 3.** Facing southwest down toward the fill slope of the location. The desirable vegetation has not reestablished at the location and there were noxious weeds observed including Red stem filaree, Field bindweed, and Scotch thistle.

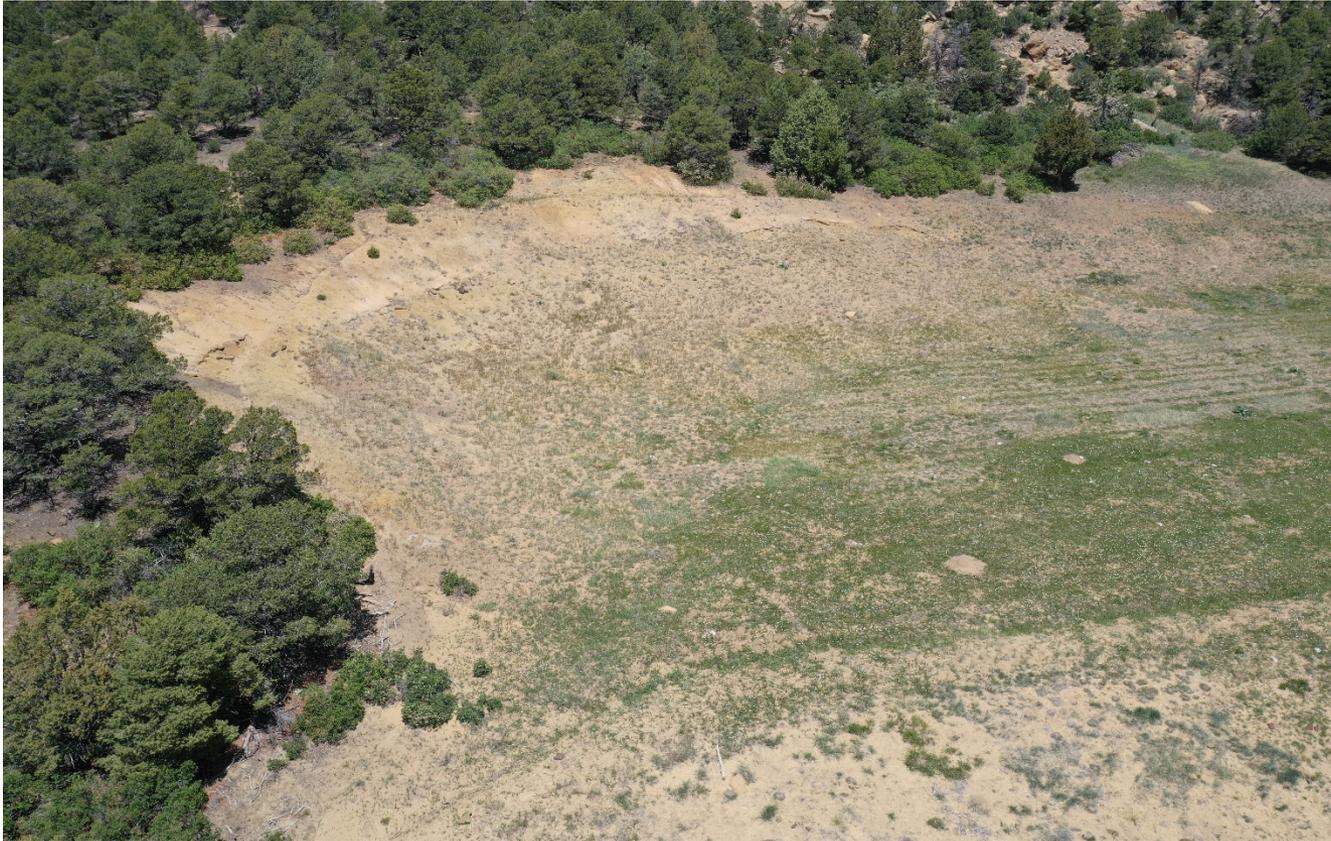
**Photo 4.** Facing northwest toward the cut slope of the location.
