Inspection Photos

API: 055-06278

Operator: EVERGREEN NATURAL RESOURCES

Inspection Date: 6/7/2022

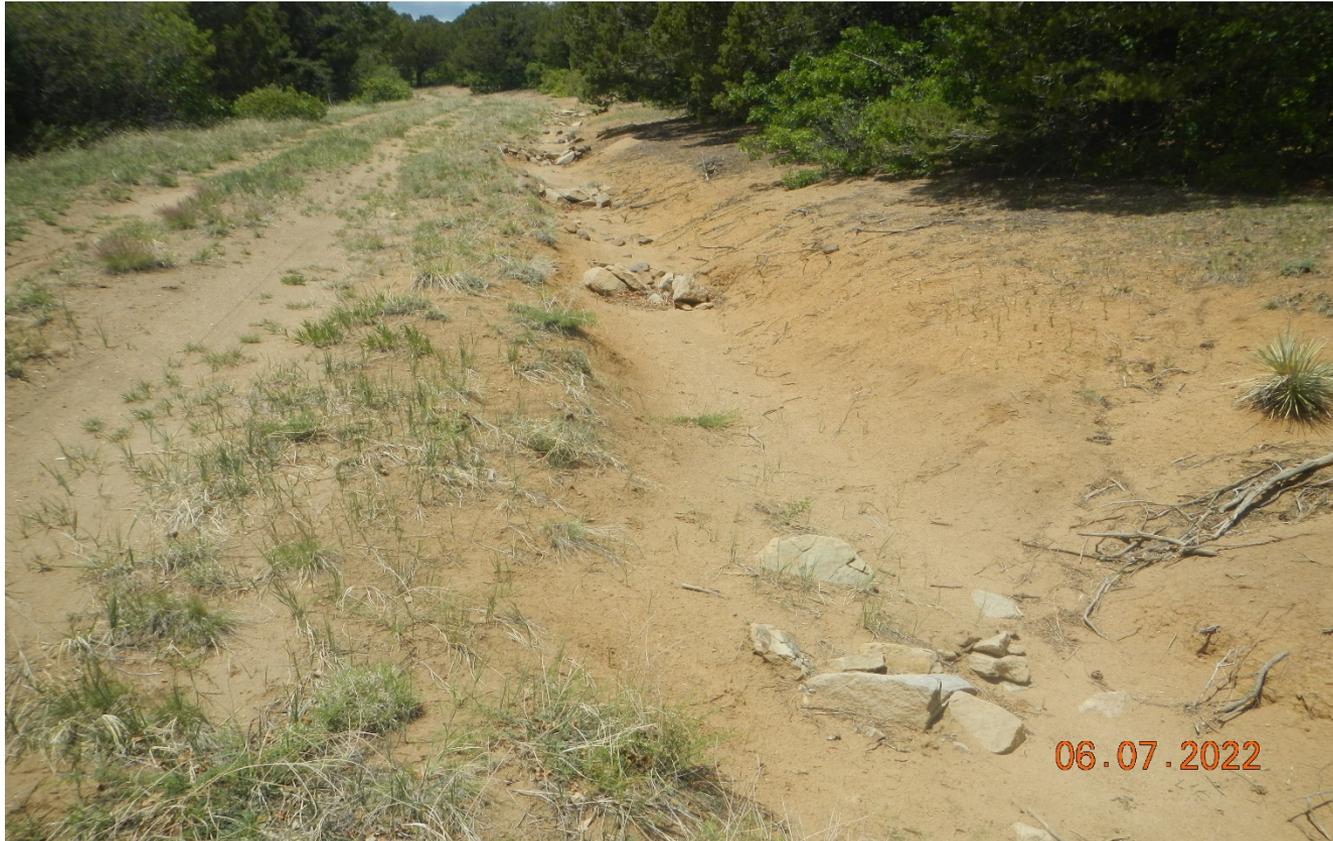
Photo 1. Facing southwest along the former access road. The road was not recontoured and reclaimed. There is erosion occurring along the road and the rock check dams are displaced. Previous corrective action was not performed.

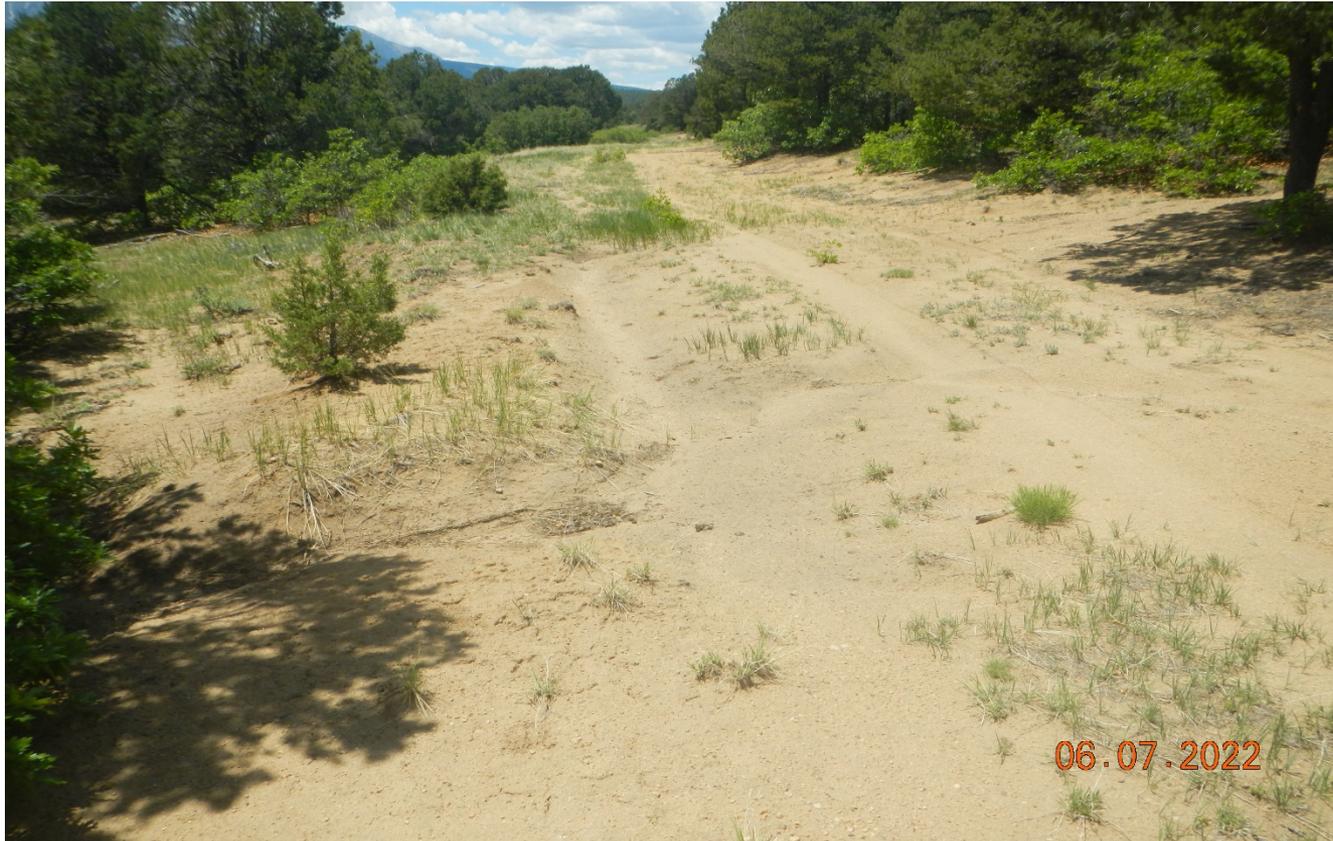
Photo 2. Facing southwest along the former access road which was not reclaimed. There are signs of erosion along the road.

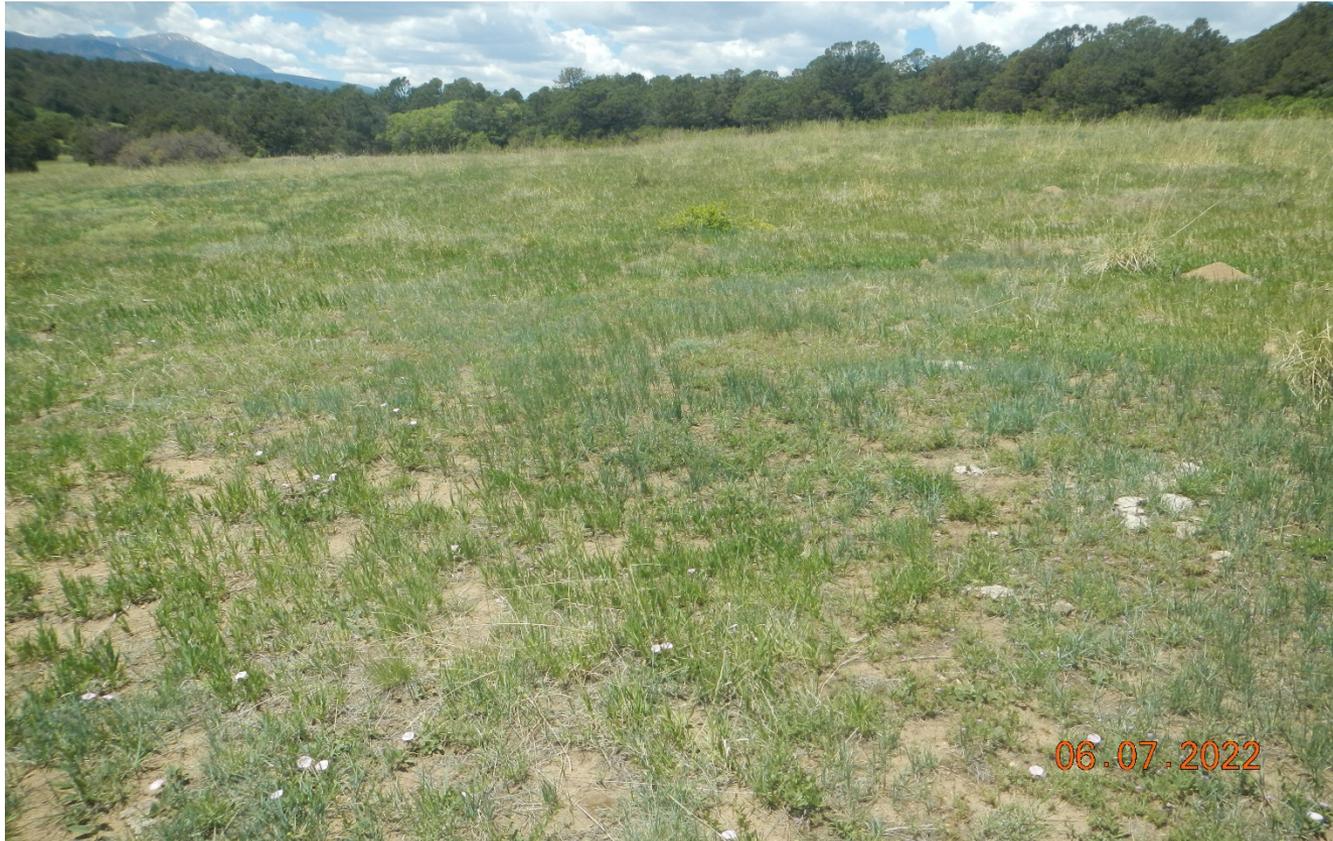
Photo 3. Facing southwest toward the location which was recontoured and reclaimed. There is desirable vegetation established throughout most of the location.

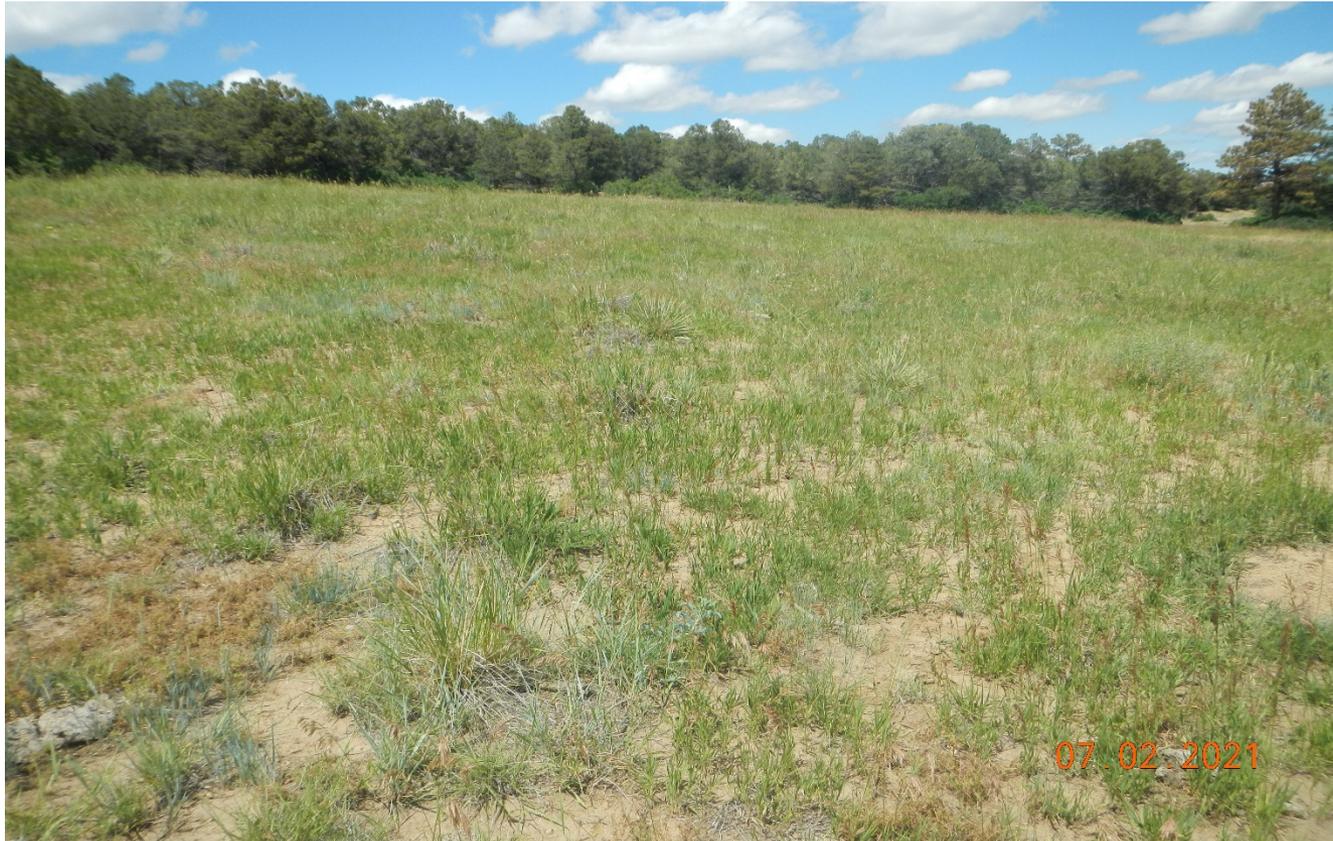
Photo 4. Facing northeast toward the location which was recontoured and reclaimed. There is desirable vegetation established throughout most of the location.

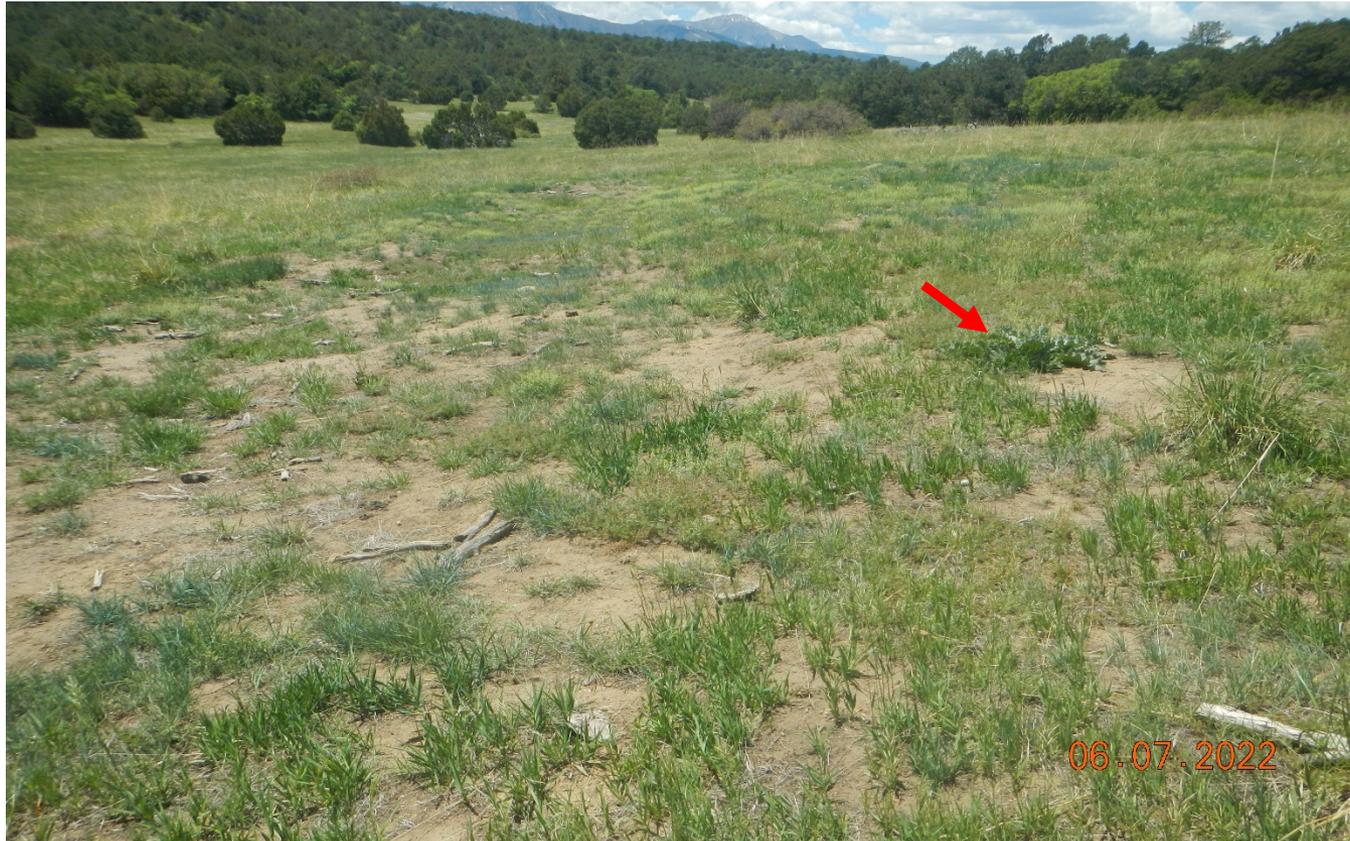
Photo 5. South side of the location facing southwest. There are some weeds in this area. Arrow points to Scotch thistle noxious weed.
