Inspection Photos
Location Name: UPRR 23 PAN AM UT D 4
Location ID: 319981

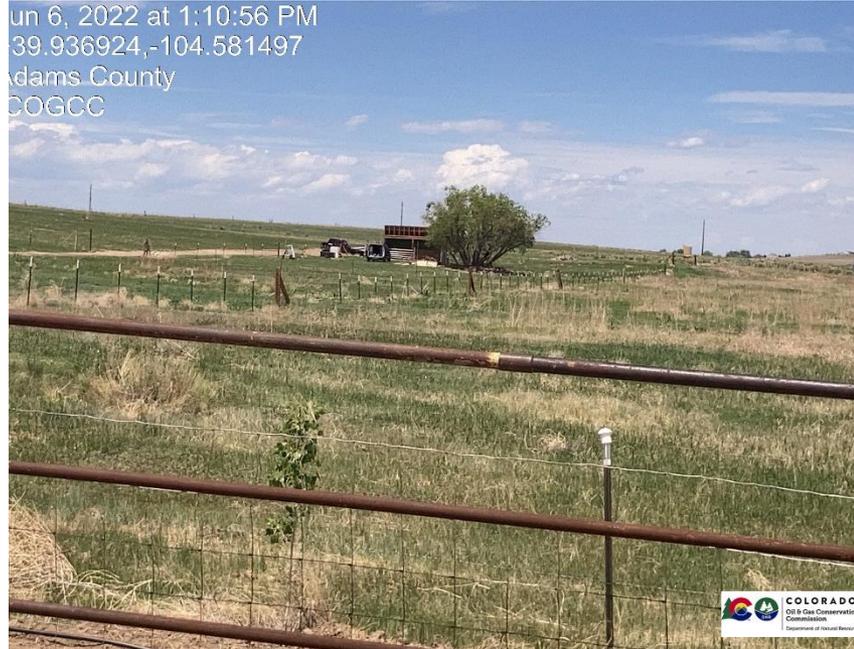
Pic 1 fencing that goes through lease road

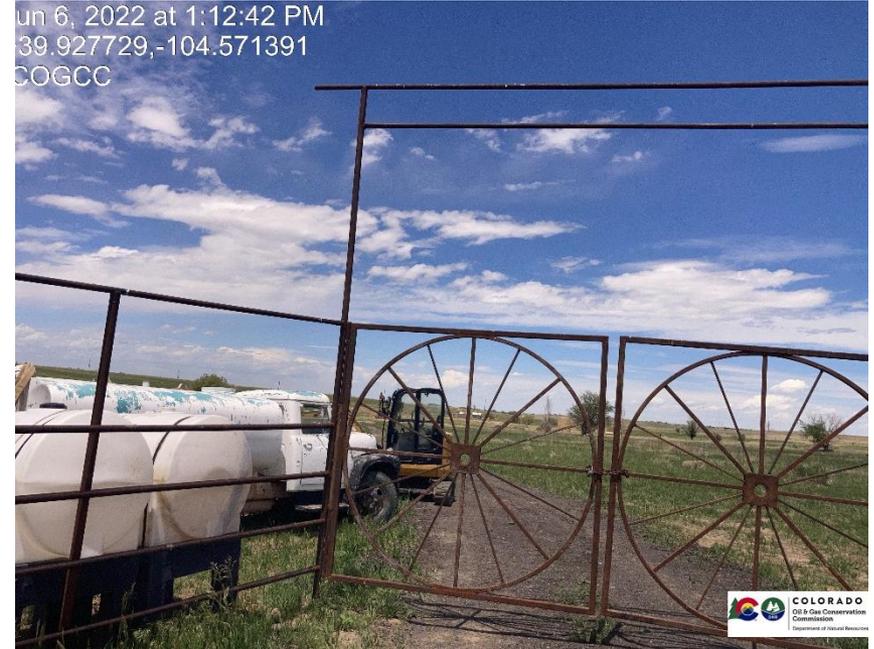
Pic 2 gate that does not have KPK lock on it
