Inspection Photos

Location Name: TEP ROCKY MOUNTAIN LLC UNION-66S96W /33NWSE

Location ID: 335237

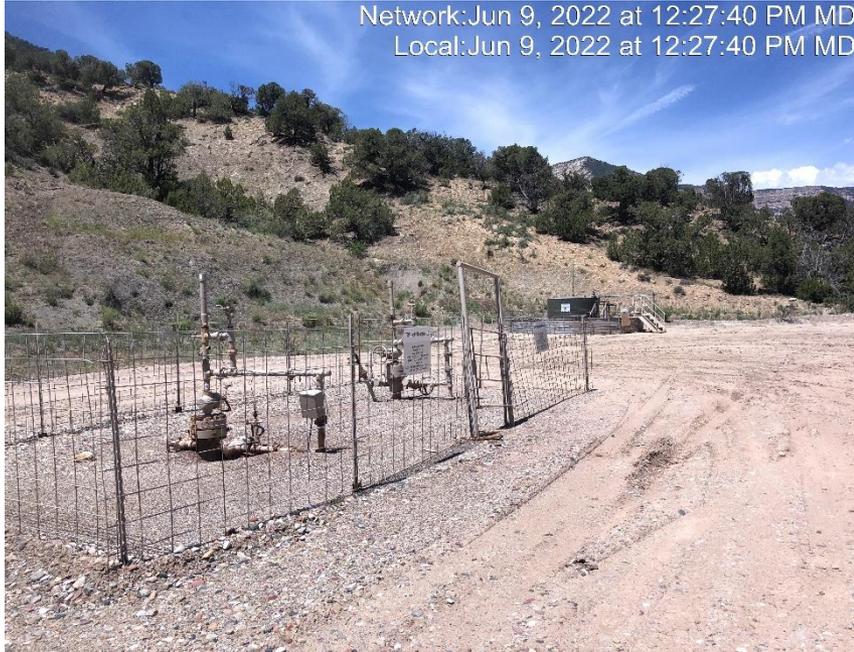
Photo #6867 from entrance to location.

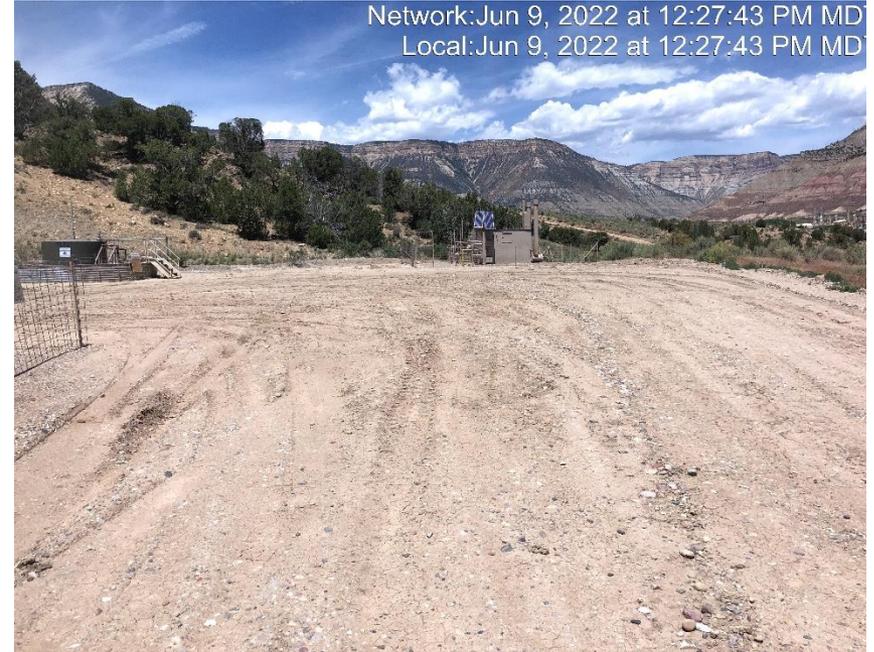
Photo #6868 from entrance to location.

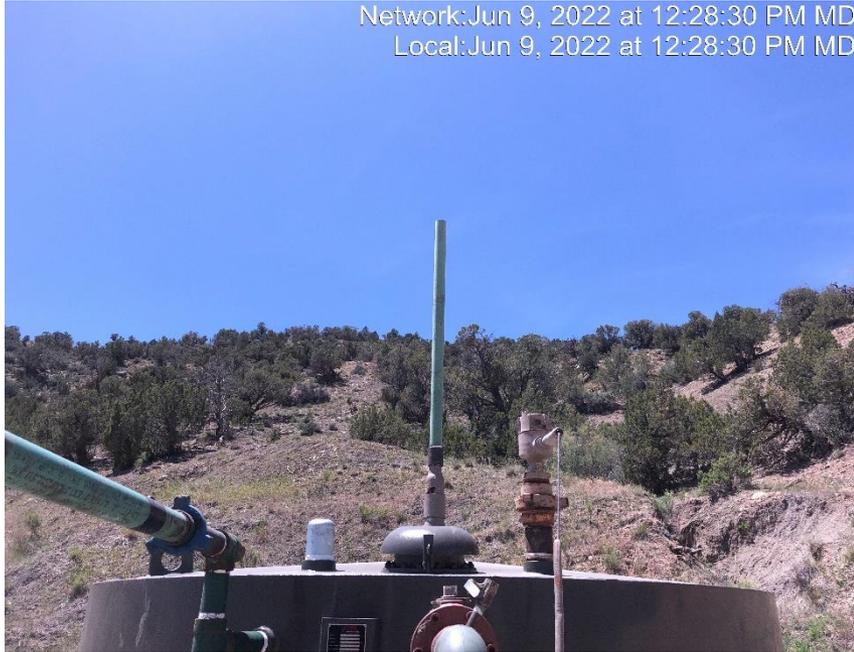
Photo #6869 Vent pipe on tank open ended.

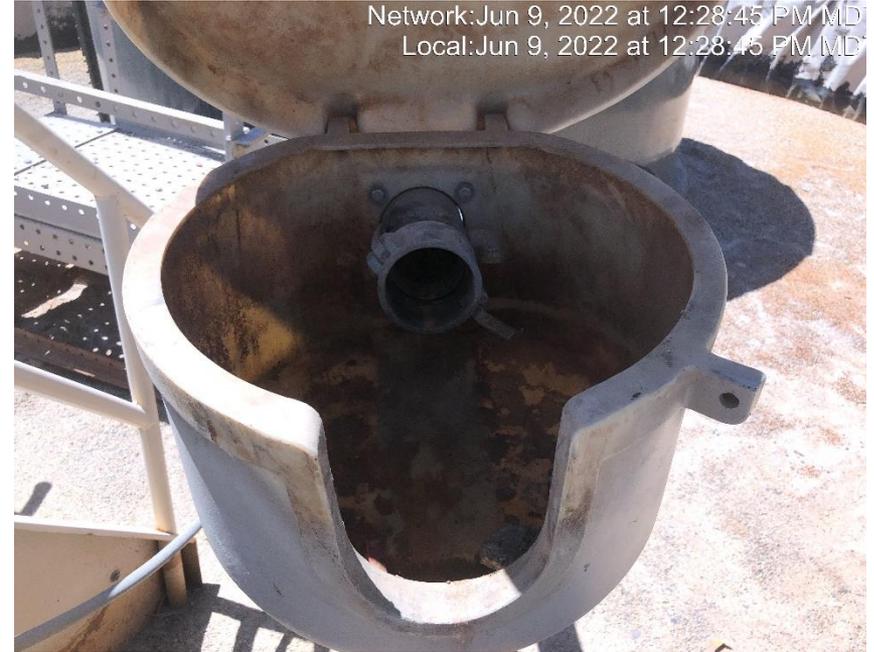
Photo #6870 Loadline open ended.

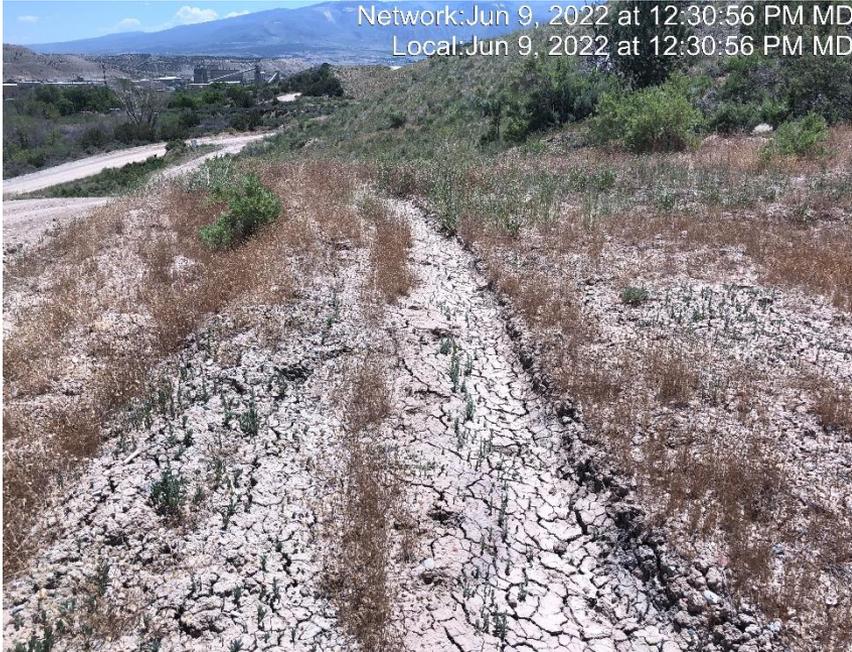
Photo #6872 Insufficient velocity checks in ditch.

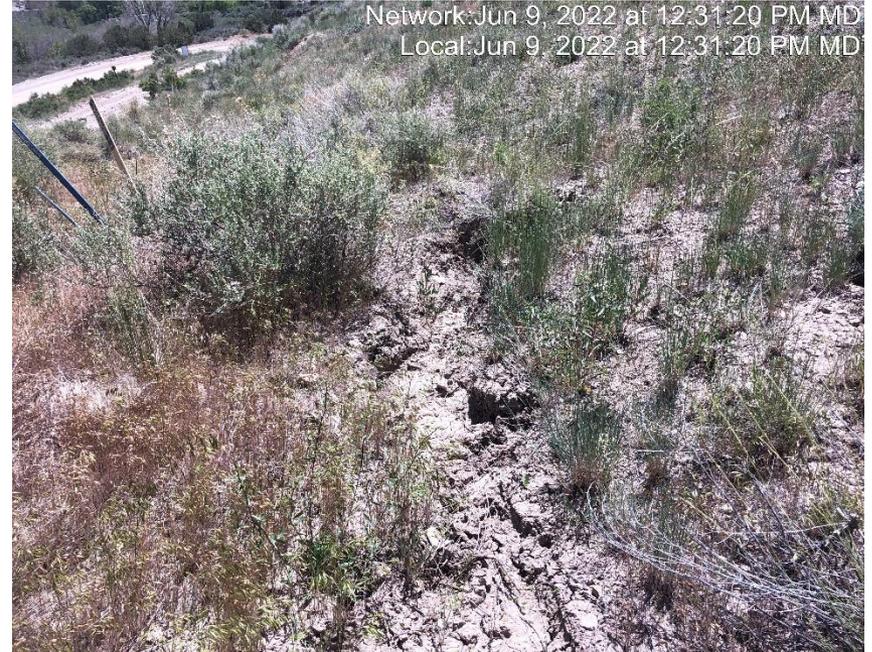
Photo #6873 Gully erosion occurring on cut slope.

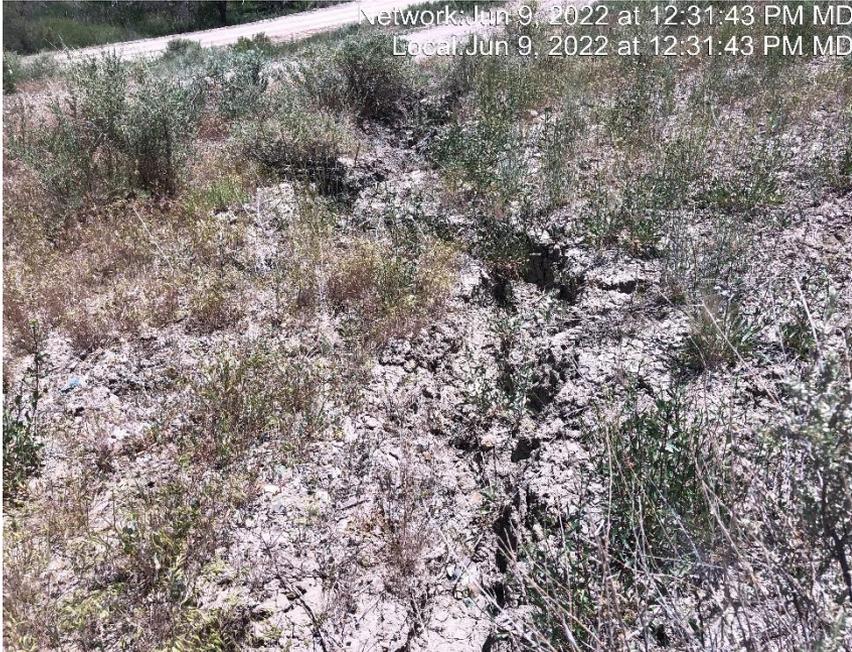
Photo #6875 Gully erosion occurring on cut slope.

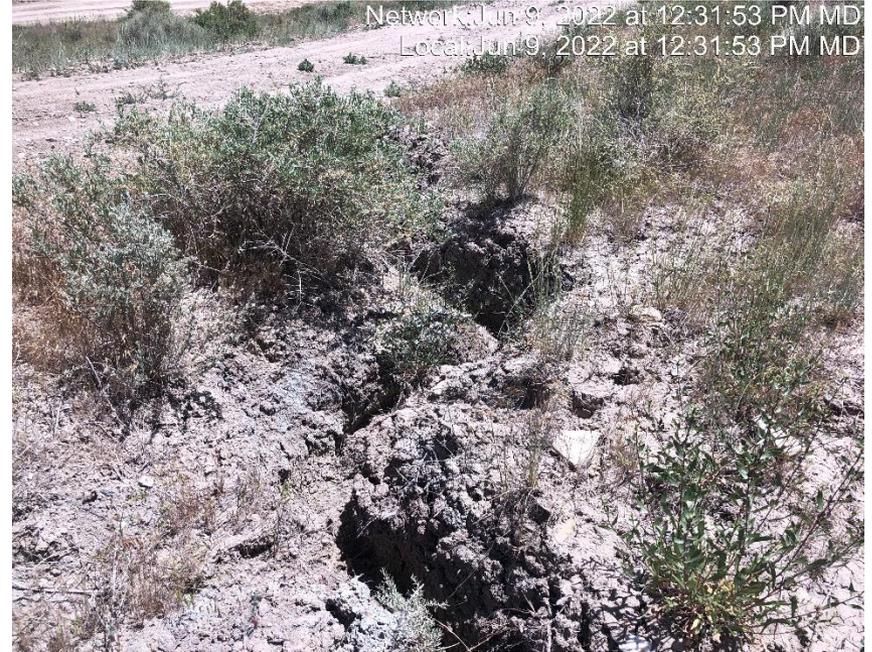
Photo #6876 Gully erosion occurring on cut slope.

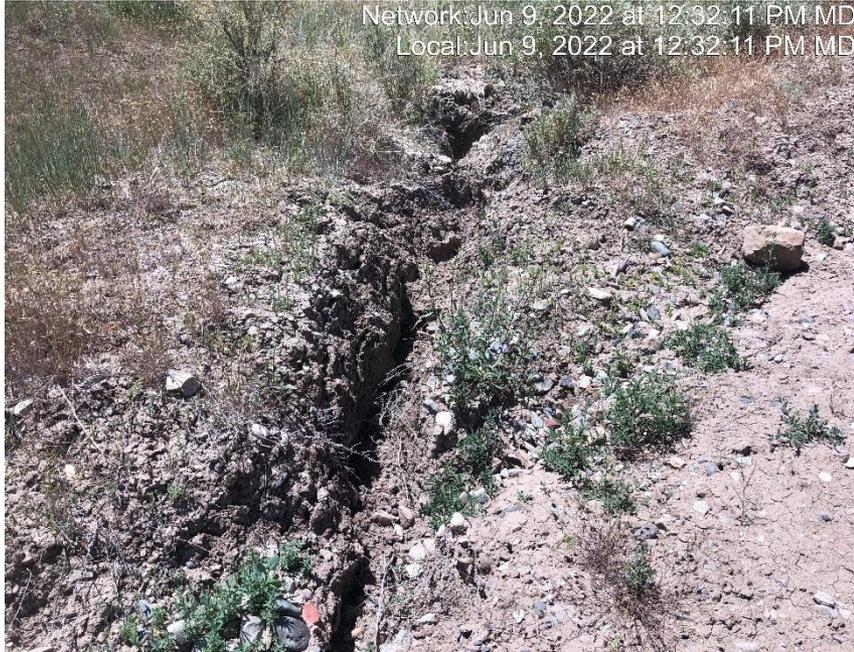
Photo #6877 Gully erosion occurring on cut slope.

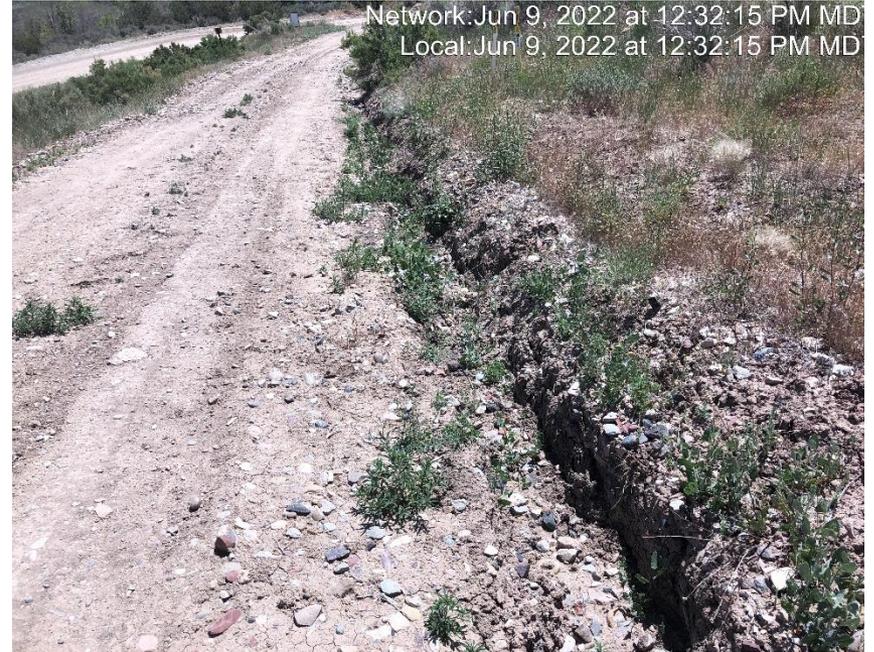
Photo #6878 Gully erosion occurring in access road ditch. Insufficient velocity checks in ditch.
