Inspection Photos  
Location Name: UPRR 42 Pan AM AP 2  
Location ID: 318646

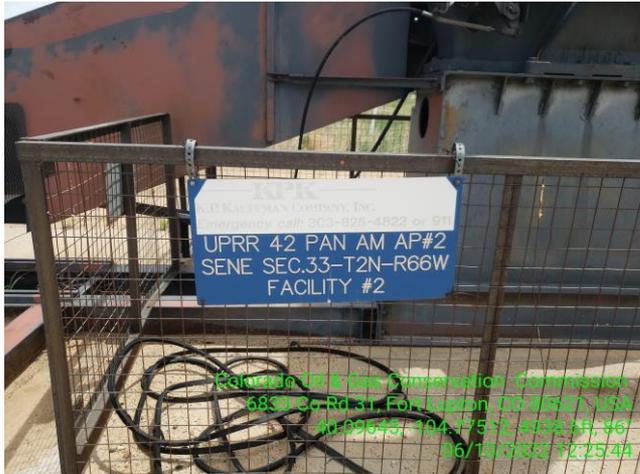
Photo 1 WH sign, beginning to fade and will need to be replaced in the near future.

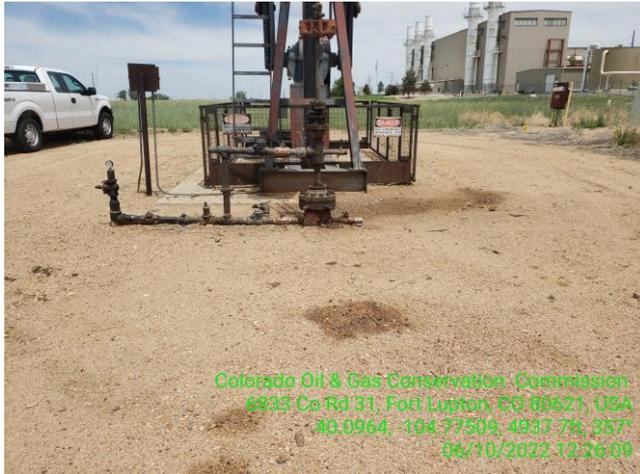
Photo 3 Stained soil near WH.

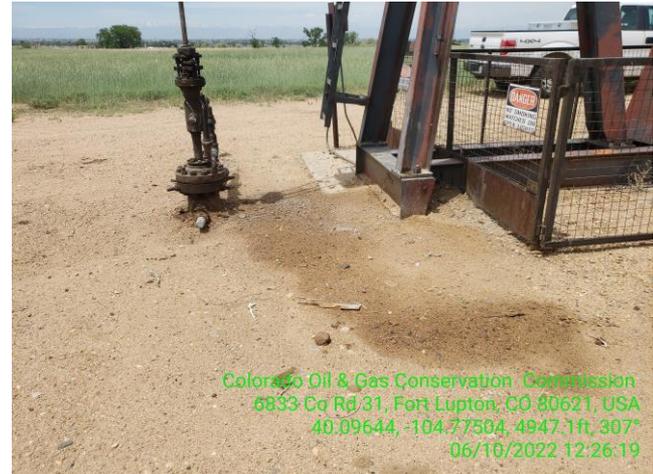
Photo 4 Stained soil near WH

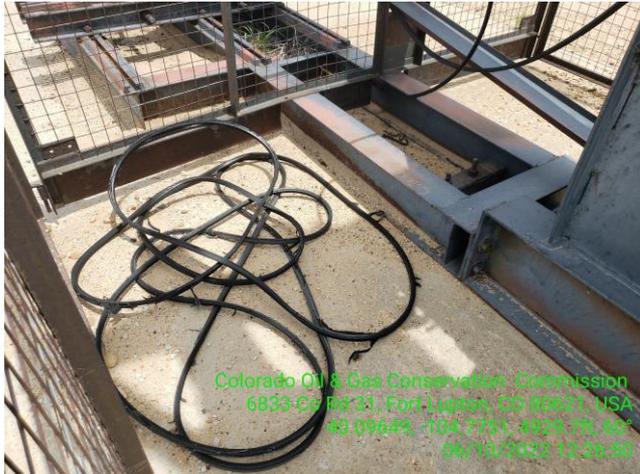
**Photo 7 trash, broken v-belt from PJ electric motor.**
