# **Refuge to Mallard Production Line Abandonment Photographic Log**

**(May 5th, 2022)**

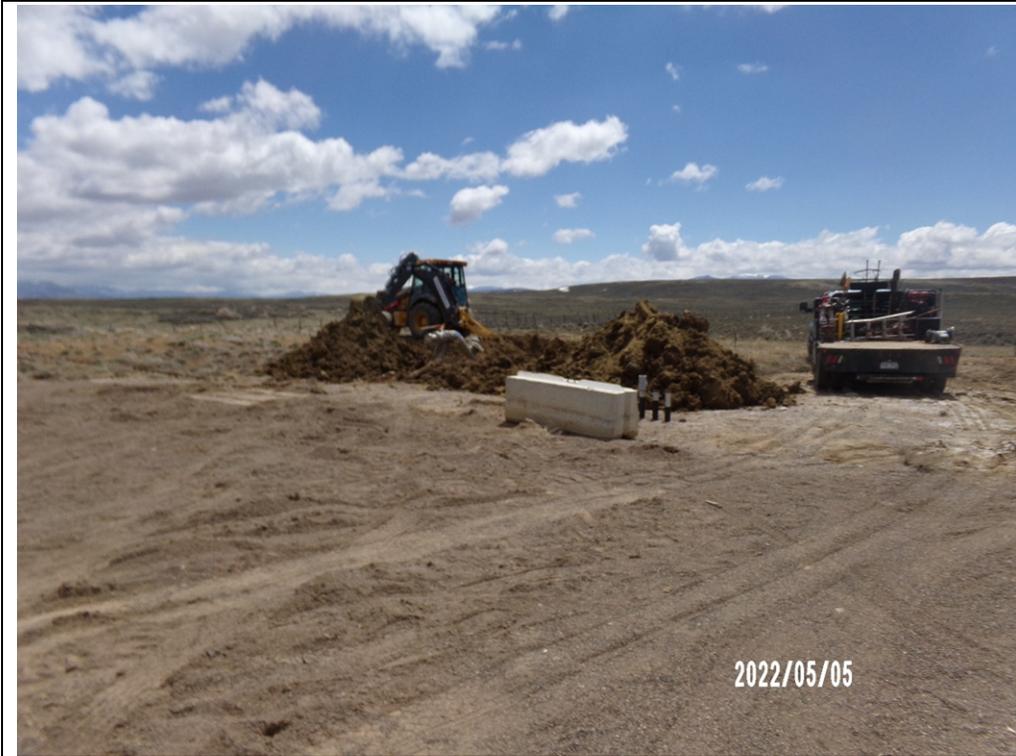
Photo No 1:

**Description:**  
Location of flowline's northern terminus, on the Refuge S16 Location. Photo facing southeast.

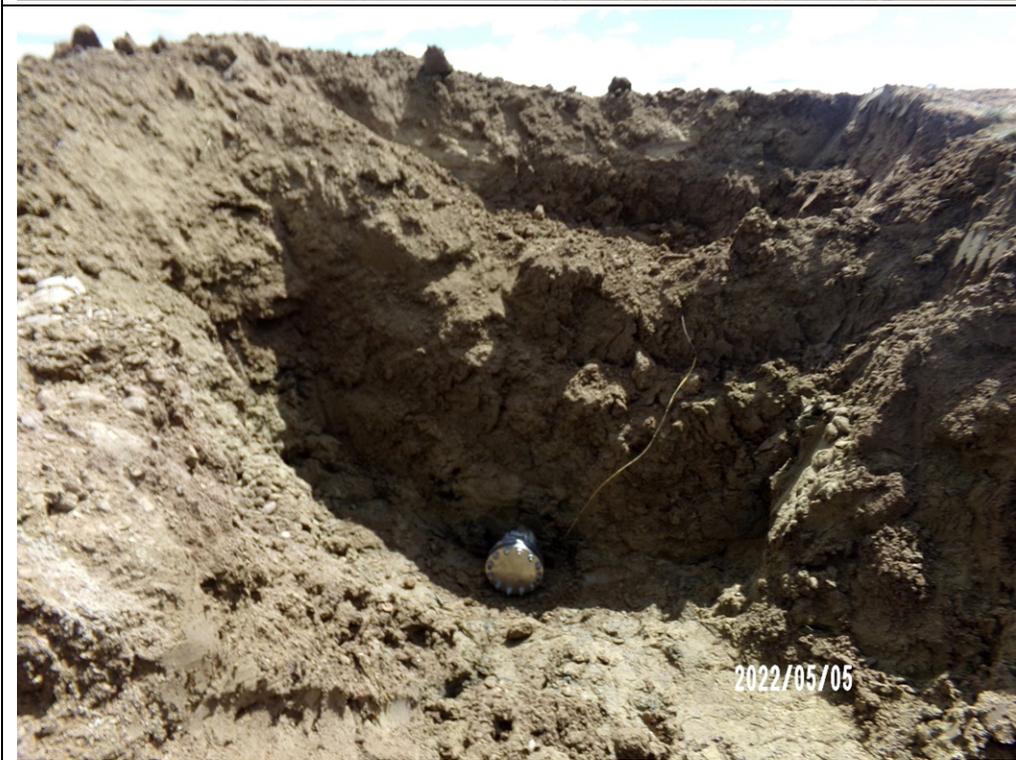
Photo No 2:

**Description:**  
Northern terminus of flowline.

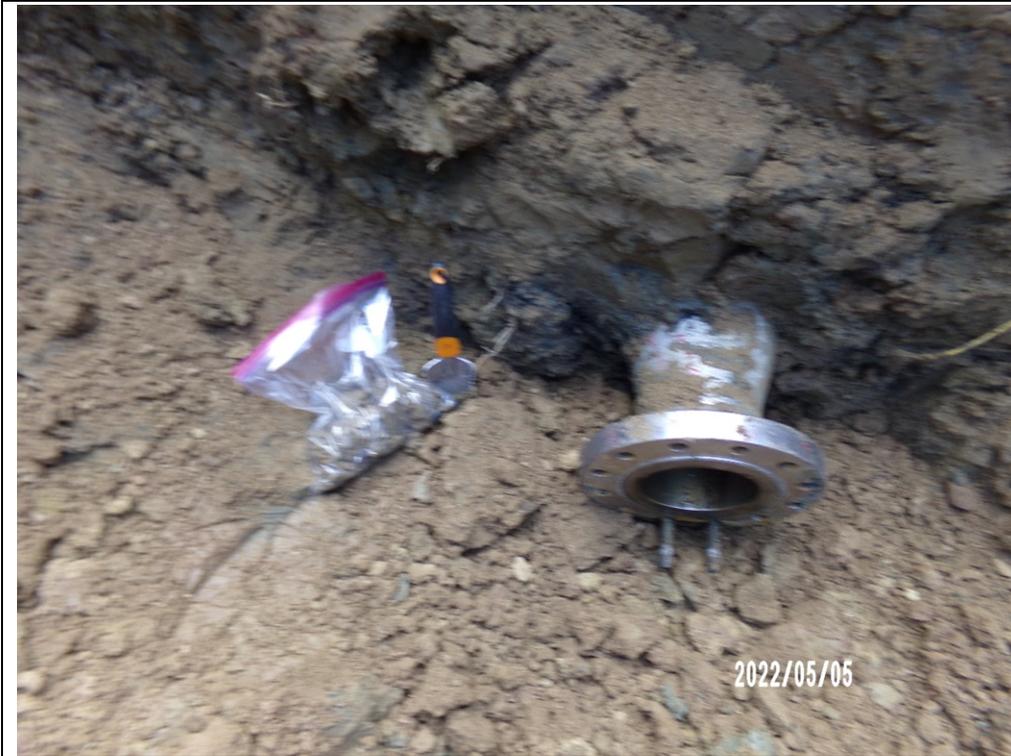
Photo No 3:

**Description:**  
Sampling location  
D90\_RP\_SS\_01, at  
northern terminus of  
flowline.

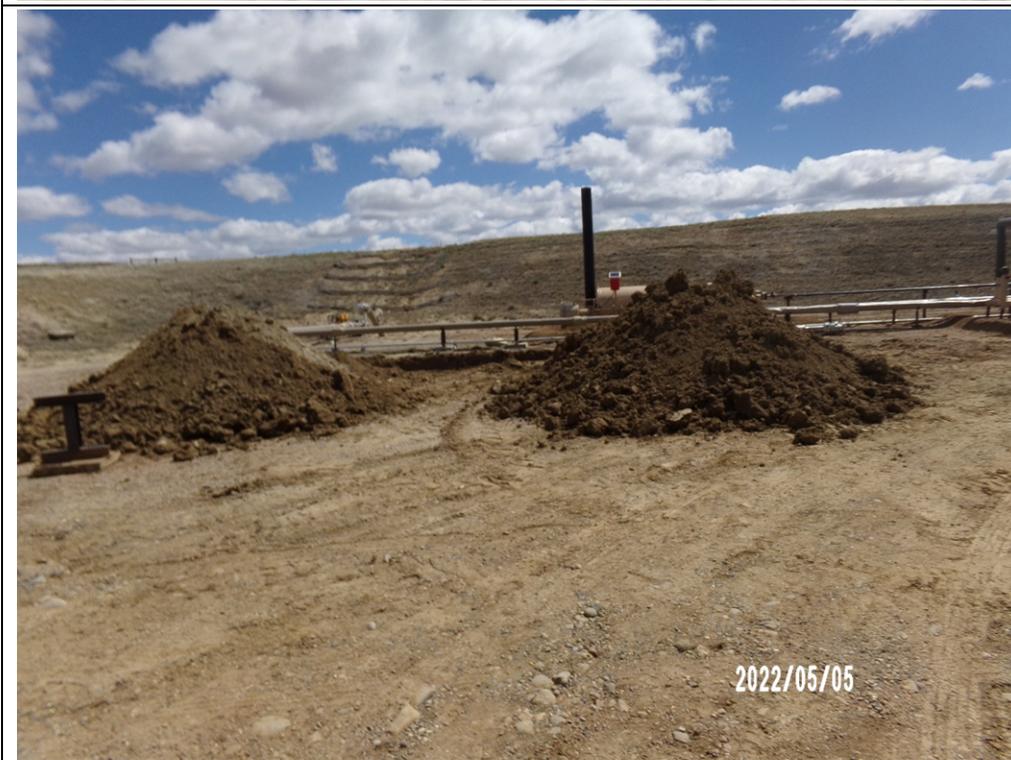
Photo No 4:

**Description:**  
Location of flowline's  
southern terminus, on  
the Pintail S16  
location. Photo  
facing south.

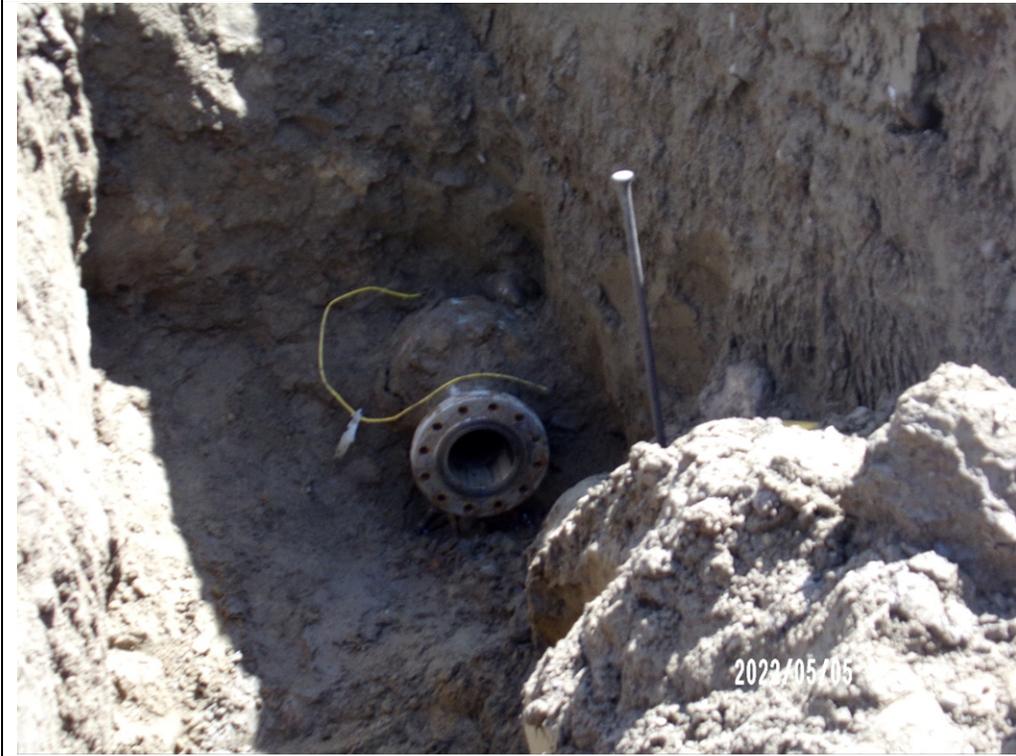
Photo No 5:

**Description:**  
Southern terminus of flowline.

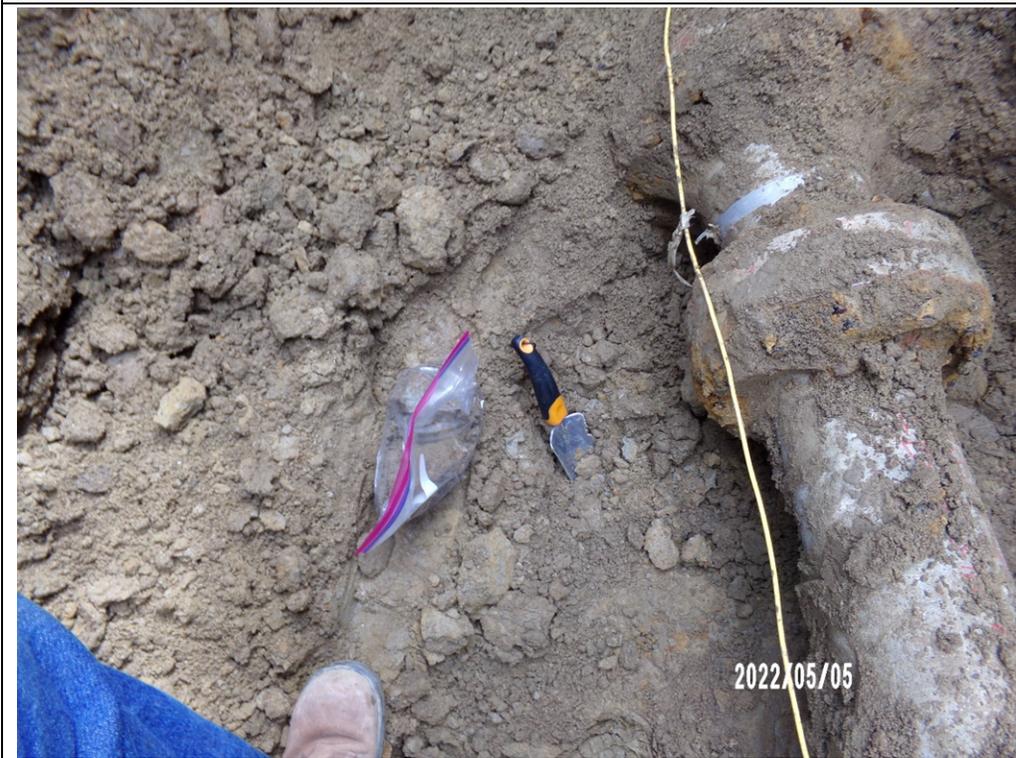
Photo No 6:

**Description:**  
Sampling location  
D90\_RP\_SS\_02, at  
southern terminus of  
flowline.

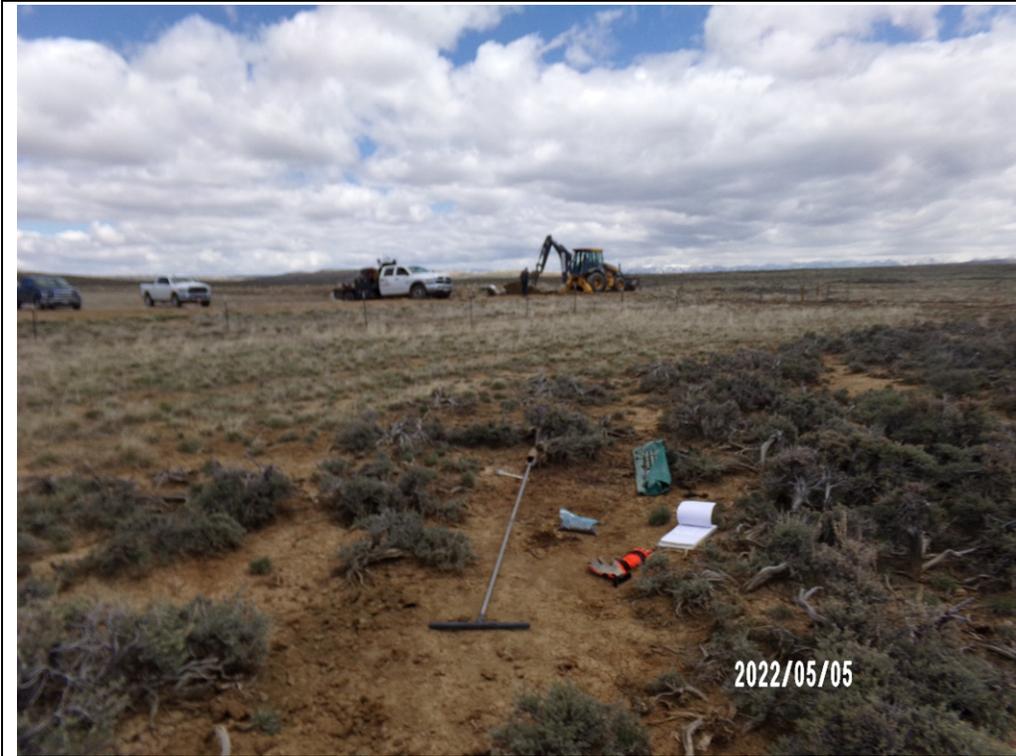
Photo No 7:

Description:  
Location of  
D90\_RP\_SS\_BG\_01,  
near the northern  
terminus of the  
flowline. Photo facing  
northeast.

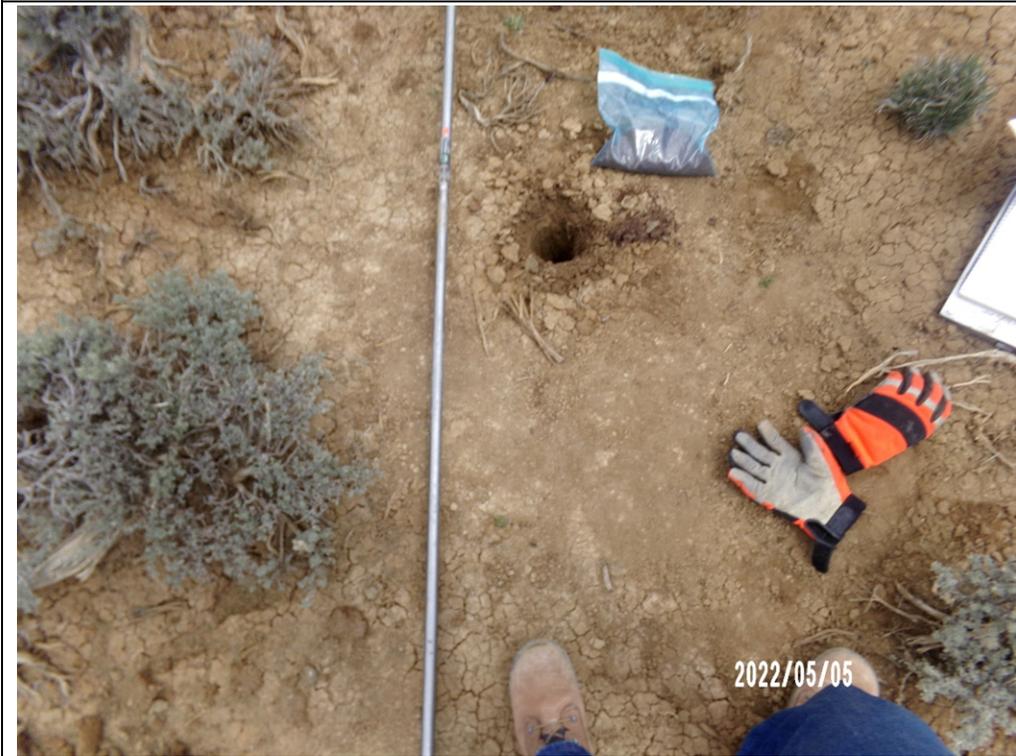
Photo No 8:

Description:  
Close view of  
D90\_RP\_SS\_BG\_01.

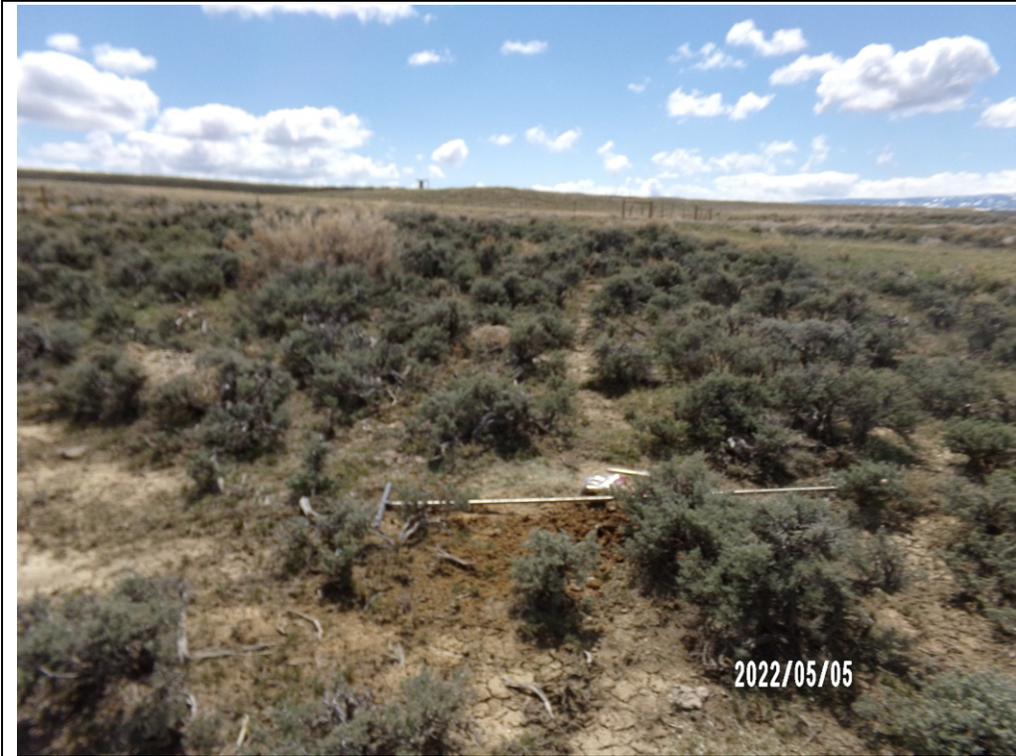
Photo No 9:

Description: Location of D90\_RP\_SS\_BG\_02, near the southern terminus of the flowline. Photo facing southwest, toward the Pintail S16 location.

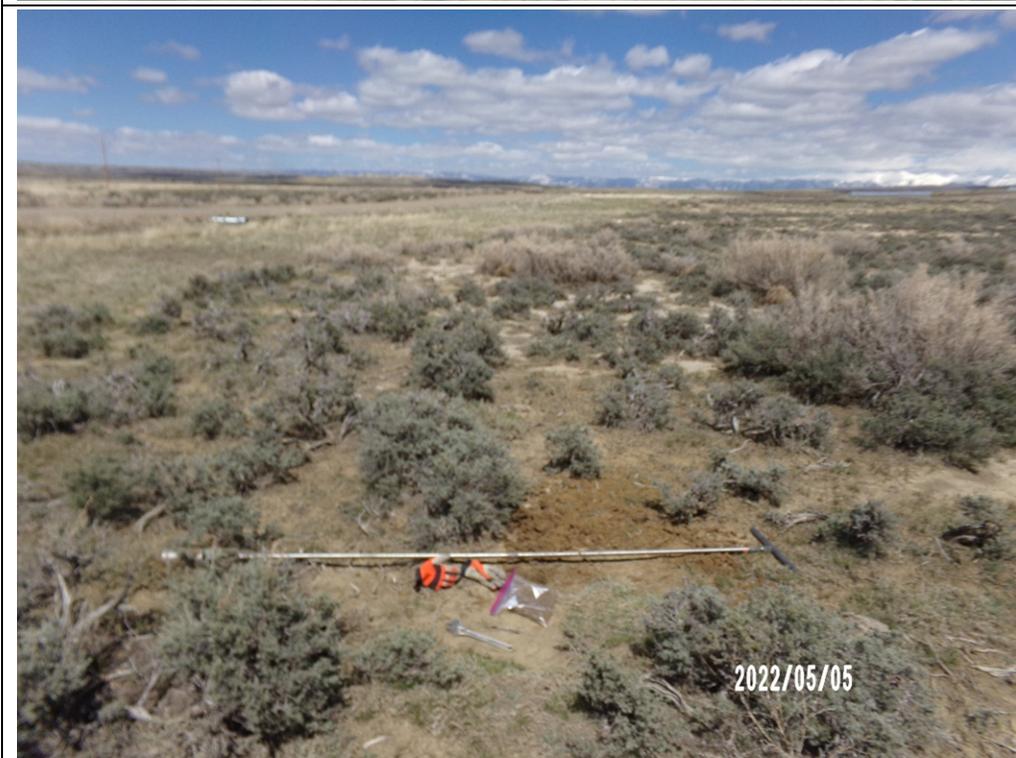
Photo No 10:

Description: Location of D90\_RP\_SS\_BG\_02, near the southern terminus of the flowline. Photo facing northeast, toward the Refuge S16 location.

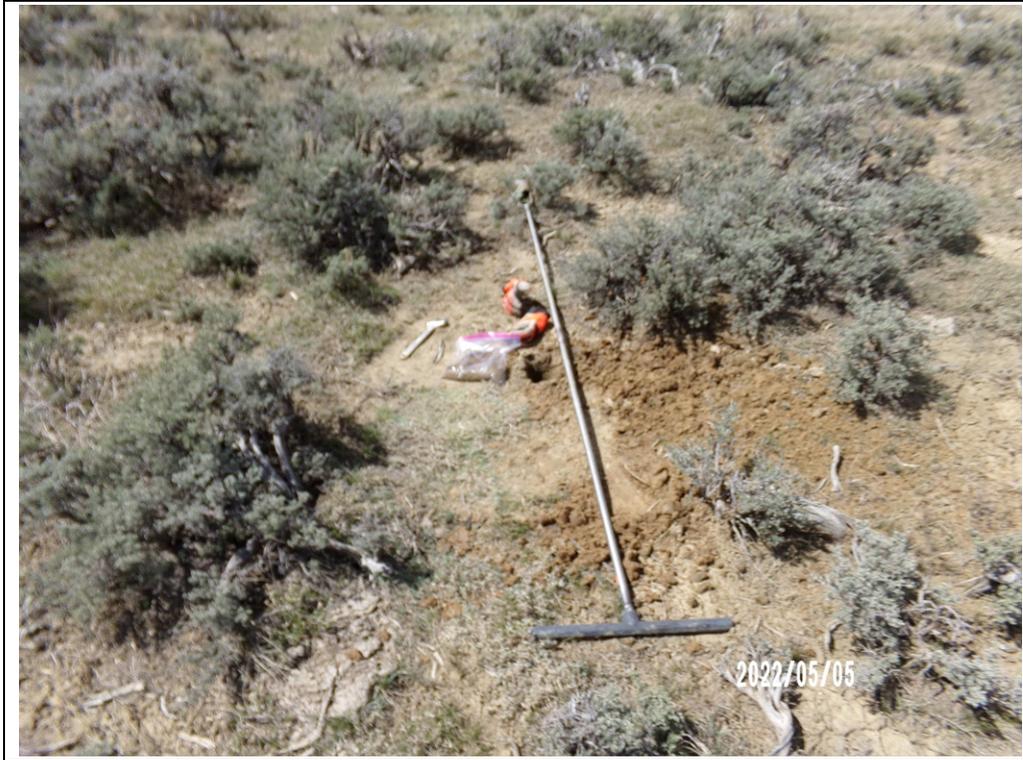
Photo No 11:

Description:  
Close view of  
D90\_RP\_SS\_BG\_02.
