TEP
Dixon
Location # 311696

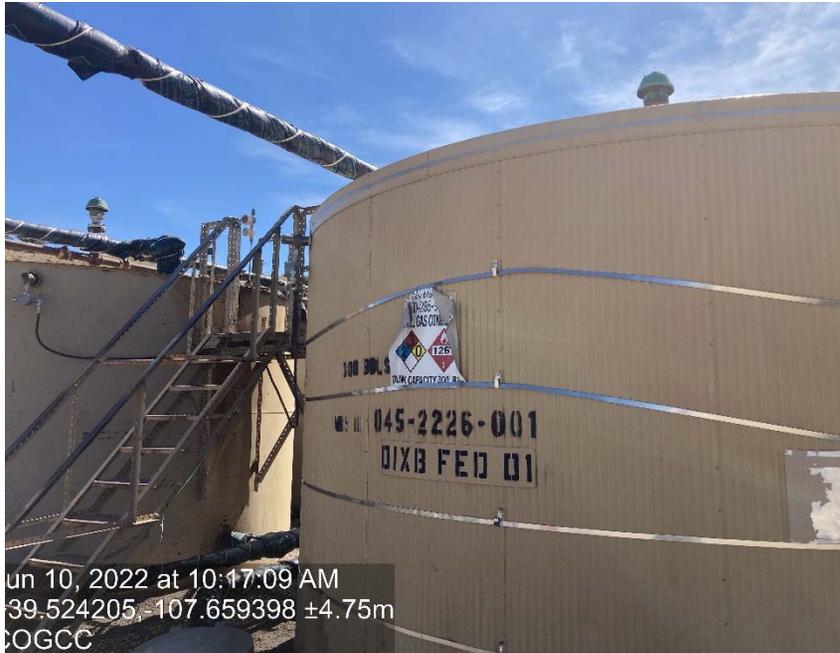
Tank labeling falling off

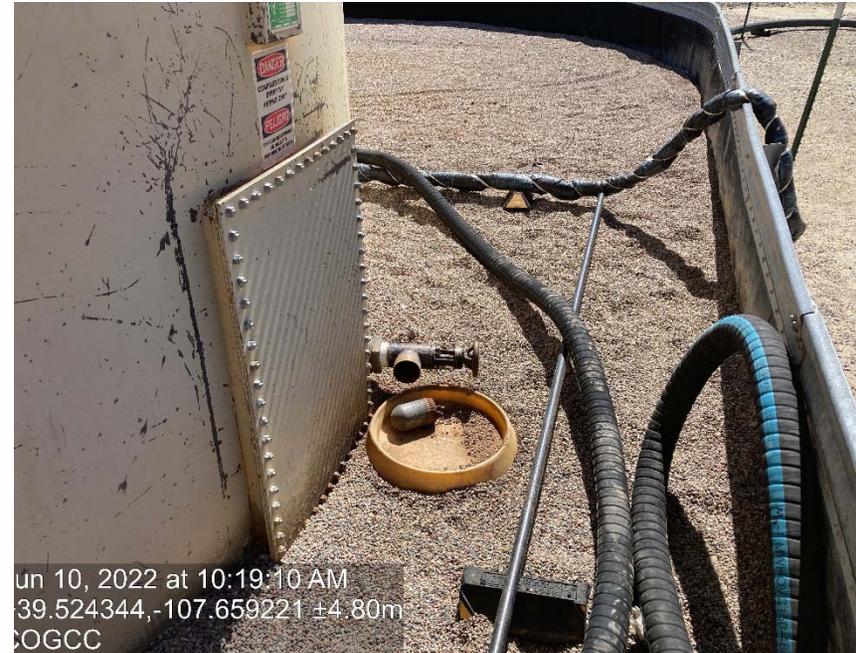
Valve missing cap/ plug

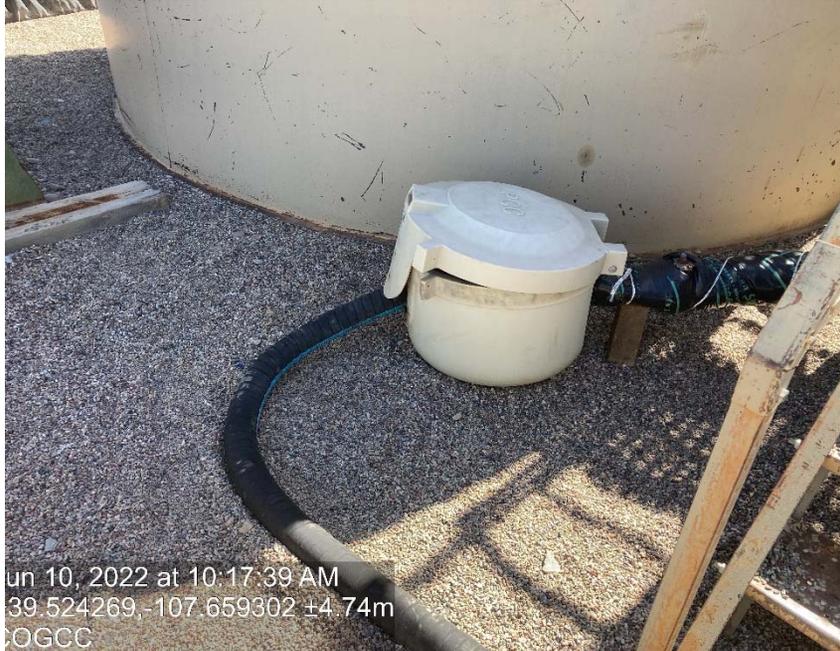
Valve missing cap/ plug

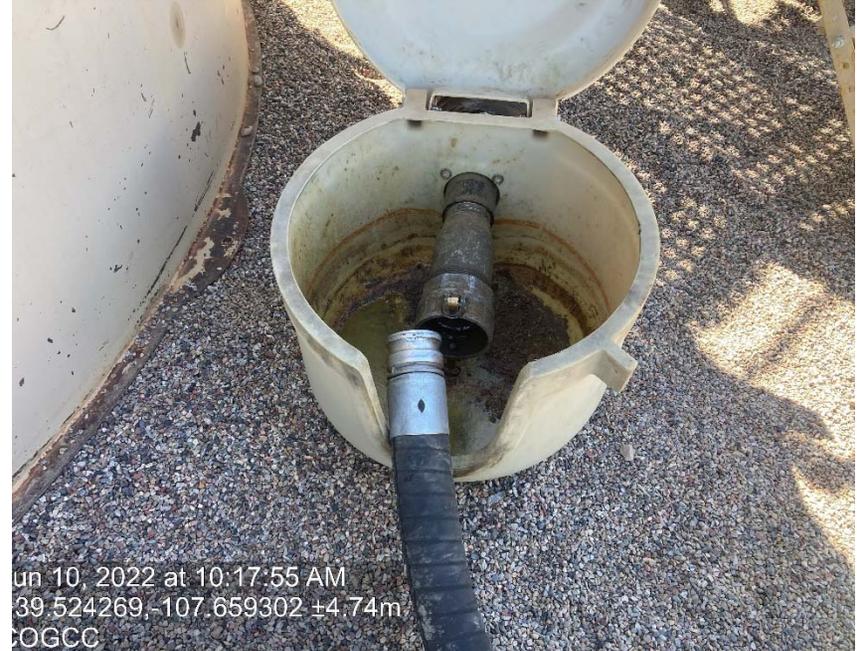
Valve missing cap/ plug

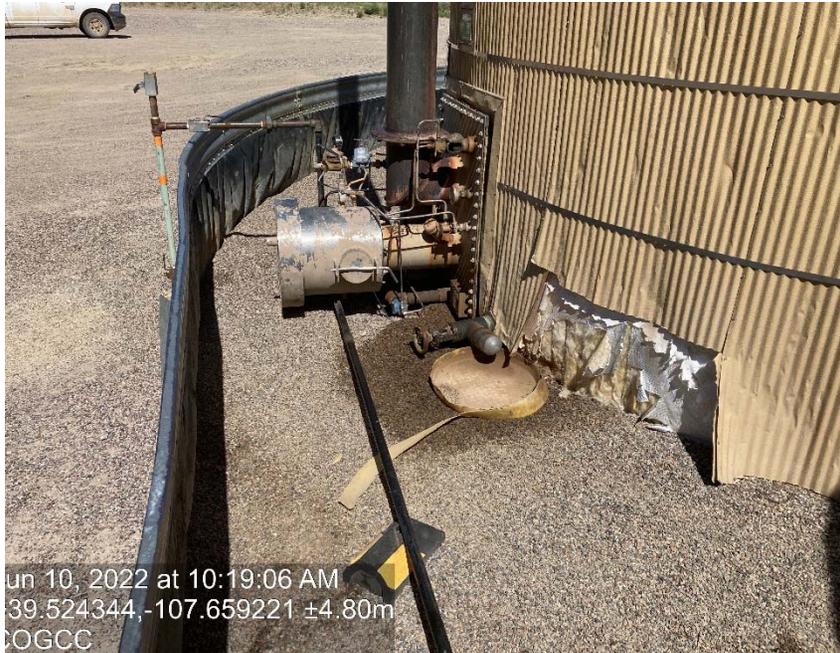
Staining

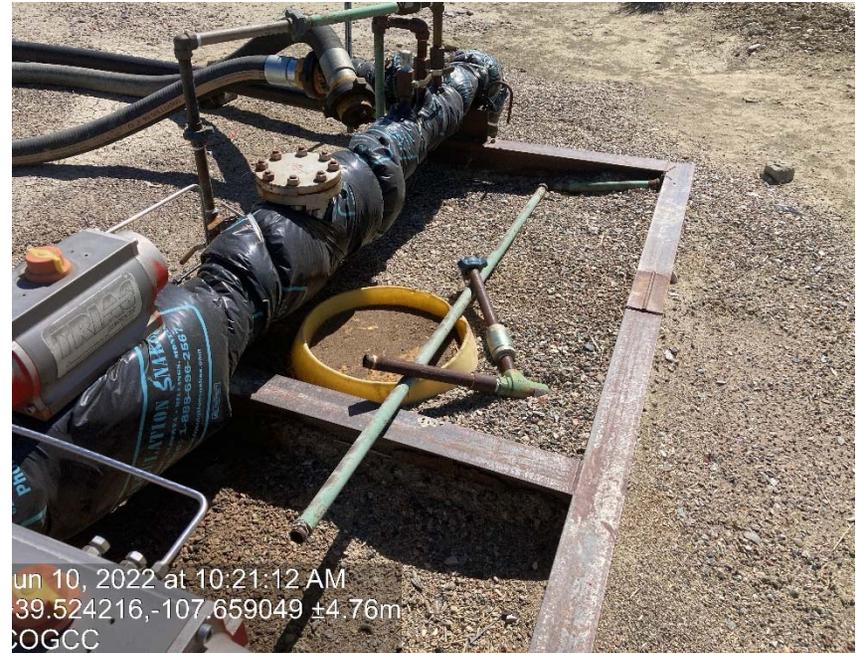
Debris

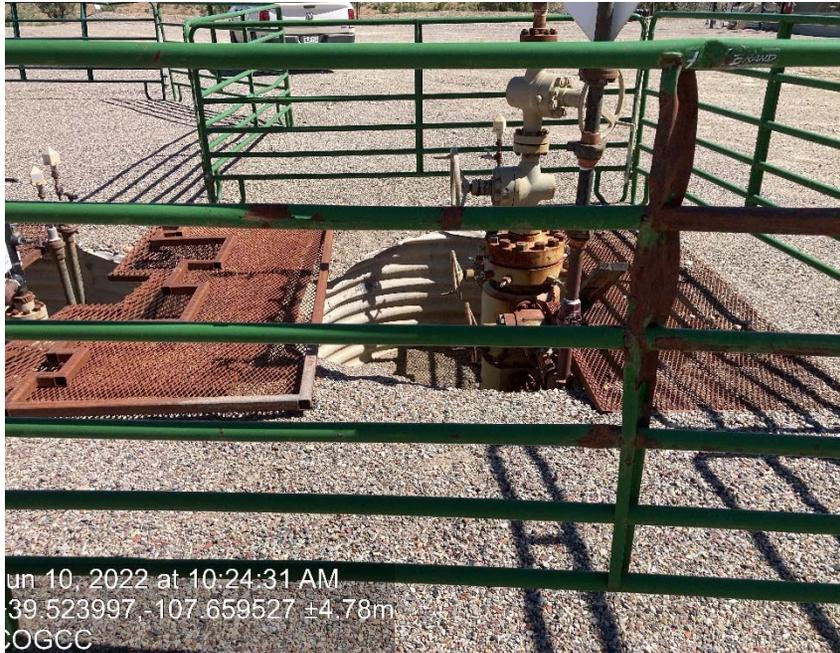
Open cellars

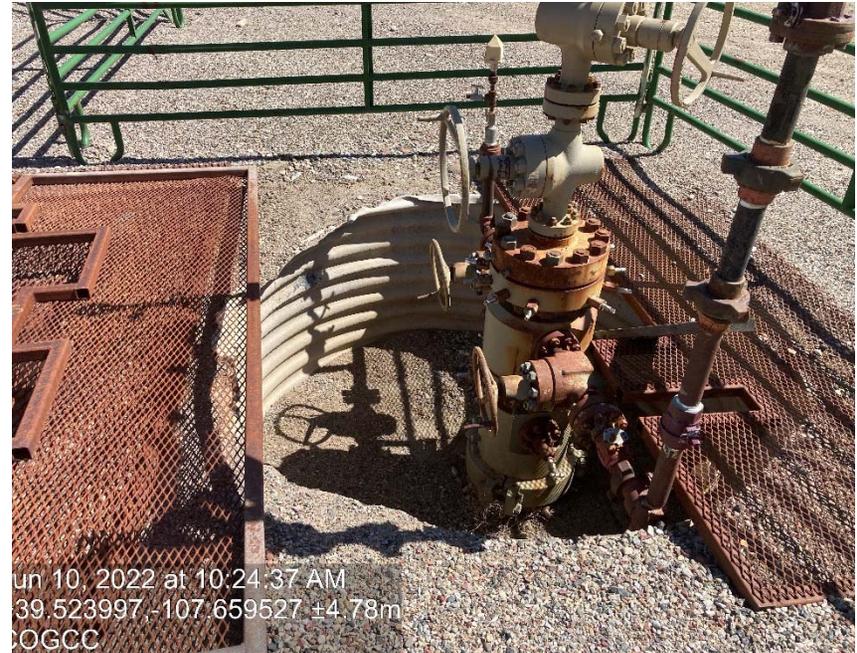
Open cellars

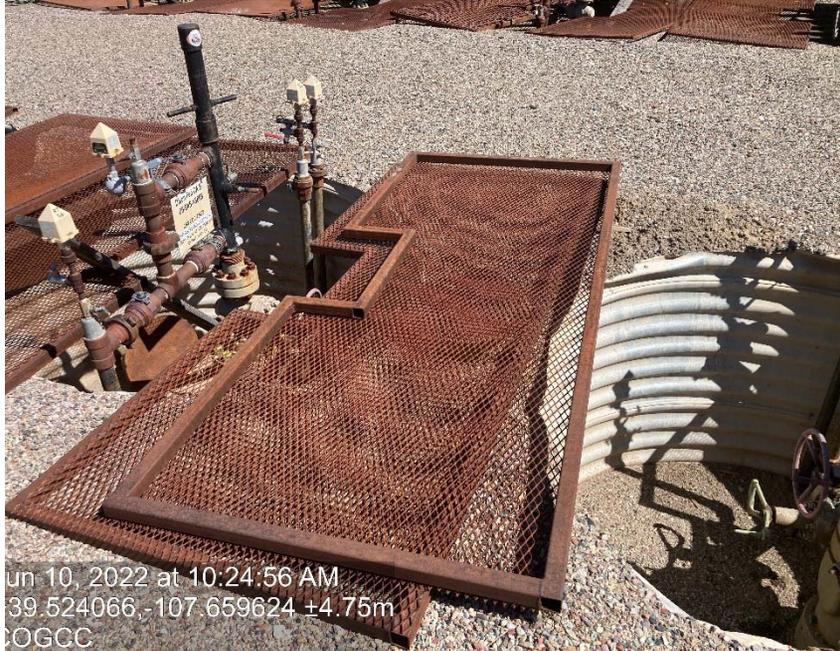
Open cellars

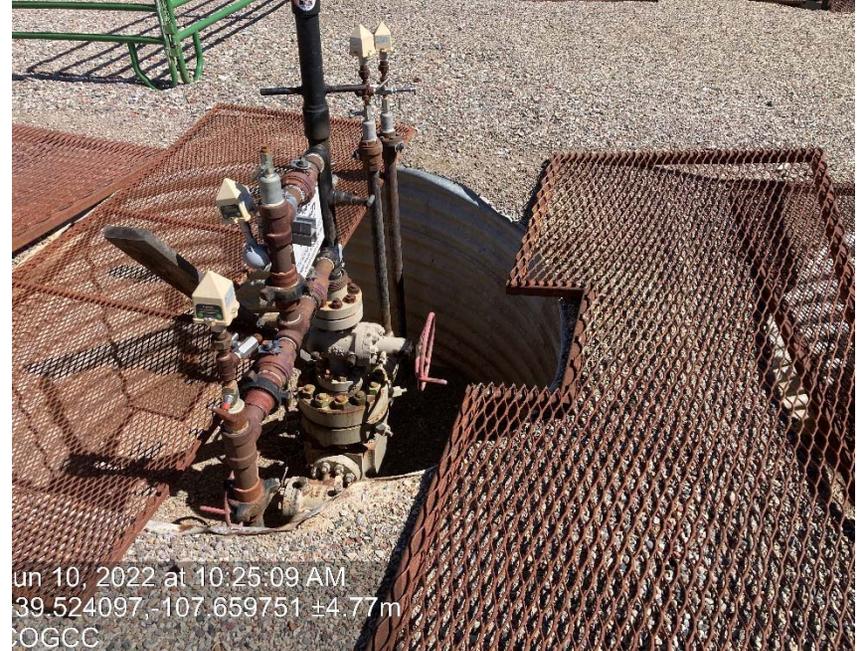
Open cellars

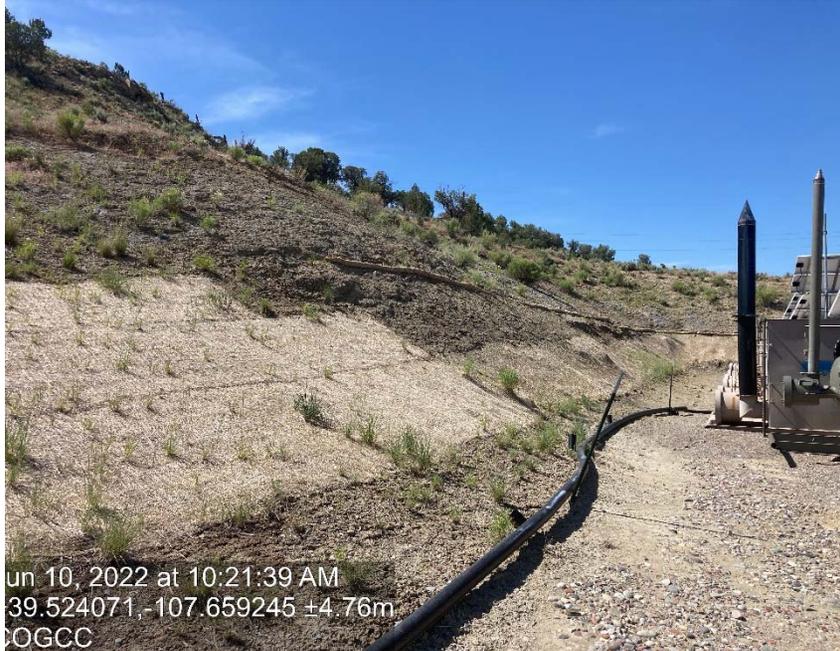
Some areas of cut slope have lack of stabilization still. Photo from recent inspection.

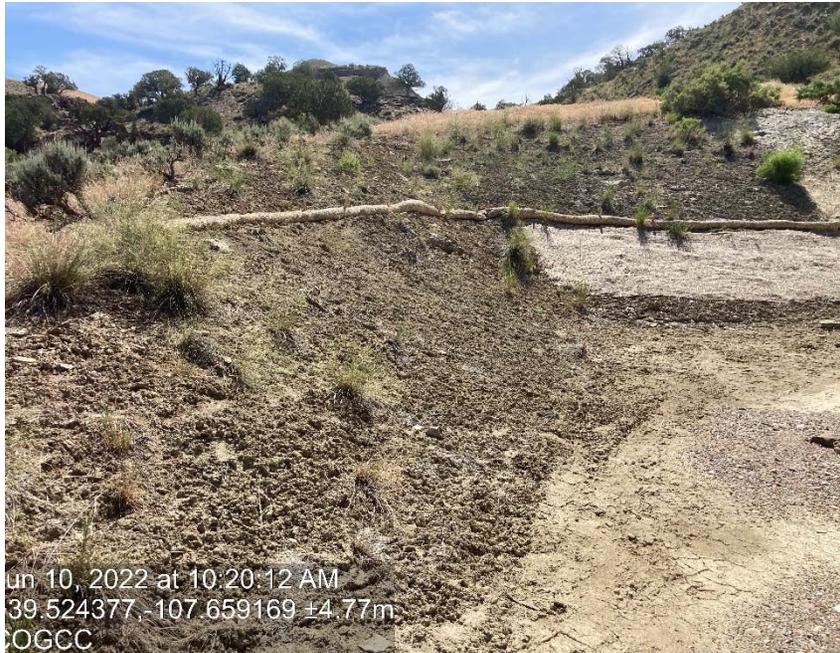
Some areas of cut slope have lack of stabilization still.

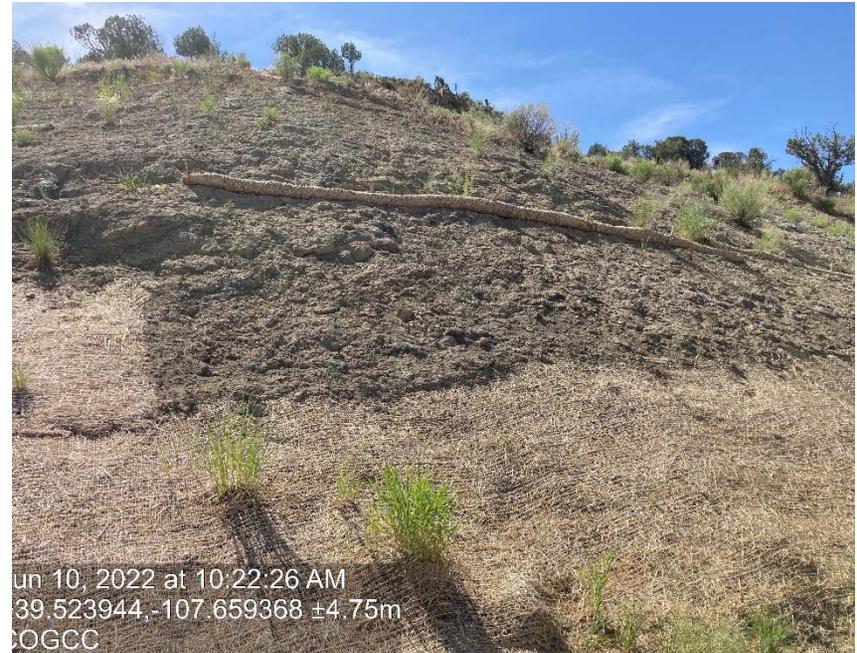
Some areas of cut slope have lack of stabilization still.

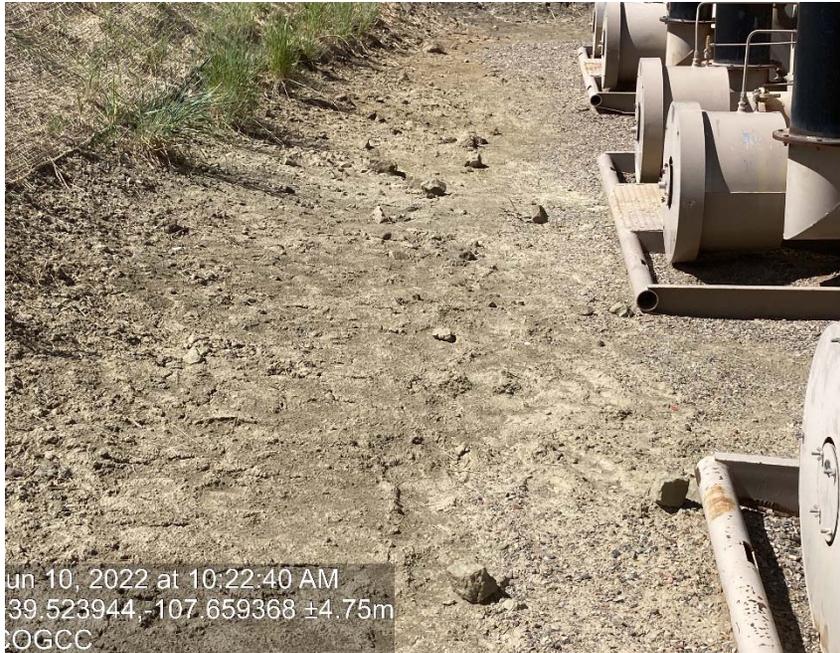
Evidence of cut slope erosion

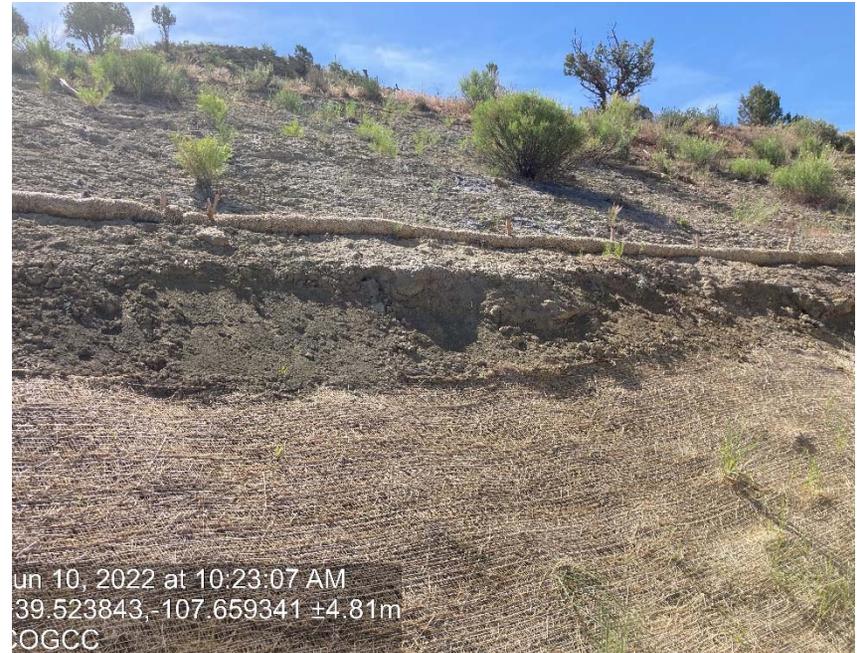
Cut slope erosion over blankets

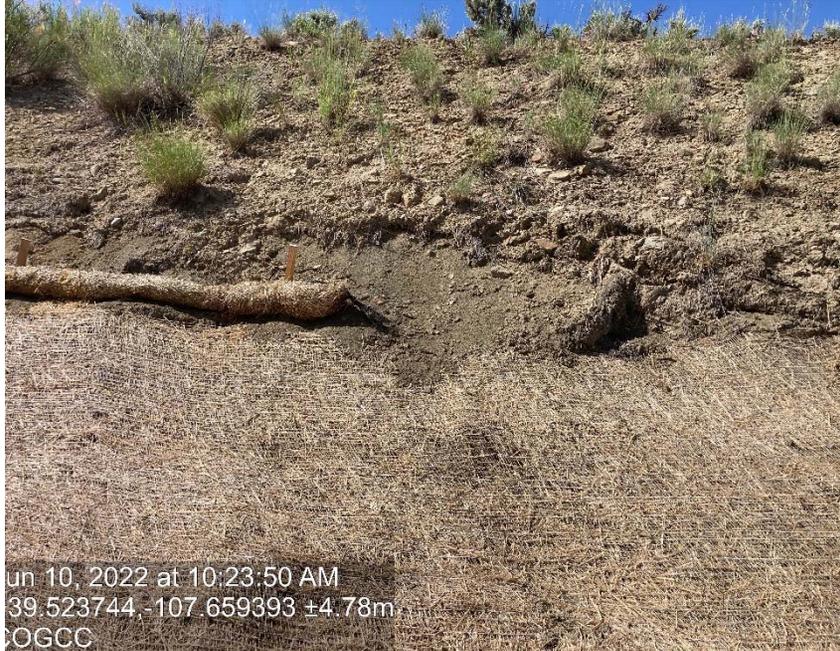
Cut slope erosion over blankets

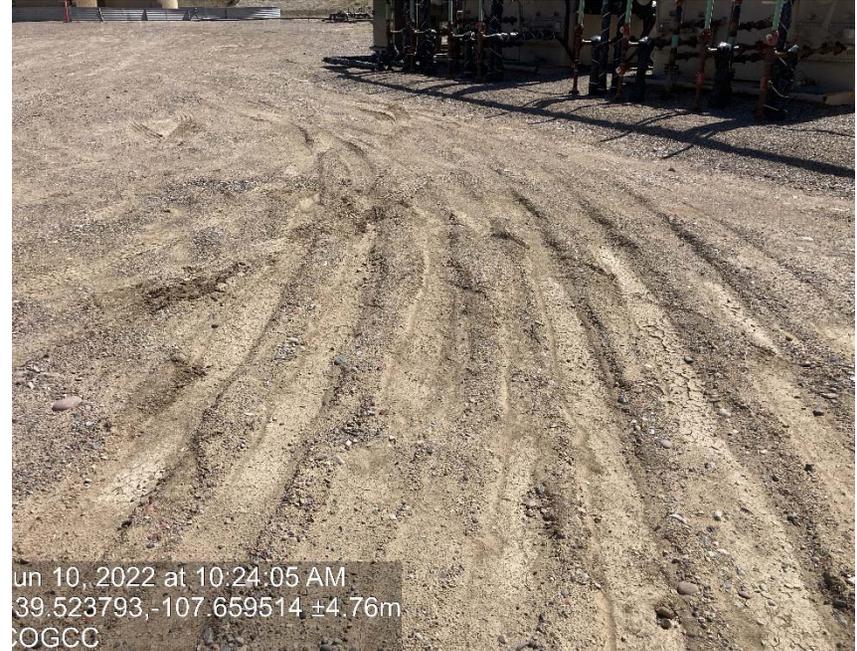
Lack of stabilization/ compaction/ degradation

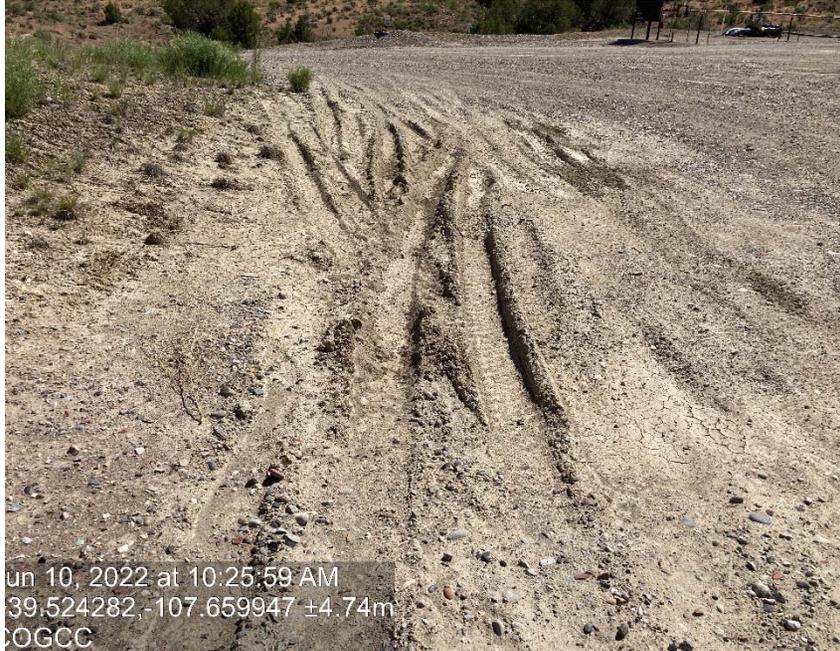
Lack of stabilization/ compaction/ degradation

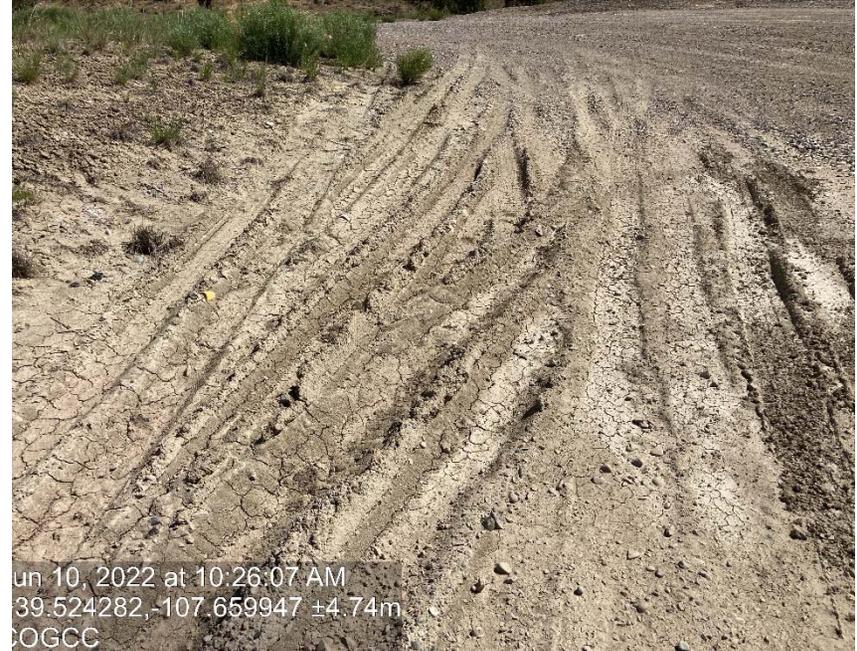
Lack of stabilization/ compaction/ degradation

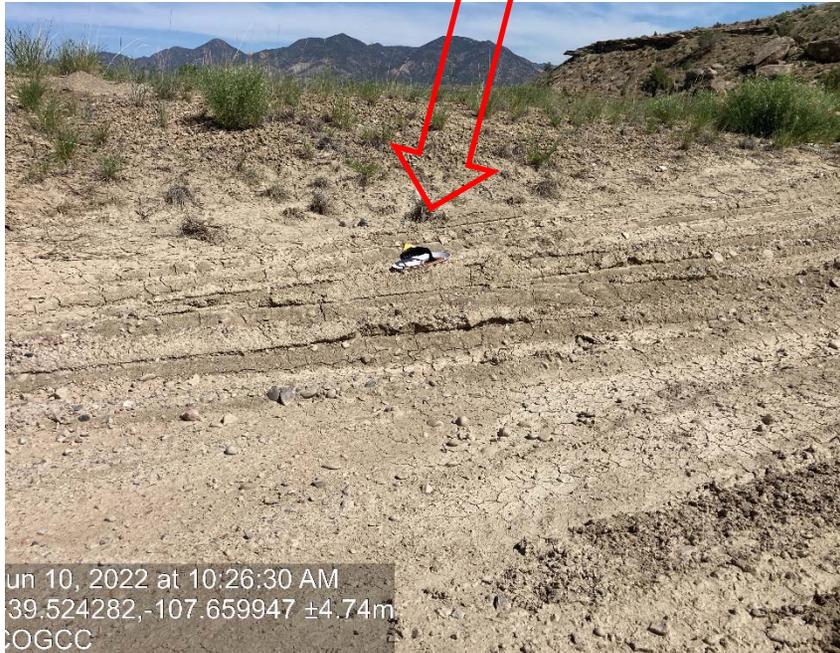
Hard hat upside down in rutting
