Inspection Photos
Location Name: Comanche Creek 1-14
Location ID: 320324

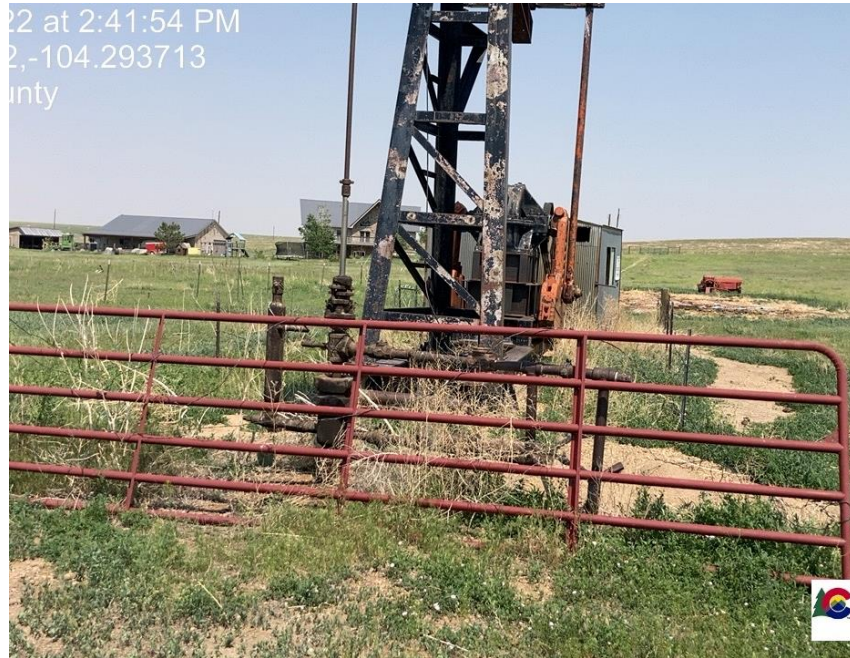
Pic 1 wellhead / pumpjack, weeds unmanaged, fence needs repair

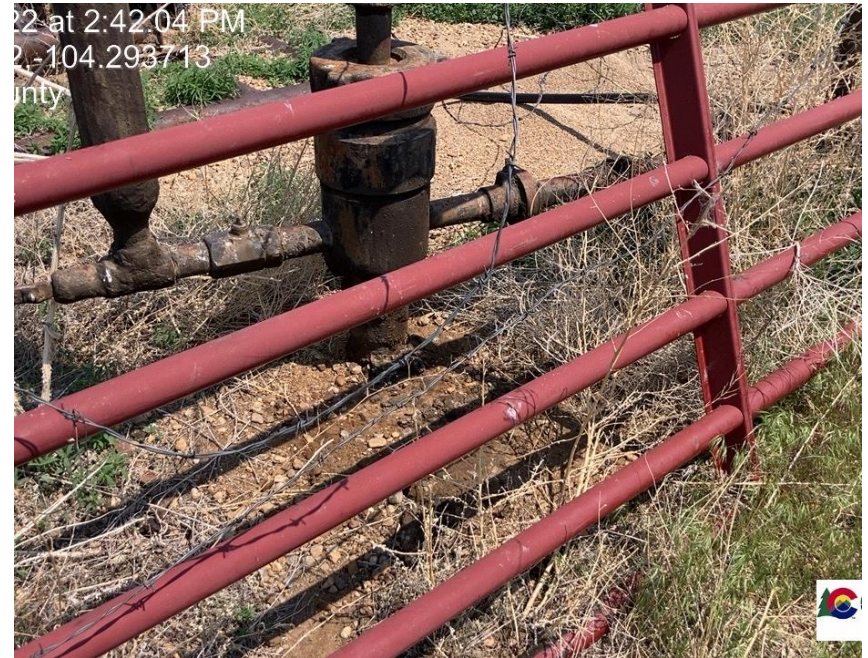
Pic 2 bradenhead is not plumbed to surface, stained soil

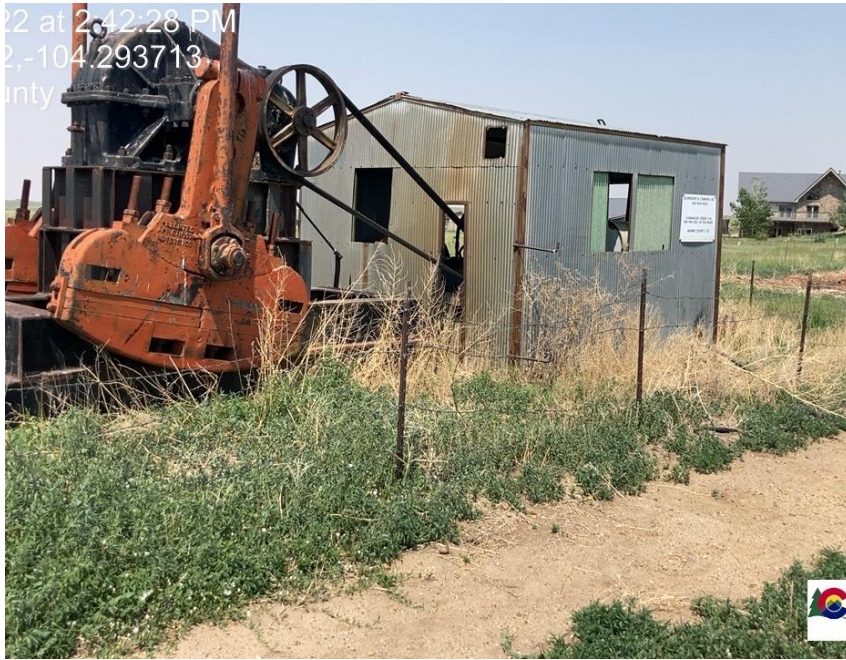
Pic 3 motor house

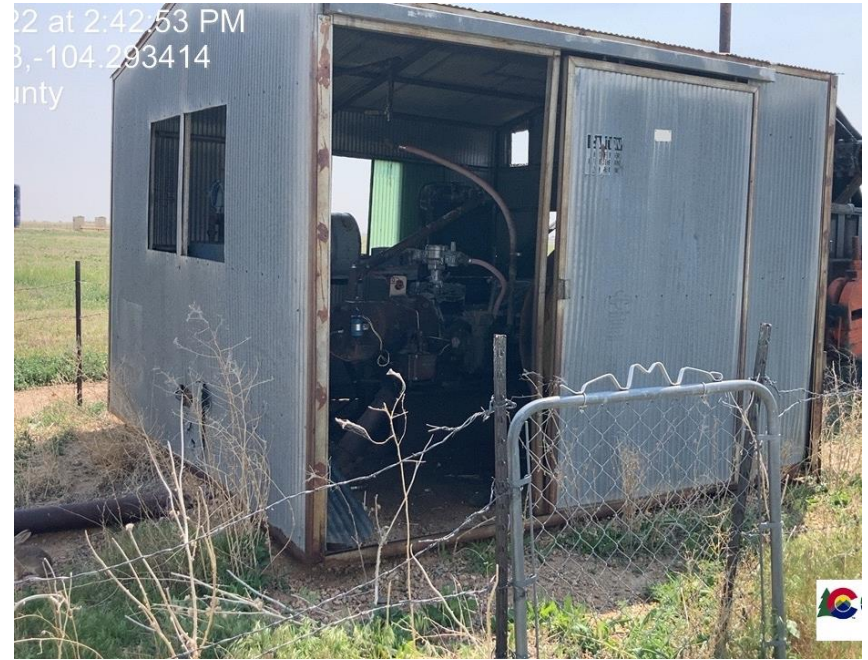
Pic 4 stained soil in motor house

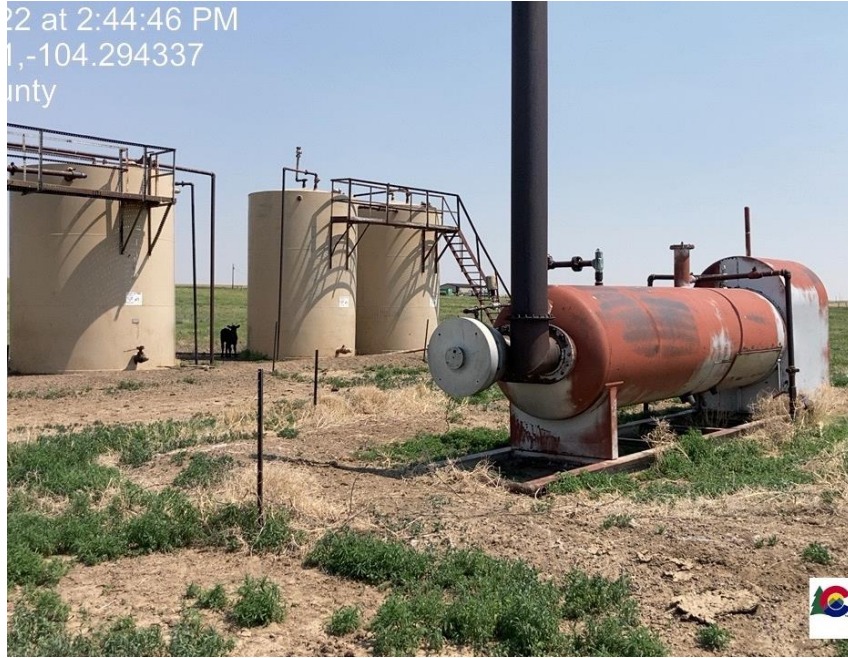
Pic 5 separator

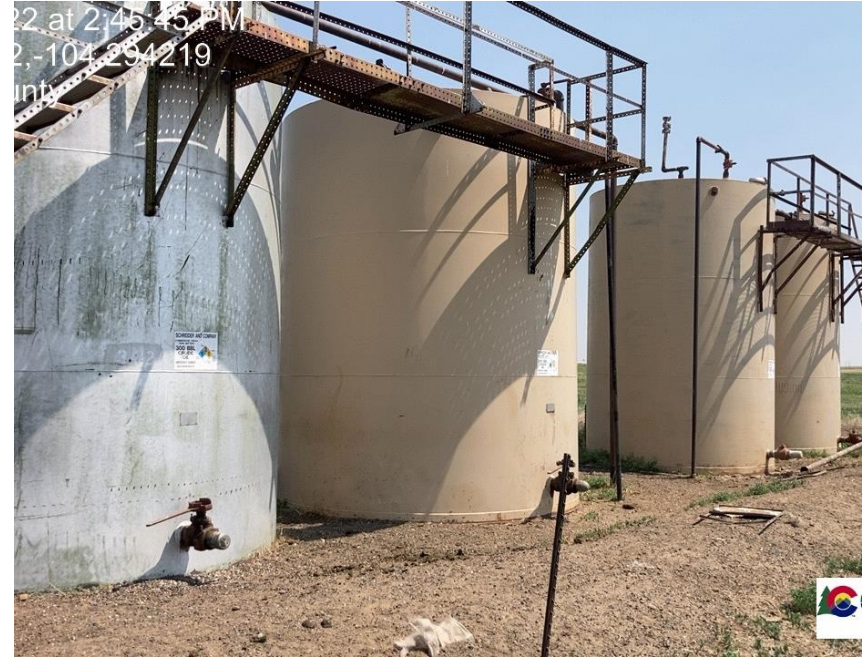
Pic 6 tanks berm is inadequate

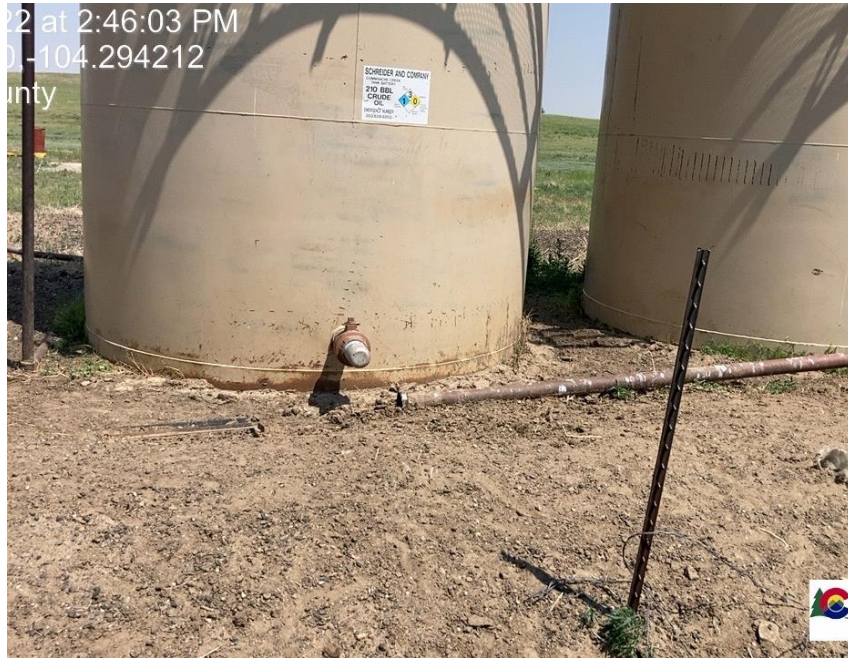
Pic 7 Previous leak from tank has been plugged

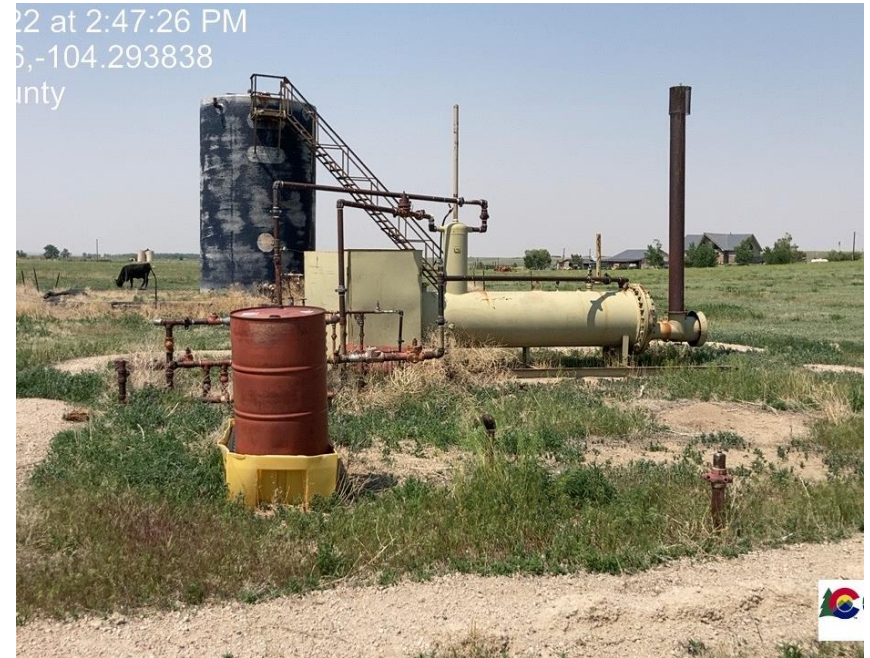
Pic 8 unused equipment / risers, separator

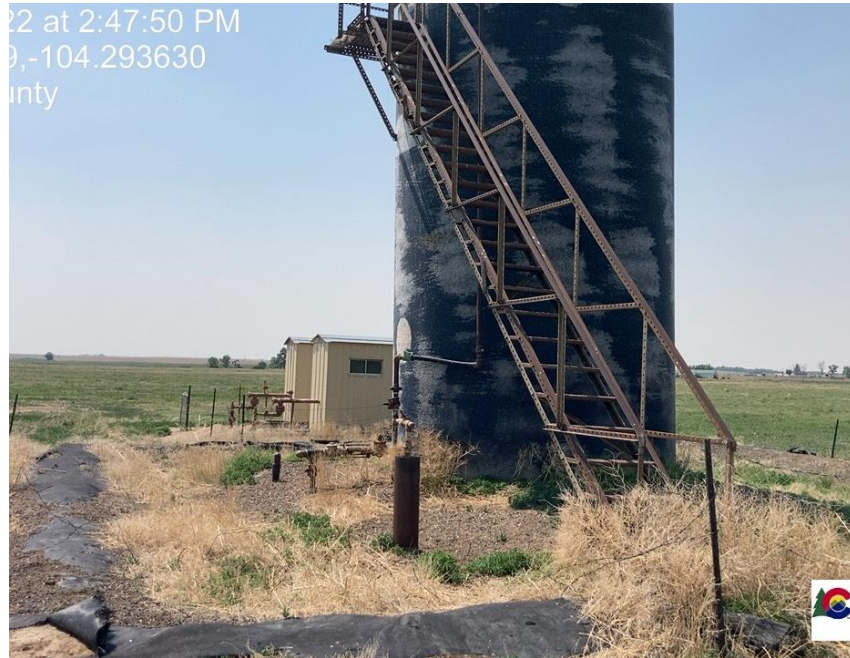
Pic 9 fiberglass tank berms are not adequate

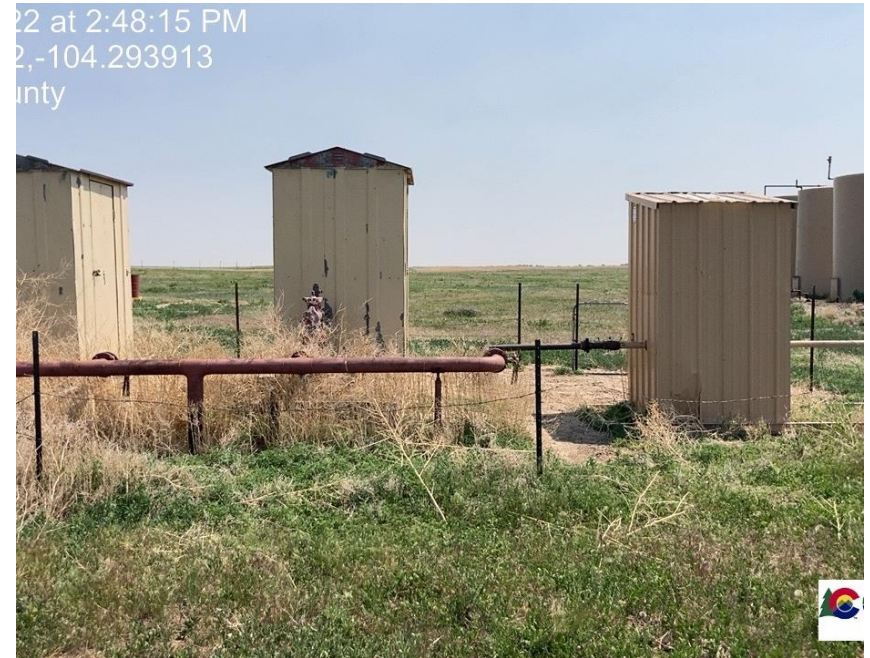
Pic 10 Three gas meter run
