# Inspection Photos

API: 071-08769

Operator: WAPITI OPERATING LLC

Inspection Date: 6/14/2022

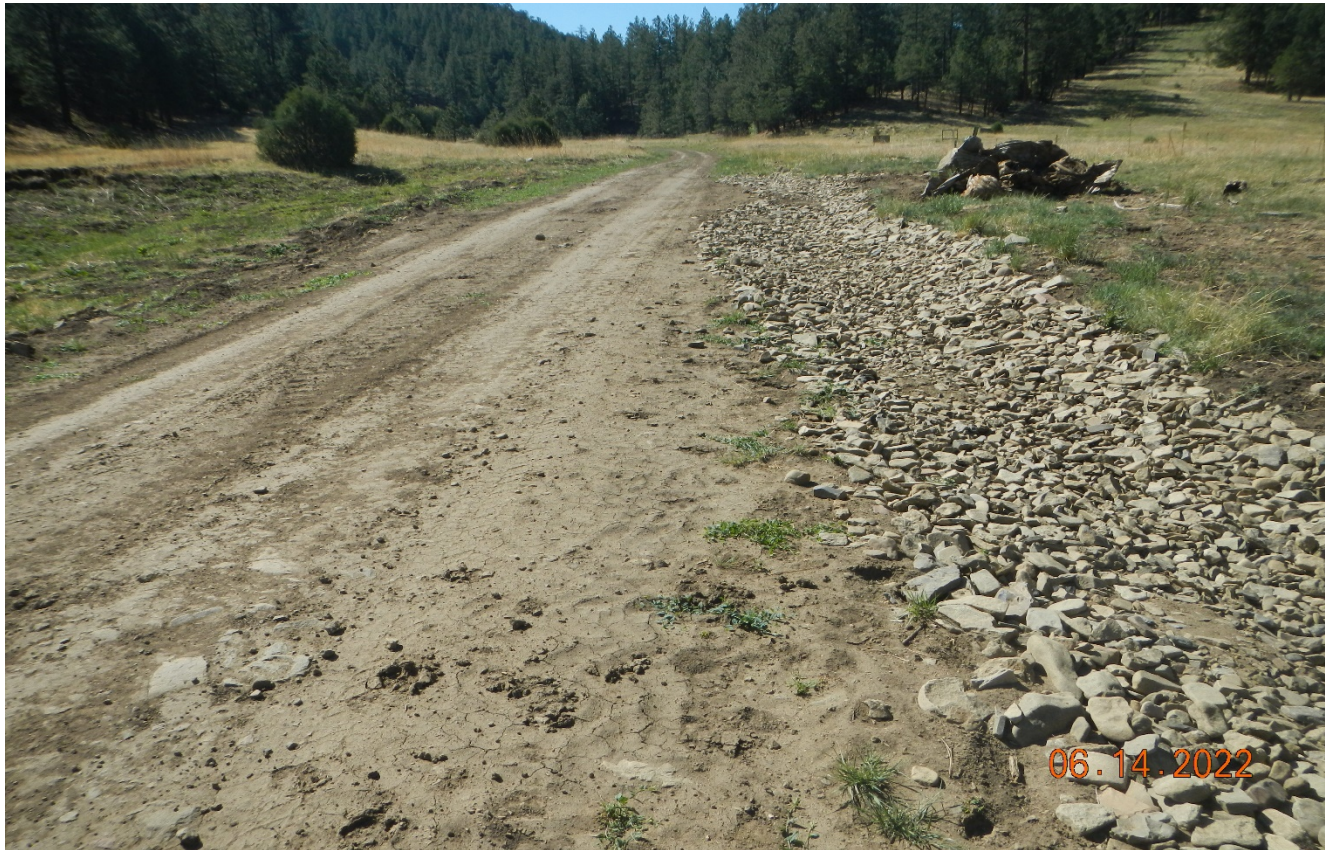
**Photo 1.** Facing southeast along the main road at the upper part of Lorencito Canyon. The erosion ins this area has been repaired. The culvert was removed and remains on the road side which needs to be removed.

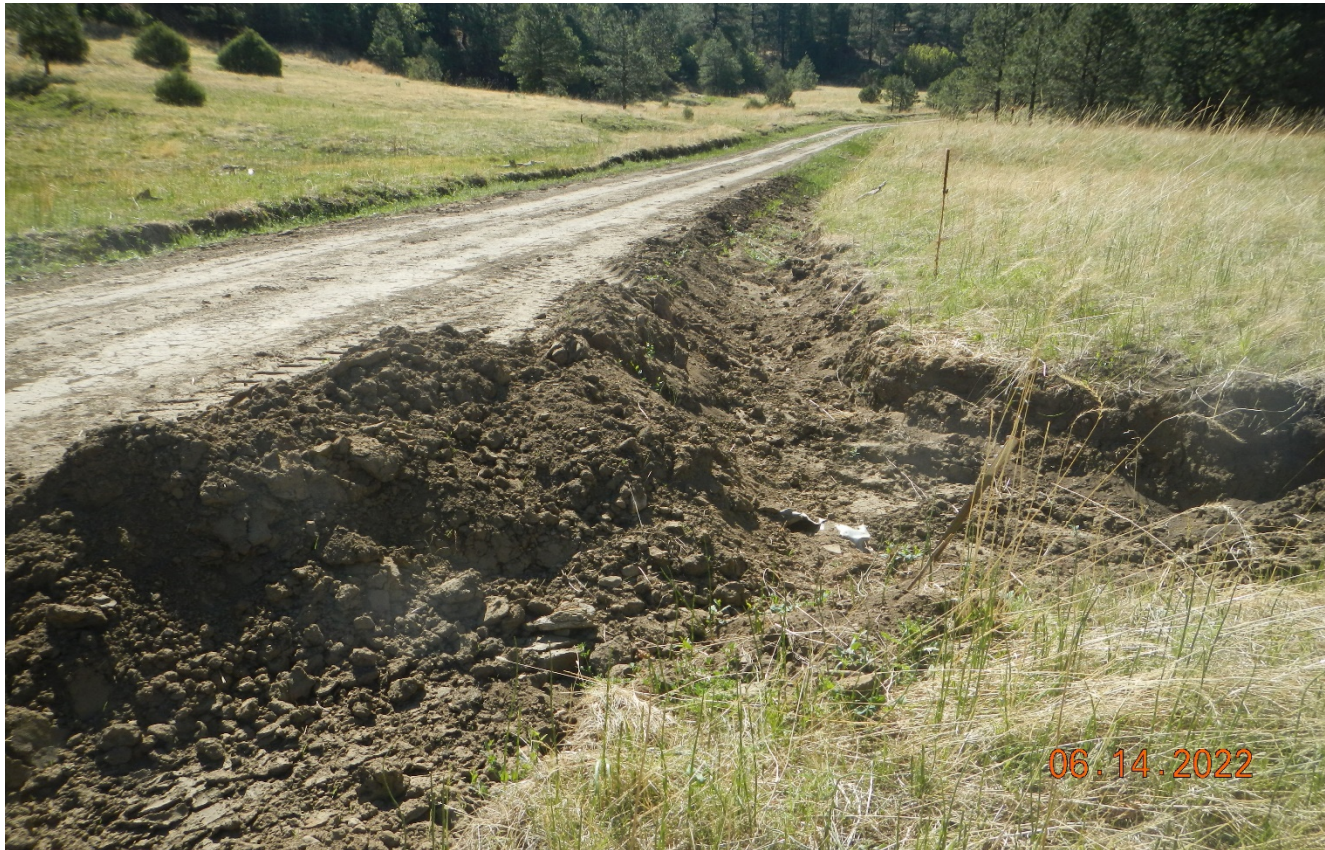
**Photo 2.** This culvert inlet was cleaned out however, the culvert is full of sediment which still needs to be cleaned out. Lat/Long:37.00581,-104.83861. Previous corrective action was not completed.

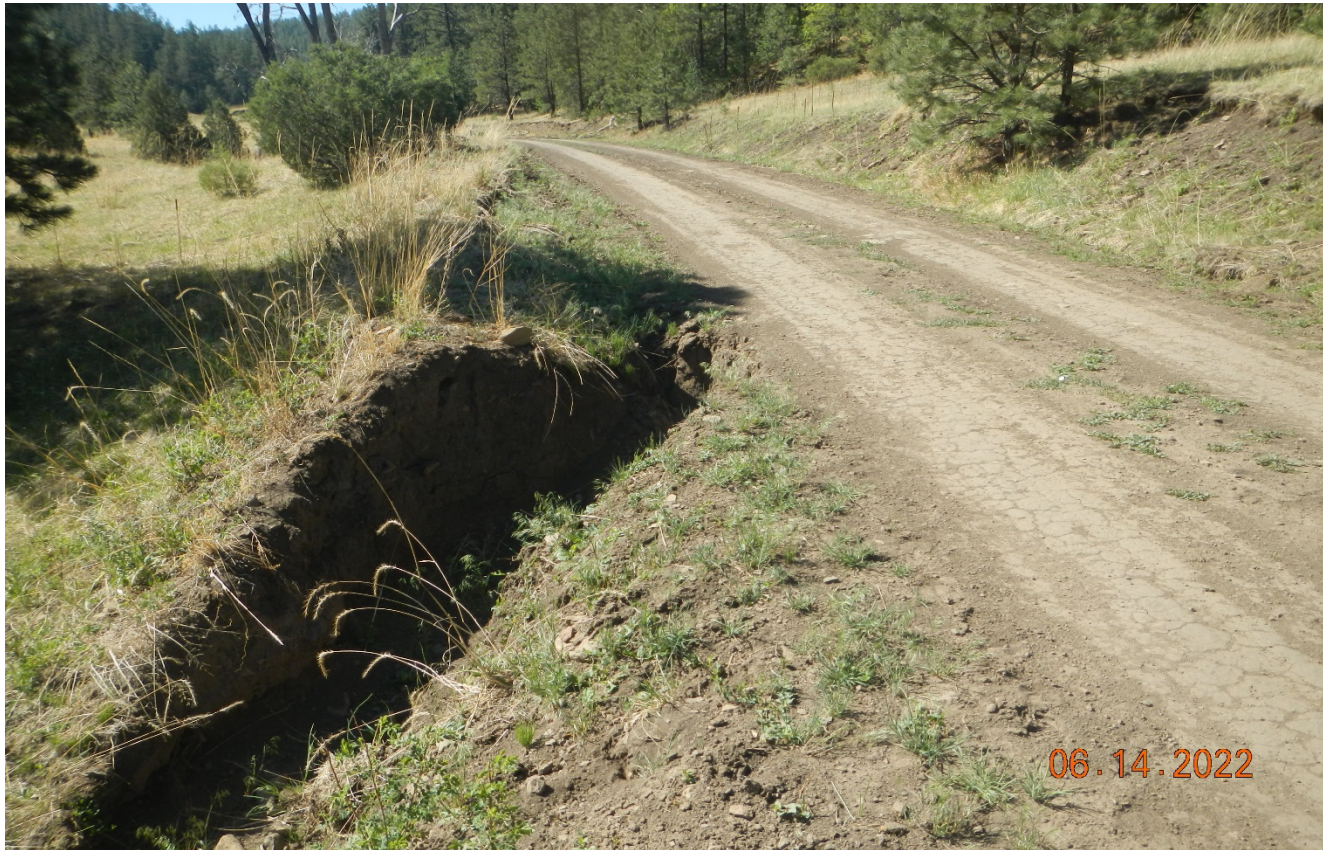
**Photo 3.** There is an erosion gully along the road that needs to be repaired and stabilized. Previous corrective action was not completed.

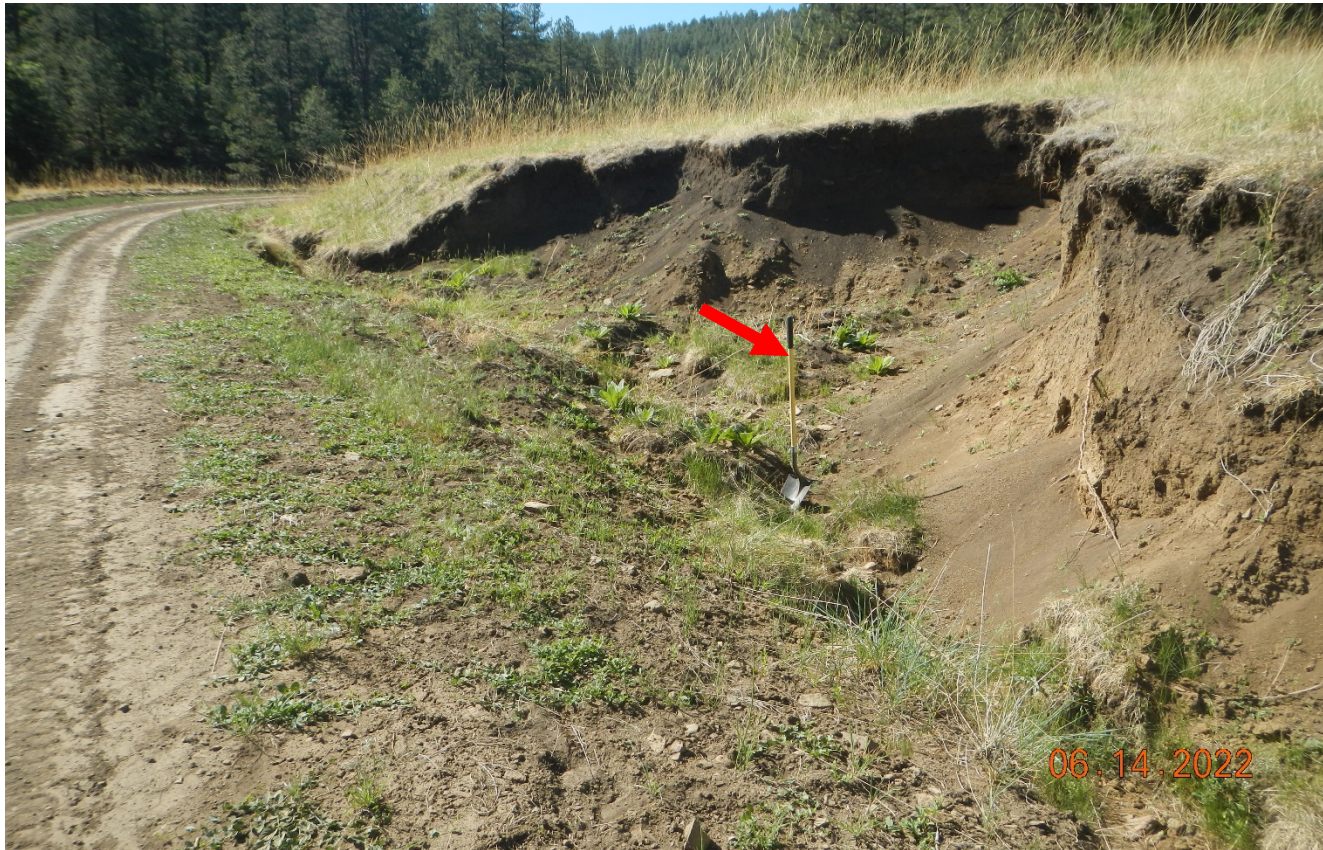
**Photo 4.** The side of the road is eroded and not stabilized at Lat/Long:36.99952,-104.83425. Erosion head cutting is continuing to occur further back. This area needs to be repaired and stabilized. Previous corrective action not completed. Red arrow points to 4.5 ft. shovel.

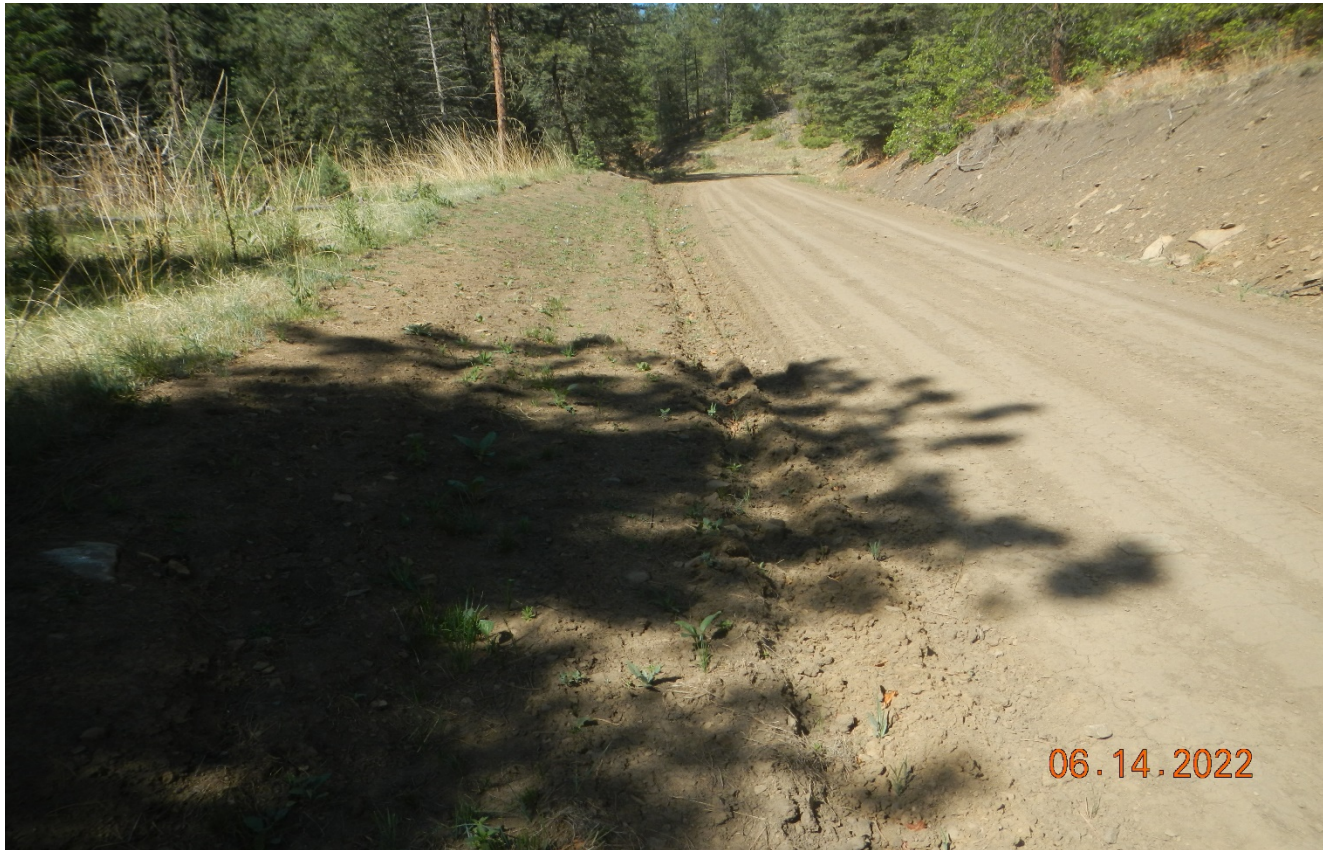
**Photo 5.** There was grading performed along the road. The disturbance along the side of the road needs to be seeded and reclaimed. Previous corrective action not completed.

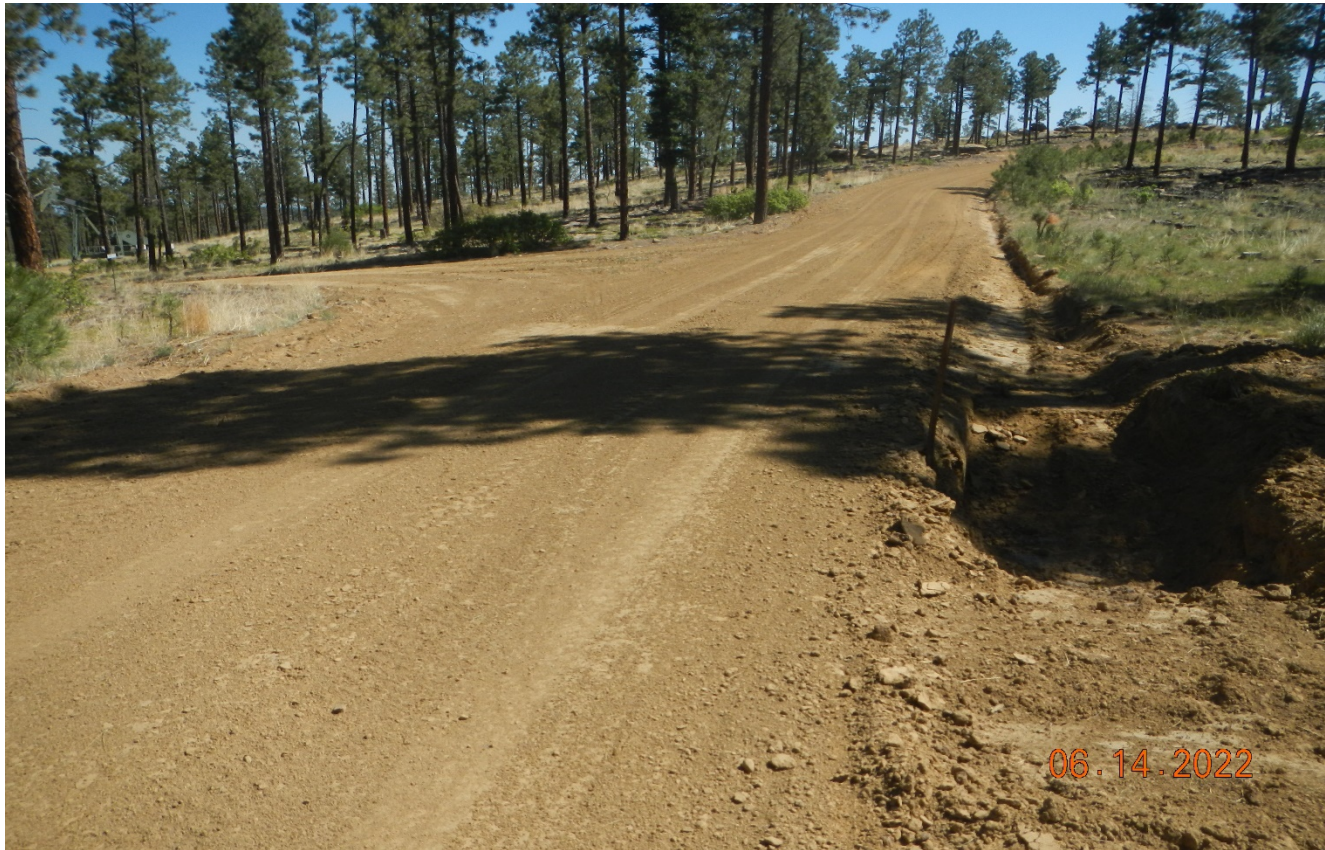
**Photo 6.** This culvert inlet was cleaned out however, the culvert is full of sediment which needs to be cleaned out. Lat/Long:36.99405,-104.84710.

Previous corrective action not completed.

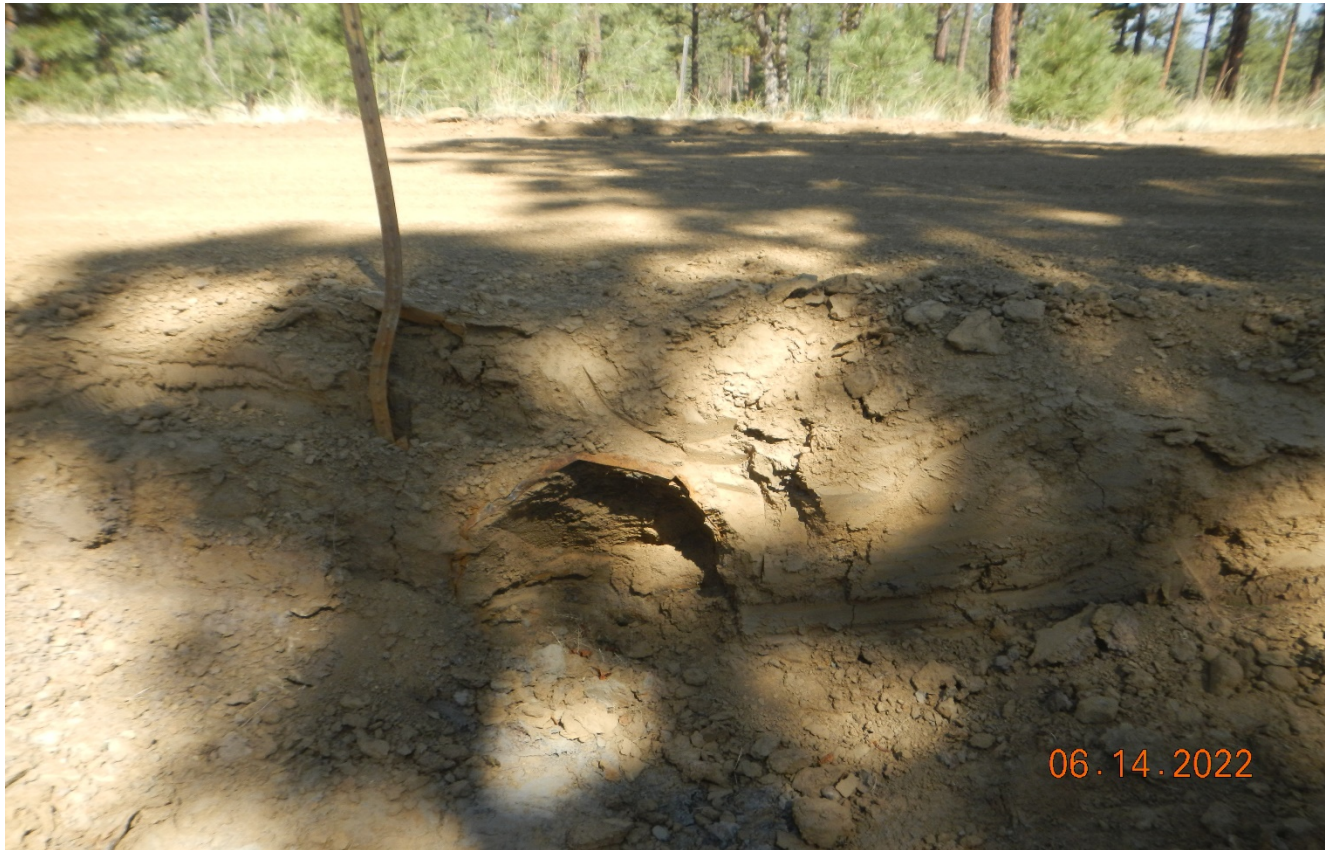
**Photo 7.** View of culvert from the previous photo which is full of sediment.

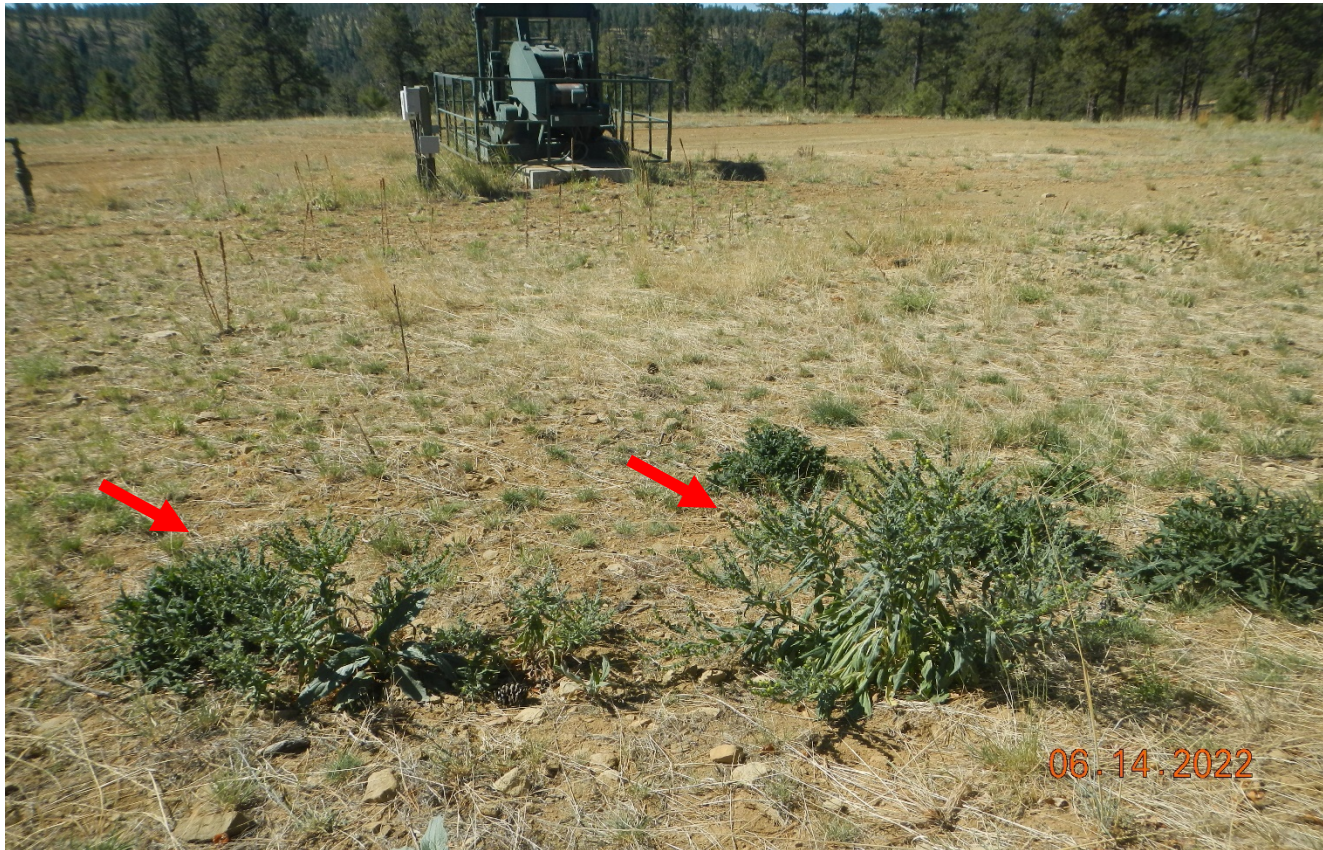
**Photo 9.** There are noxious weeds Hounds tongue which has not been controlled. The noxious weeds have already produced seed so the weeds will now need to be bagged and removed. Previous corrective action not completed.
