Inspection Photos
Operator: Hilcorp Energy
API: 067-08245
Date: 6/1/2022

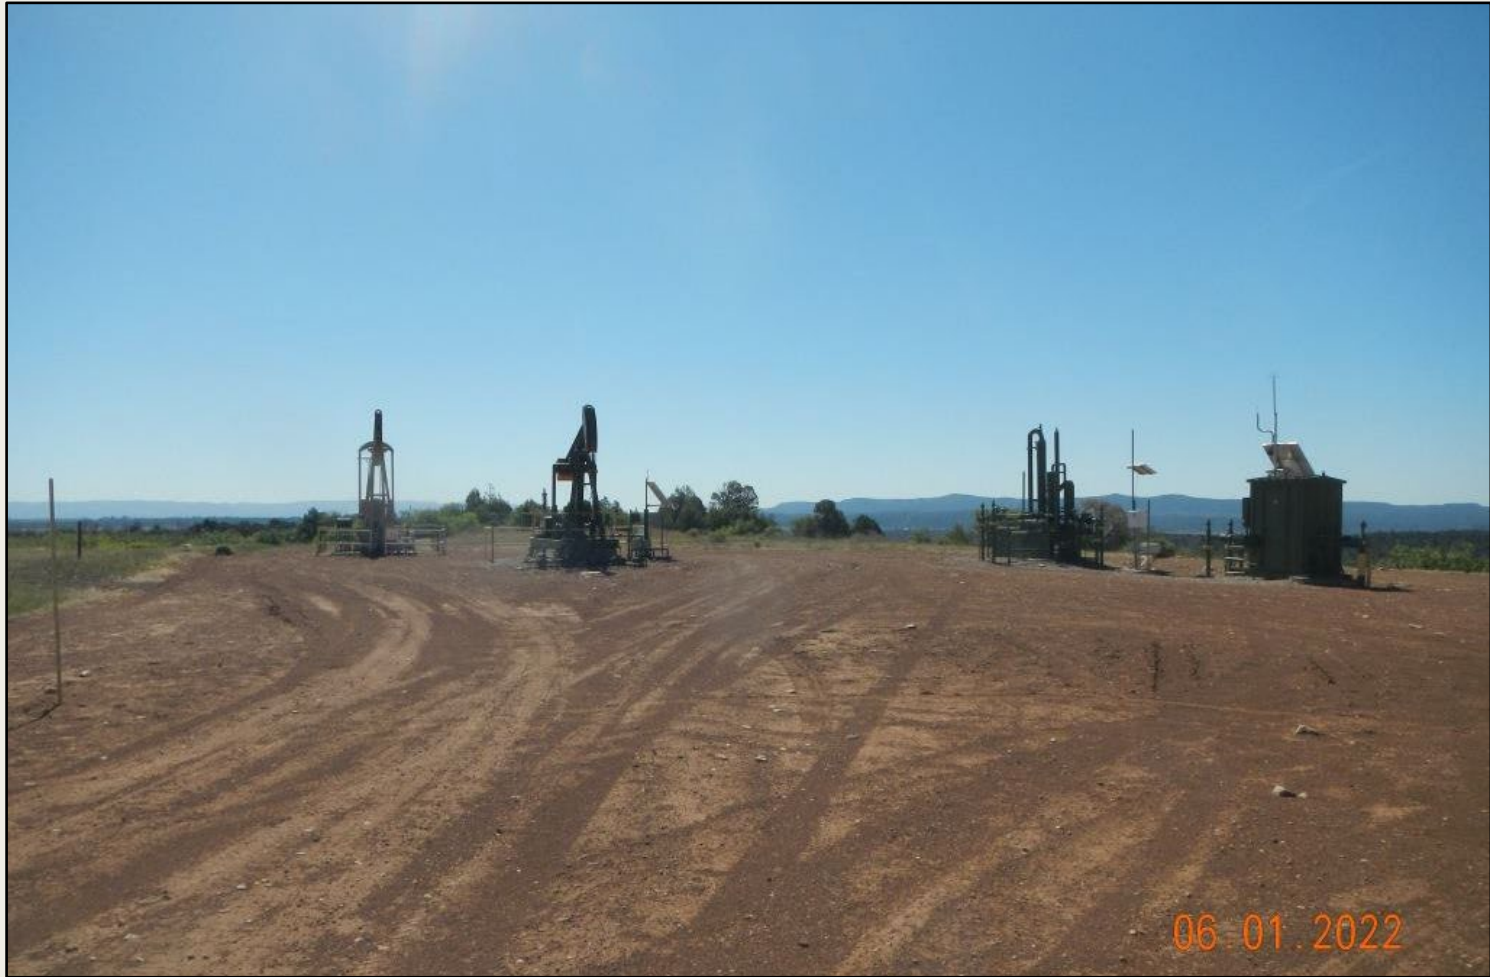
Photo 1. View of the project area from the well pad entrance facing center.

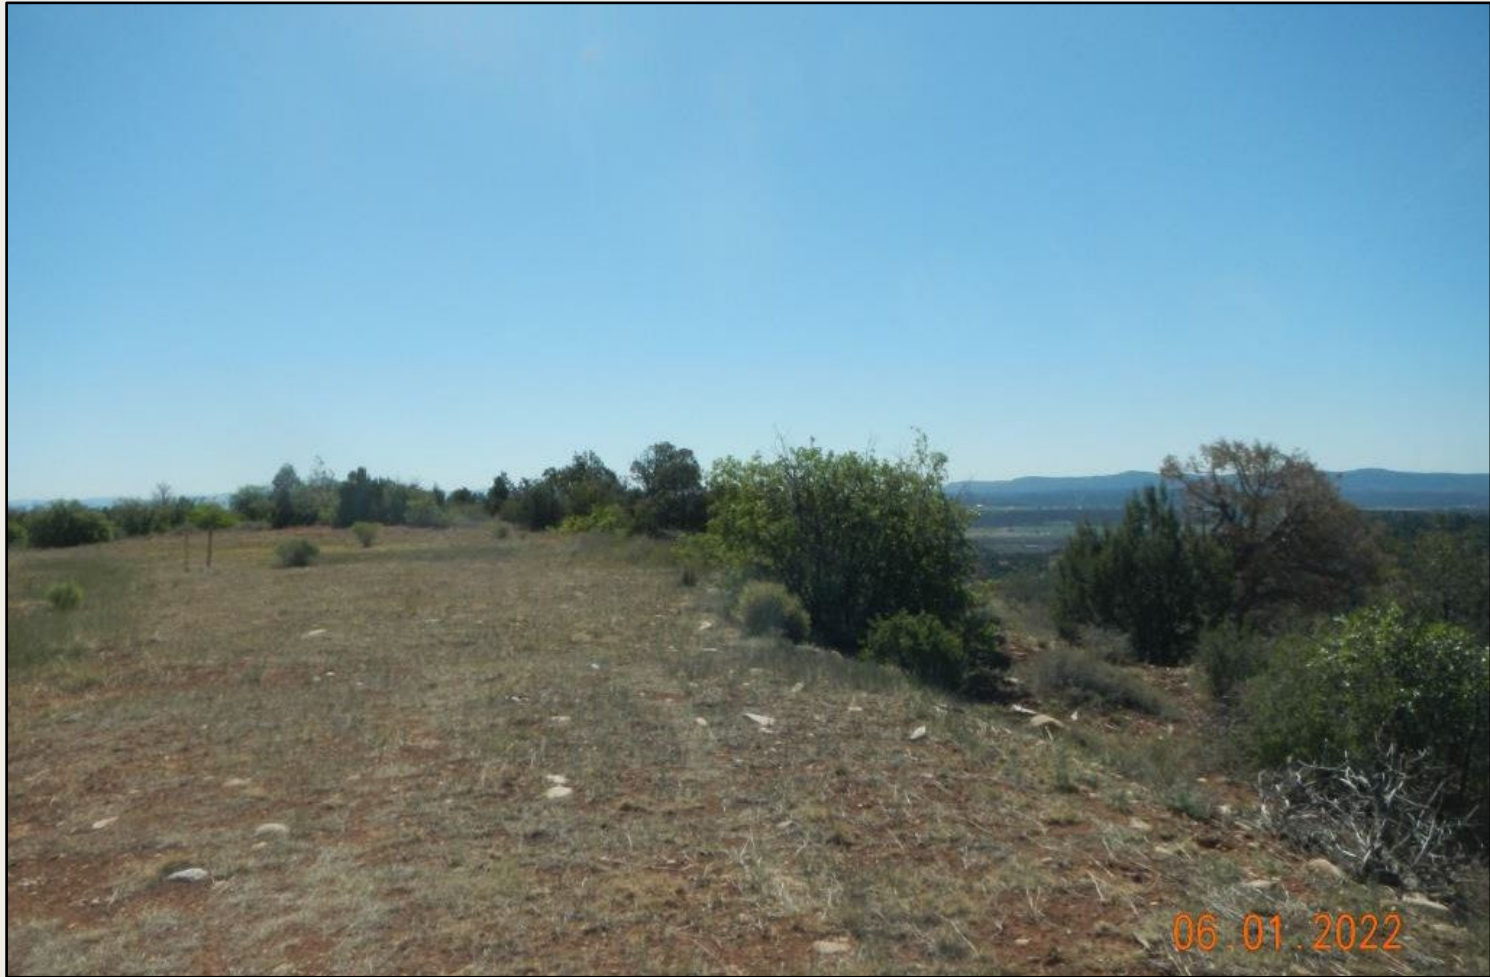
Photo 2. View of the southern project area from the southeastern corner facing westward. Revgetation is progressing largely with western wheatgrass and sand dropseed.

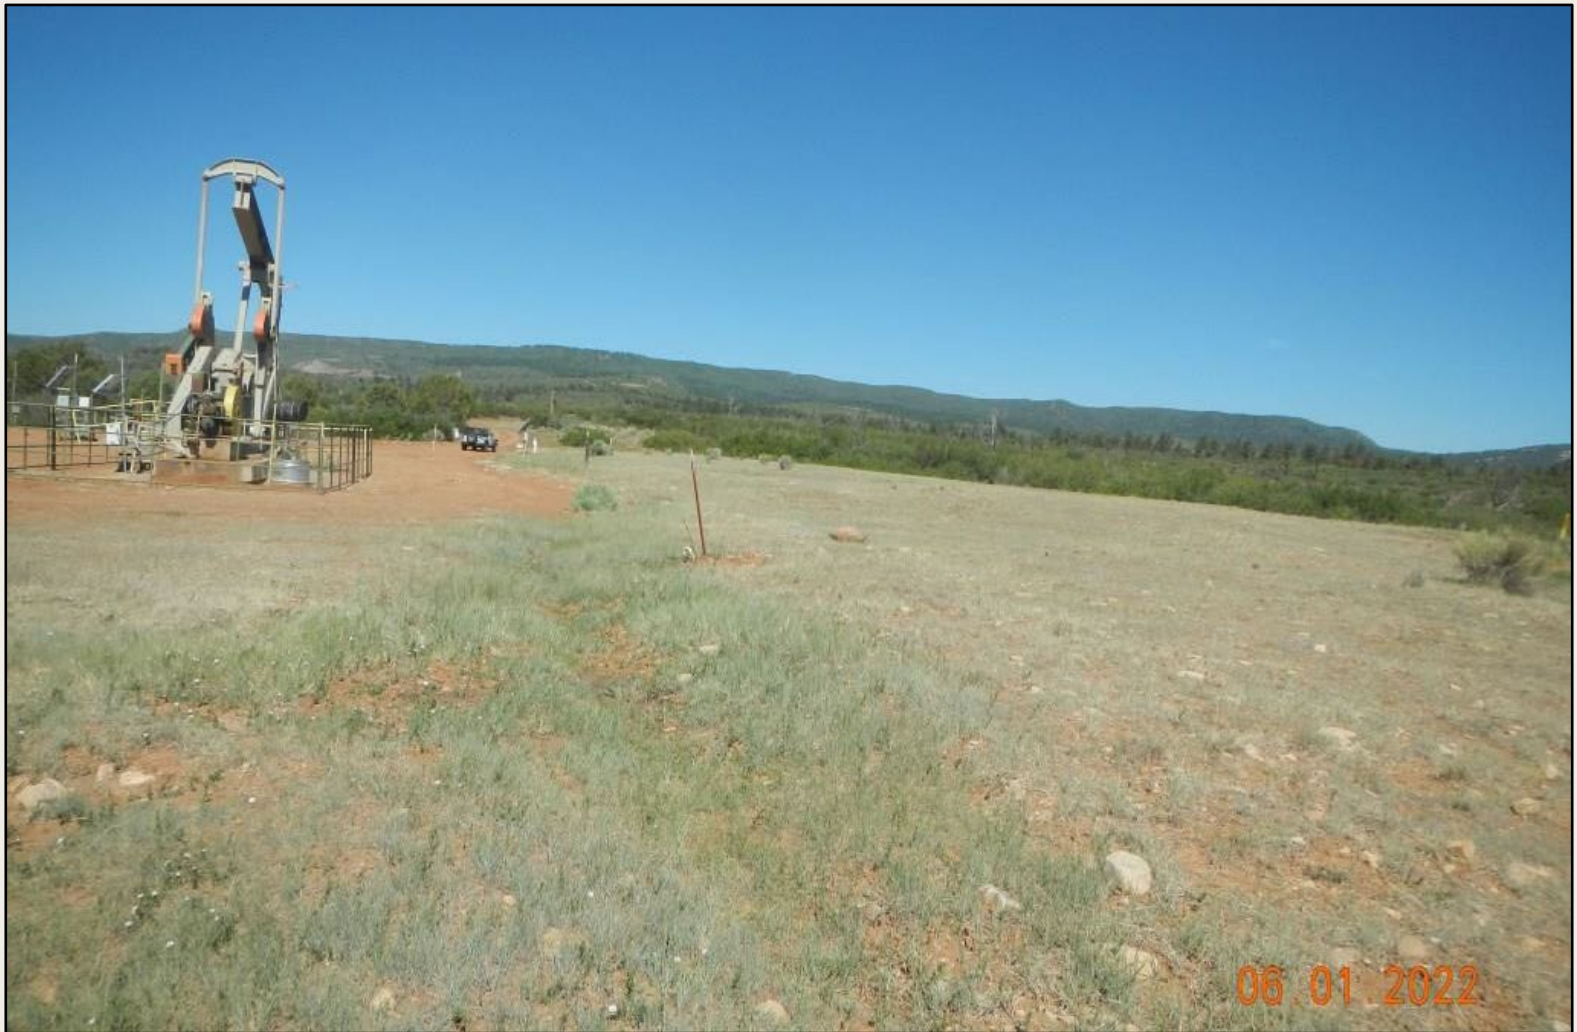
Photo 3. View of the northern project area from the northeastern corner facing westward.

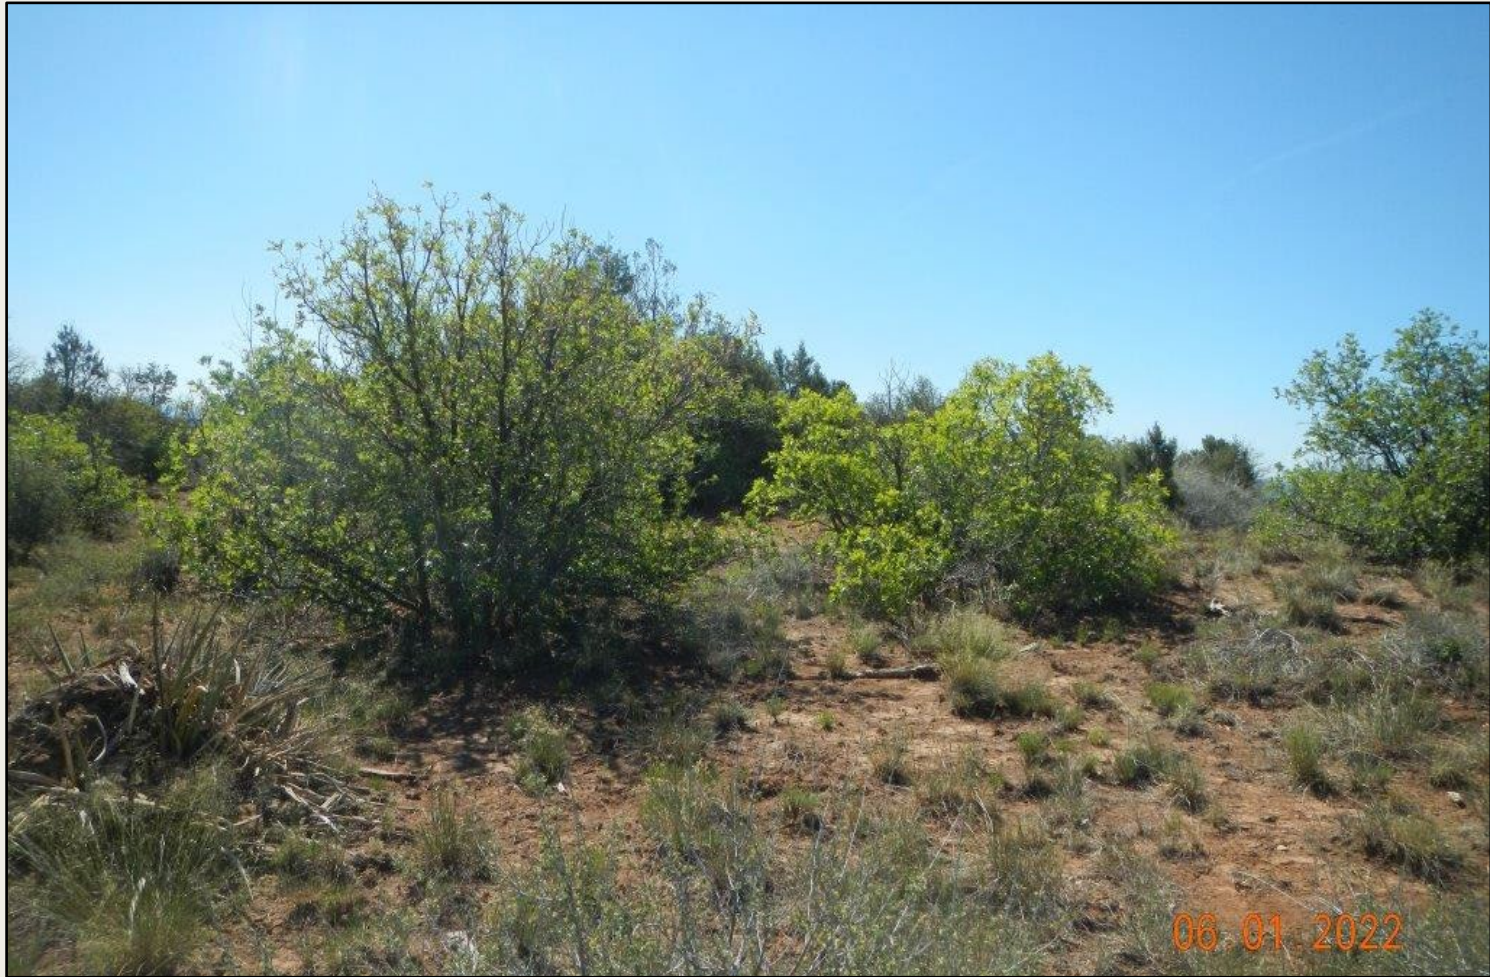
Photo 4. View of reference area comprised of gambel oak shrubland with Indian ricegrass, yucca, snakeweed, squirreltail, and *chaetopappa ericioides*.
