Inspection Photos

Operator: Hilcorp Energy
API: 067-09374
Date: 6/1/2022

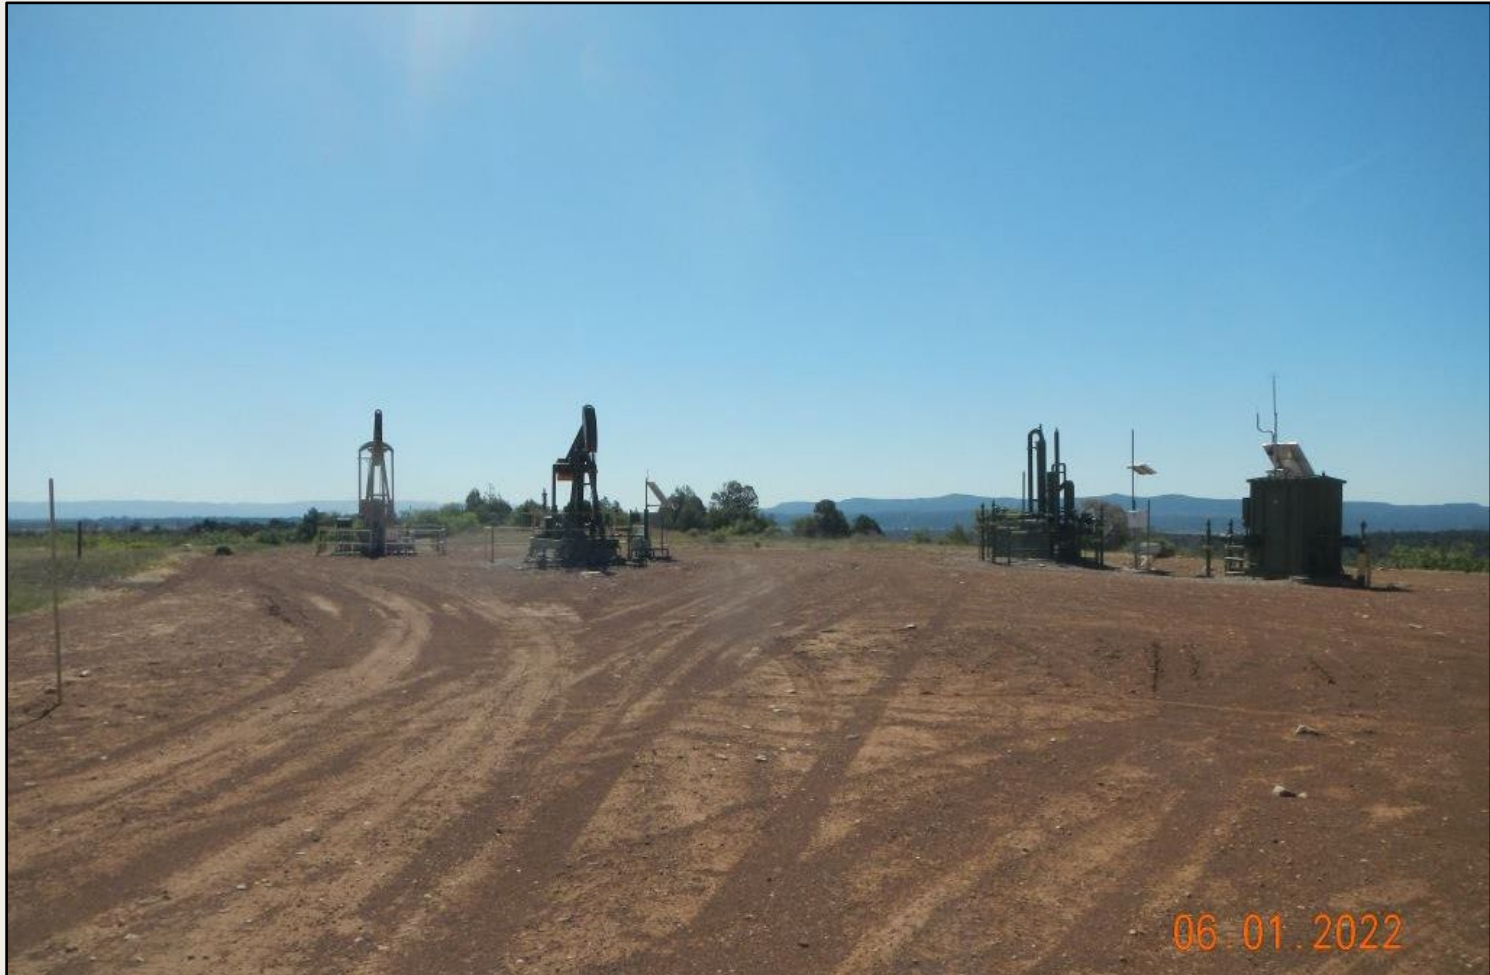
Photo 1. View of the project area from the well pad entrance facing center.

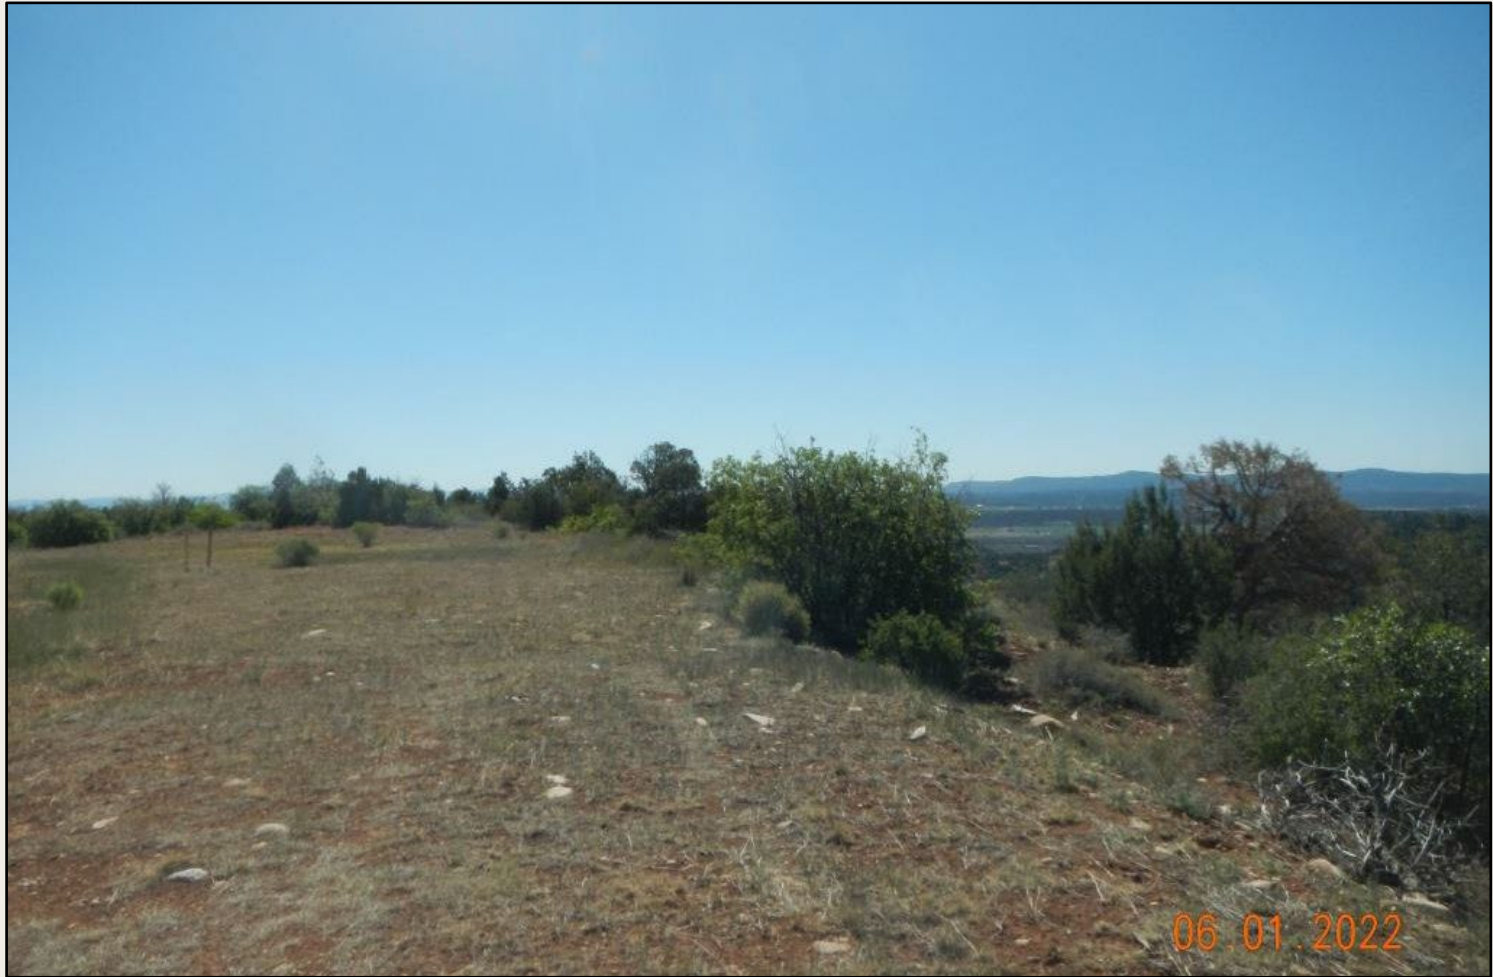
Photo 2. View of the southern project area from the southeastern corner facing westward. Revgetation is progressing largely with western wheatgrass and sand dropseed.

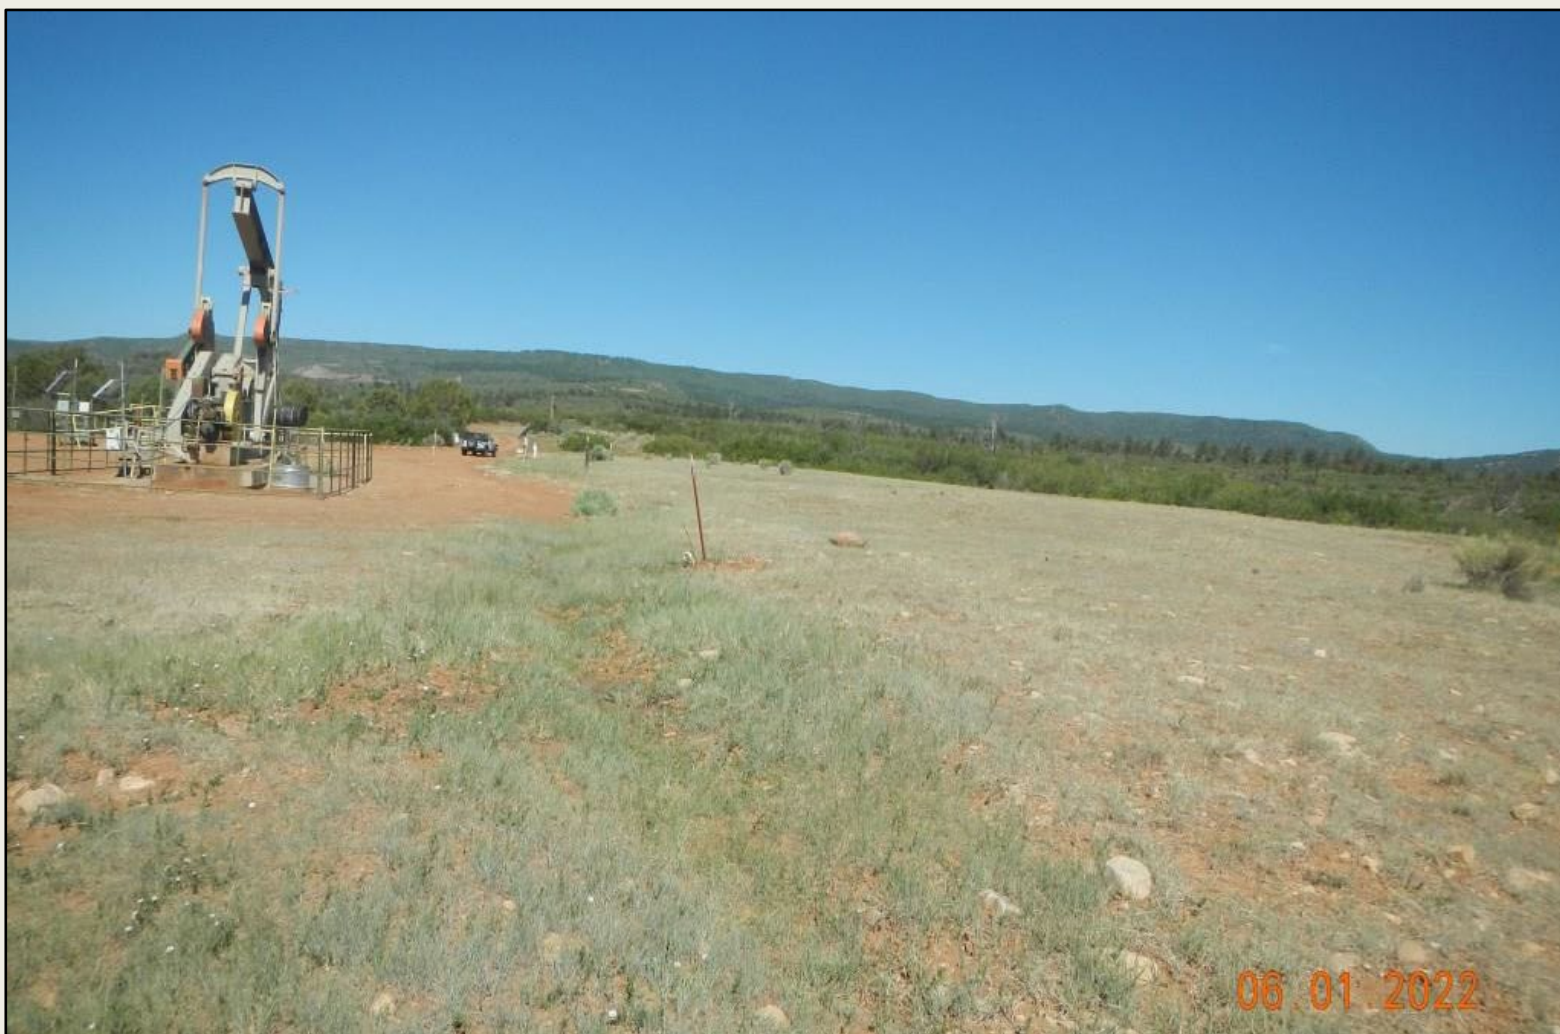
Photo 3. View of the northern project area from the northeastern corner facing westward.
