# Inspection Photos

Operator: Hilcorp Energy  
API: 067-08641  
Date: 6/1/2022

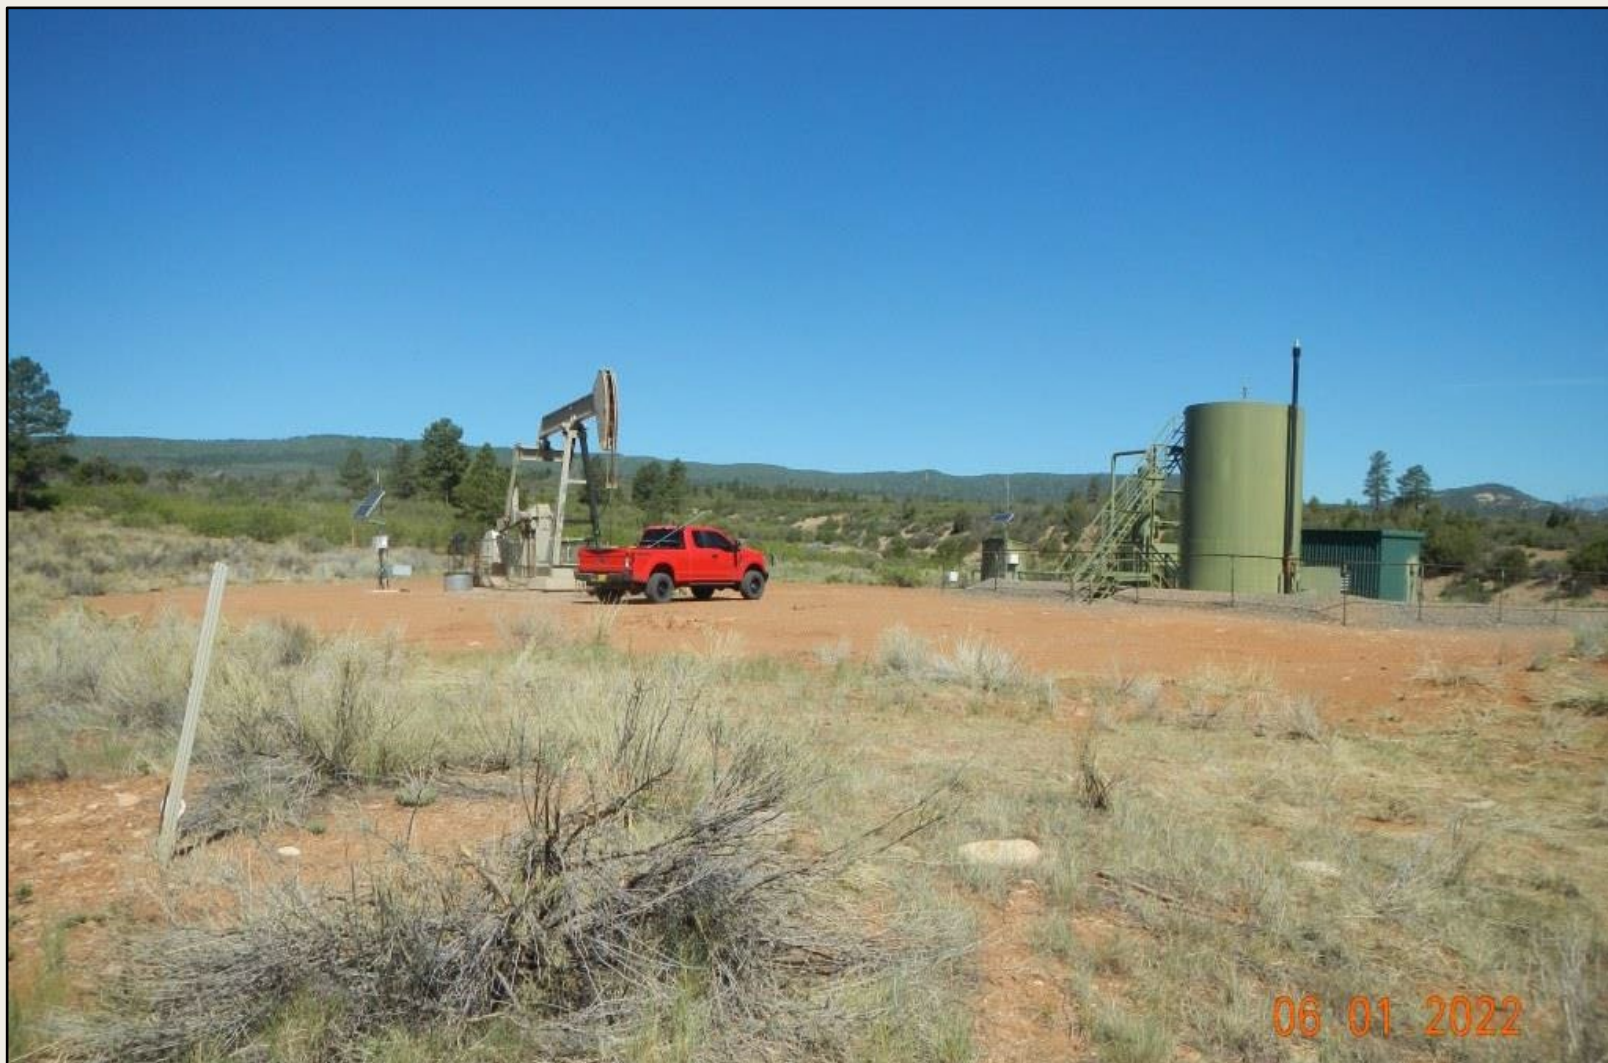
Photo 1. View of the project area from the southeastern corner facing center.

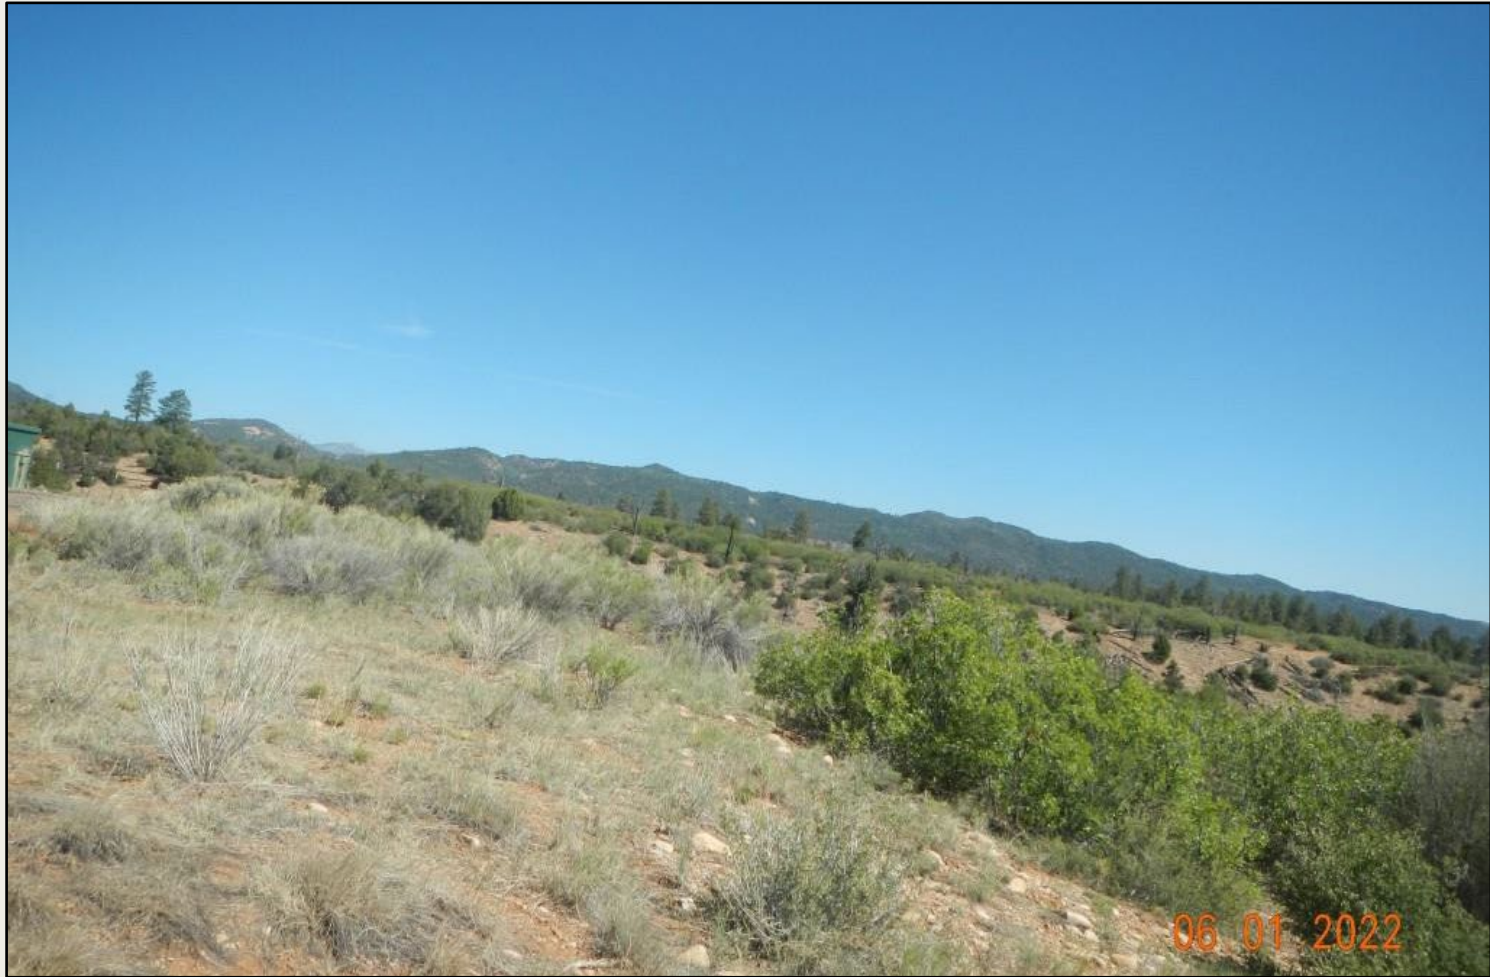
Photo 2. View of the northern project area from the northeastern corner facing westward. Revgetation is progressing largely with western wheatgrass, purple threeawn, and rubber rabbitbrush.

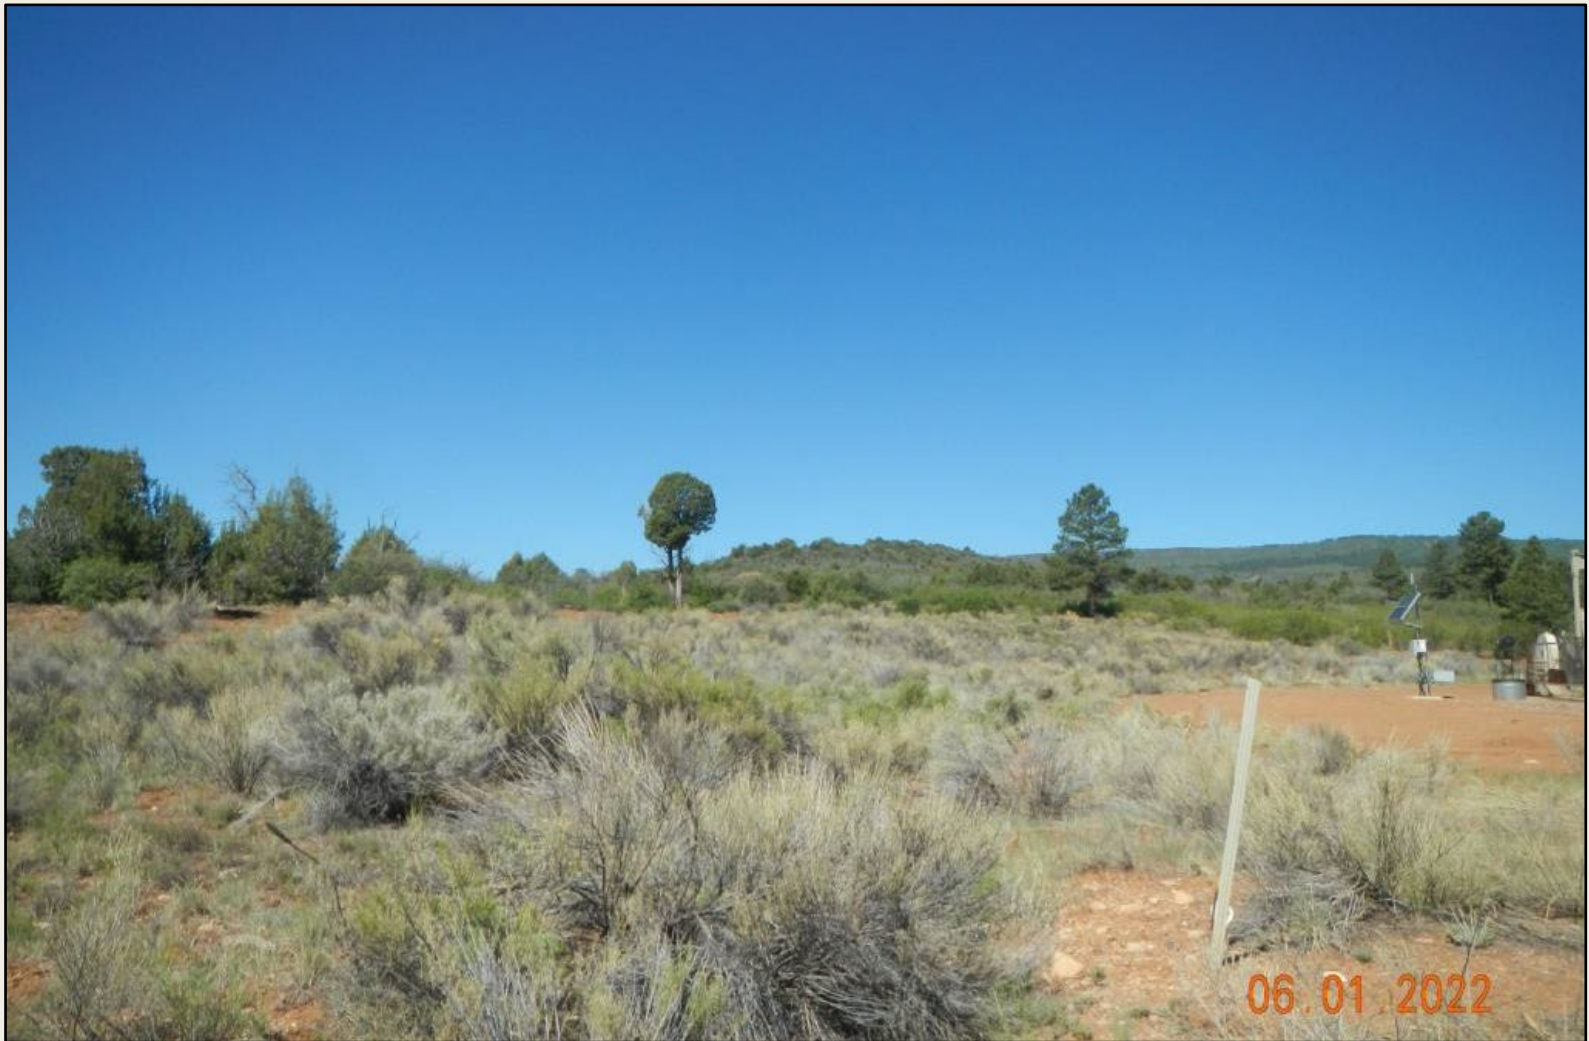
Photo 3. View of the southern project area from the southeastern corner facing westward.

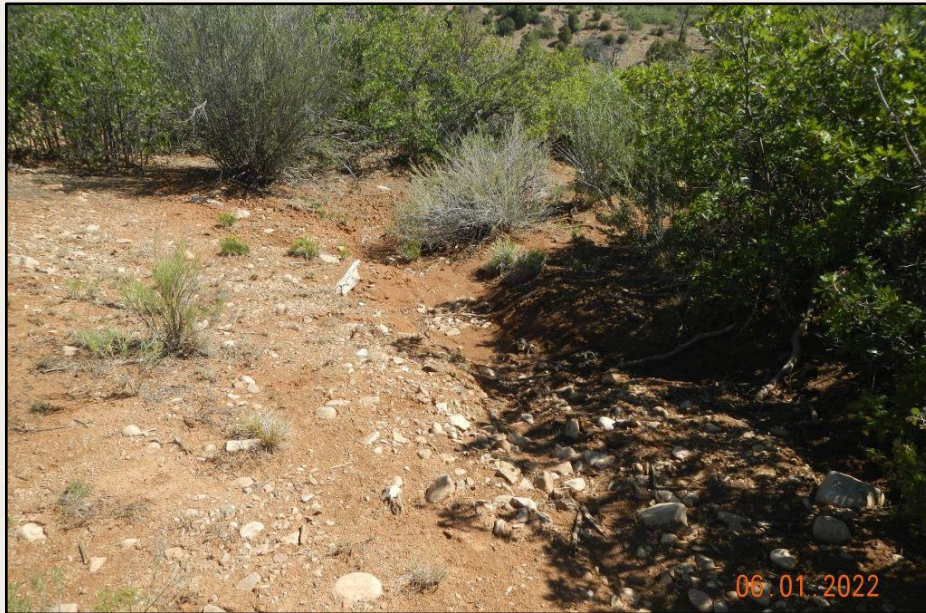
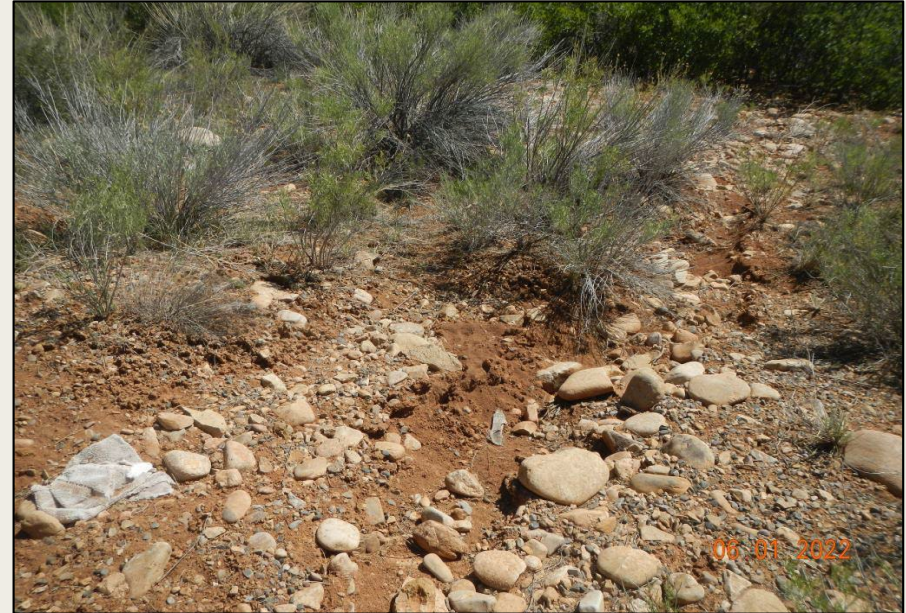
Photos 4/5. View of erosional channeling within the northern fill slope, approximately 12-18 wide and deep needing stabilization.
