**Inspection Photos**  
**Operator: Hilcorp Energy**  
**API: 067-09069**  
**Date: 6/1/2022**

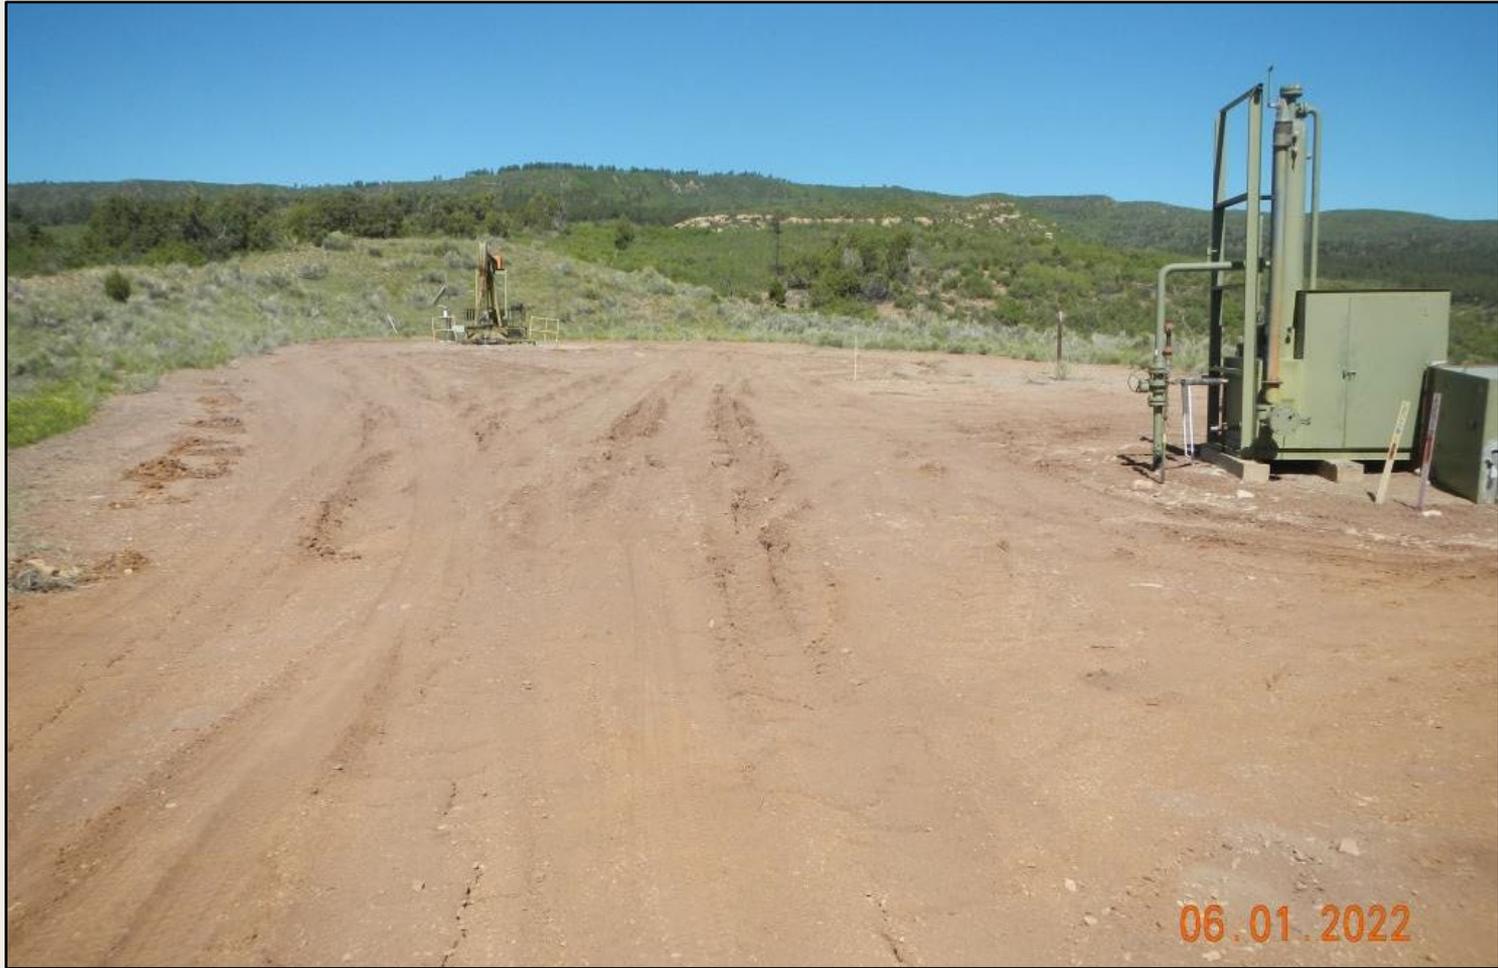
Photo 1. View of the project area from the well pad entrance facing center.

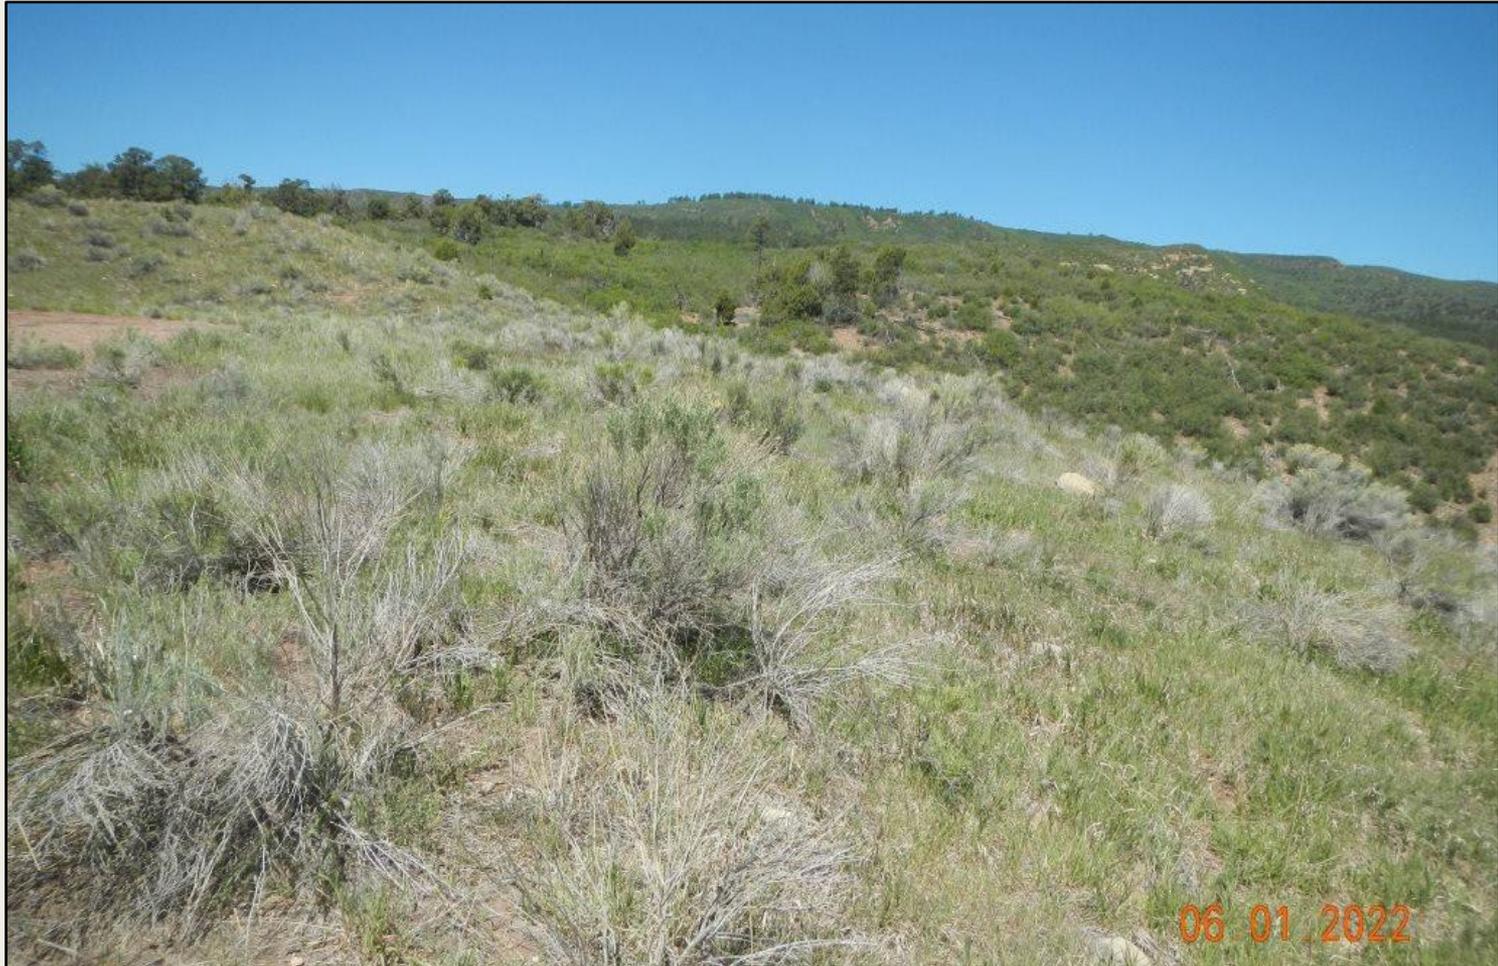
Photo 2. View of the northern project area from the northeastern corner facing westward. Revgetation is progressing largely with western wheatgrass, smooth brome, crested wheatgrass, and rubber rabbitbrush.

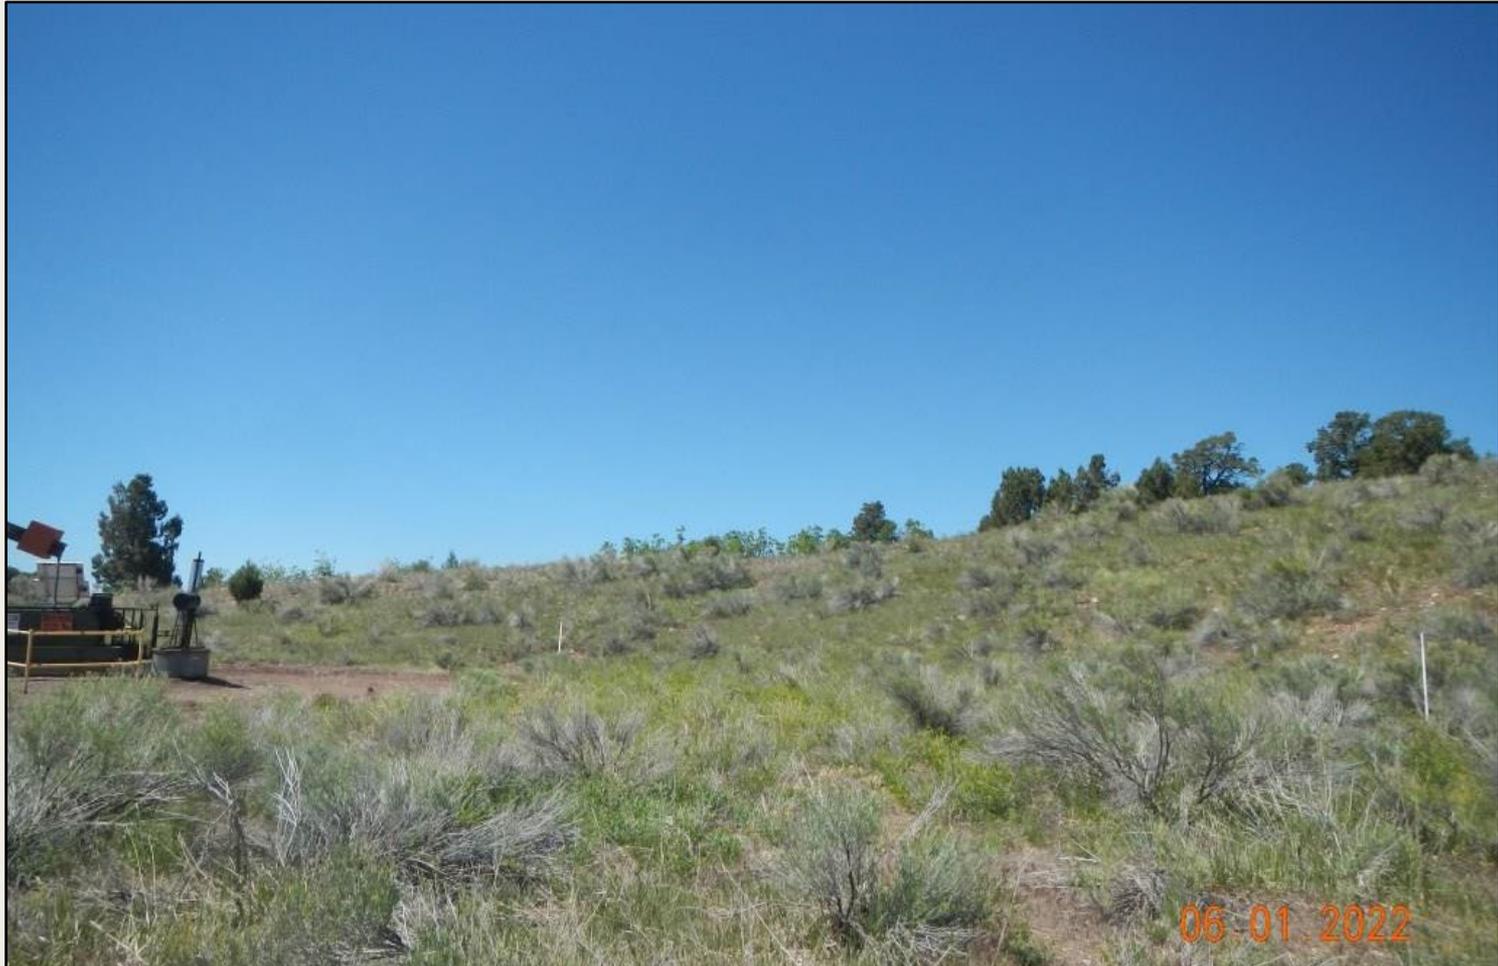
Photo 3. View of the western project area from the northwestern corner facing southward.

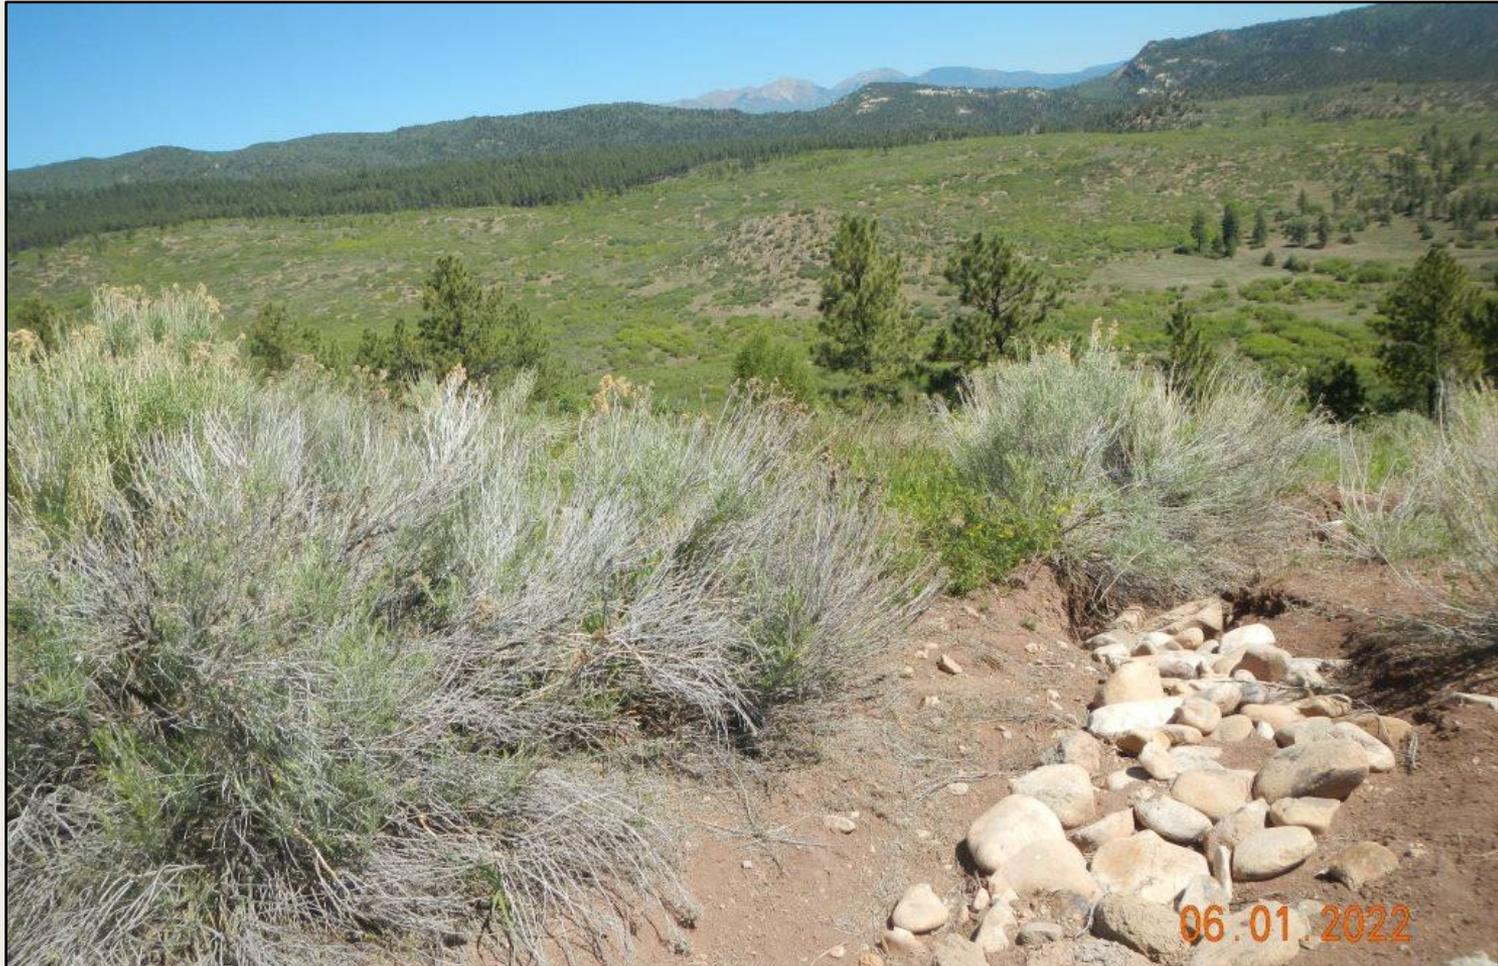
Photo 4. View of erosional channel with cobble placed in the northern project area (approximately 2-3ft wide and deep). Erosional channeling continues here, around cobble rocks and down-slope.

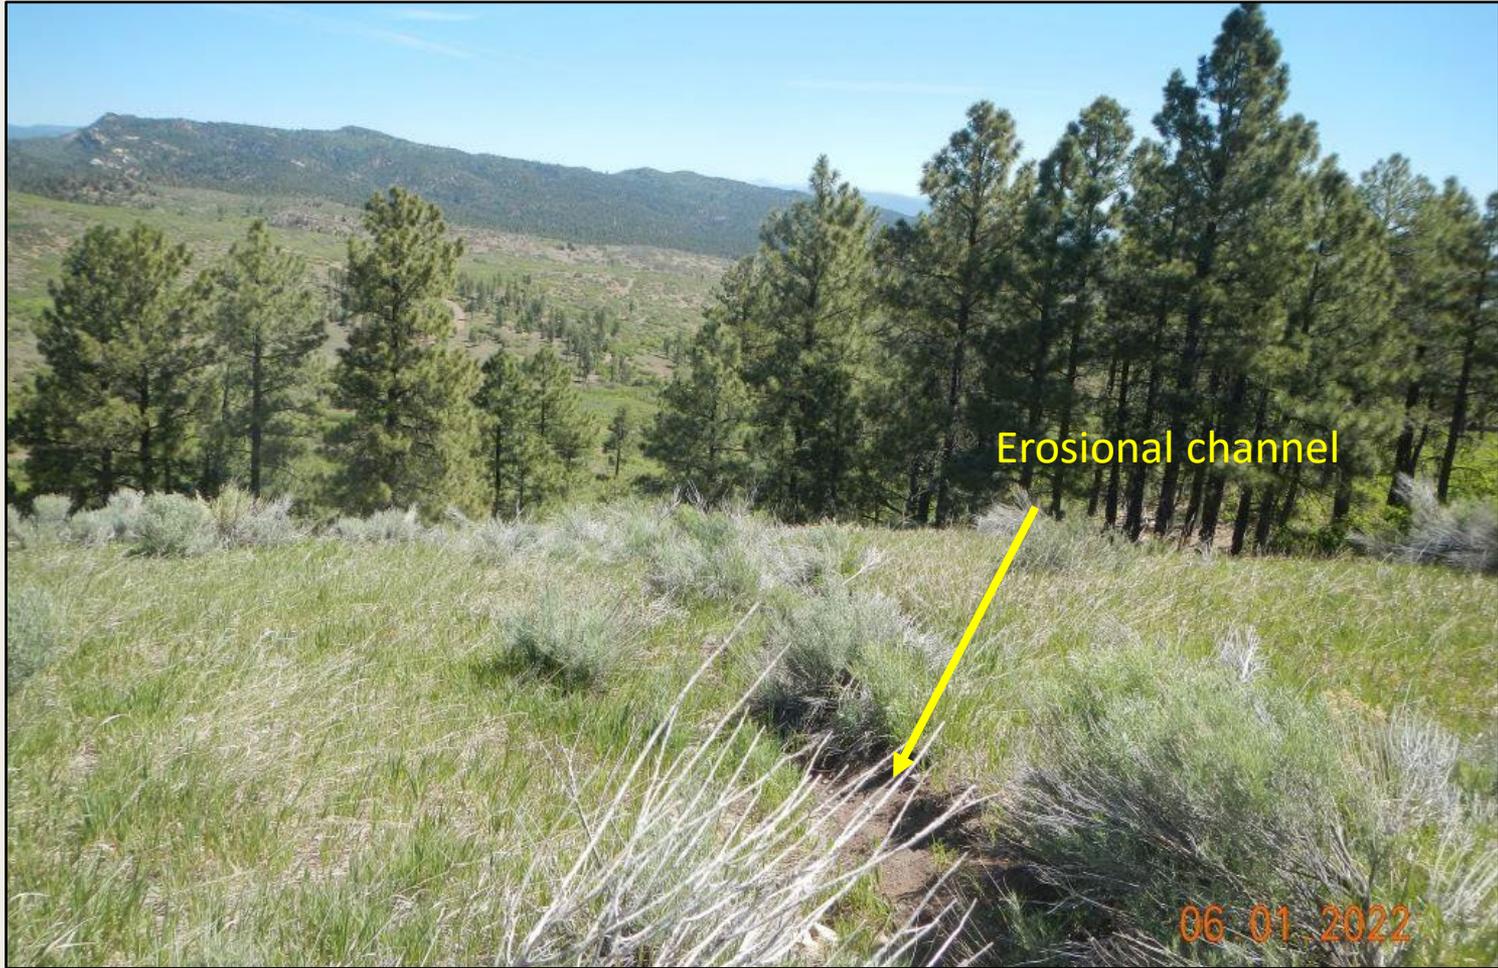
Photo 5. View of another erosional channel forming within the northeastern portion of the project area (approx. 1-2ft wide and deep).

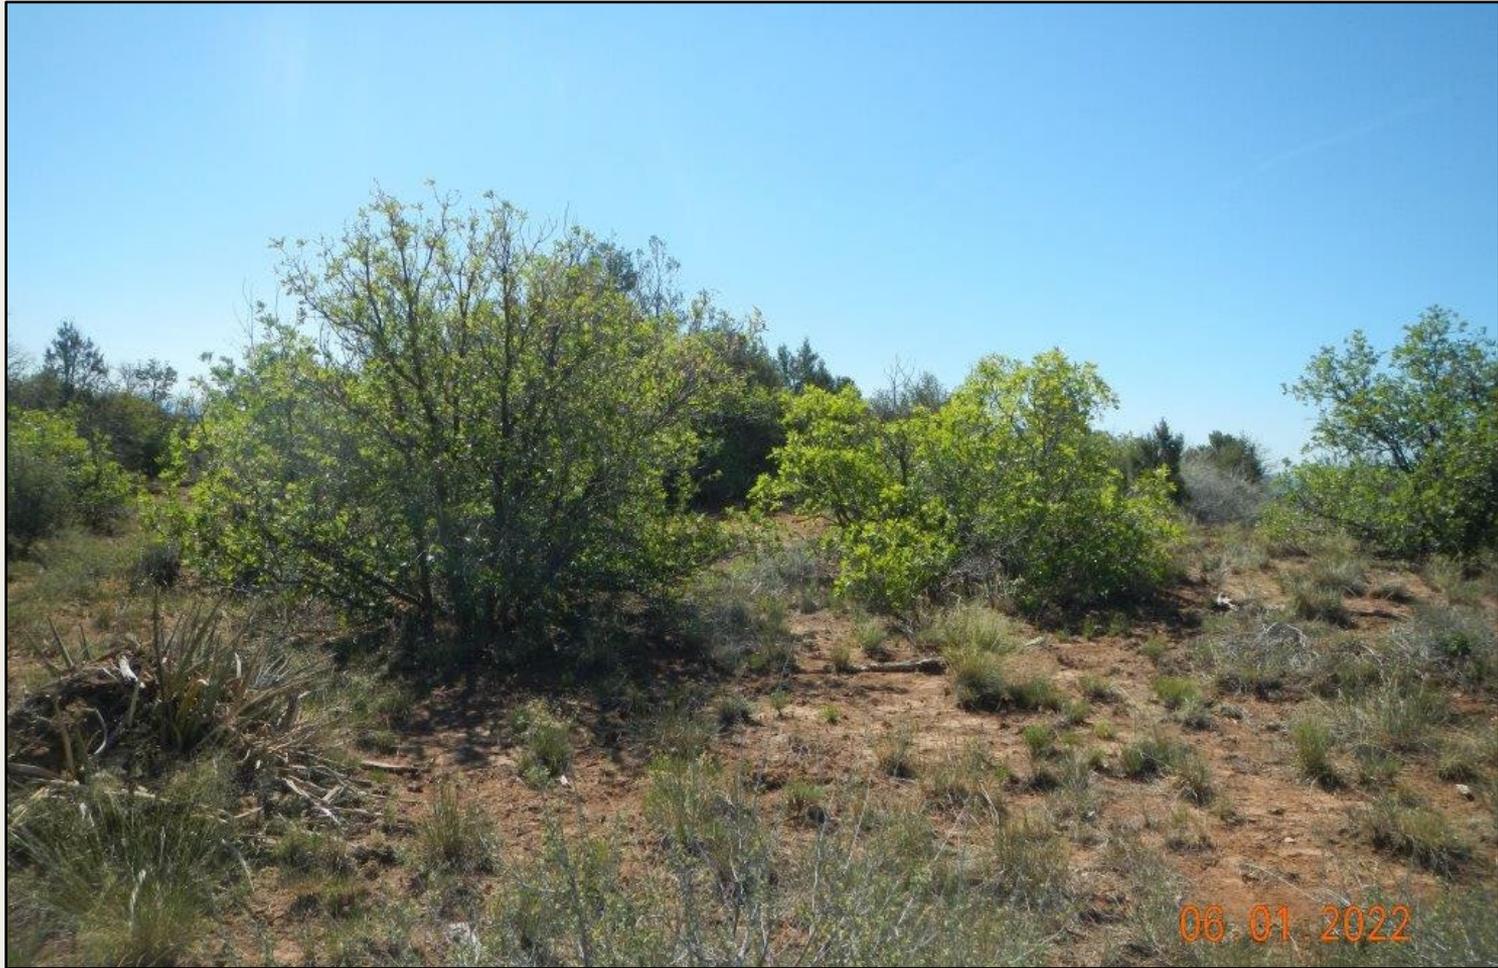
Photo 6. View of reference area comprised of gambel oak shrubland with Indian ricegrass, yucca, snakeweed, squirreltail, and *chaetopappa ericioides*.
