Inspection Photos  
Location Name: Davis 2-5  
Location ID: 326465

**COLORADO**  
Oil & Gas Conservation  
Commission  
Department of Natural Resources

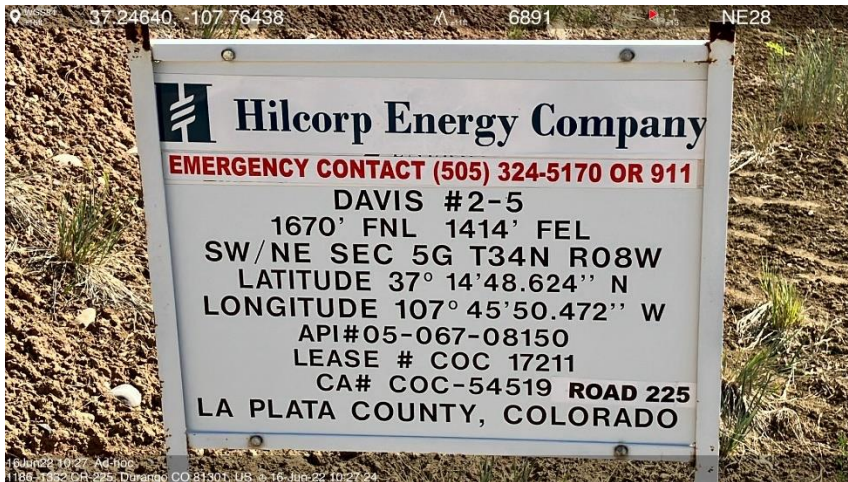
IMG 01  
Well sign

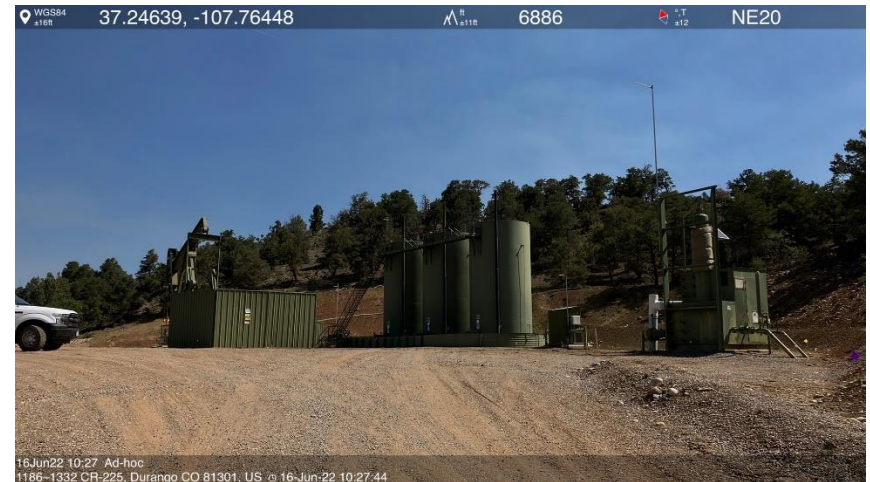
IMG 02  
Site overview

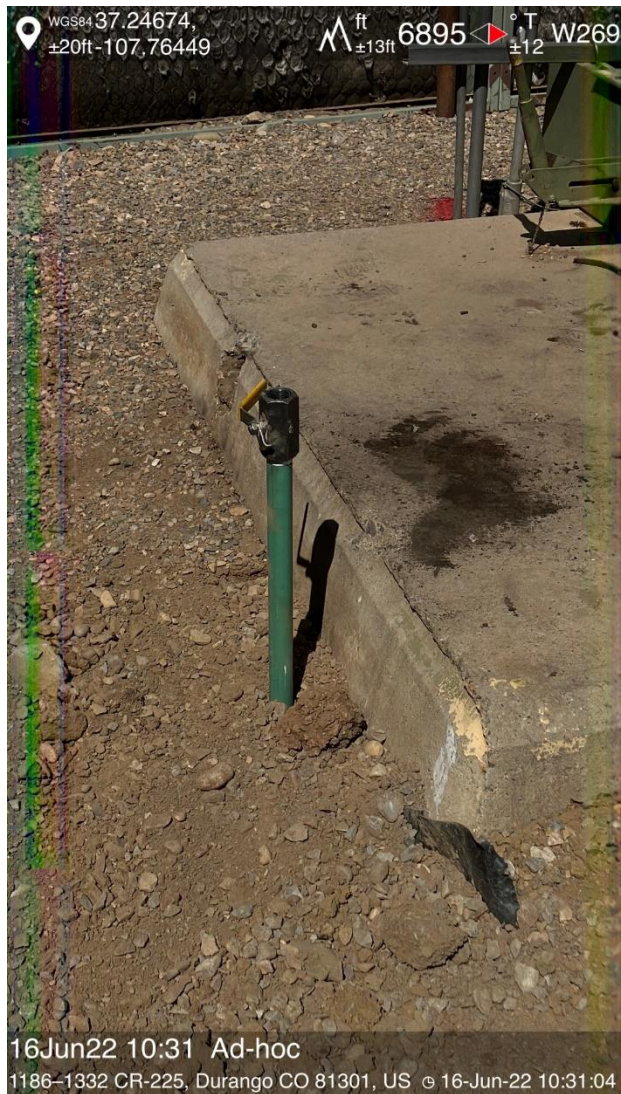
**IMG 03**  
**Unused flow line**

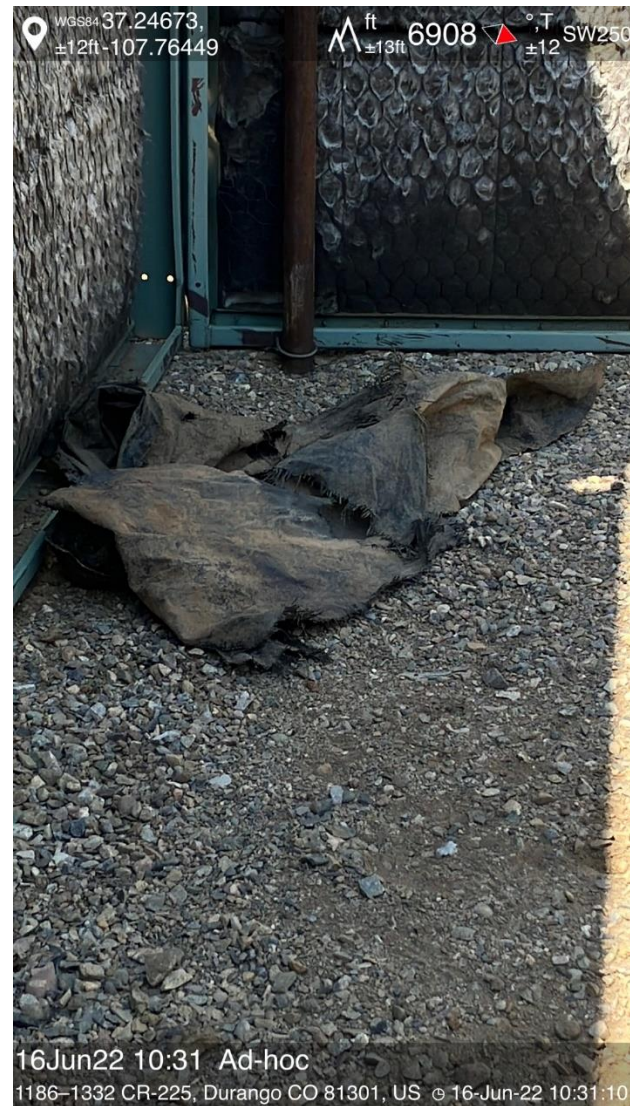
**IMG 04**  
**Trash near pump jack prime mover**

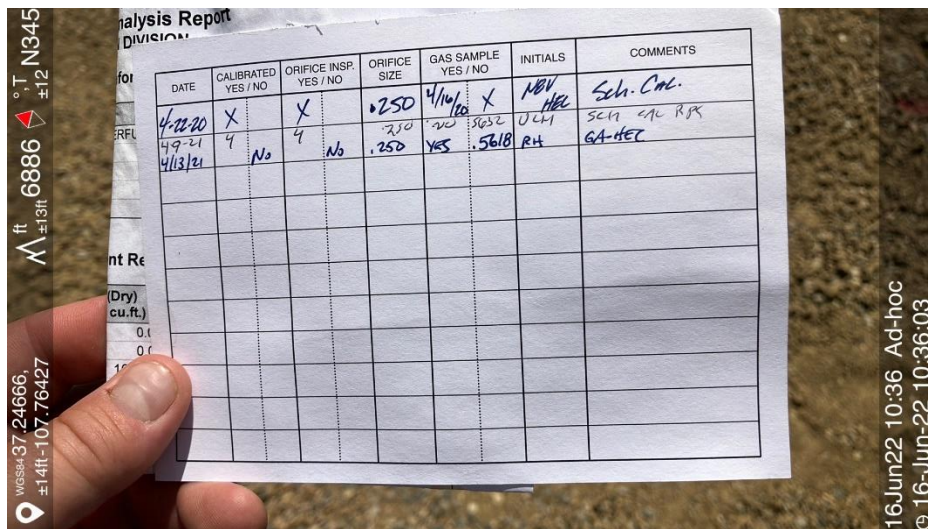
IMG 05

Gas meter calibration out of date

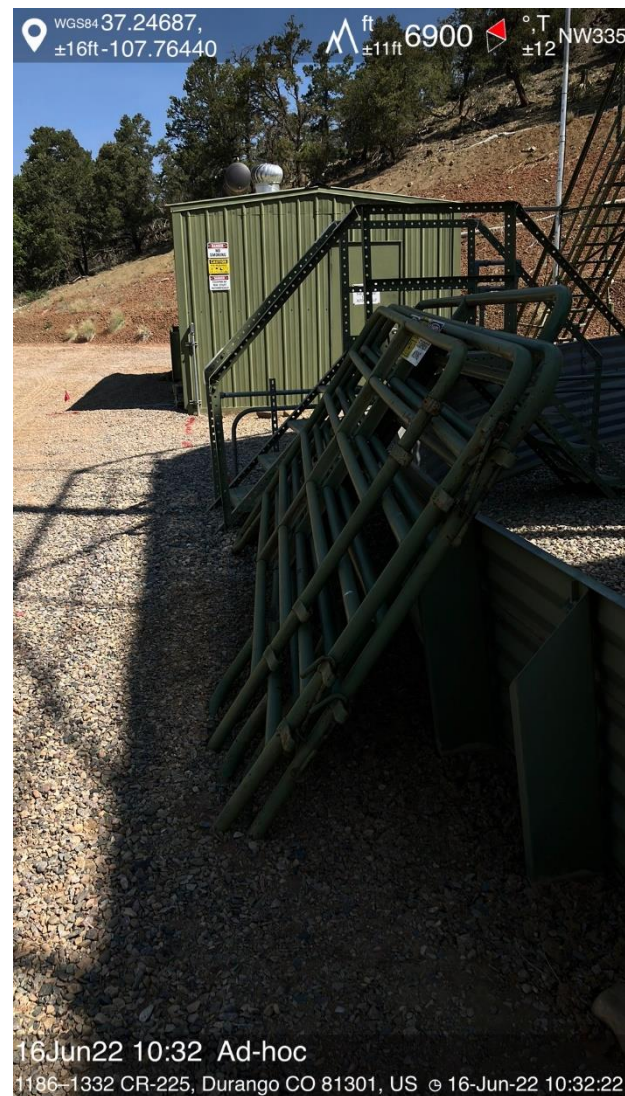
IMG 06

Unused stock panel near produced water tanks

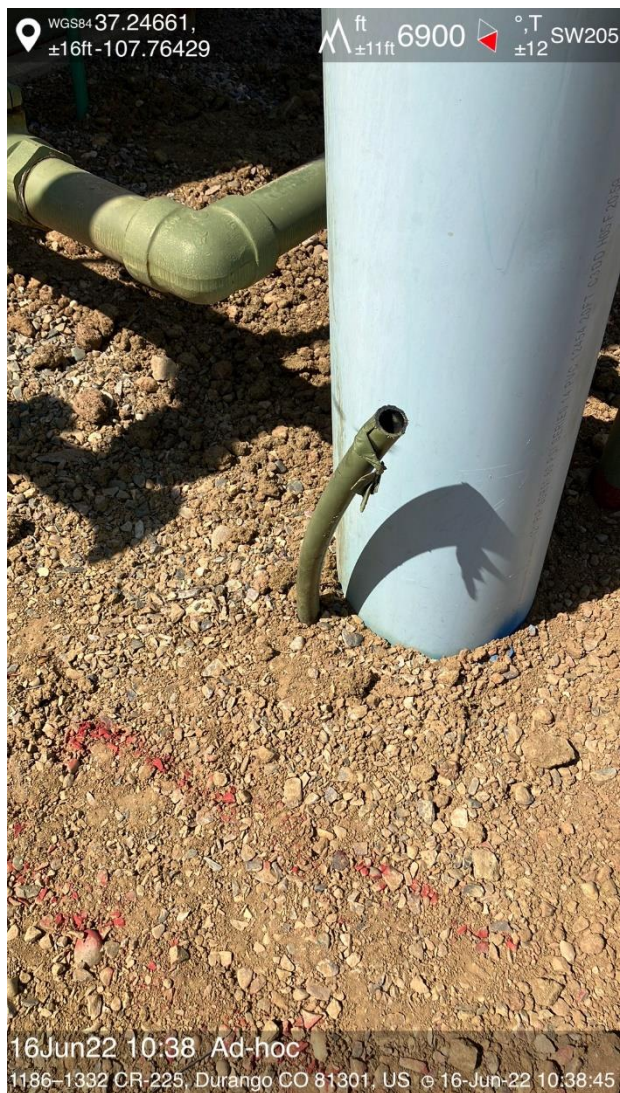
**IMG 07**

**Unused flow line near separator**

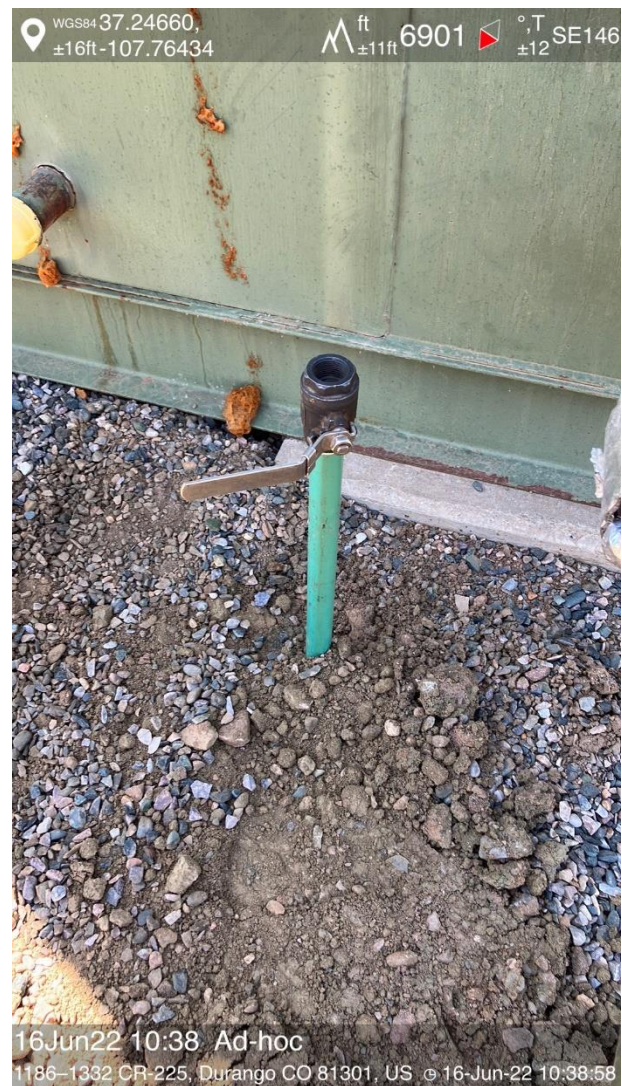
**IMG 08**

**Unused flow line near separator**

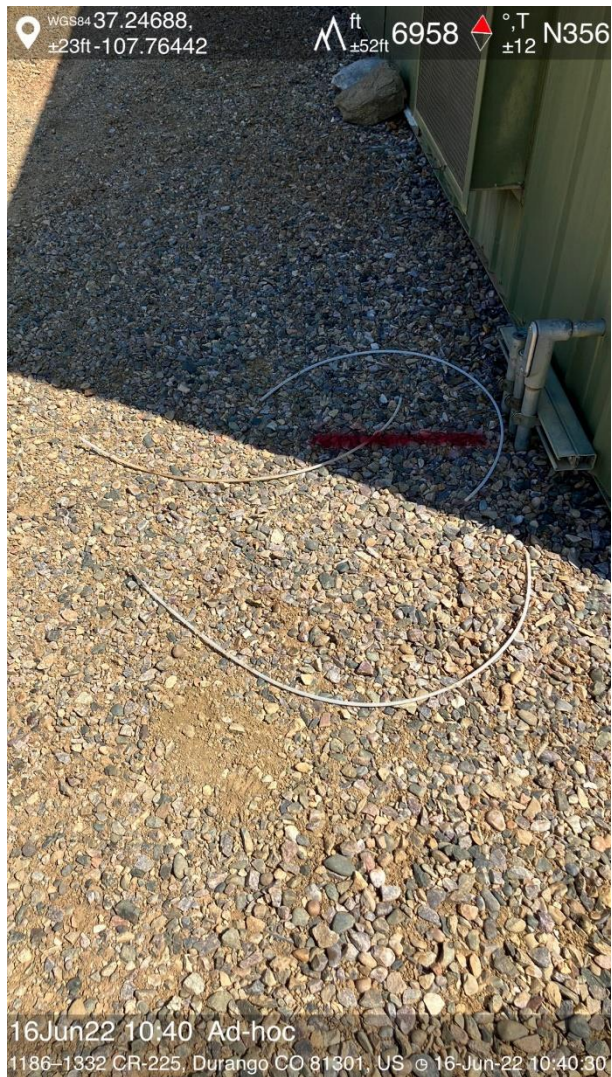
IMG 09

Trash near compressor house

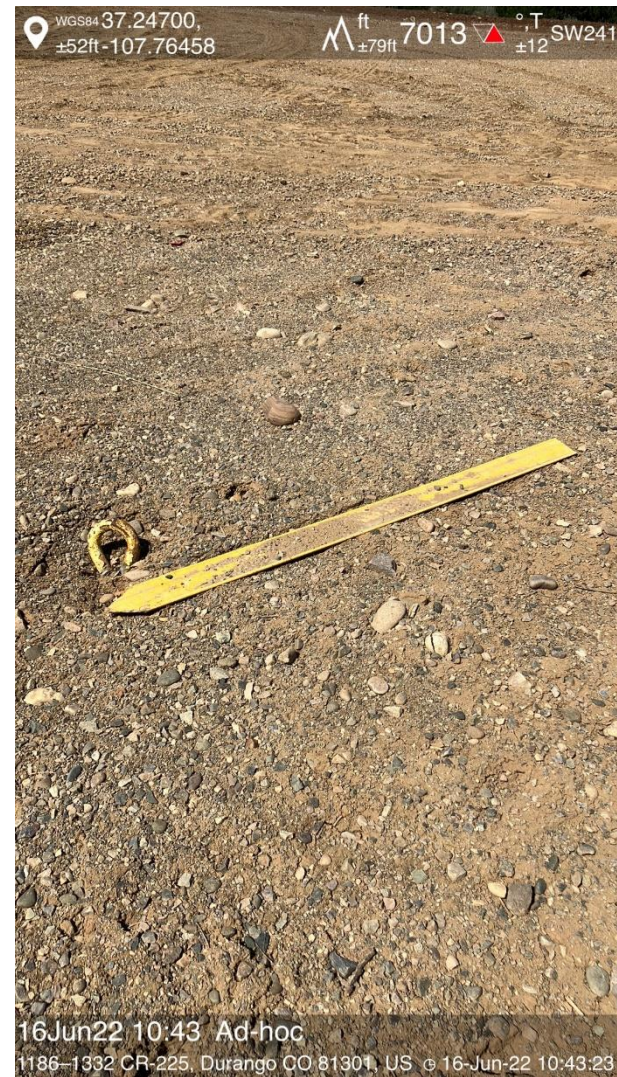
IMG 10

Rig anchor not secured

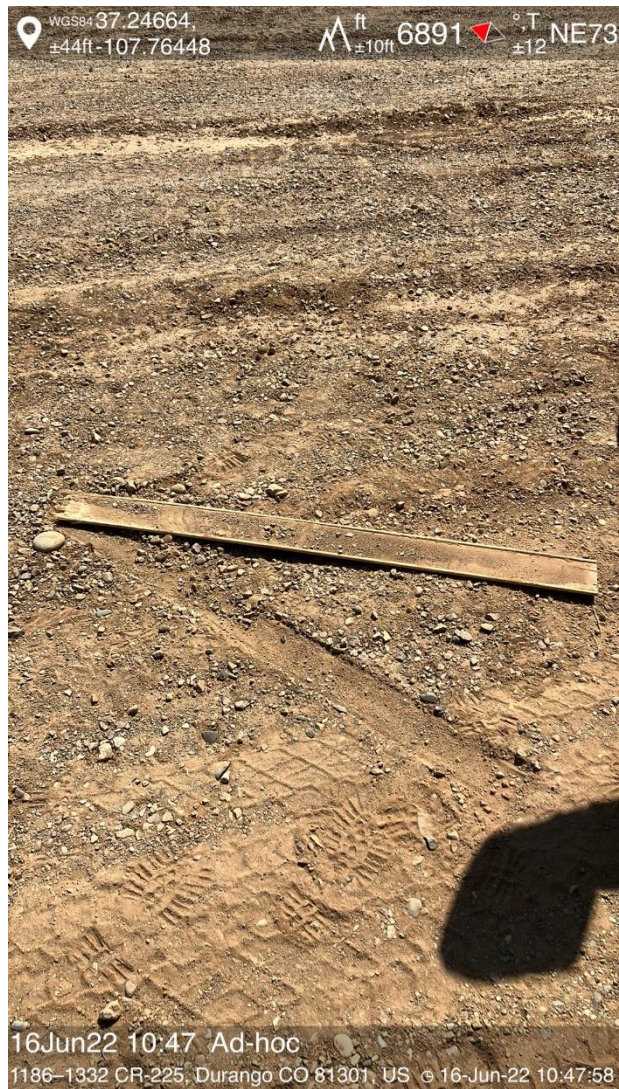
IMG 11

Rig anchor not secured

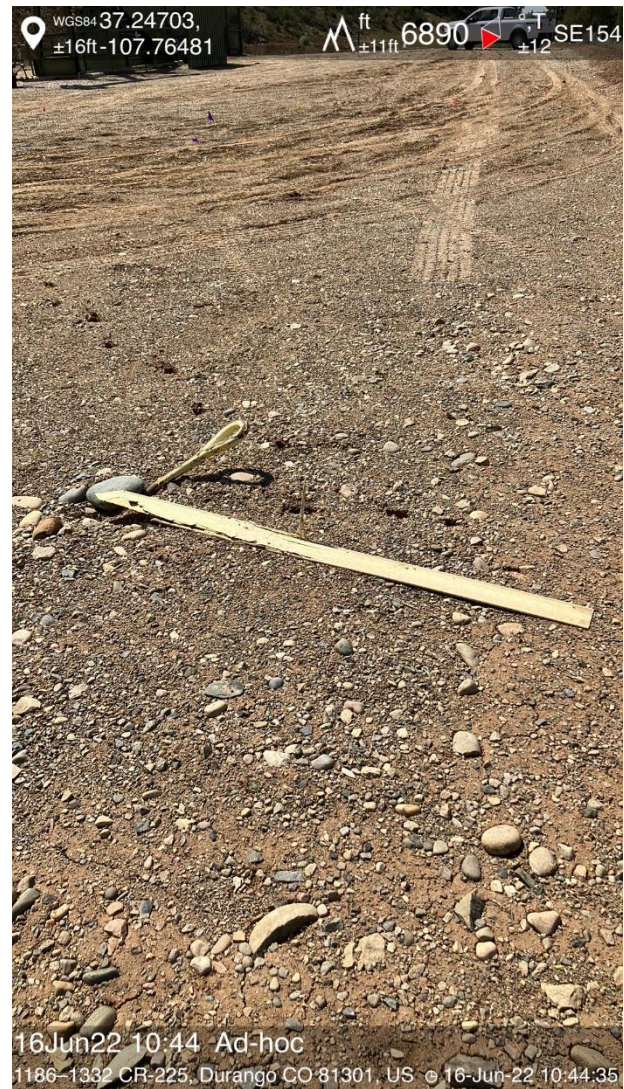
IMG 12

Rig anchor not secured
