Inspection Photos
Location Name: Kendrick 3-31
Location ID: 326463

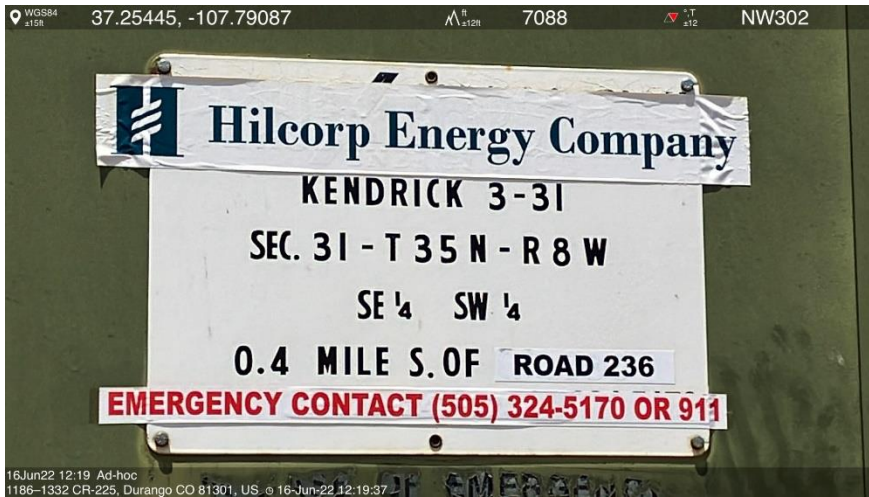
IMG 01
Well sign

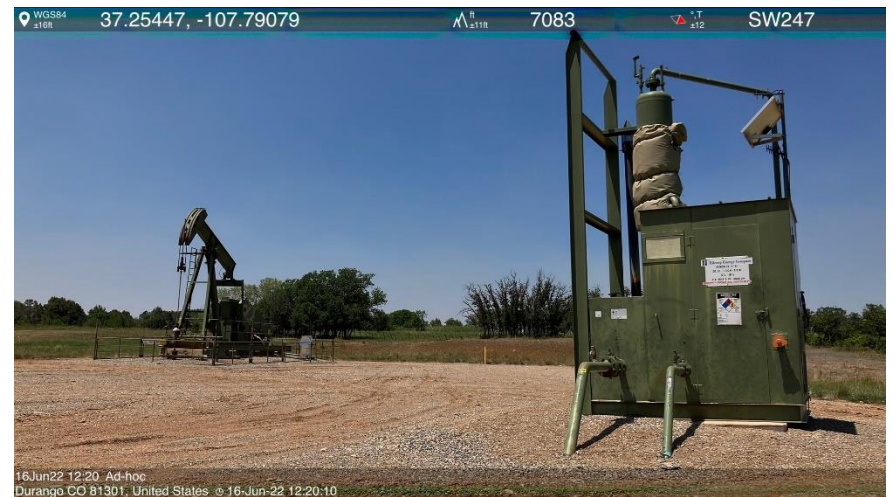
IMG 02
Location overview

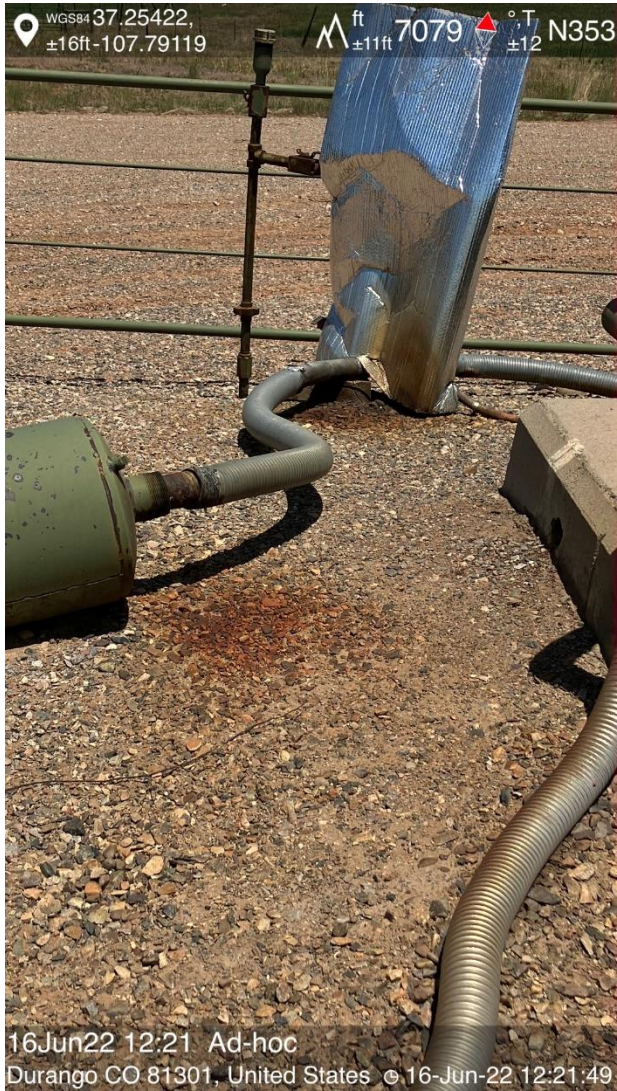
IMG 03

Muffler exhaust has begun to impact material
