Inspection Photos  
Location Name: Kendrick 3-6  
Location ID: 326462

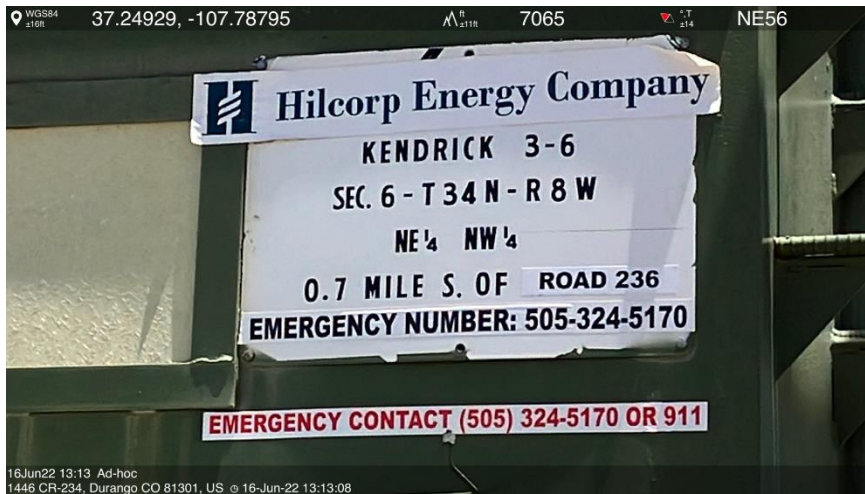
IMG 01  
Well sign

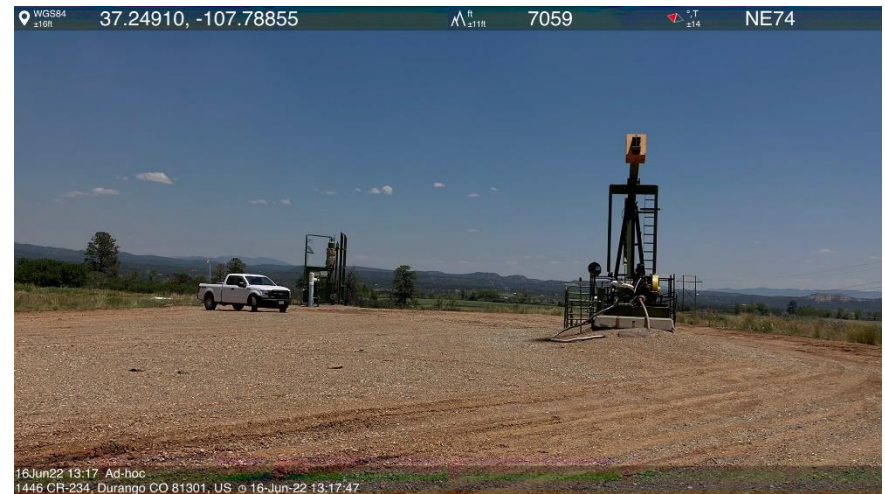
IMG 02  
Location overview

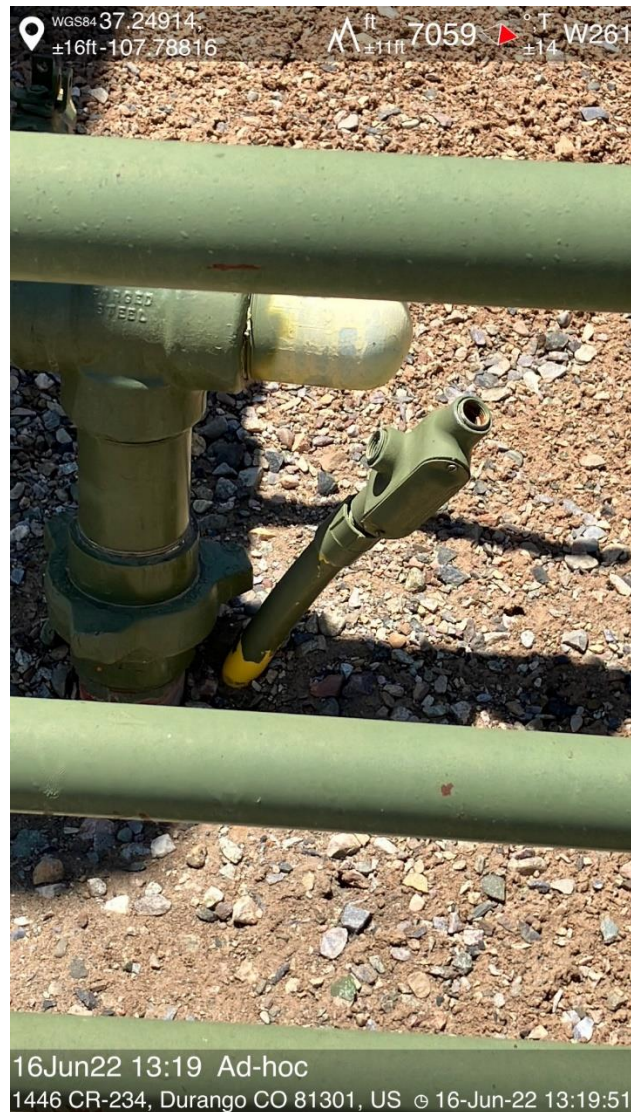
**IMG 03**

**Electrical conduit**

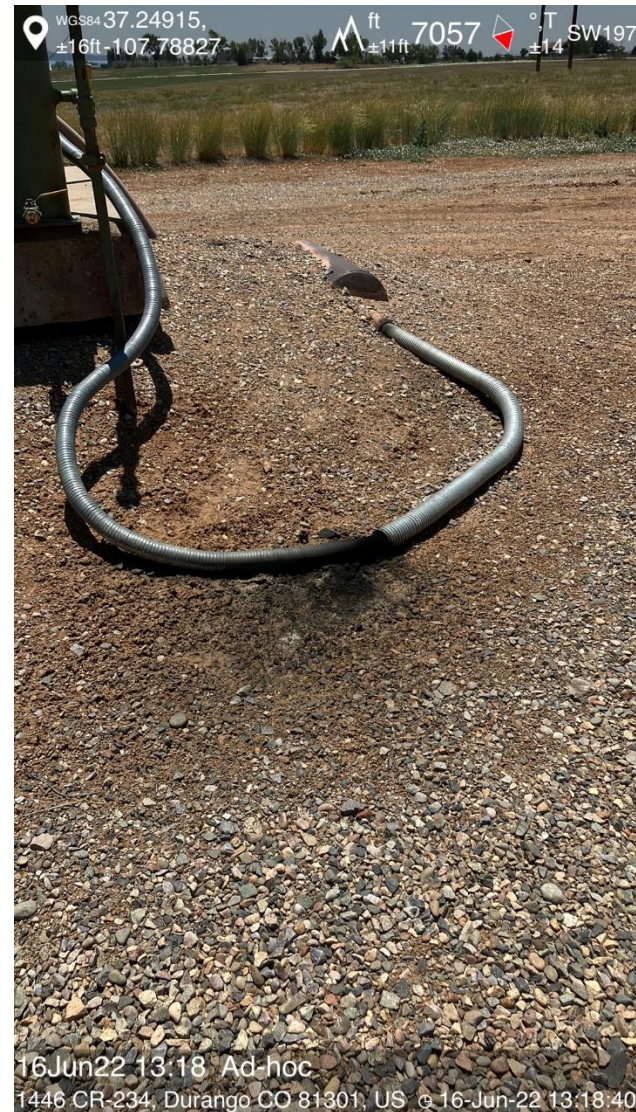
**IMG 04**

**Muffler has begun impacting material**

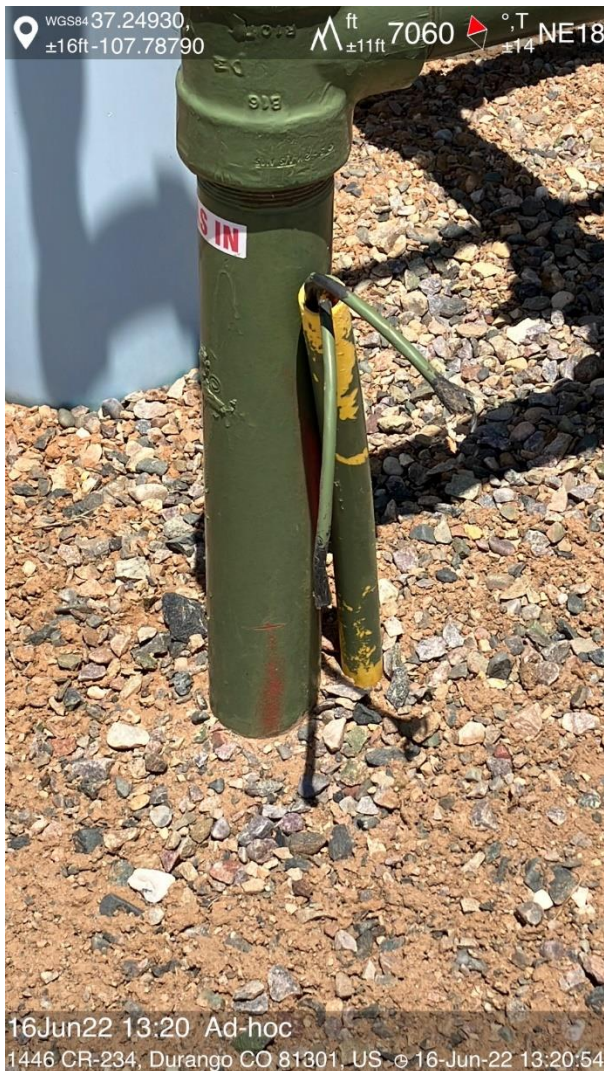
**IMG 05**  
**Electrical conduit**

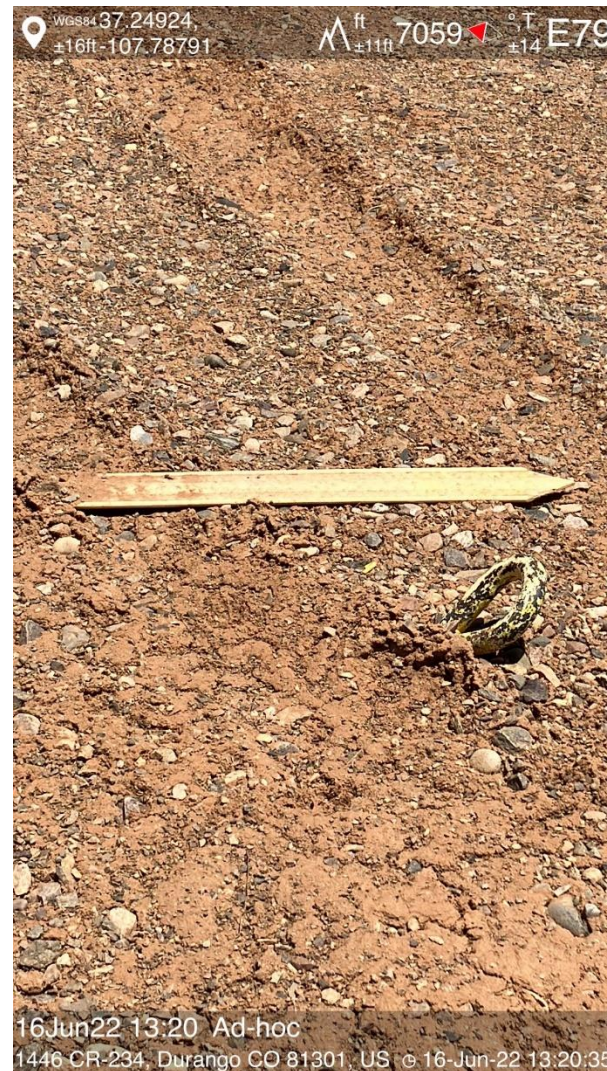
**IMG 06**  
**Rig anchor not secured**

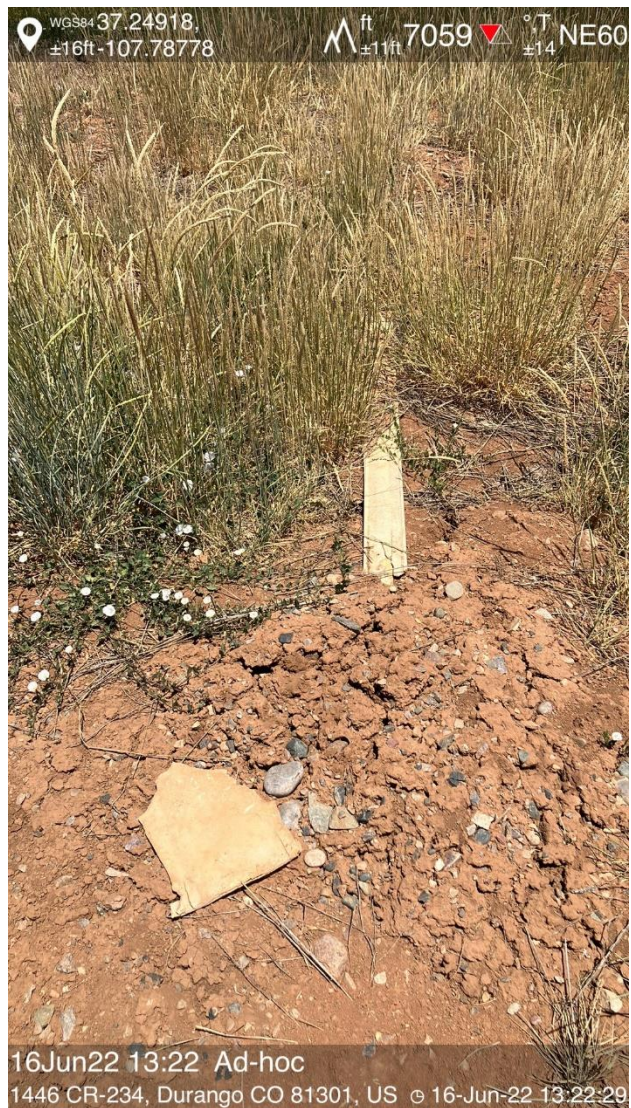
**IMG 07**

**Trash on east edge of location**

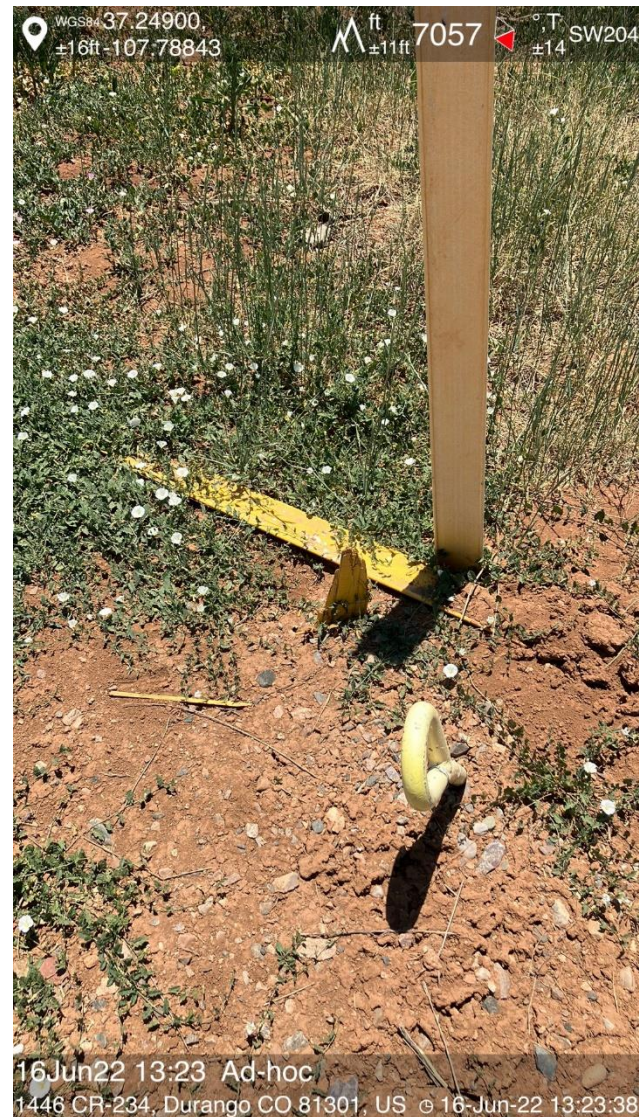
**IMG 08**

**Trash near rig anchor on southwest corner of location**

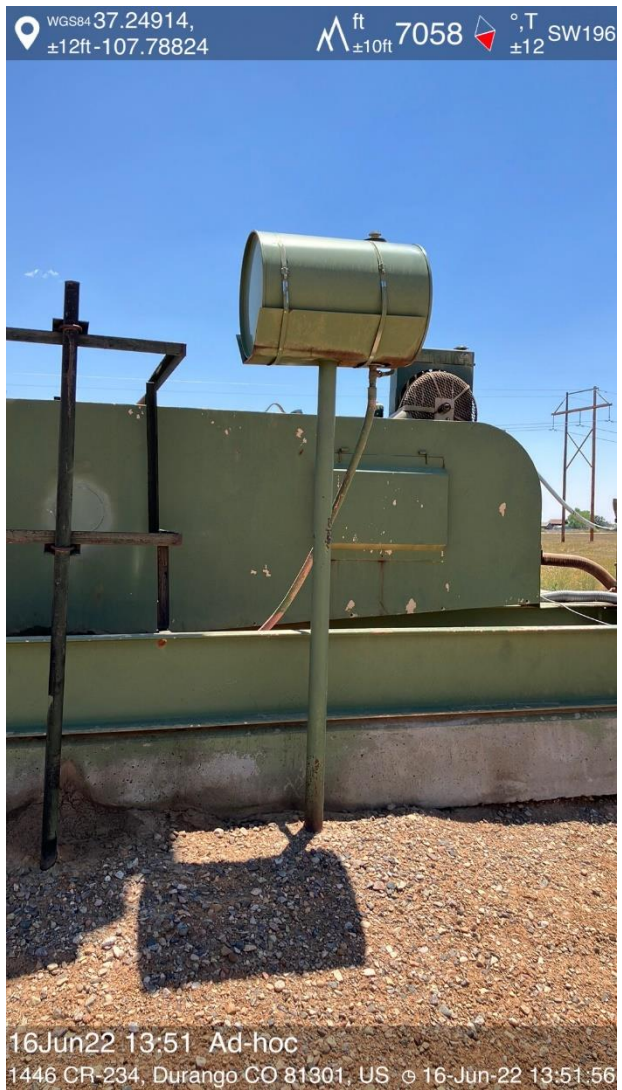
**IMG 09**

**Lube oil with no spill protection**
