Inspection Photos

ID: 412161

Operator: WAPITI OPERATING LLC

Inspection Date: 6/14/2022

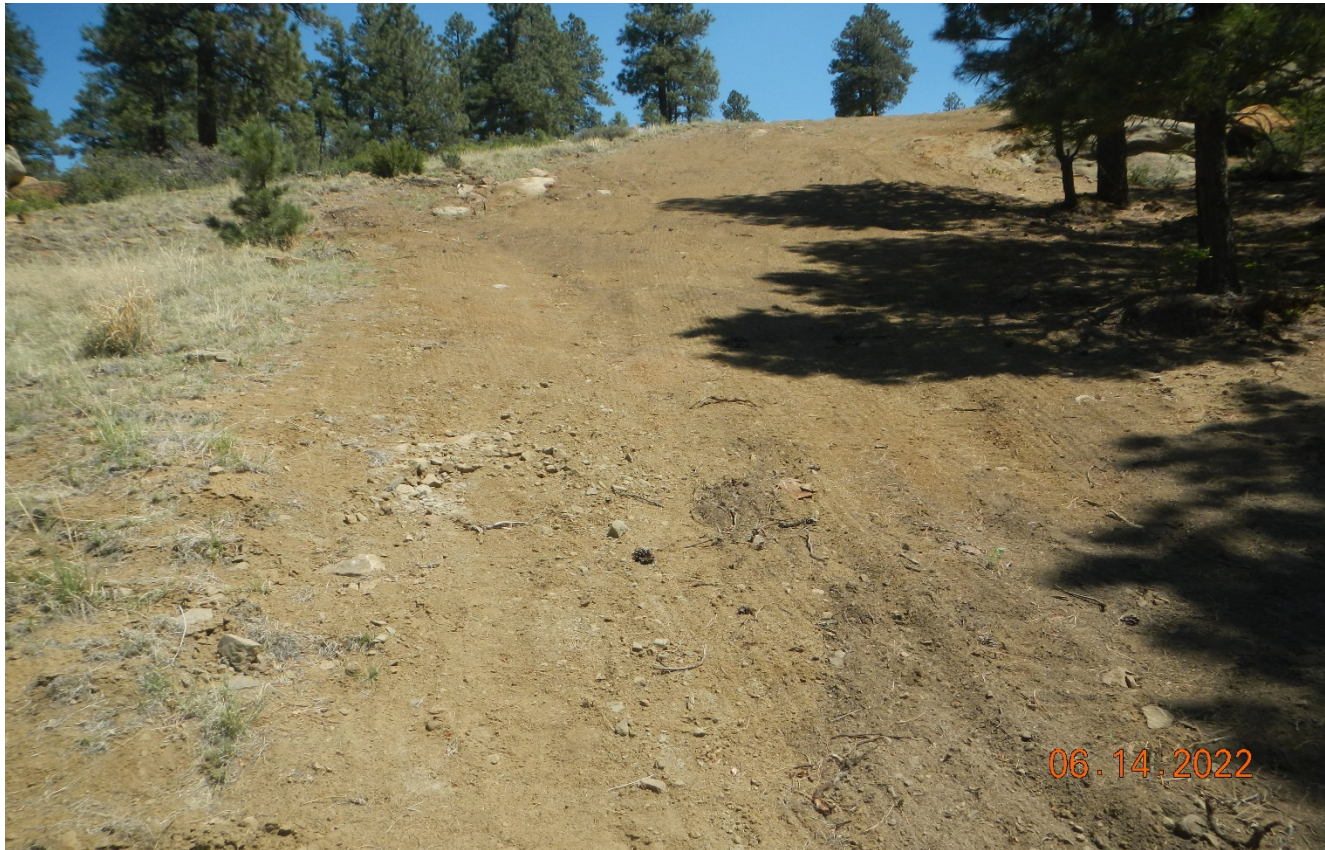
Photo 1. Facing northeast at the disturbance along the gathering pipeline at Lat/Long:37.05440,-104.76614. This area has been reseed however, soils are not stabilized and are susceptible to erosion.

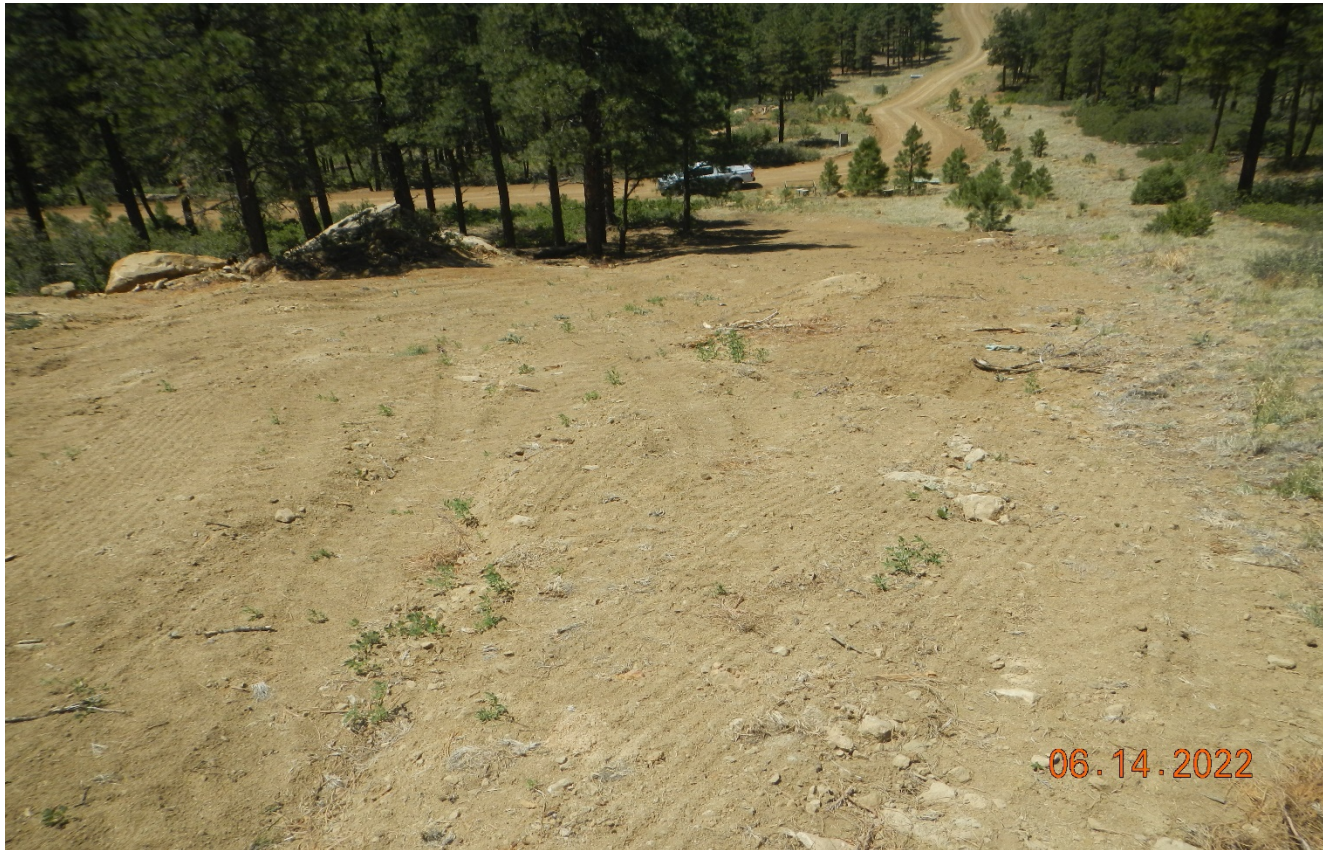
Photo 2. Facing southwest along the pipeline disturbance. The disturbed soils are susceptible to erosion due to seep conditions and lack of stabilization until vegetation establishes.

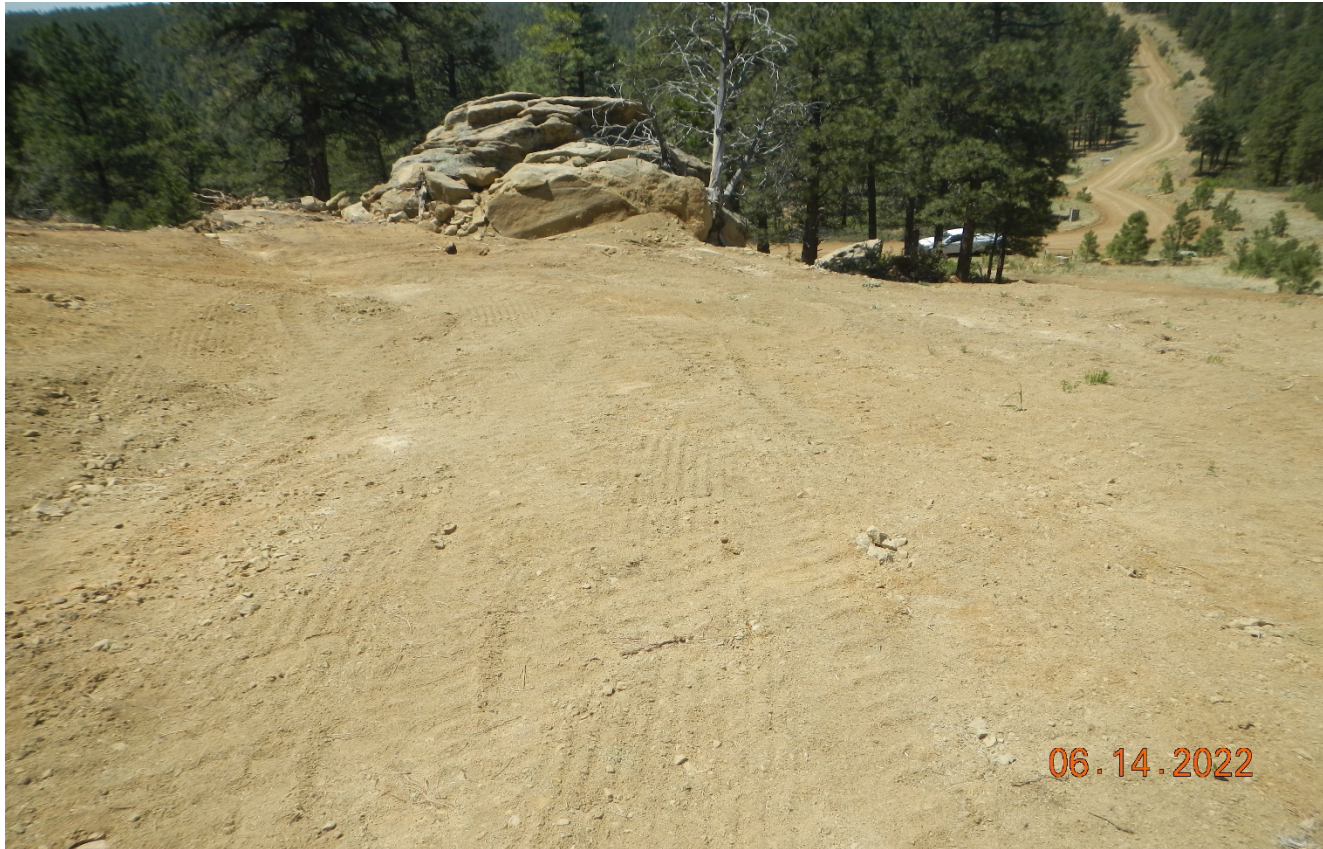
Photo 3. Facing southwest along the pipeline disturbance. The disturbed soils are susceptible to erosion due to seep conditions and lack of stabilization until vegetation establishes.

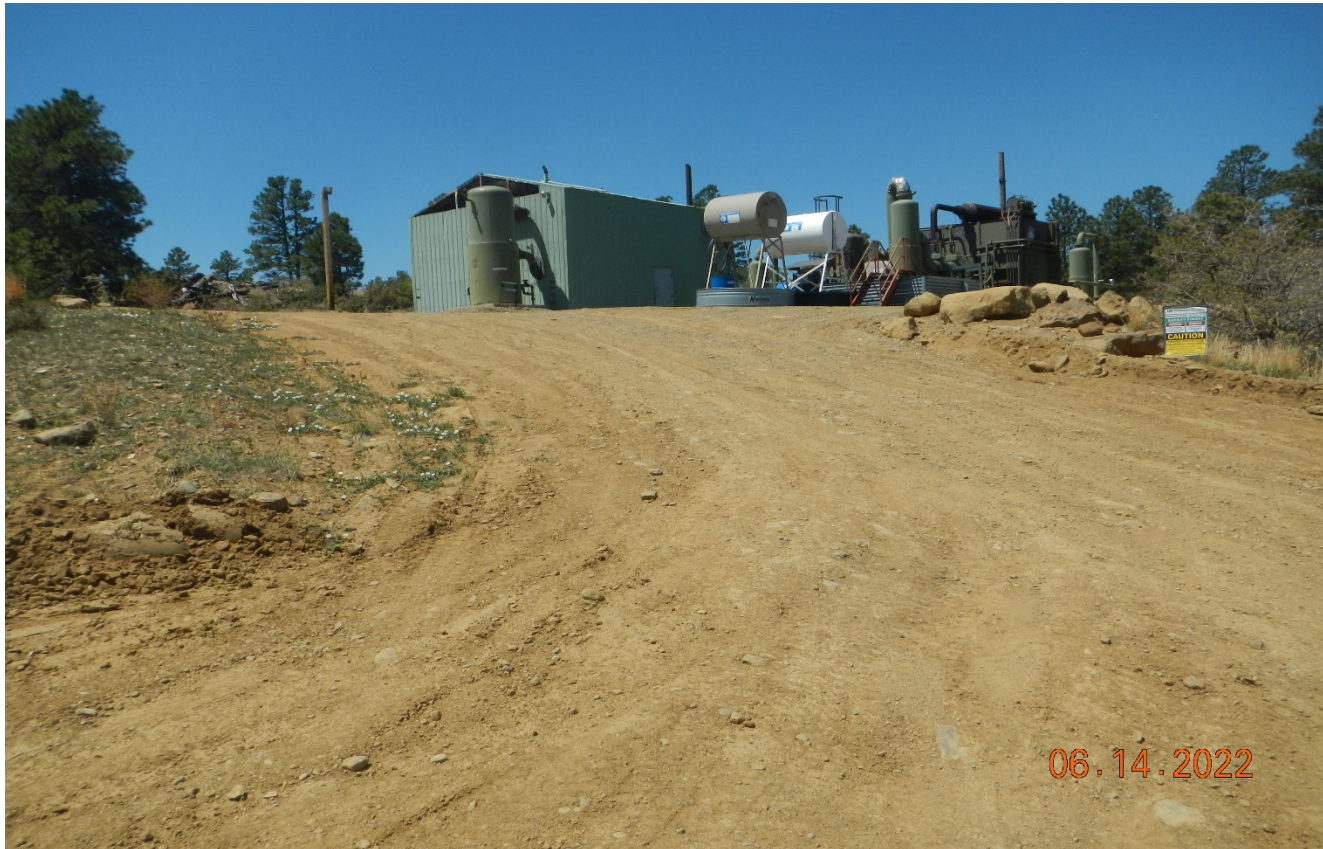
Photo 4. Facing toward the VPRC CENTRAL FACILITY UNIT C-3.
