Overview of WC20 Location ID 314509

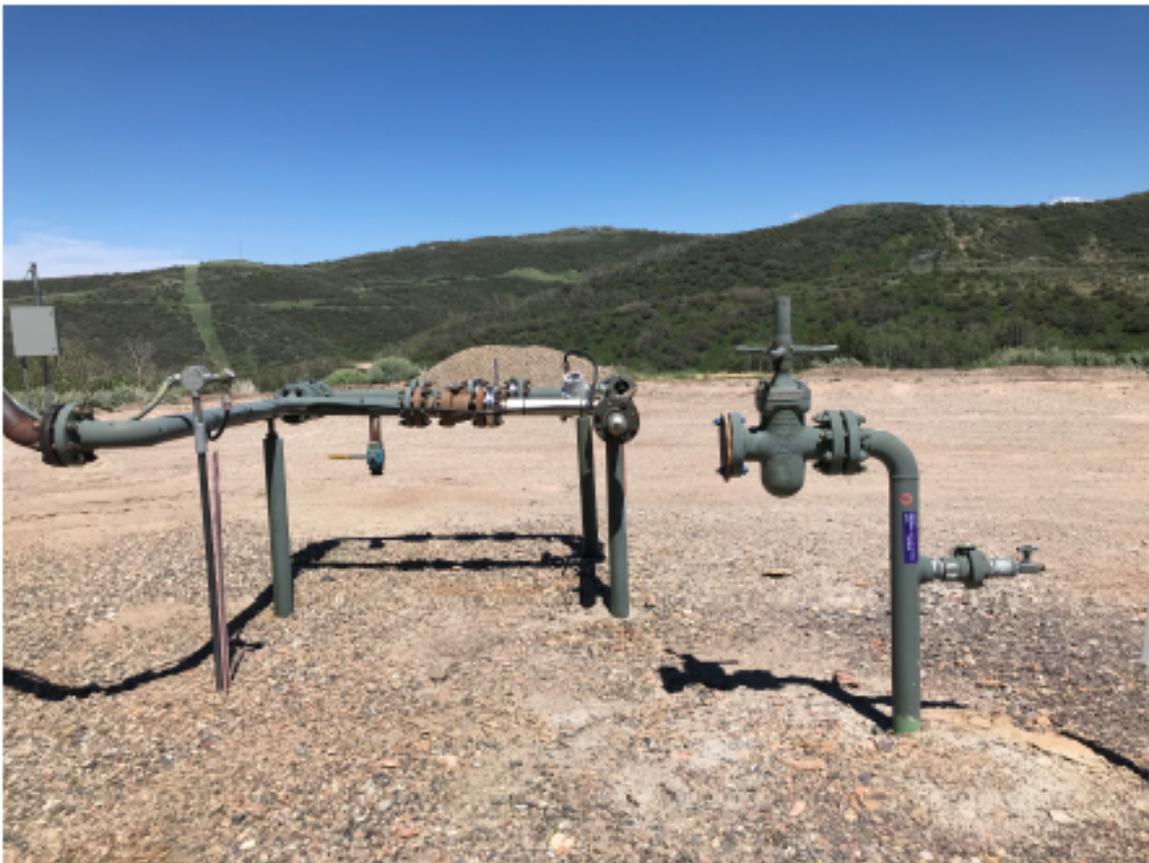
Equipment at the wellhead has been removed

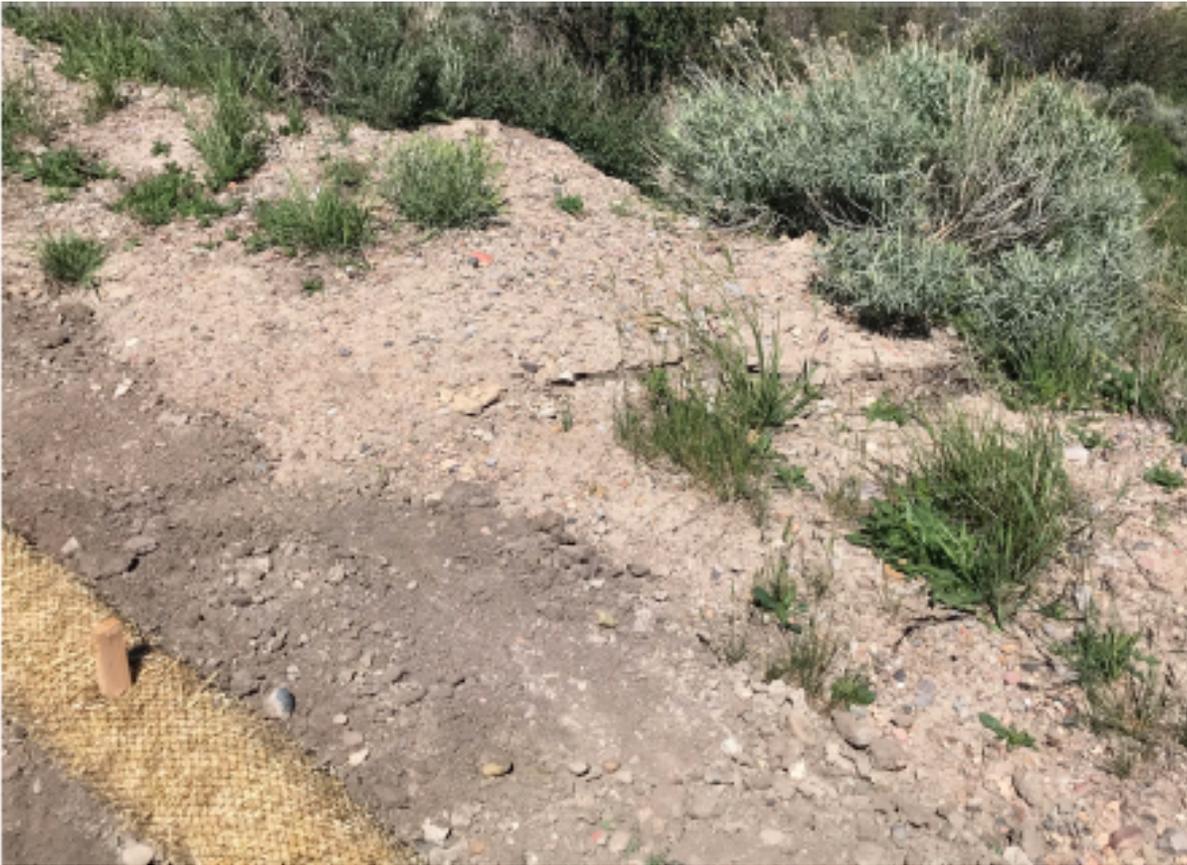
Area has been repaired and waddles have been repaired or replaced to control sediment migration.

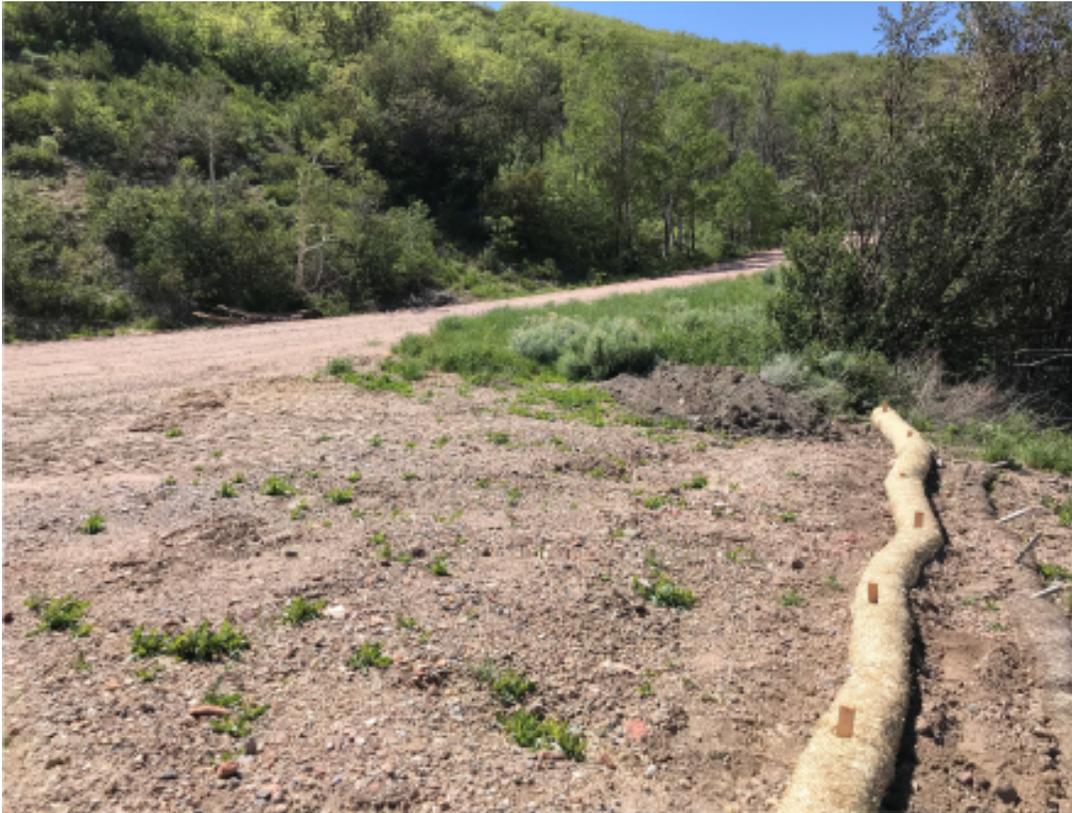
Area has been repaired and waddles have been repaired or replaced to control sediment migration

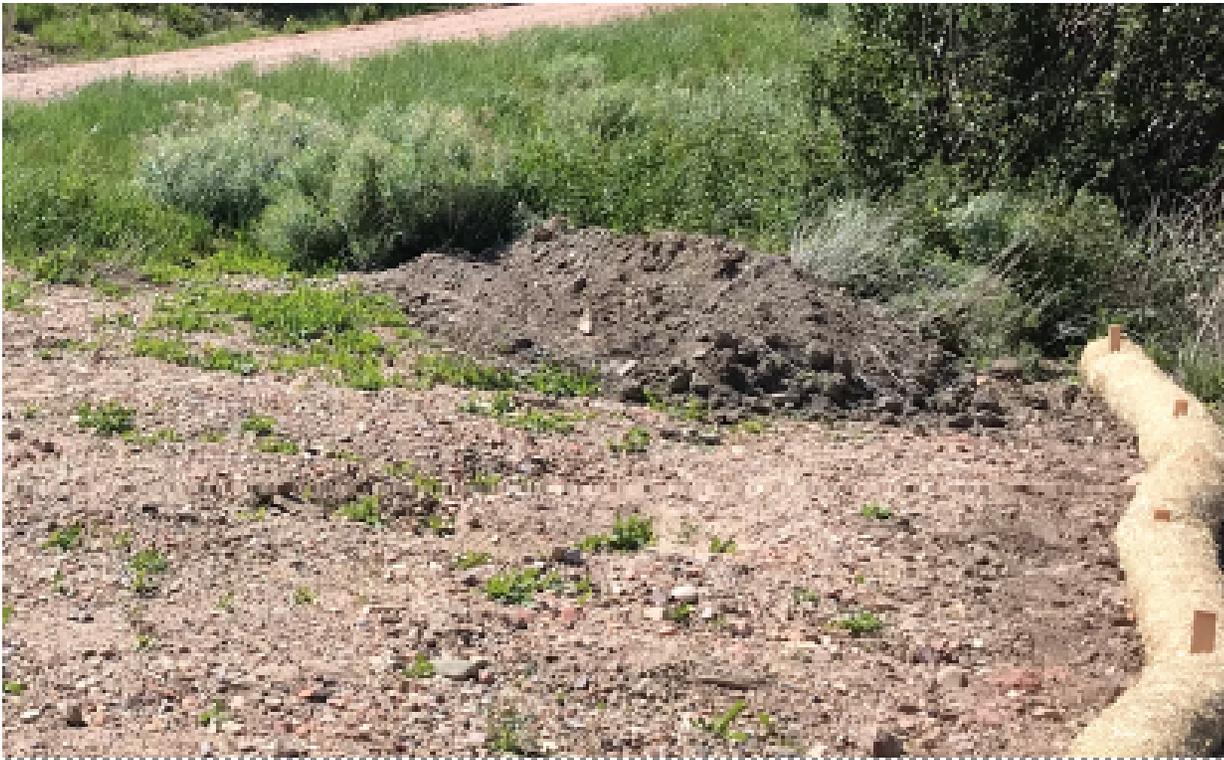
Anchor was removed
