# Inspection Photos

ID: 442224

Operator: OXY USA INC

Inspection Date: 6/16/2022

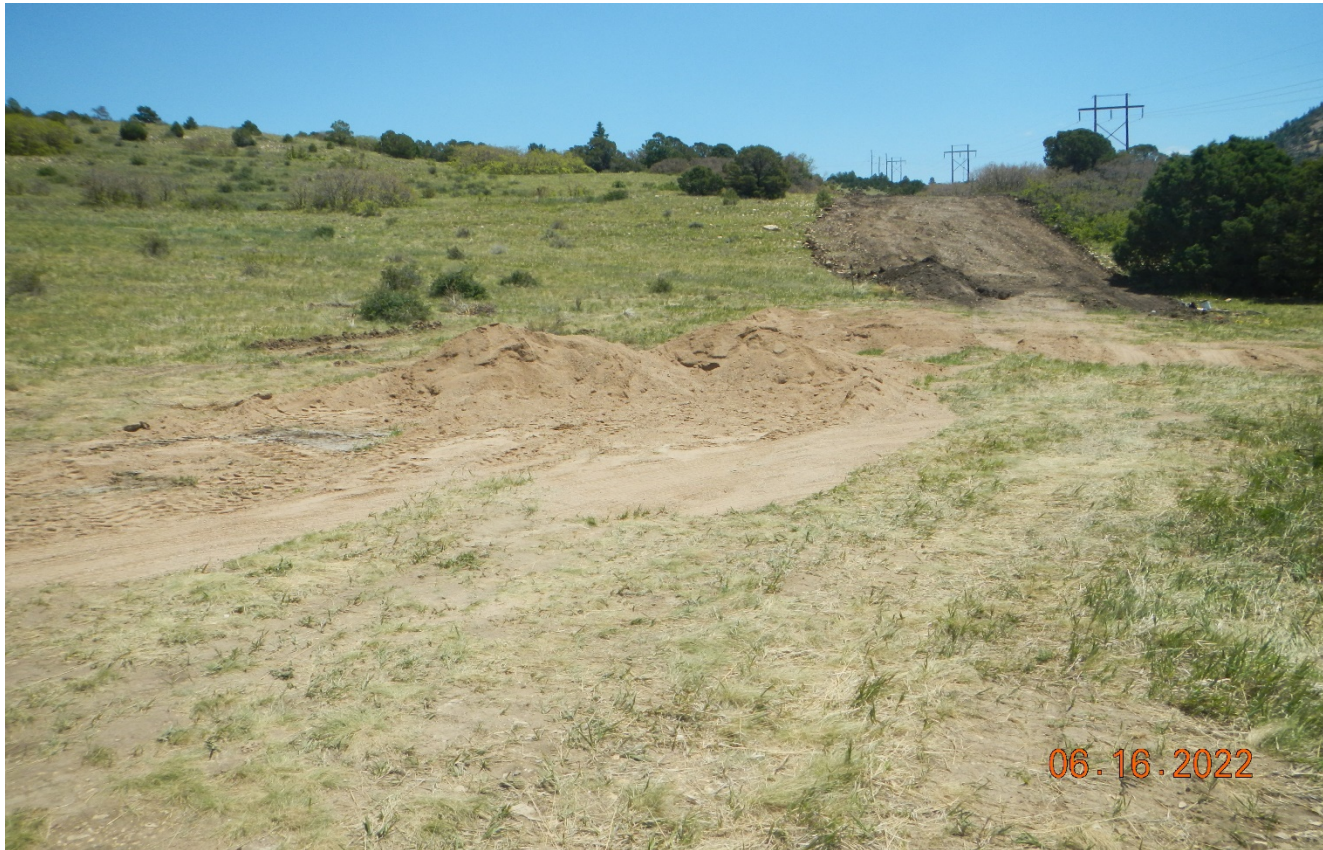
**Photo 1.** Facing southeast. There has been disturbance along the flowline from the Compressor to the meter station. There is a pile of sand fill material that will need to be removed. All soils will need to be replaced, reclaimed, and stabilized.

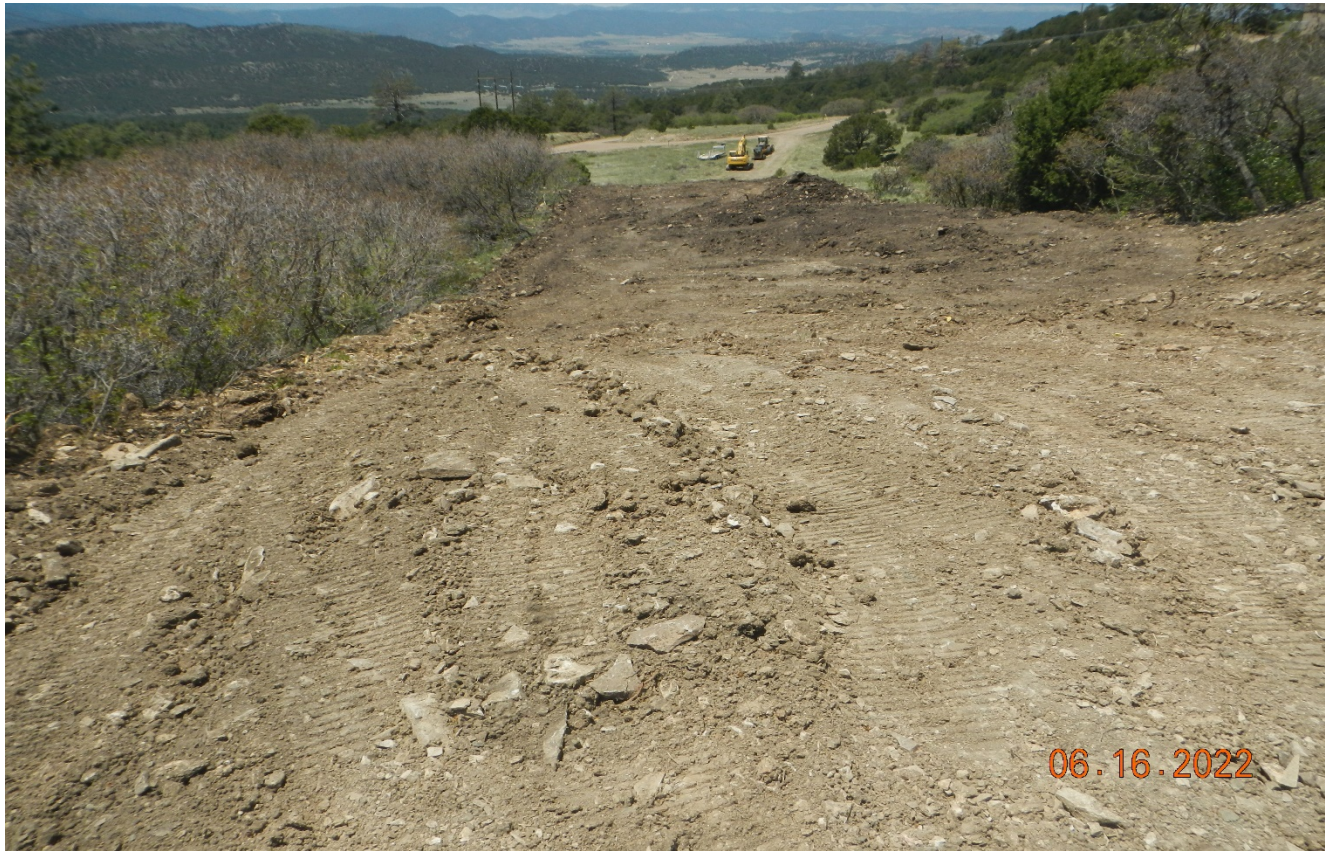
**Photo 2.** Facing back to the northwest along the flowline disturbance. All soils will need to be replaced, reclaimed, and stabilized.

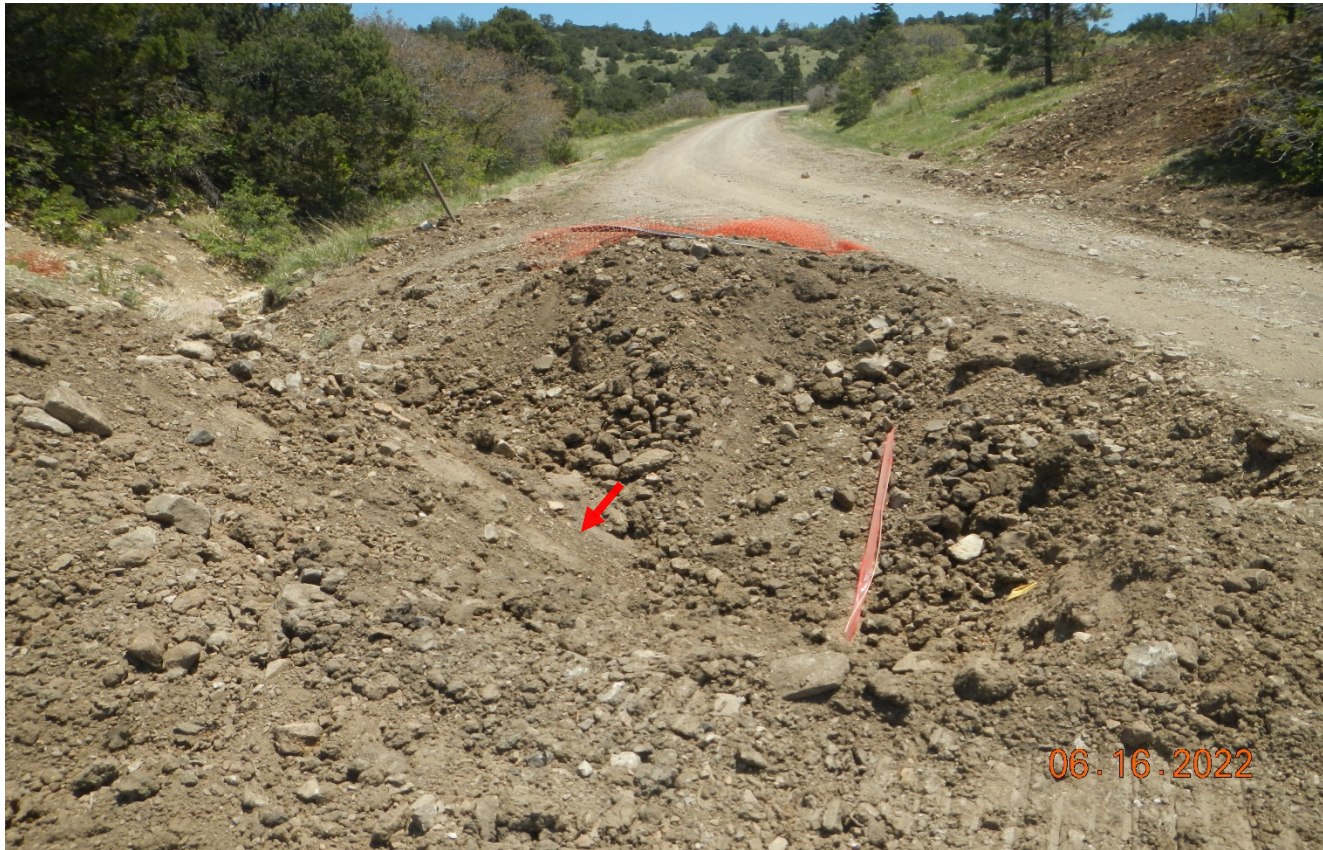
**Photo 3.** The flowline crossed the road at this point. The orange safety fence is not maintained and there is a large excavated I the road way.

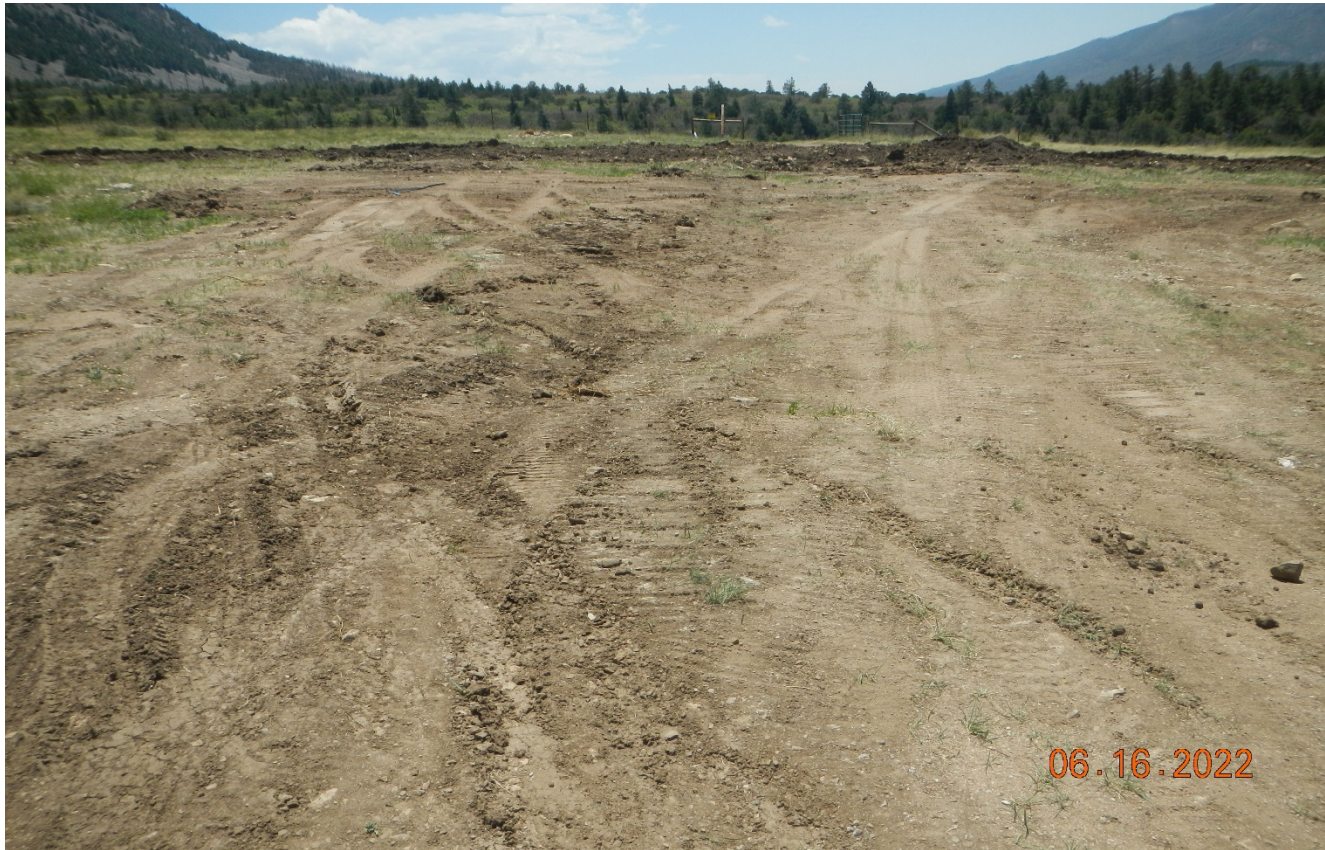
**Photo 4.** Facing south toward the Koscove #1 wellsite. There has been disturbance in this area that needs to be reclaimed.

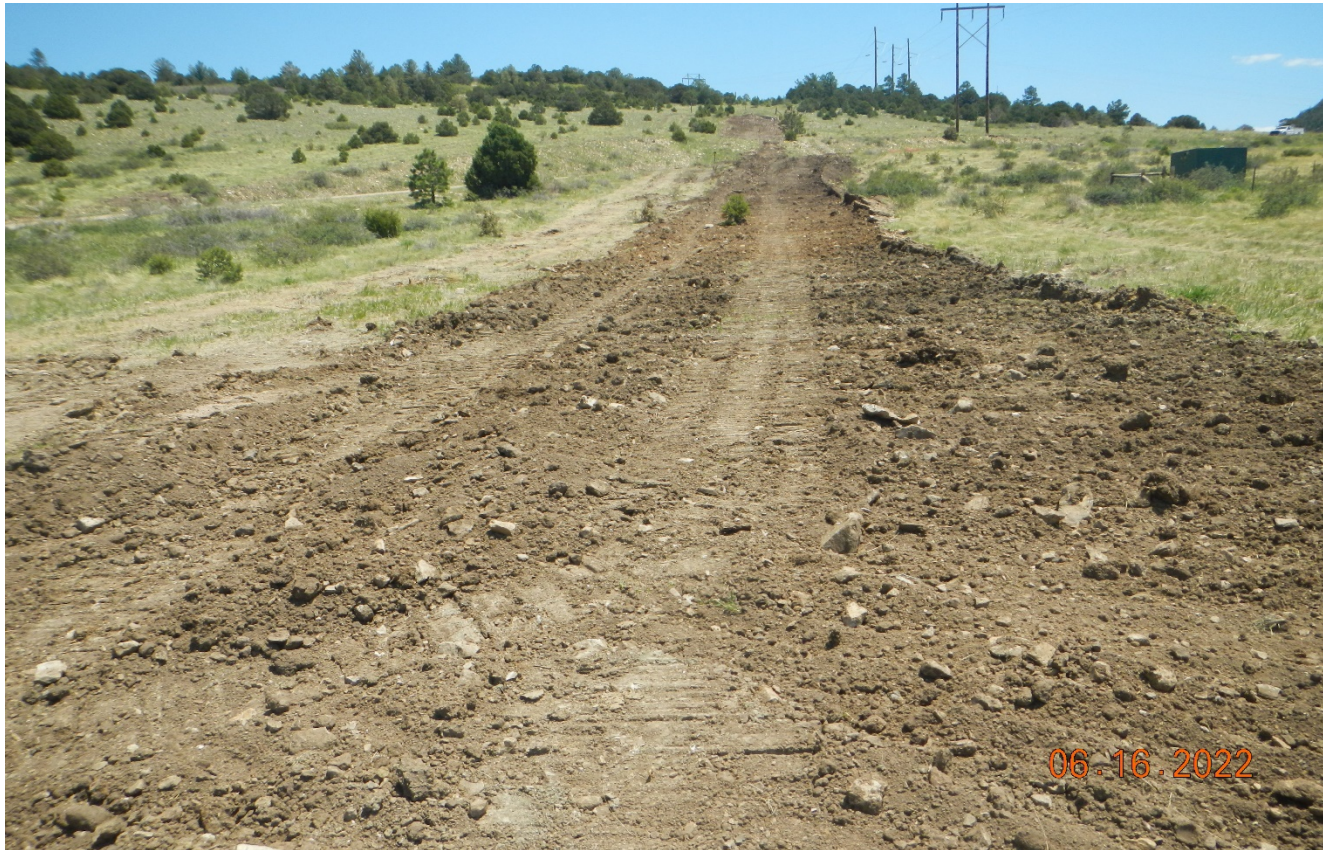
**Photo 5.** Facing east toward the flowline disturbance between the meter station and compressor. All soils will need to be replaced, reclaimed, and stabilized.

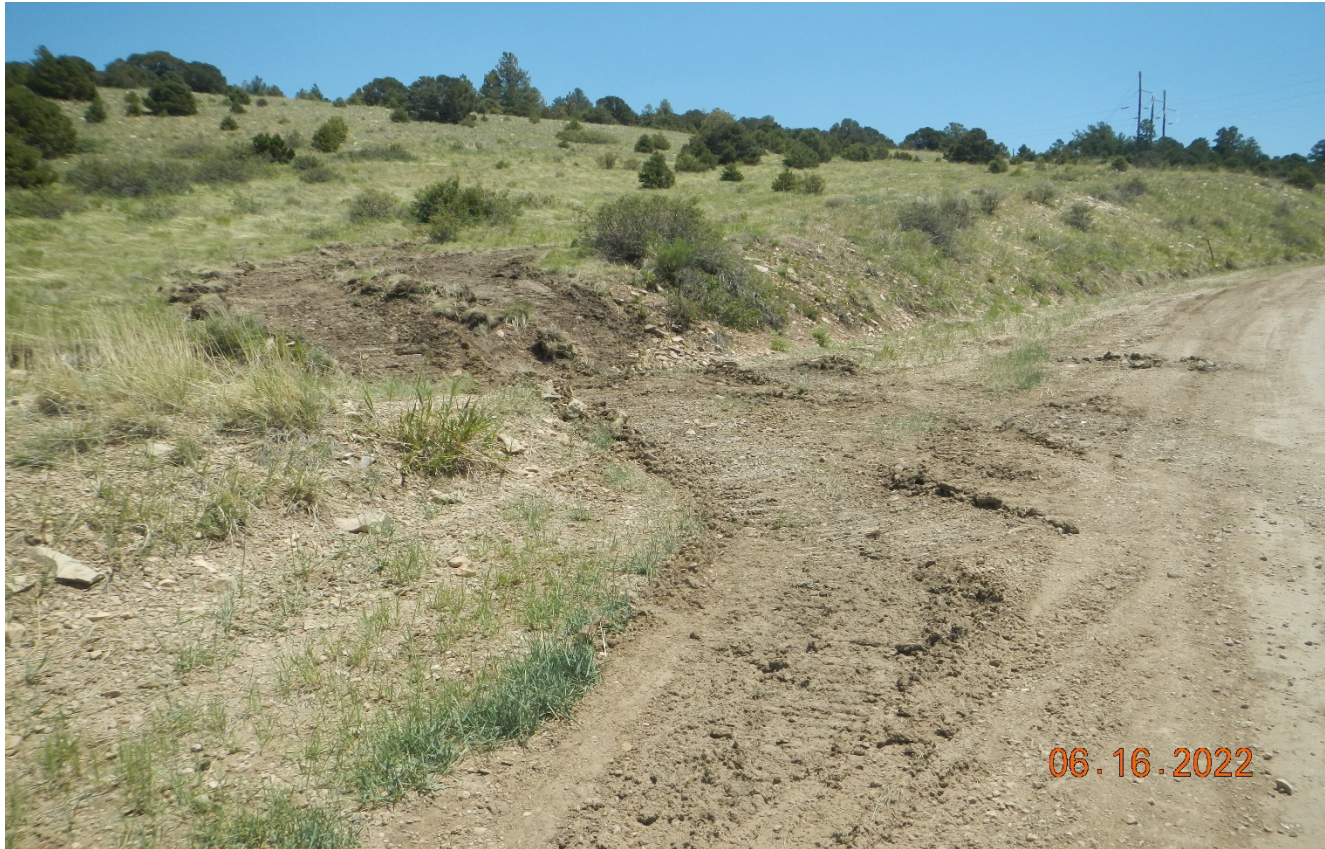
**Photo 6.** There are areas of disturbance caused by equipment that will need to be reclaimed and stabilized.

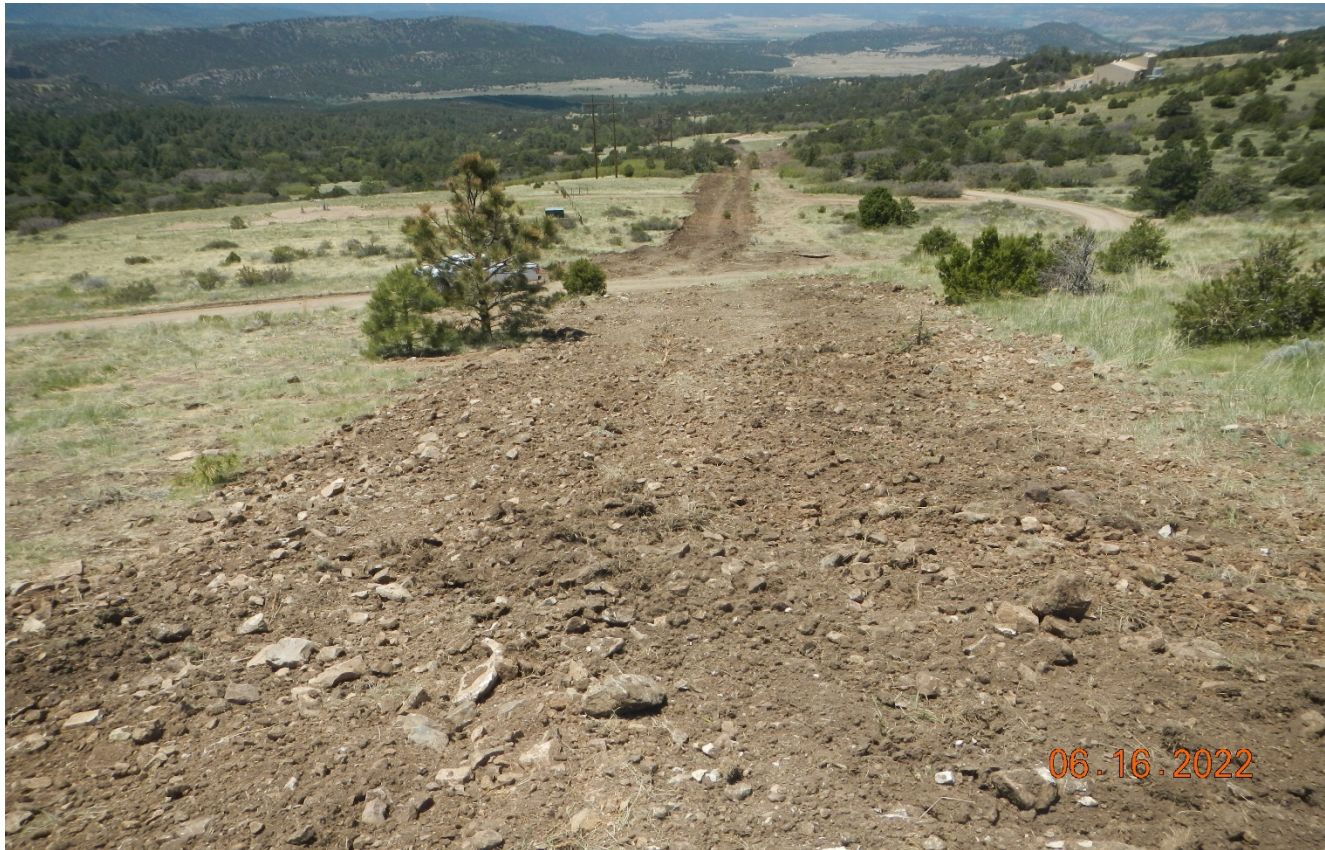
**Photo 7.** Facing west toward the flowline disturbance between the meter station and compressor. All soils will need to be replaced, reclaimed, and stabilized.

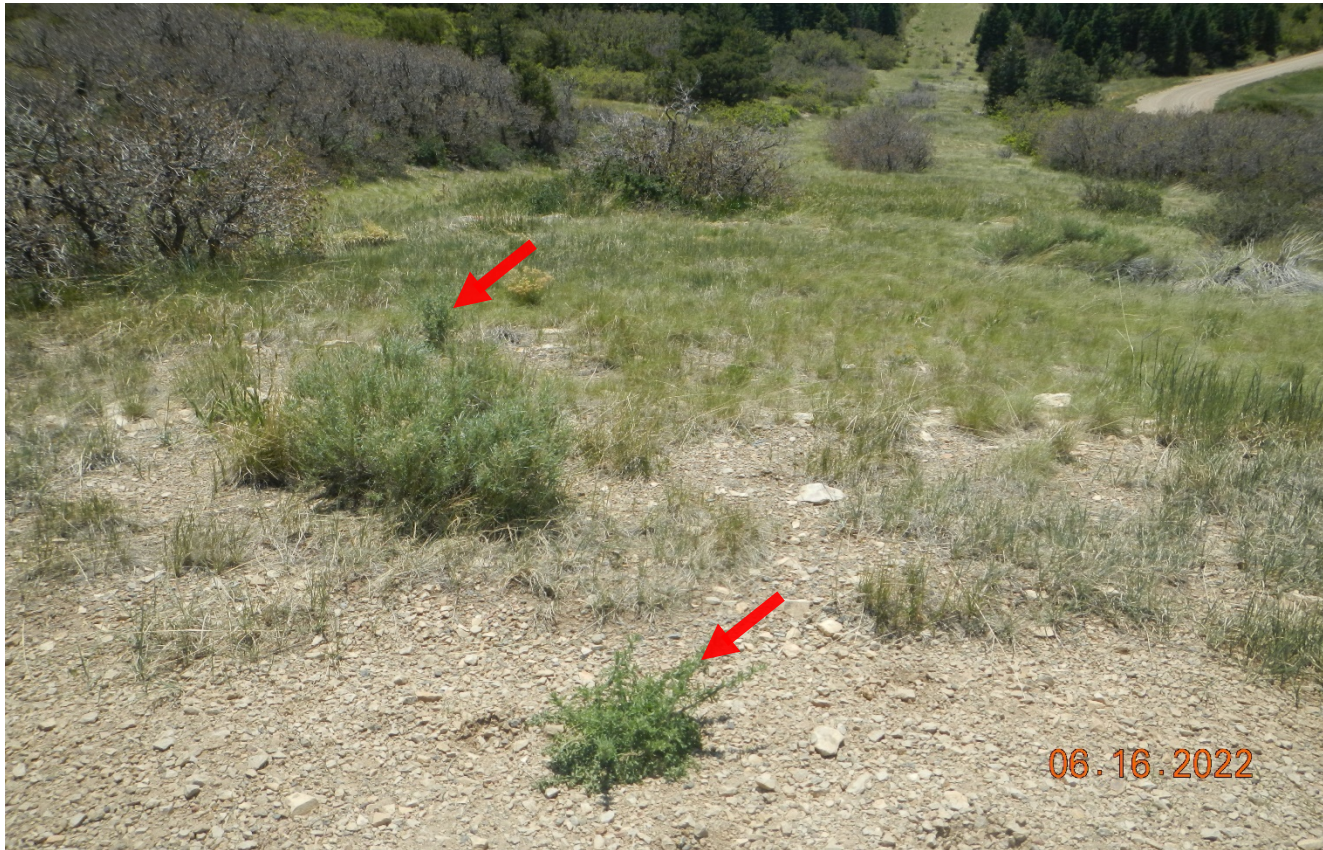
**Photo 8.** There are noxious weeds along the road side and along the flowline areas. Diffuse knapweeds is shown at red arrows and needs to be controlled soon to prevent seed dispersal.

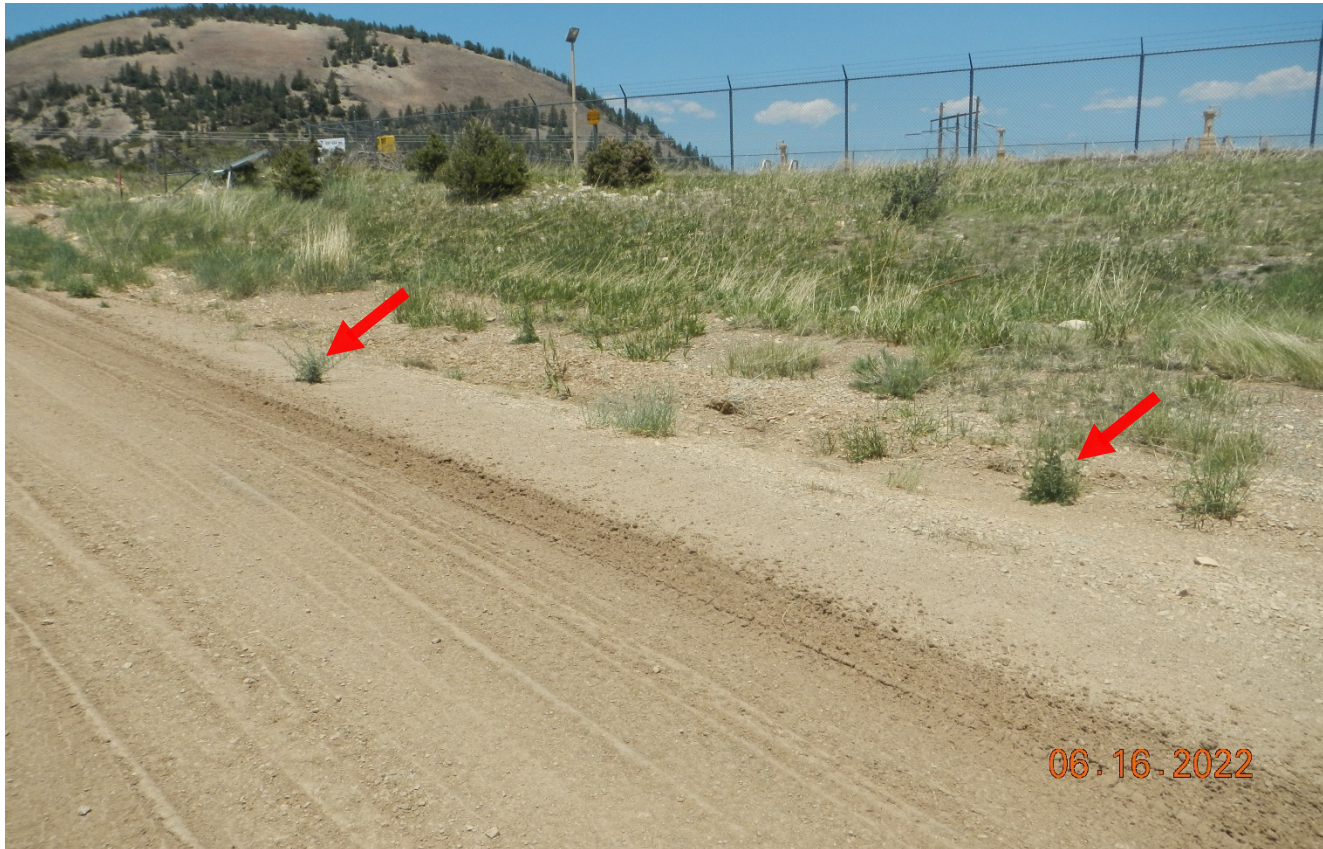
**Photo 9.** Facing northeast toward the meter station. Diffuse knapweeds is shown at red arrows and needs to be controlled soon to prevent seed dispersal.

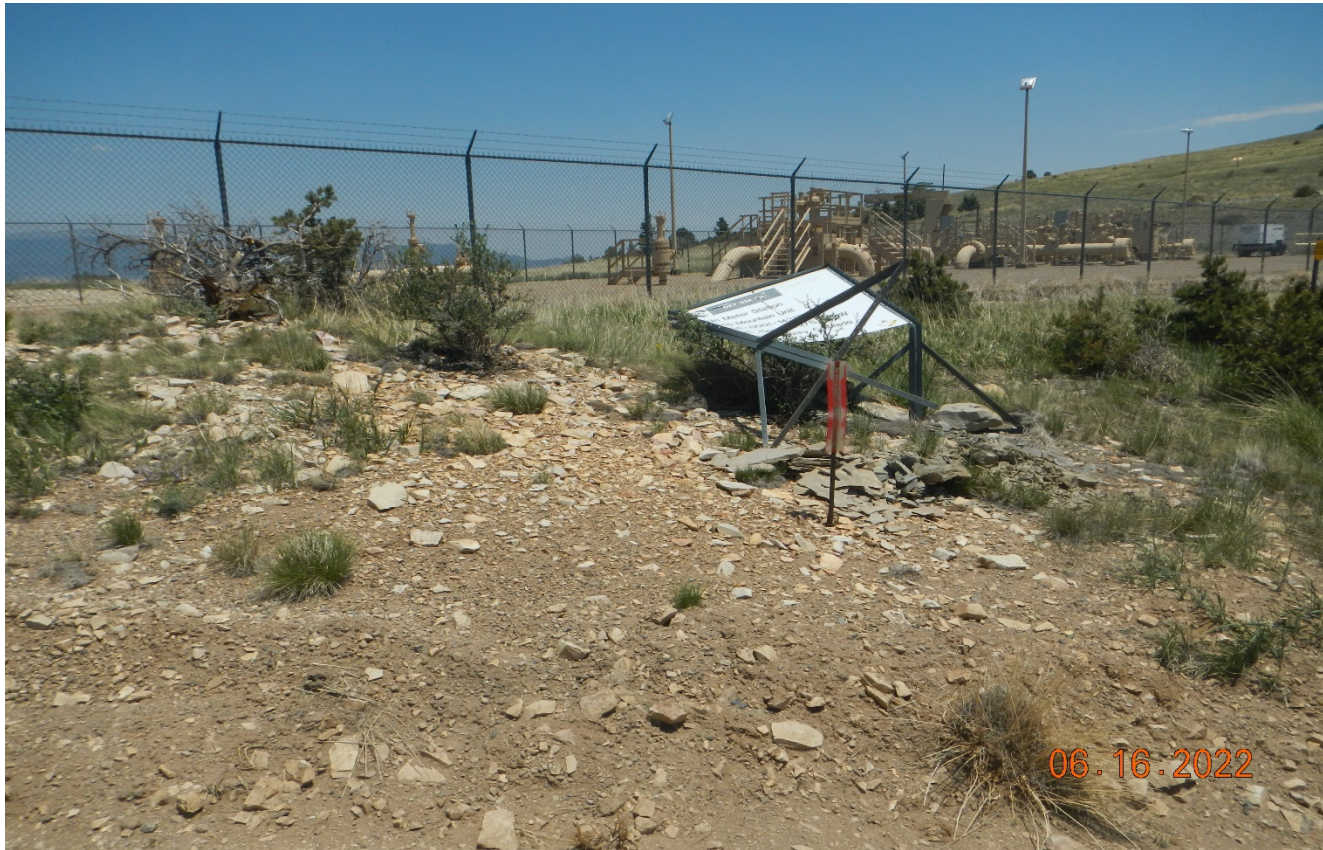
**Photo 10.** There are still degraded wattles on the cut slope that need to be removed. There are noxious weeds in this area that need to be controlled.

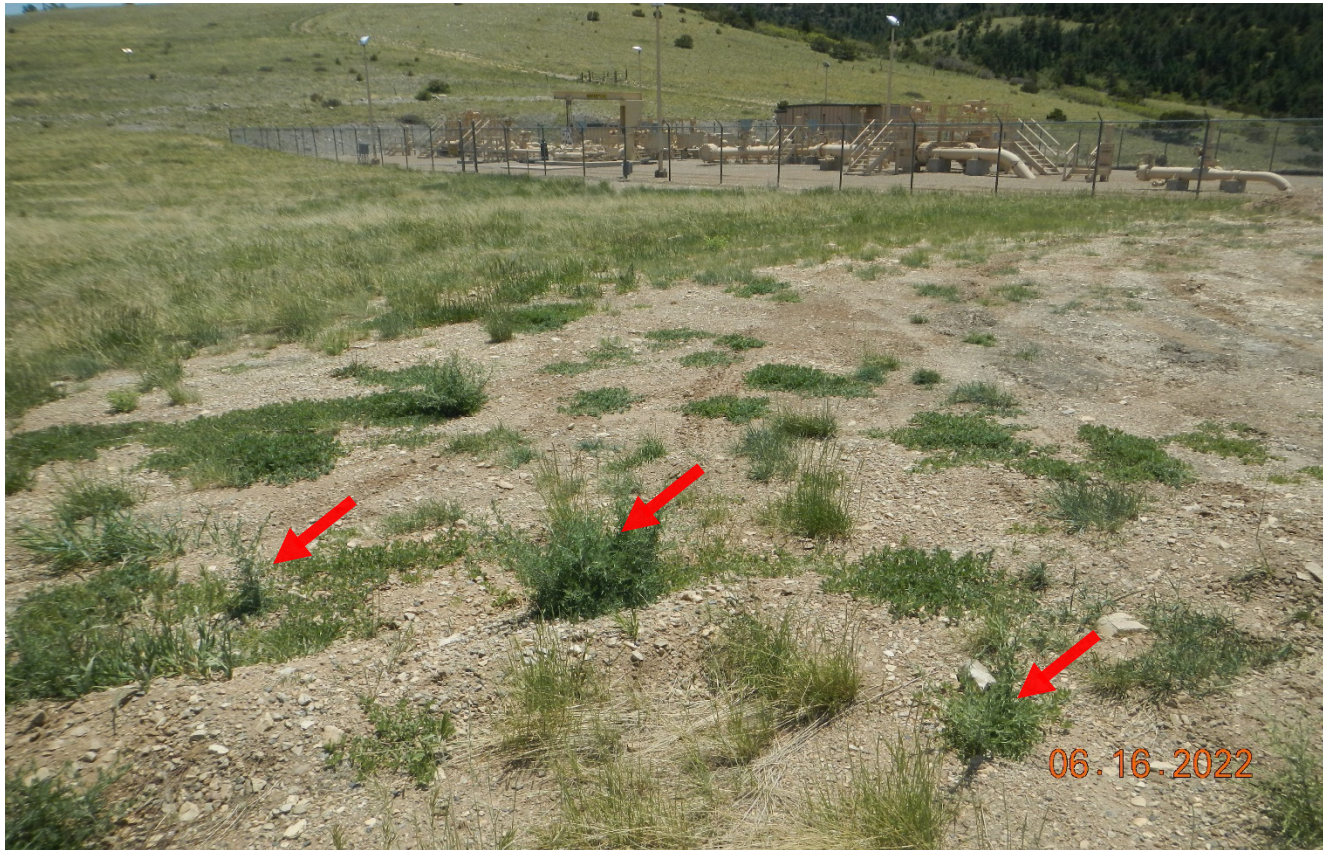
**Photo 11.** Facing southeast toward the meter station. Diffuse knapweeds is shown at red arrows and needs to be controlled soon to prevent seed dispersal.
