Inspection Photos

API: 055-06068

Operator: OXY USA INC

Inspection Date: 6/16/2022

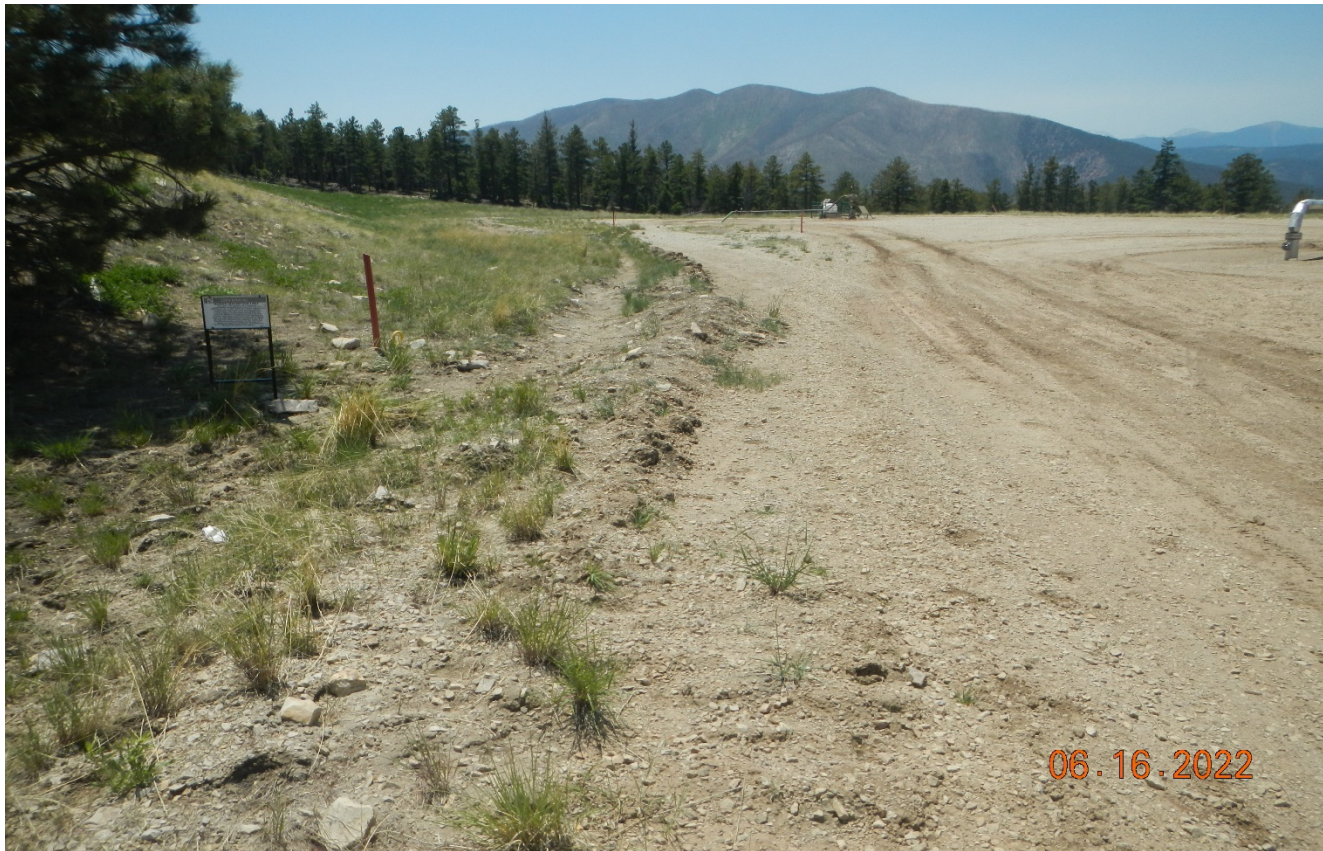
Photo 1. Facing southwest at the location.

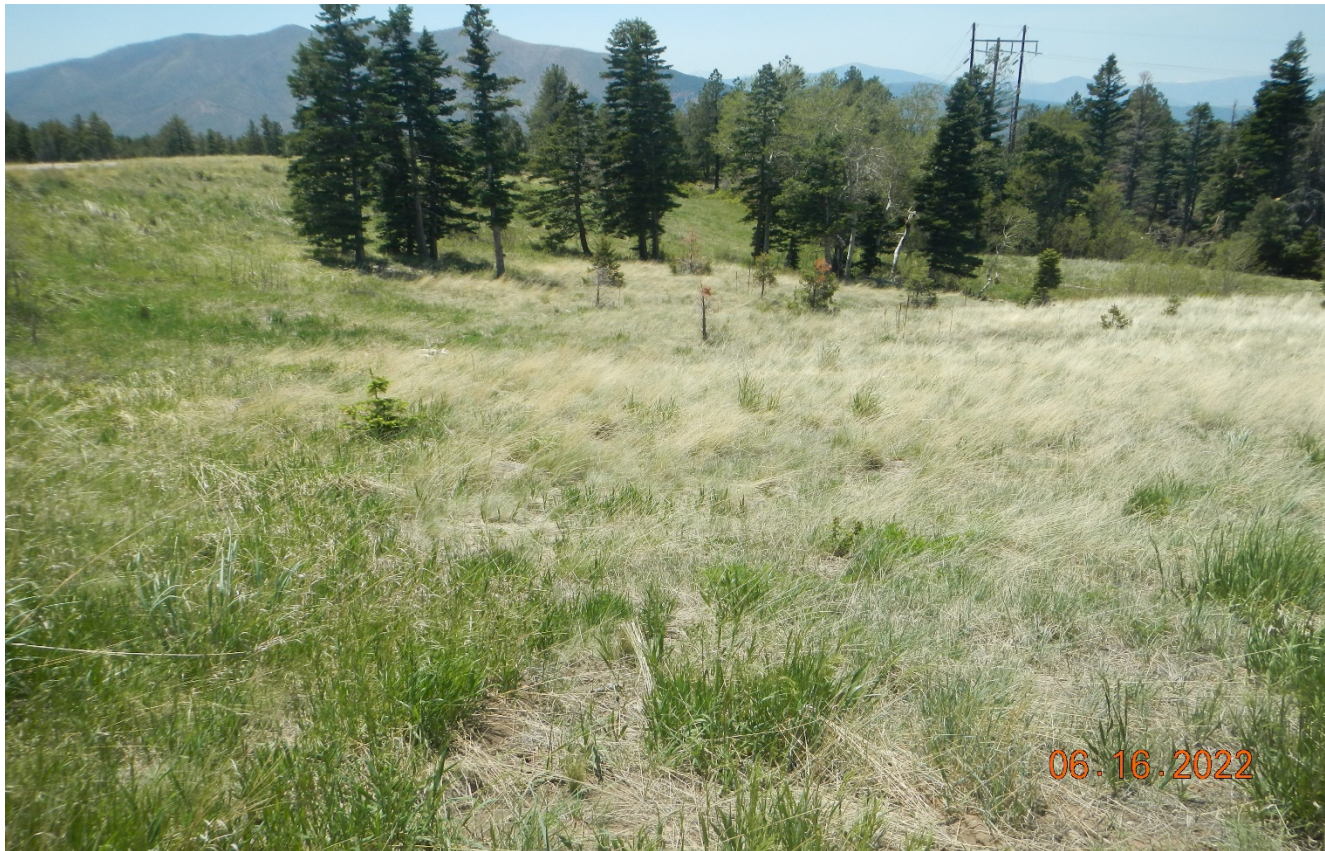
Photo 2. Facing northwest toward the reclaimed area at the northwest side of the location.

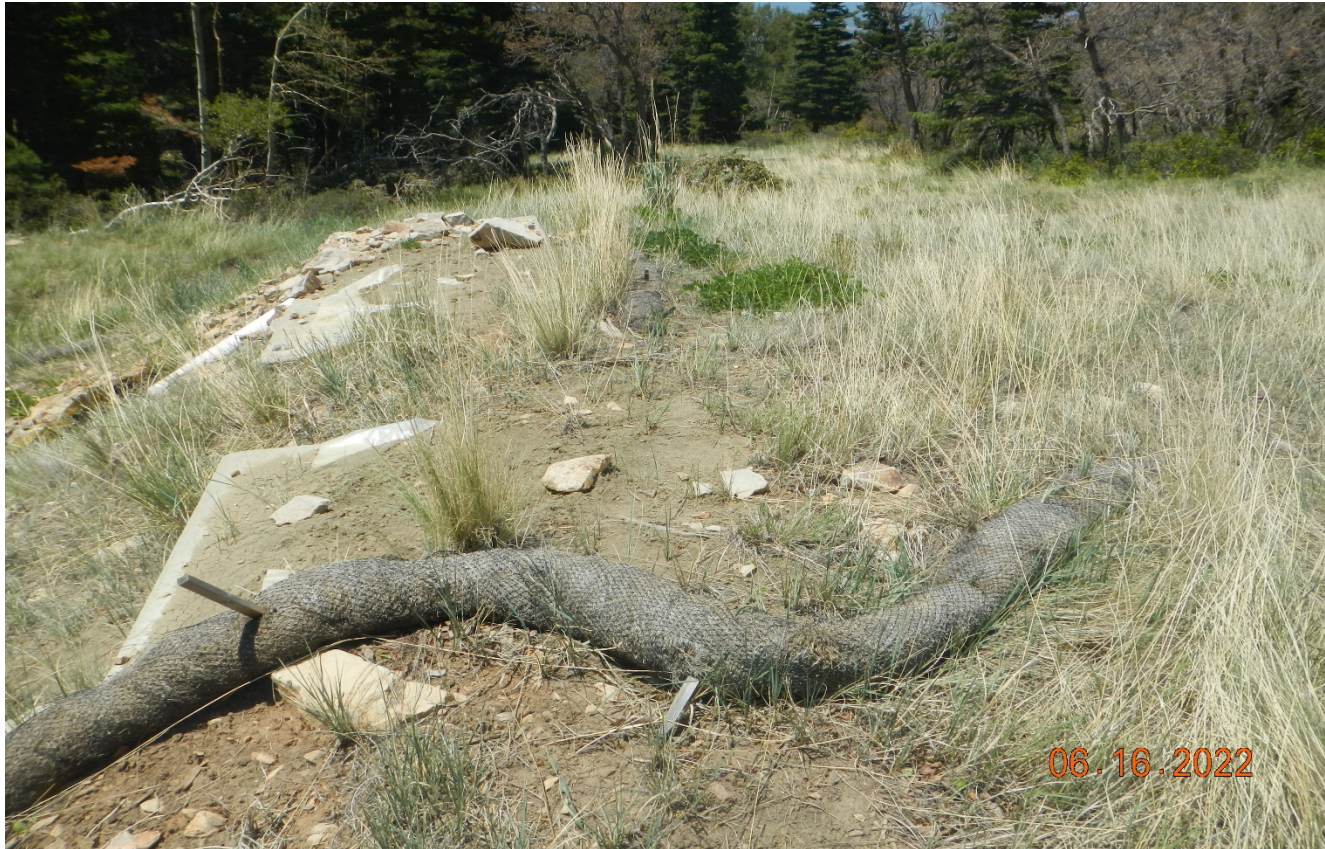
Photo 3. There are some displaced straw wattles at the spring area at the northwest side of the location.

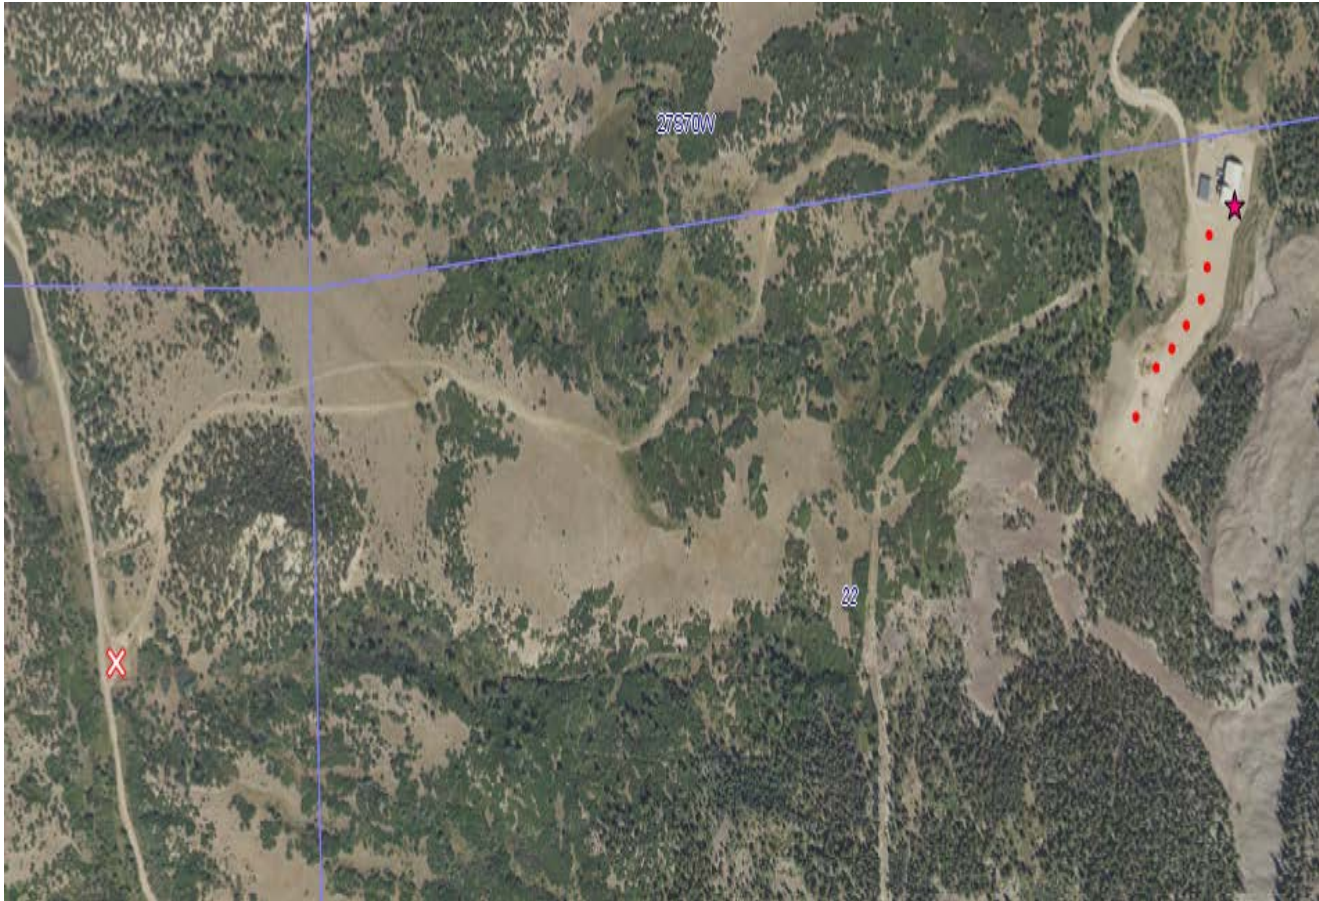
Photo 4. 2015 aerial image of the well site and compressor in the upper right of photo. The red X in the lower left of photo is the associated facility along the County road shown in the next two photos.

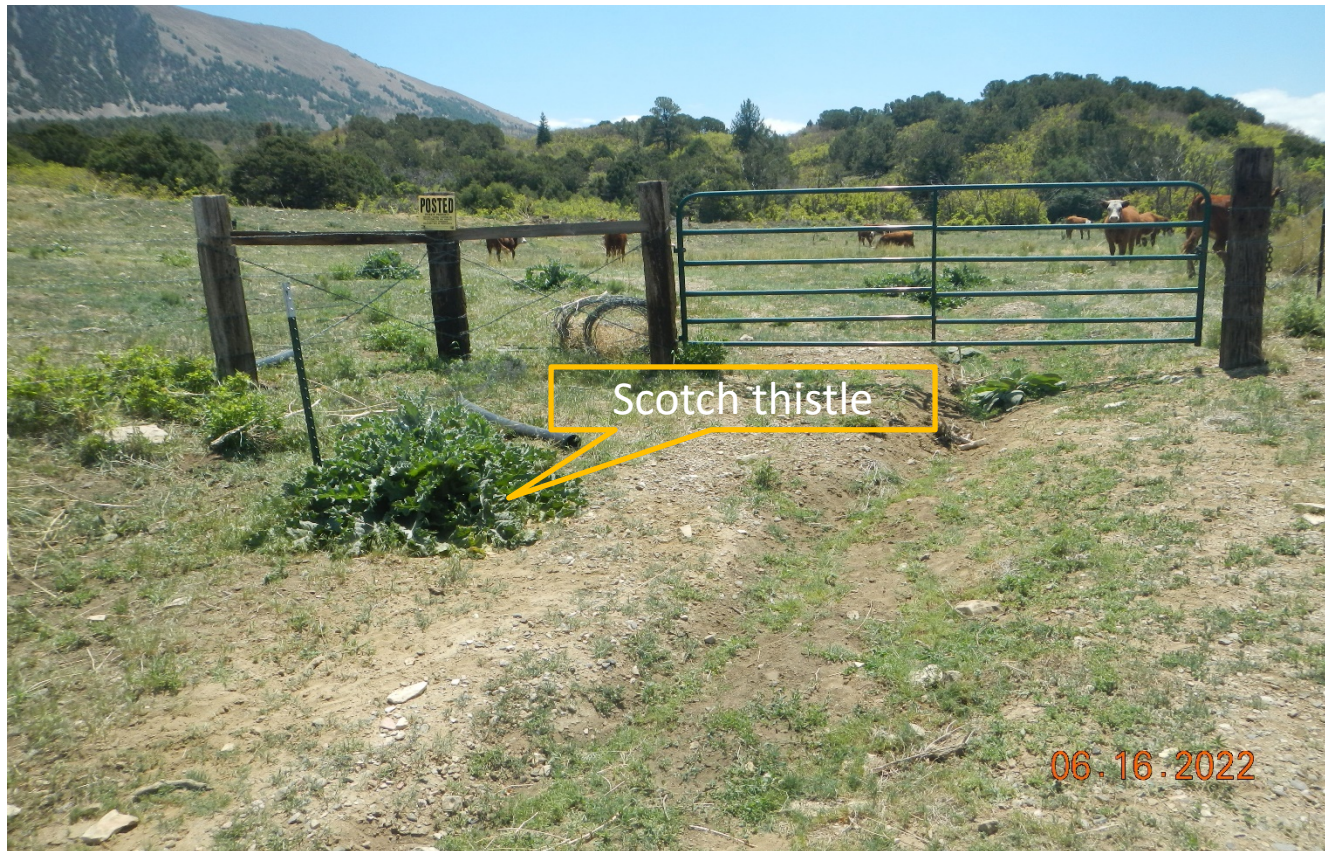
Photo 5. Facing southeast toward the associated facility adjacent to CR 562.

Lat/Long: 37.689083, -105.219413.

There are noxious weeds in this area that need to be controlled.

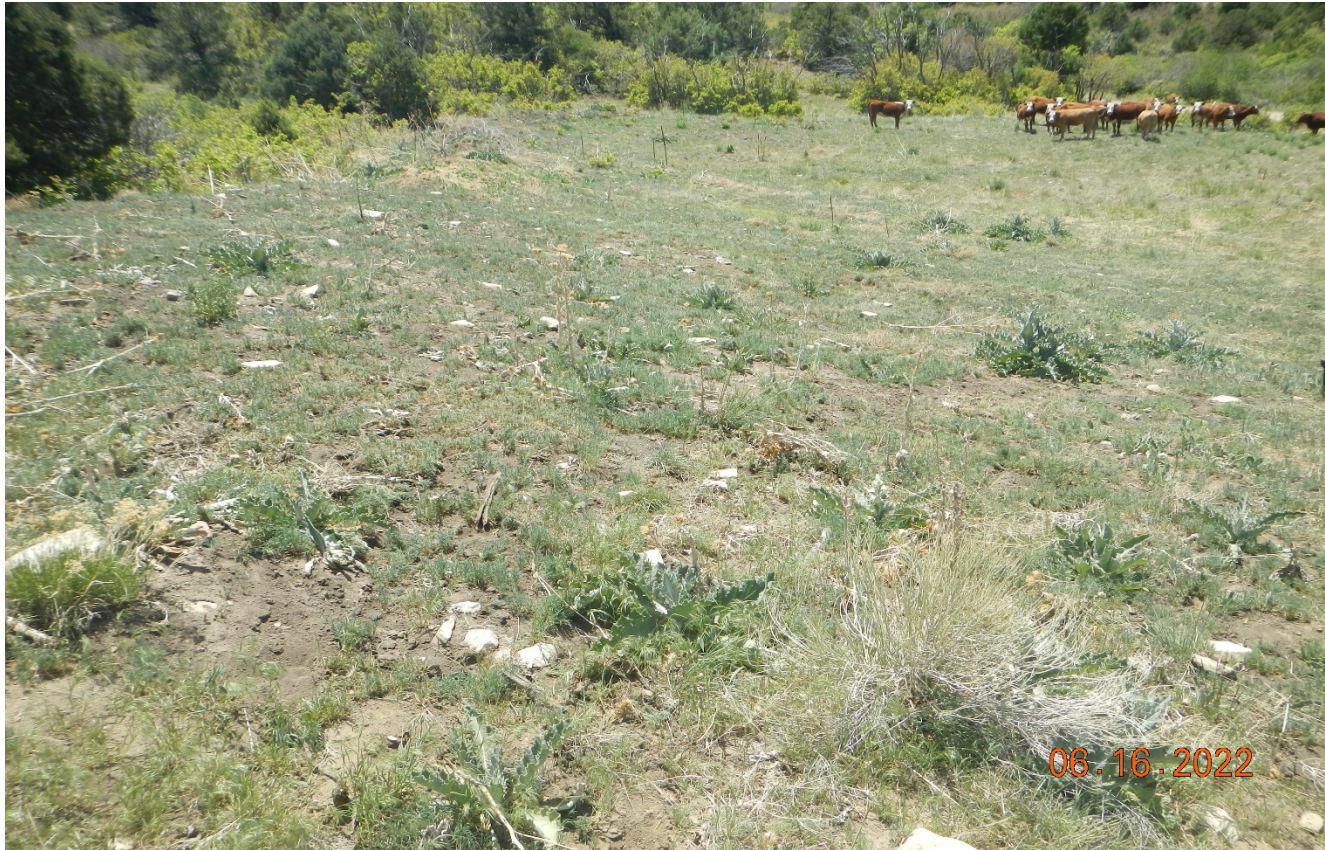
Photo 6. Facing south at the associated facility. This area is not establishing desirable vegetation and needs to be reseeded. There are numerous noxious weeds in this area that need to be controlled.
