Inspection Photos
Operator: Hilcorp Energy
API: 067-08640
Date: 6/1/2022

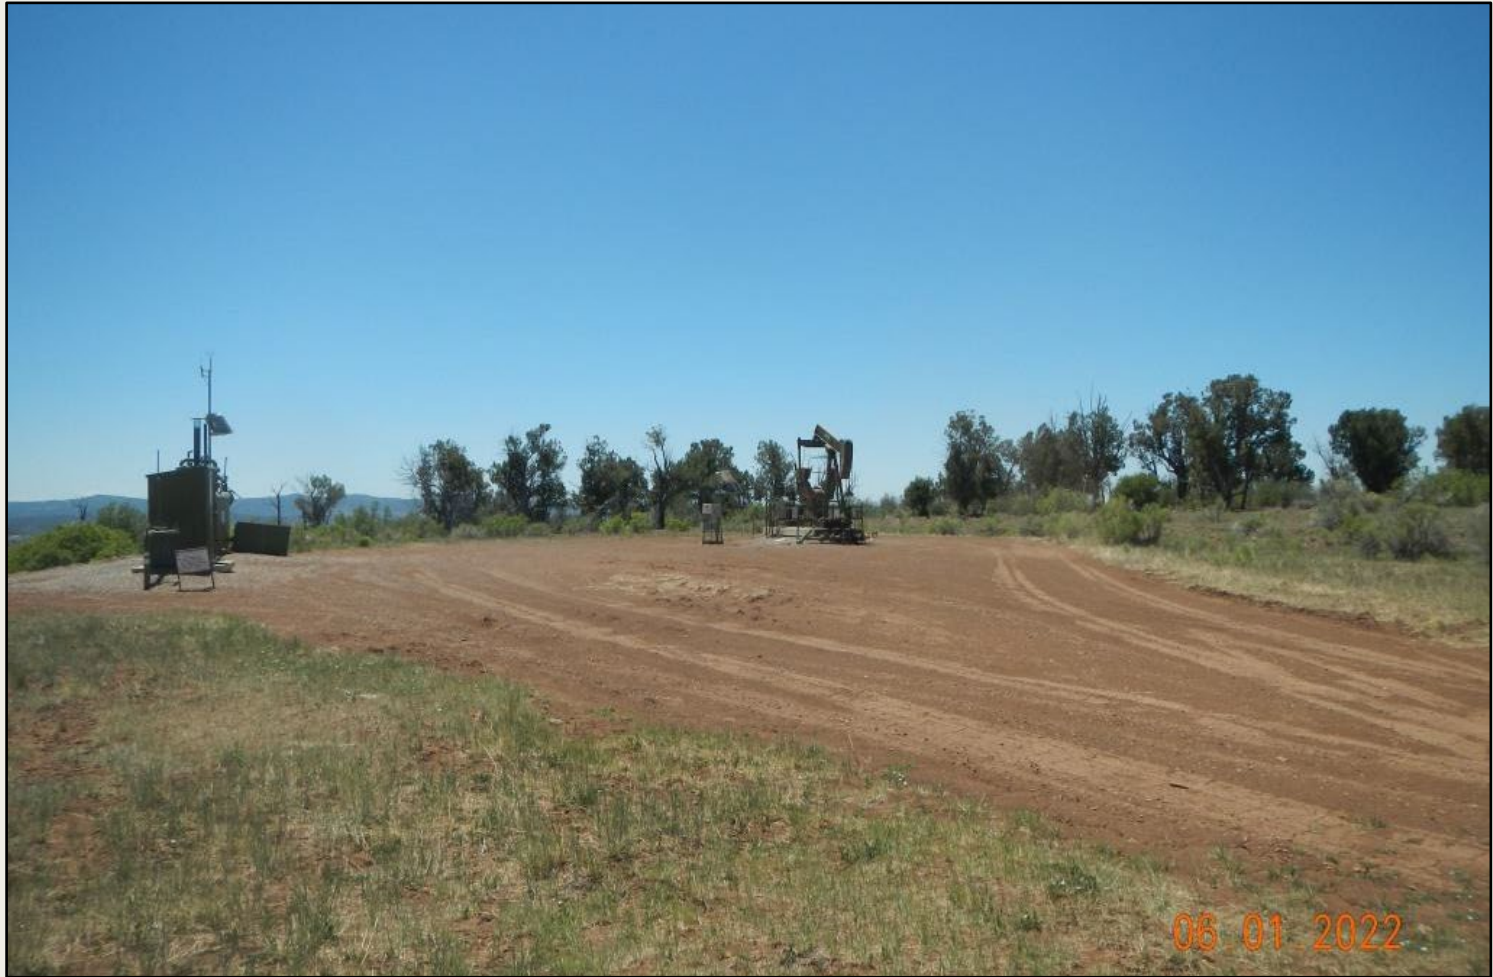
Photo 1. View of the project area from the well pad entrance facing center.

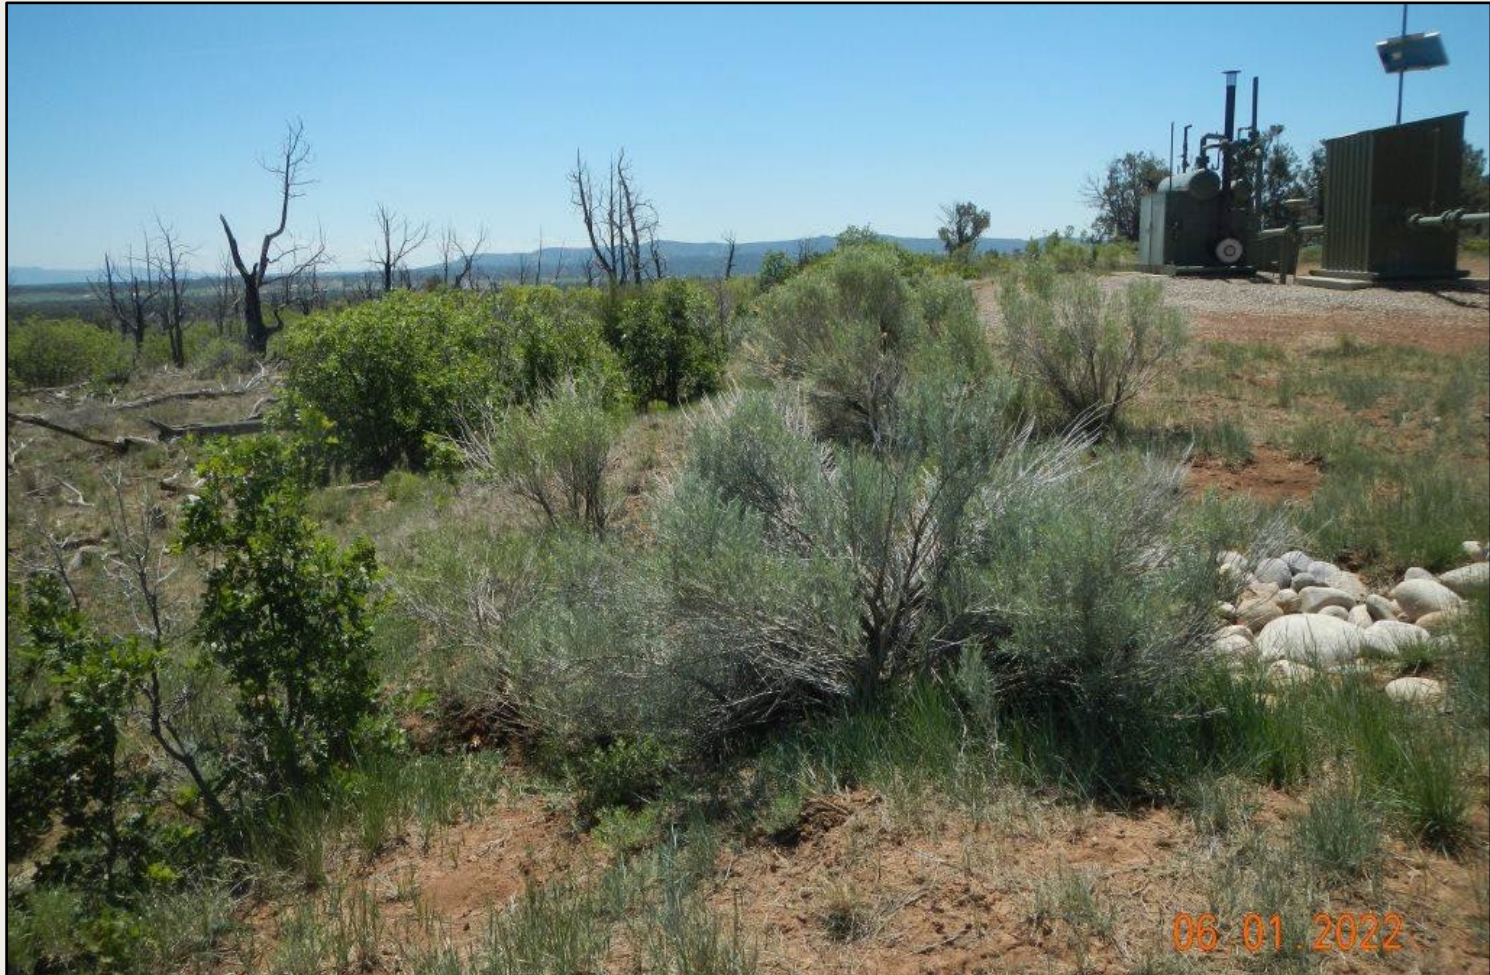
Photo 2. View of the eastern project area from the northeastern corner facing southward. Revgetation is progressing largely with western wheatgrass, smooth brome, crested wheatgrass, and rubber rabbitbrush.

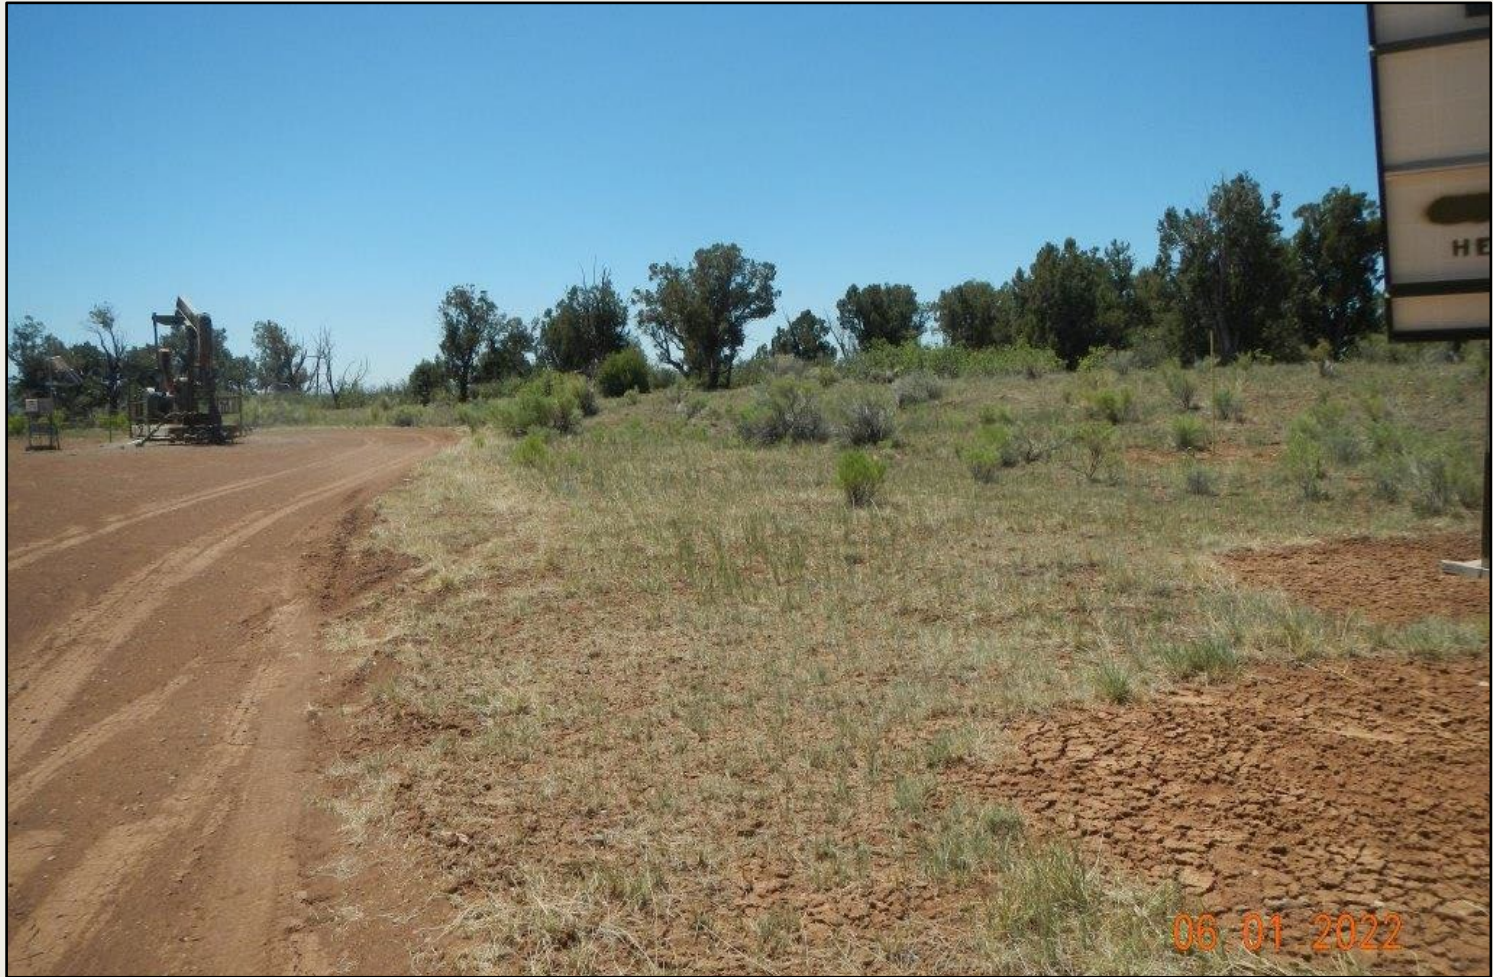
Photo 3. View of the western project area from the northwestern corner facing southward.
