Inspection Photos
Operator: Simcoe
API: 471426
Date: 6/13/2022

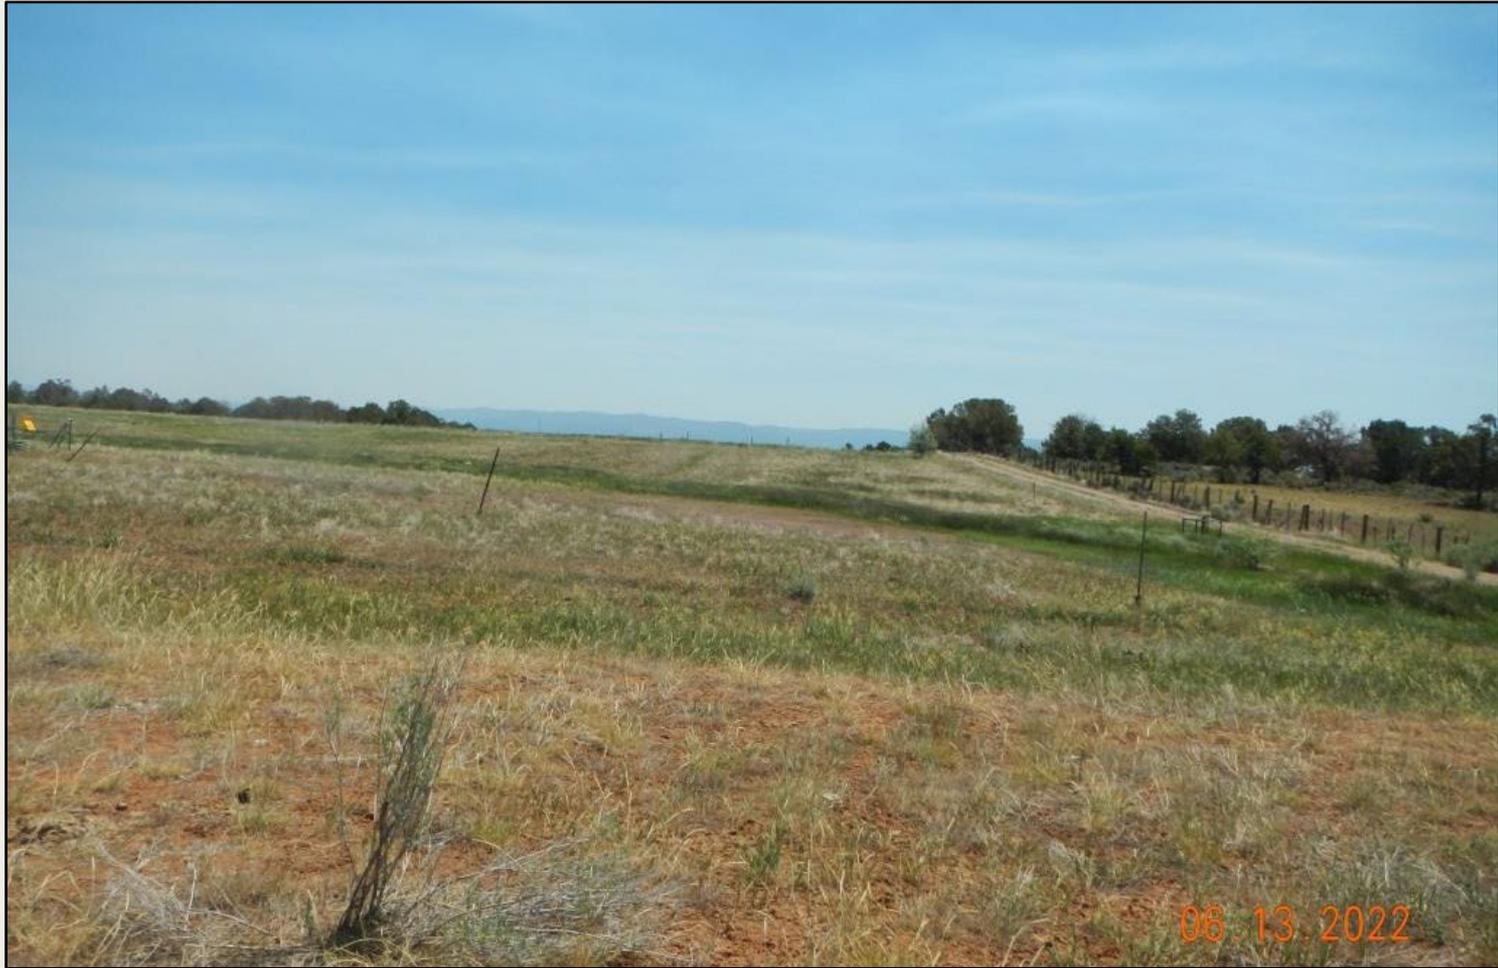
Photo 1. View of the right of way (ROW) from access entrance facing eastward along ROW.

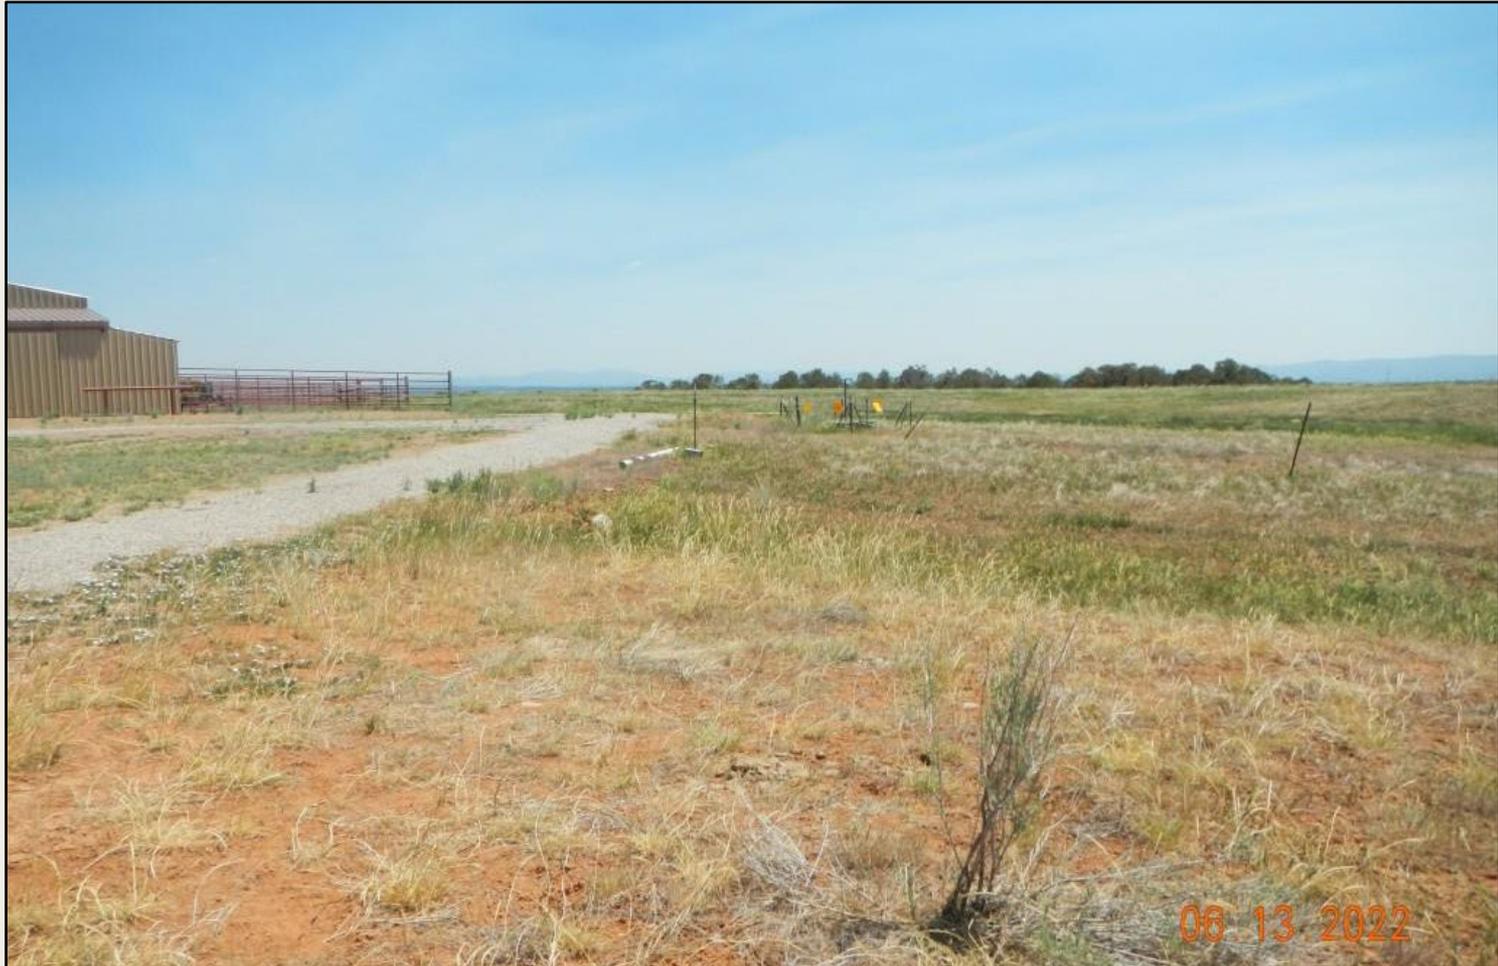
Photo 2. View of ROW in foreground facing northward. Desirable vegetation such as sand dropseed, crested wheatgrass, and smooth brome observed.

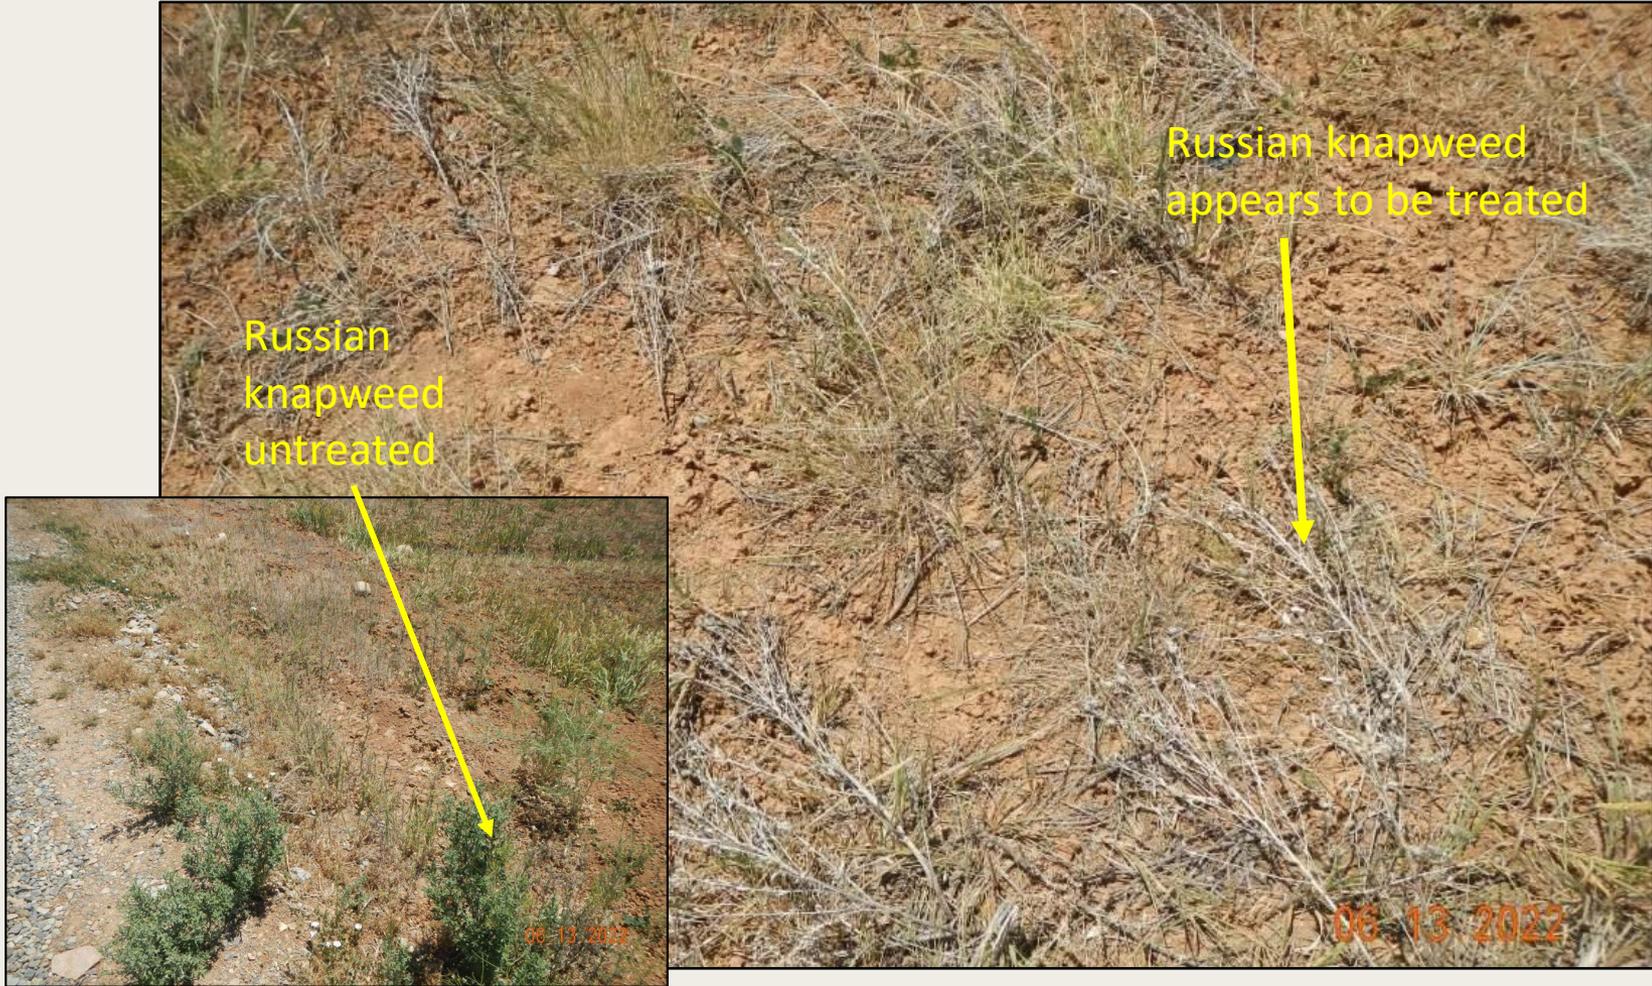
Photo 3. View of Russian knapweeds both treated and untreated observed along the pipeline ROW. Similar to surrounding pasture, Russian knapweeds partially appear treated and additional individuals remain. Continued management and treatment is needed.

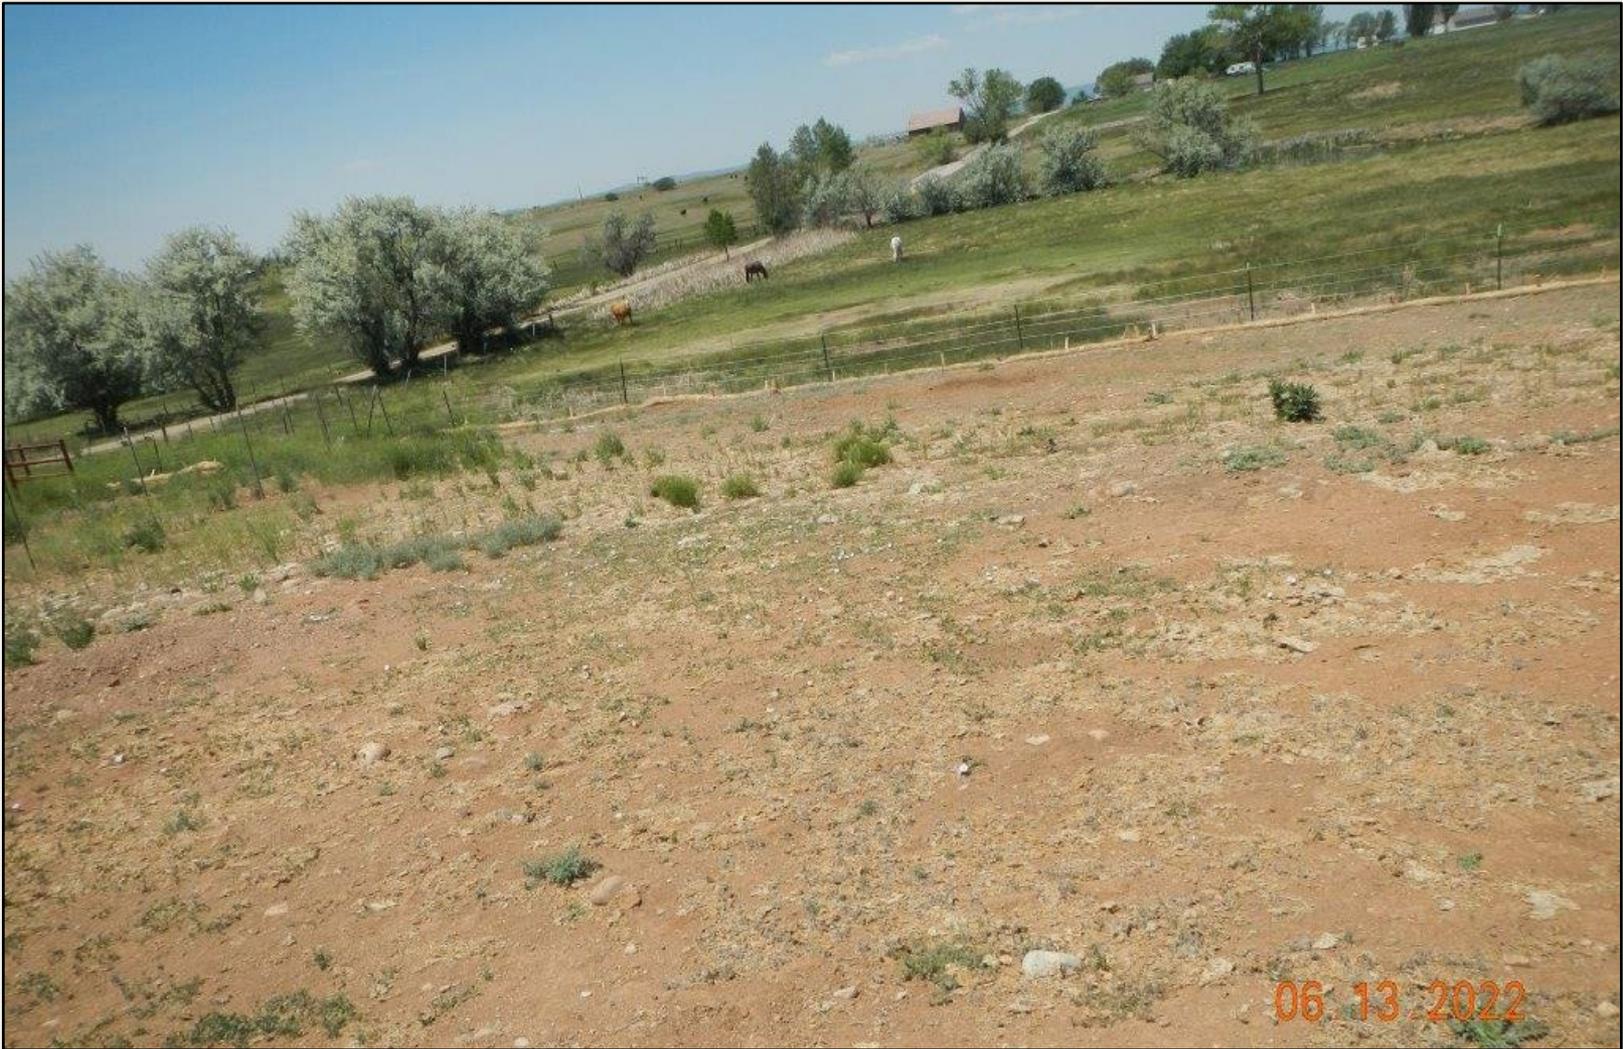
Photos 4. View of area along the western portion of the pipeline ROW where hydromulch is observed and seeding appears to be conducted.

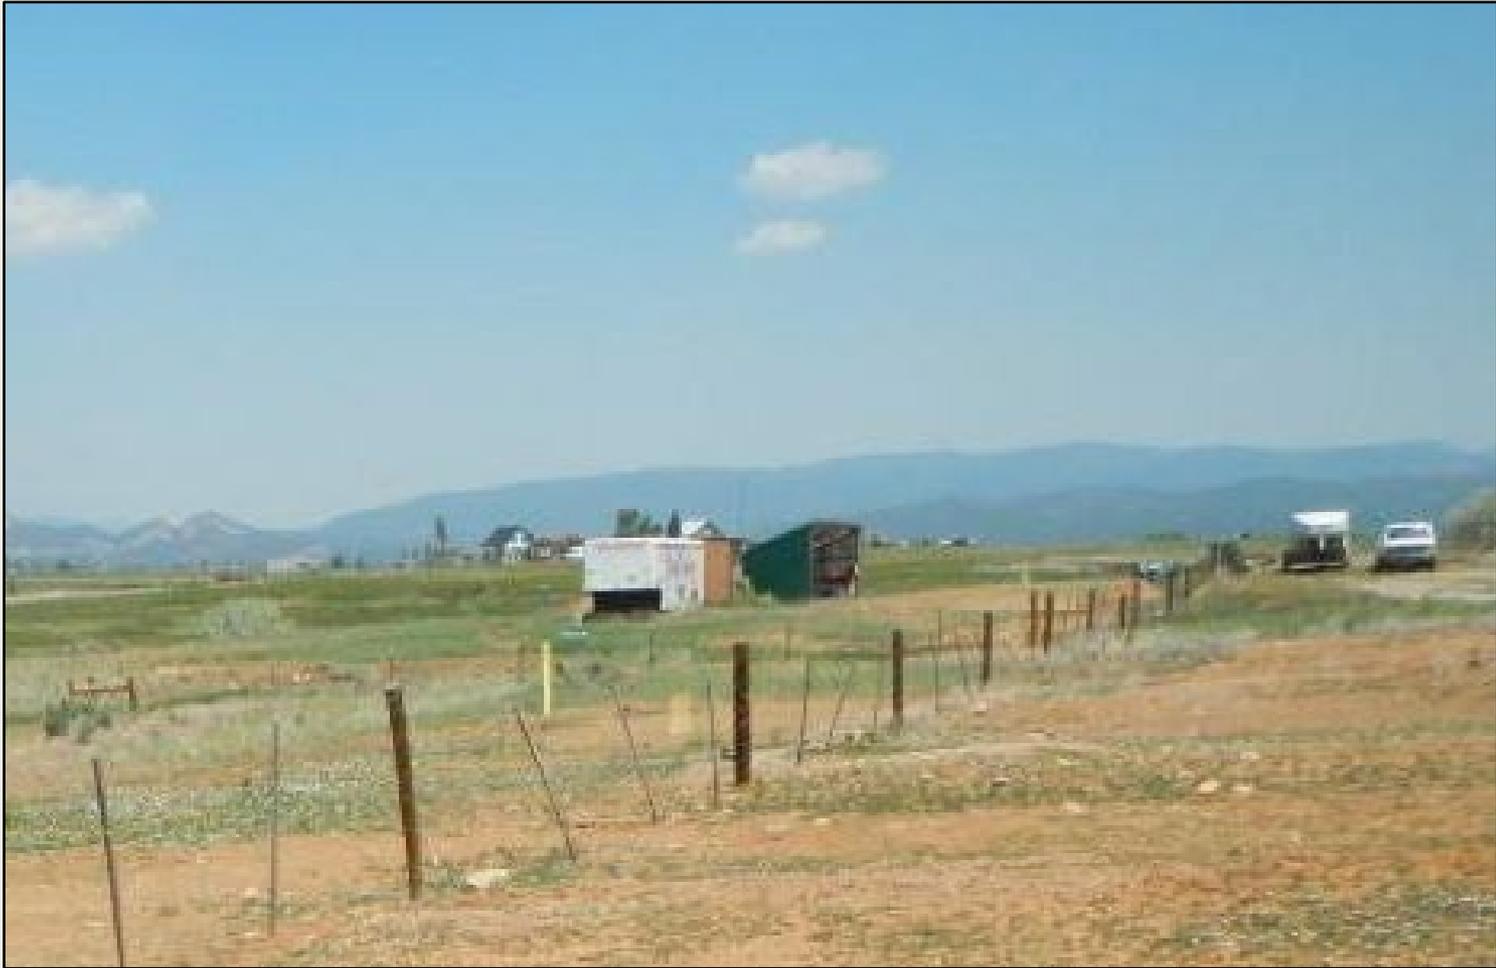
Photo 5. View of fencing repaired in the western portion of the pipeline ROW.

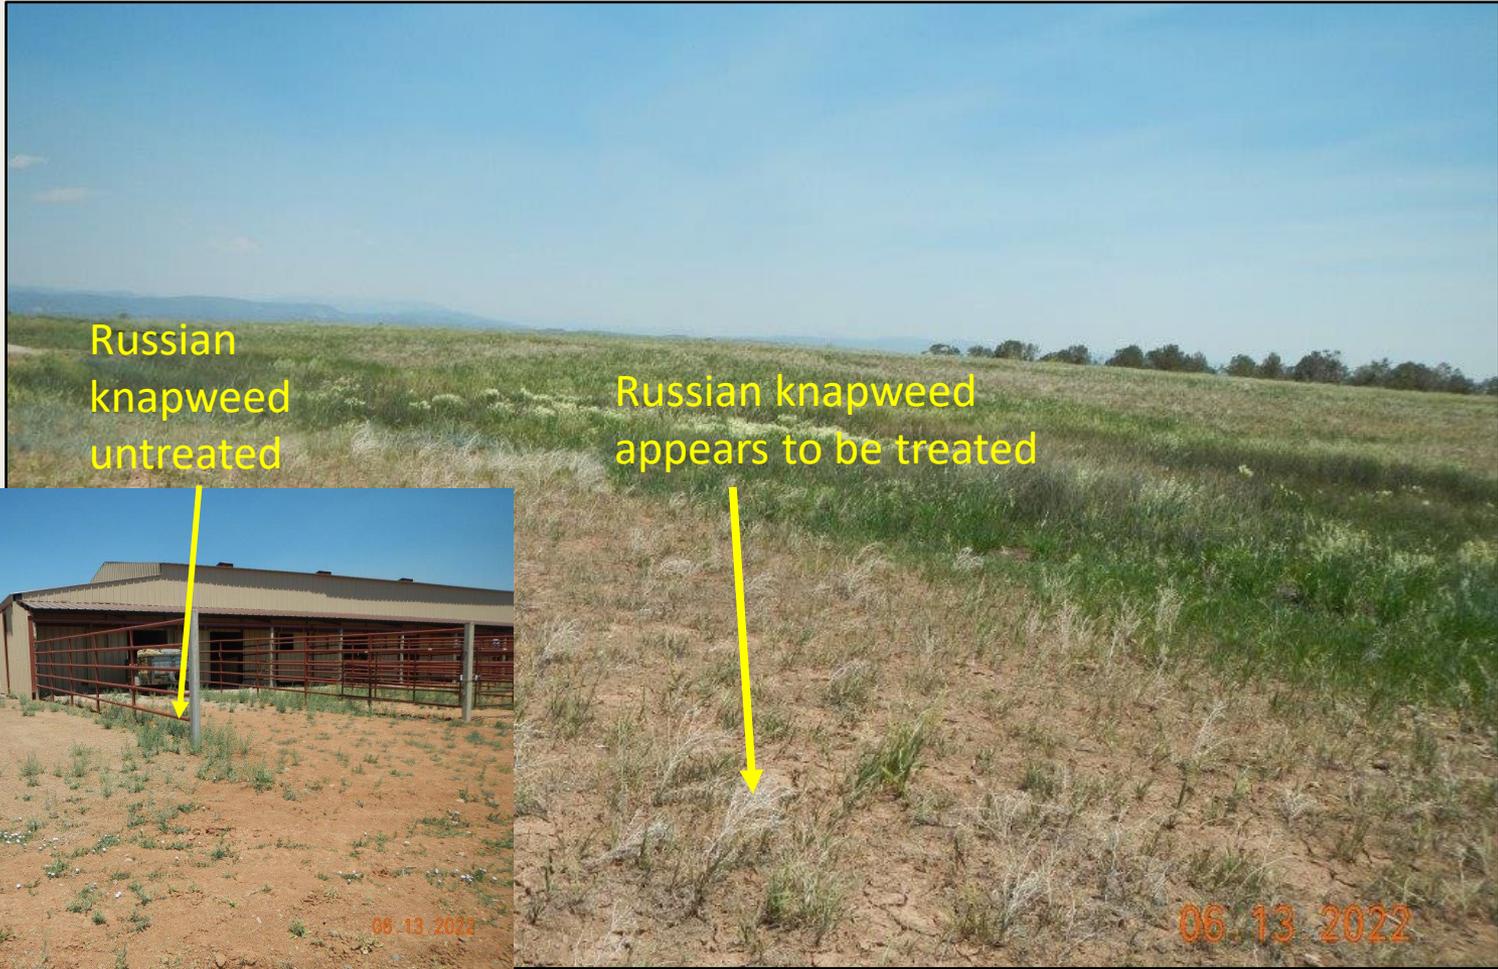
Photo 6. View of reference area comprised of open grass pasture with smooth brome, crested wheatgrass, and foxtail. Russian knapweeds infestation outside of ROW appears partially treated as living a treated individuals remain.
