Inspection Photos
Operator: Simcoe
API: 067-09190
Date: 6/13/2022

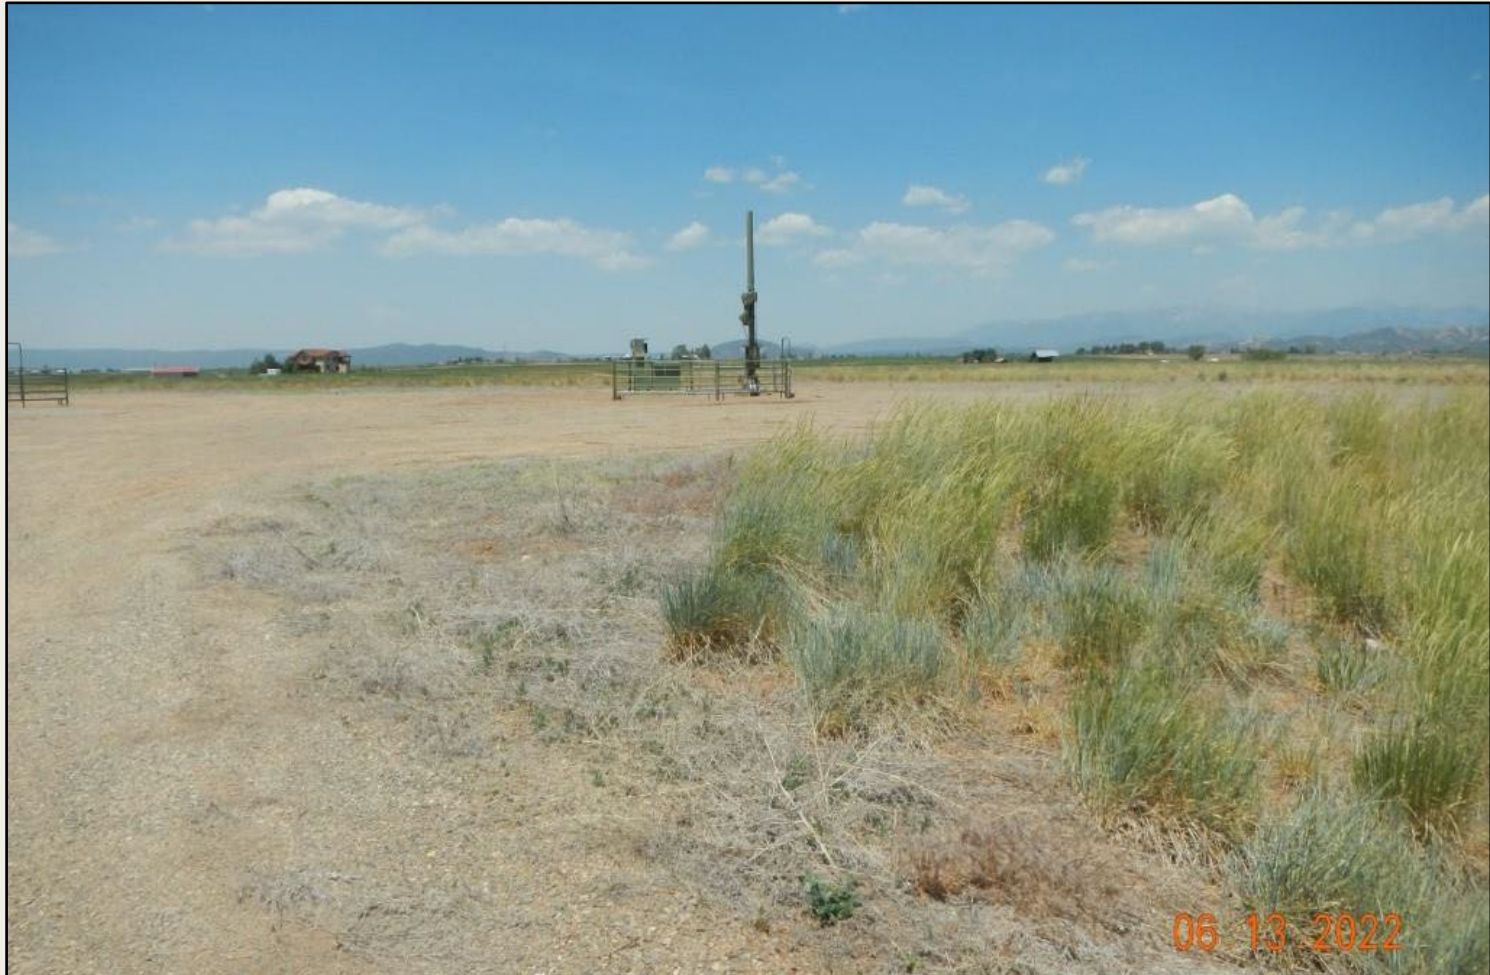
Photo 1. View of the project are from the well pad entrance facing center.

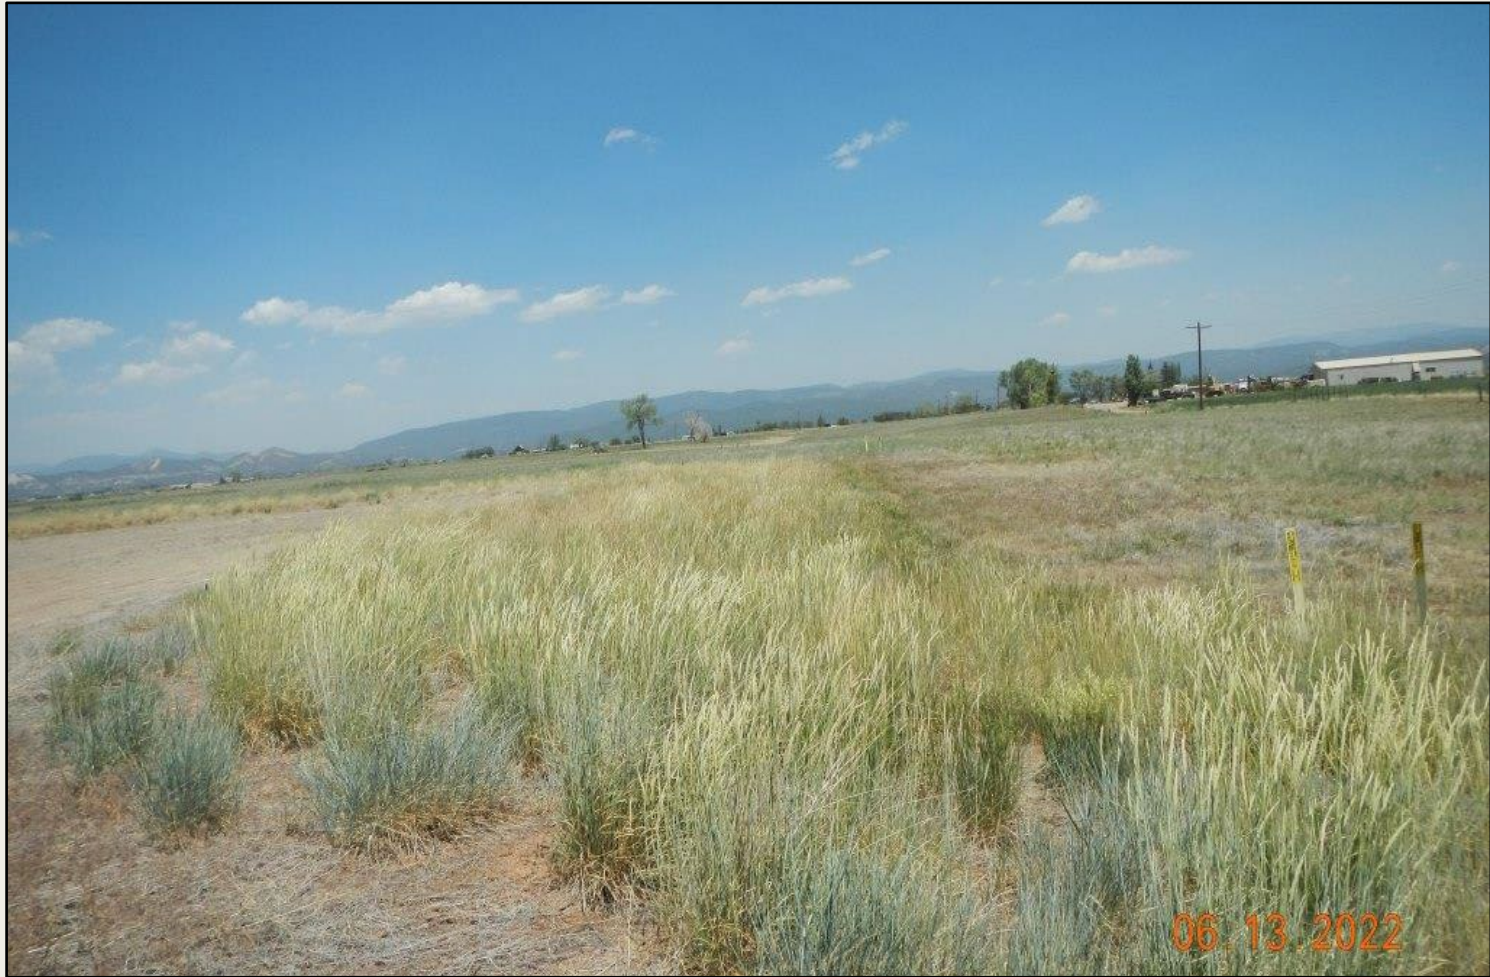
Photo 2. View of the eastern project area from the well pad entrance facing northward. Revegetation is progressing with crested wheatgrass, sand dropseed, and western wheatgrass.

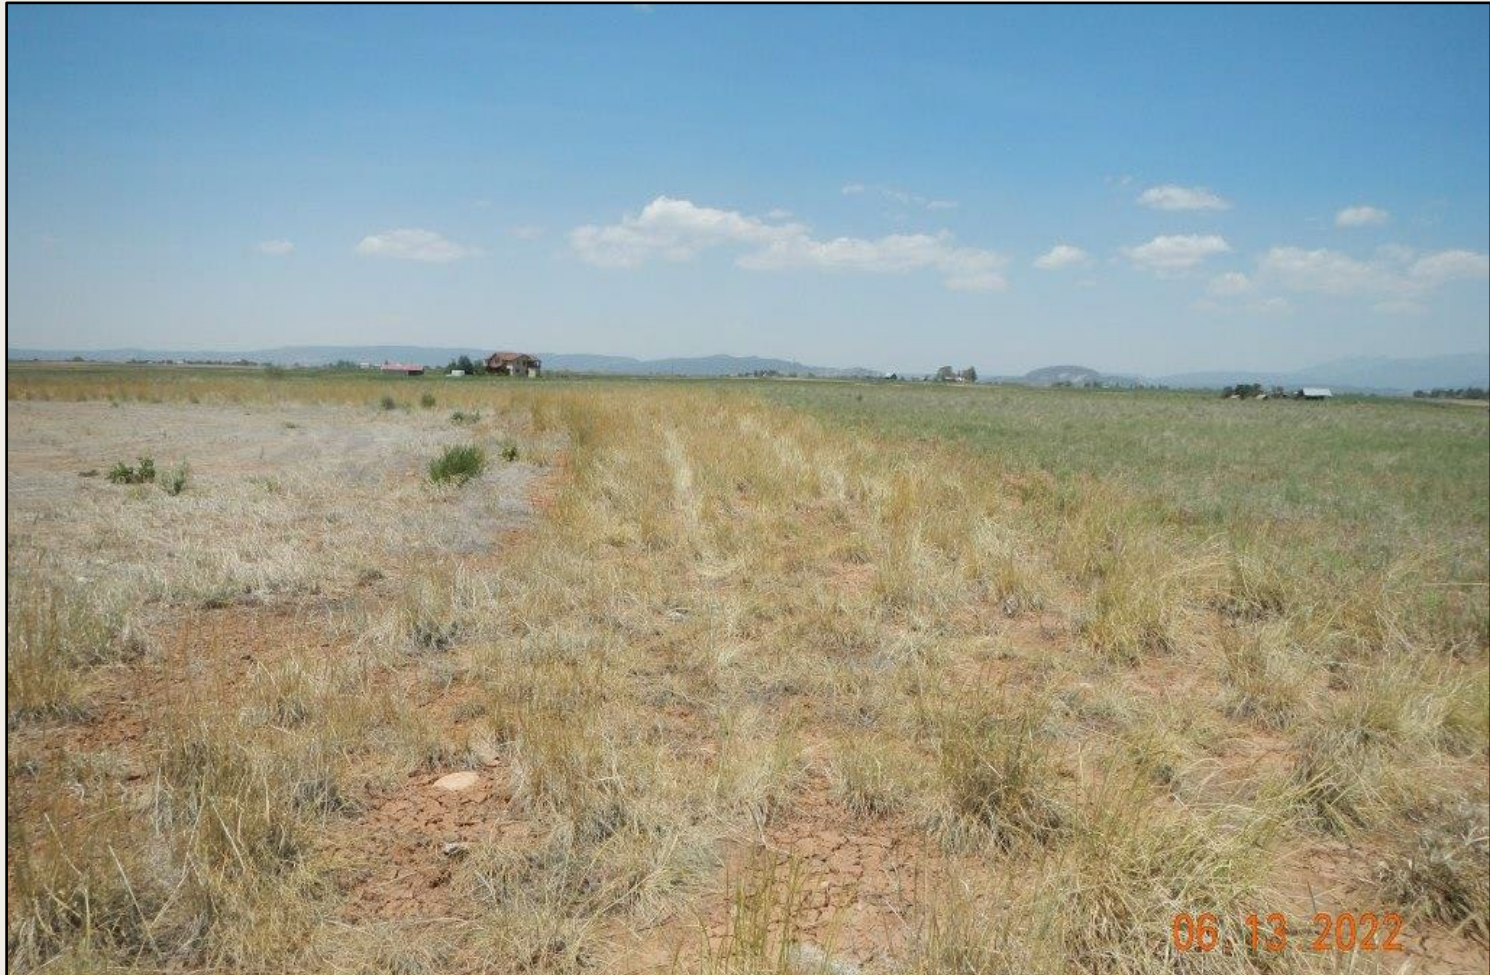
Photo 3. View of the northern project area from the northeastern corner facing westward.

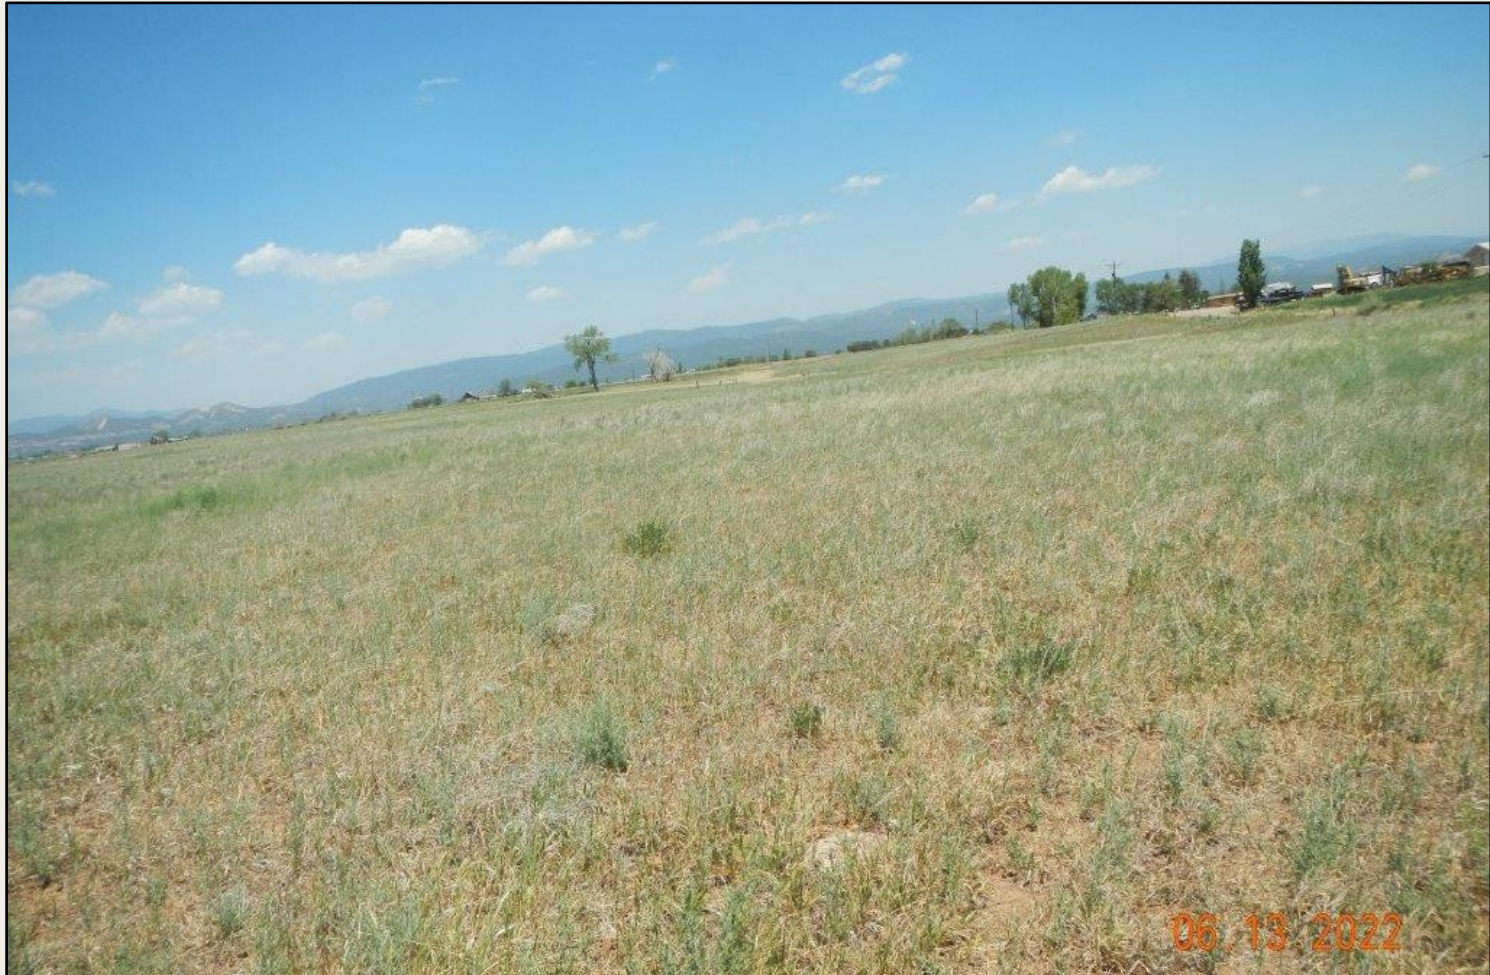
Photo 4. View of reference area comprised of open grass field with smooth brome, crested wheatgrass, and western wheatgrass. As Russian knapweed is present here, continued vigilance and treatment within the project area is needed.
