Inspection Photos
Operator: Simcoe
API: 067-06686
Date: 6/13/2022

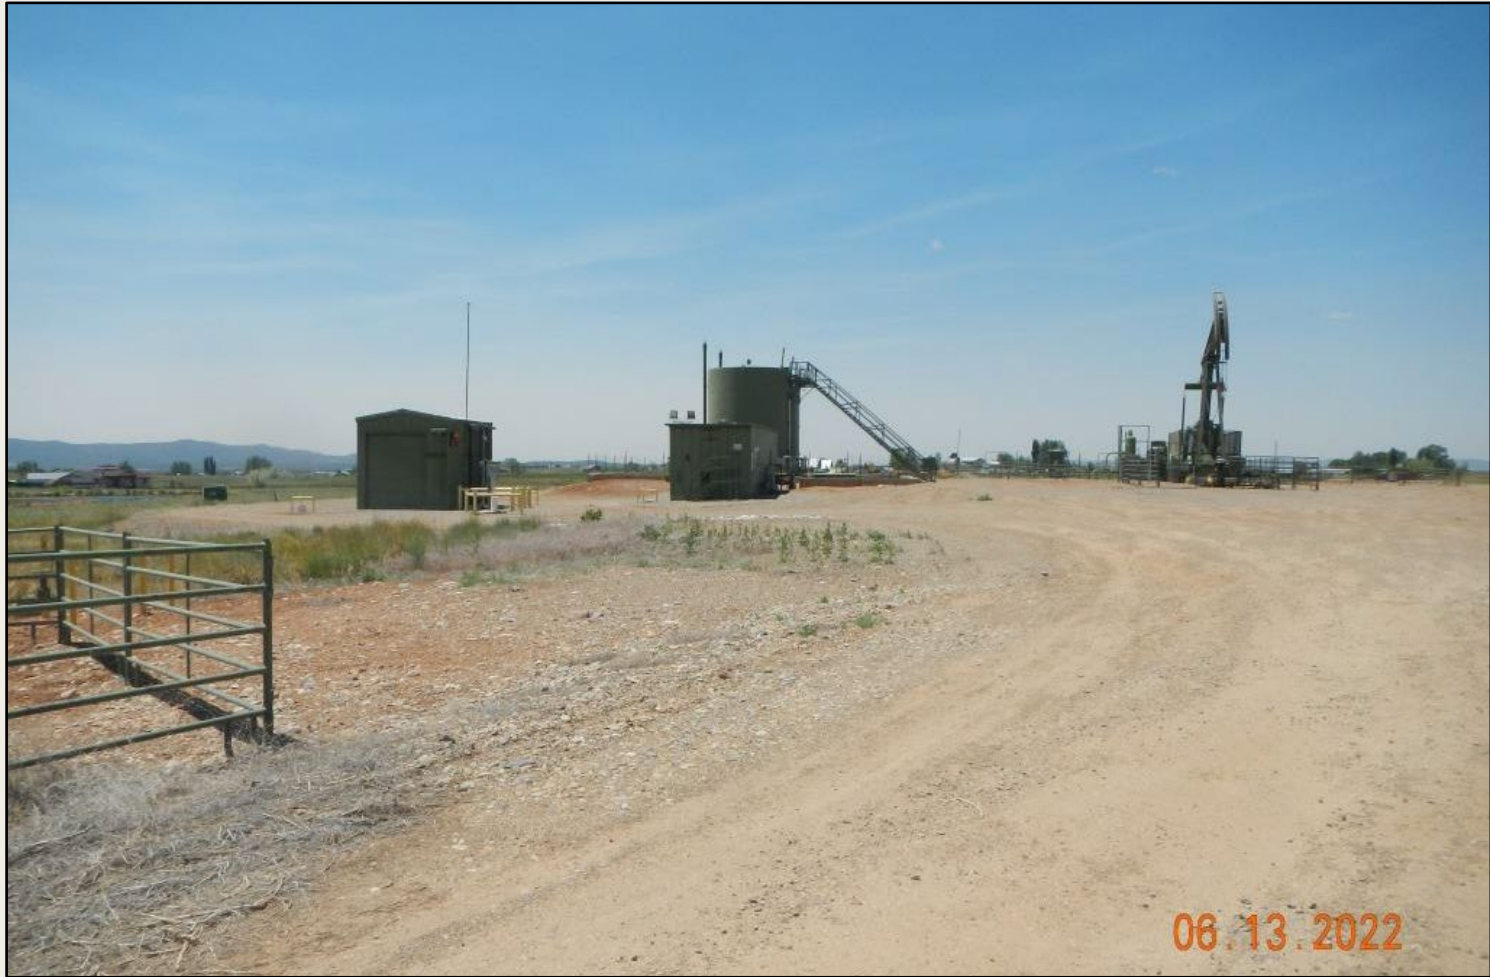
Photo 1. View of the project are from the well pad entrance facing center.

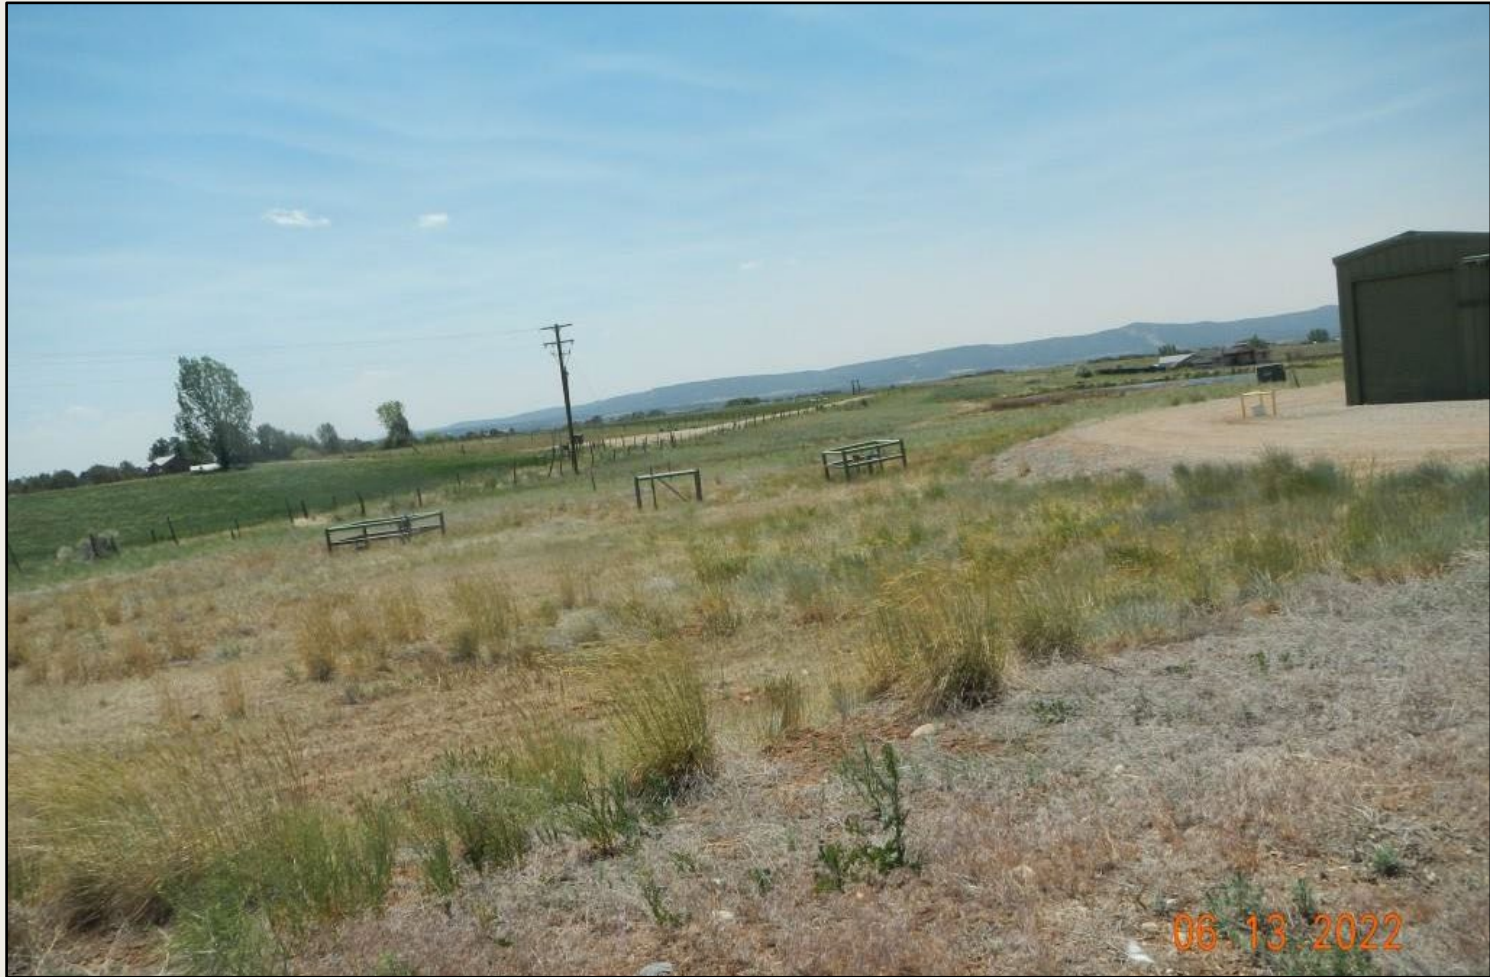
Photo 2. View of the eastern project area from the well pad entrance facing southward. Revegetation is progressing with crested wheatgrass, sand dropseed, and western wheatgrass.

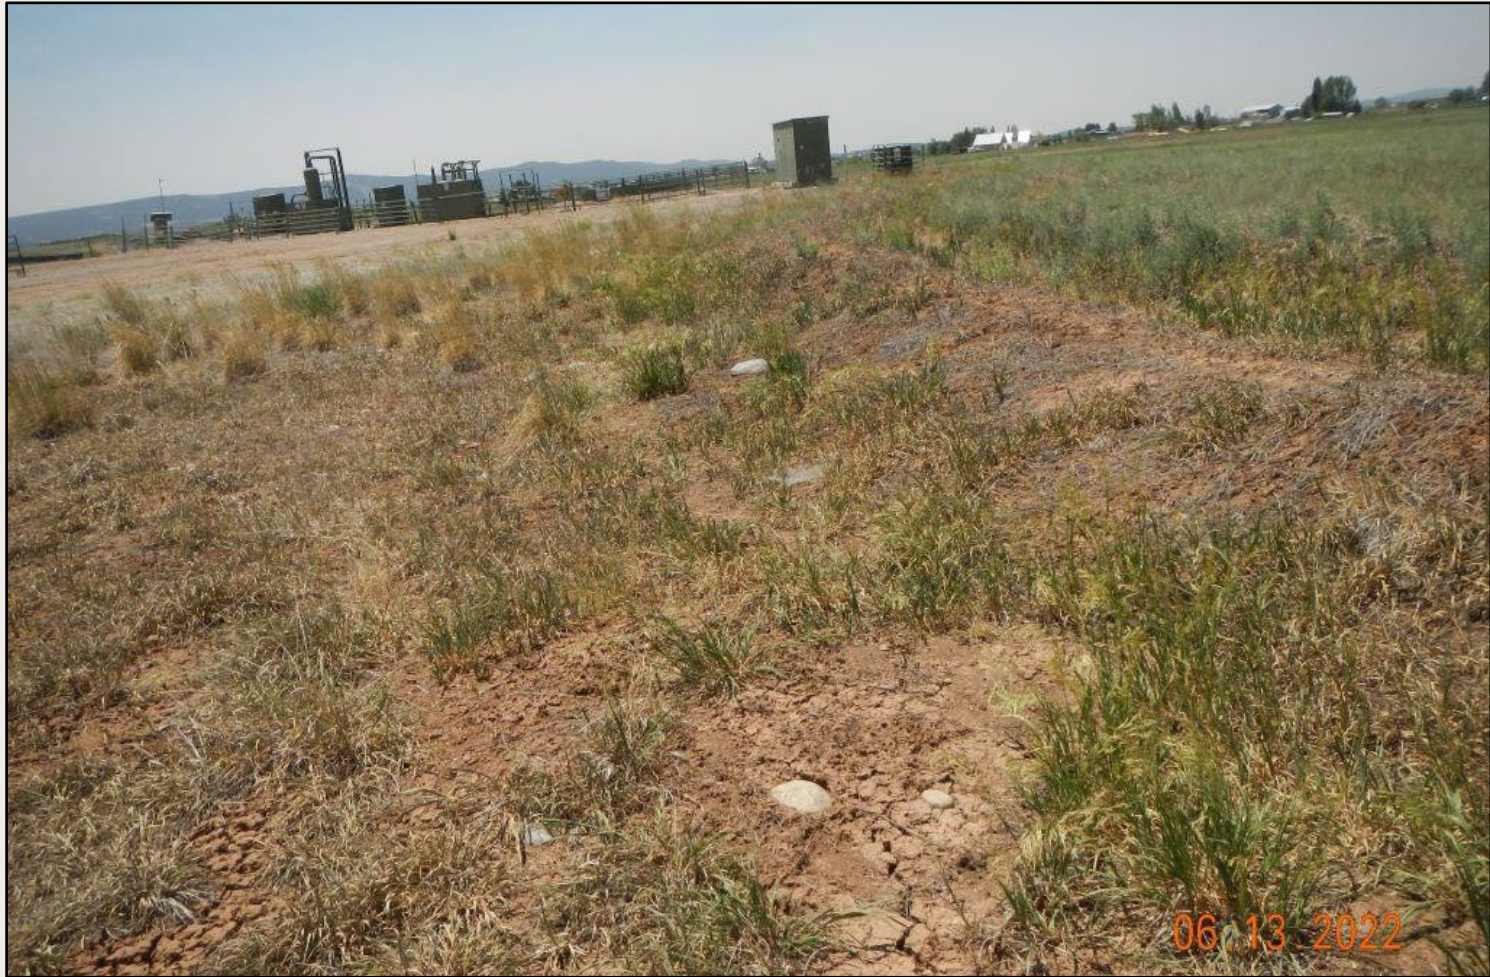
Photo 3. View of the western project area from the northwestern corner facing southward.
