Inspection Photos

API: 055-06316

Operator: OXY USA INC

Inspection Date: 6/16/2022

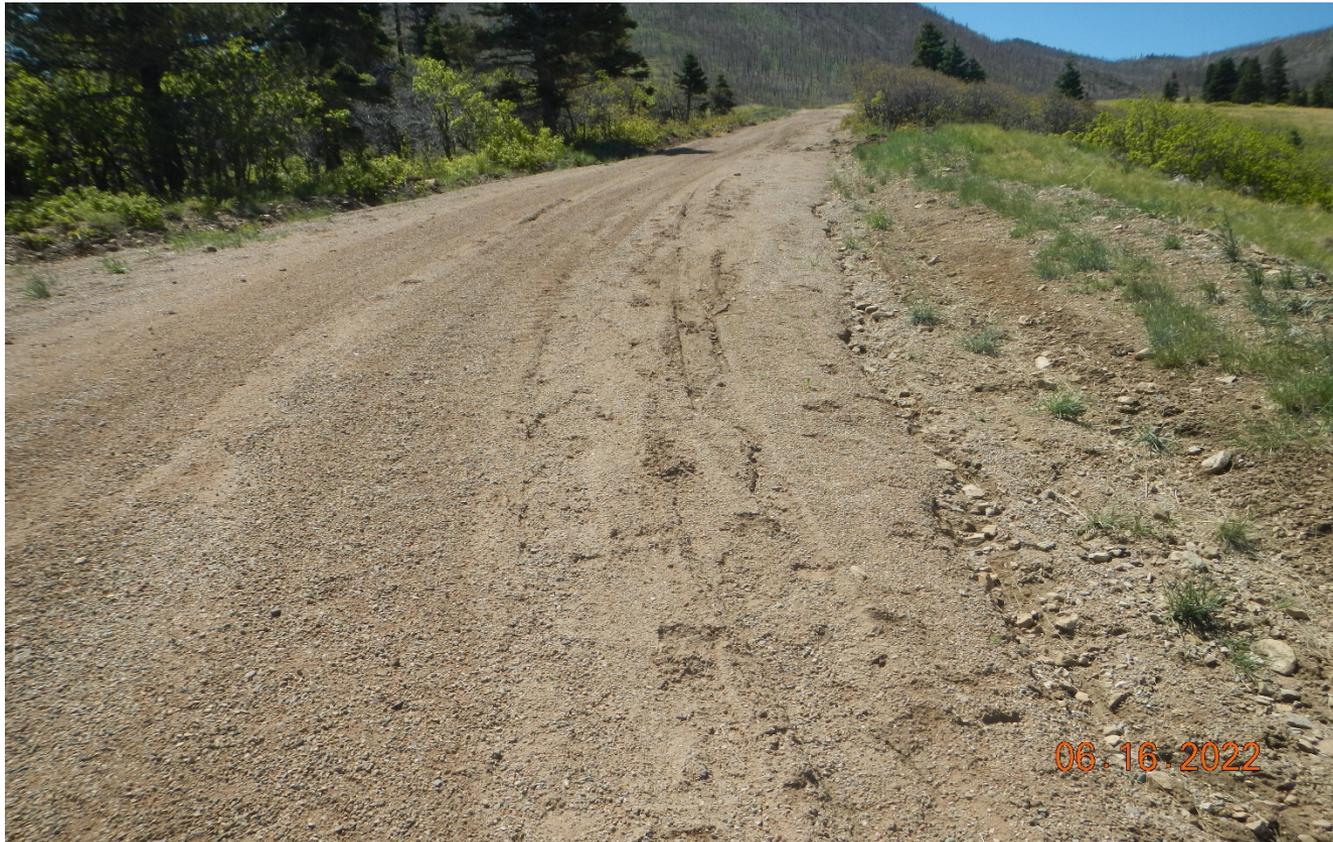
Photo 1. Facing south along the access road. There are some signs of erosion along the steep grade of the road. Stormwater should be diverted off the road to reduce erosion.

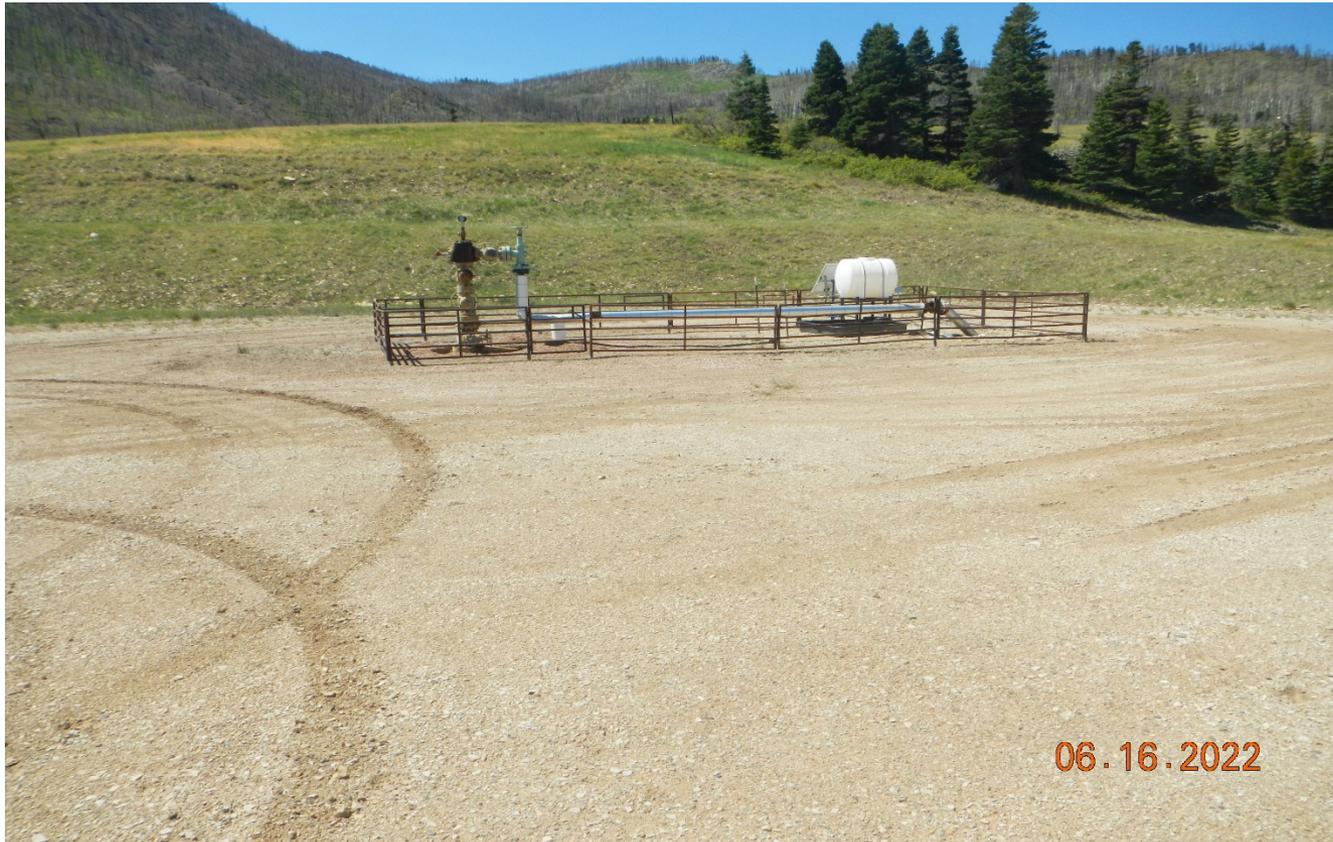
Photo 3. Facing toward the wellsite.

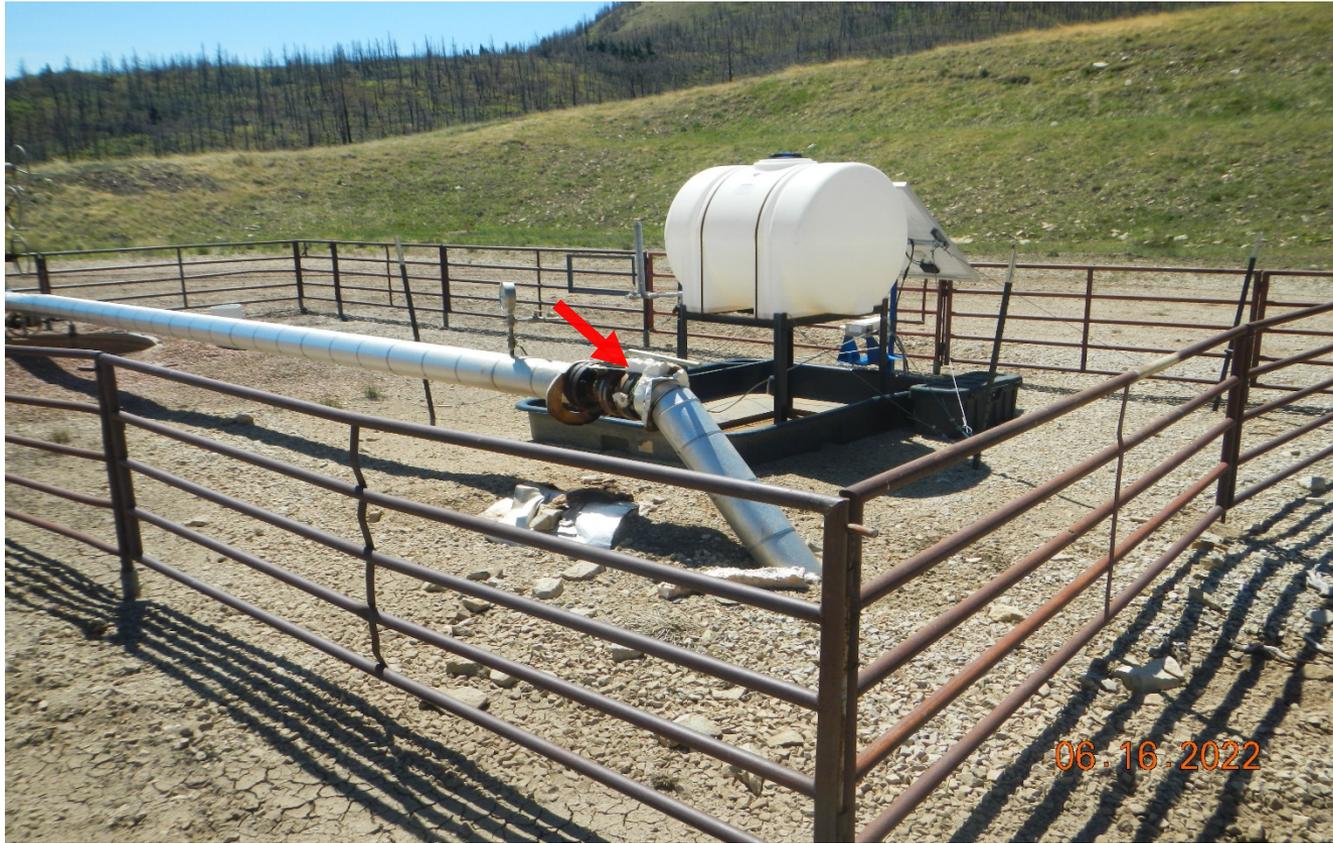
Photo 4. There was an audible gas leak. Gas monitor also detected a leak. Operator was notified by phone call of this issues.

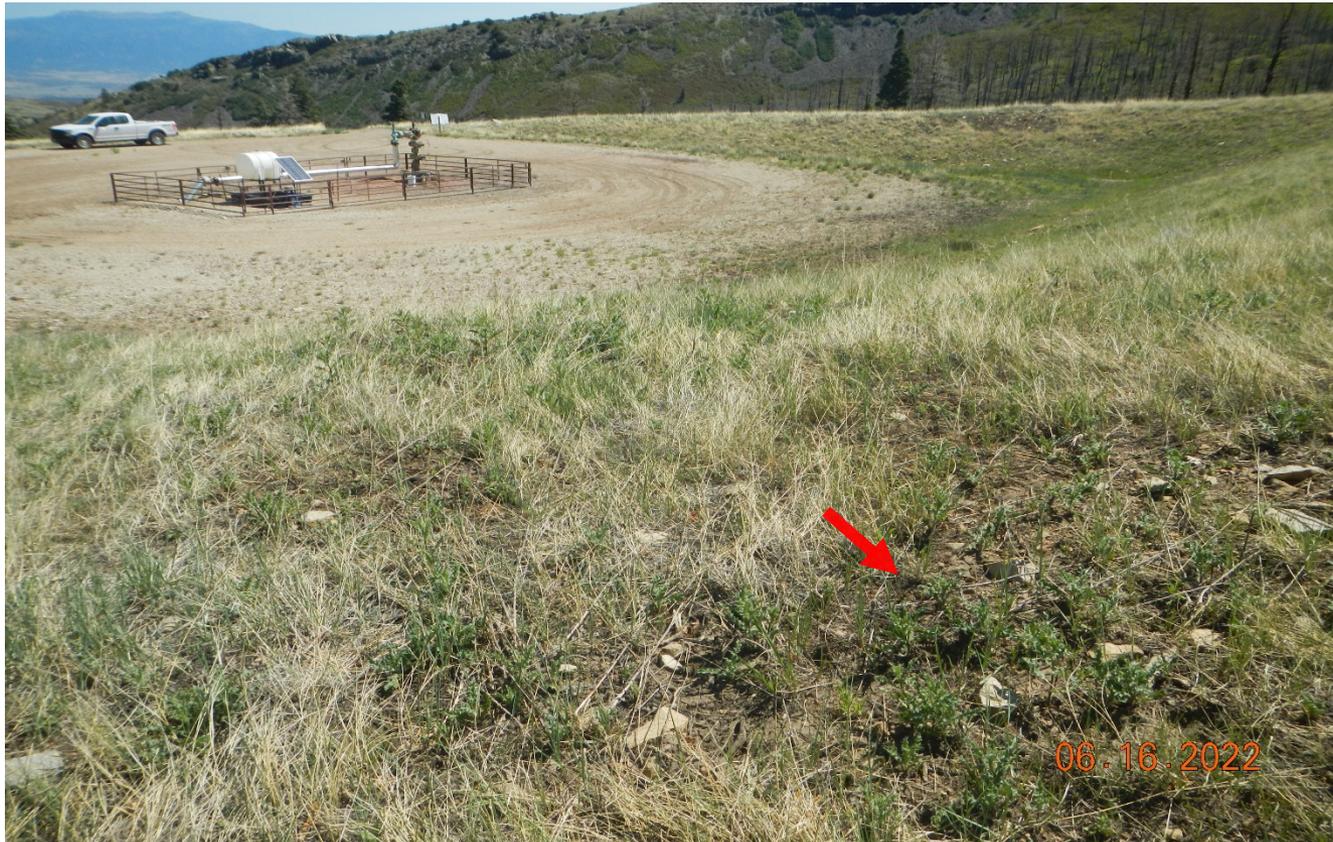
Photo 5. There are noxious weeds at the southwest corner of the location.
Red arrow → Canada thistle
