Inspection Photos

Operator: TEP Rocky Mountain- #96850

Location Name: Savage-66S94W /35SWSW

Inspection Document #: 702800377

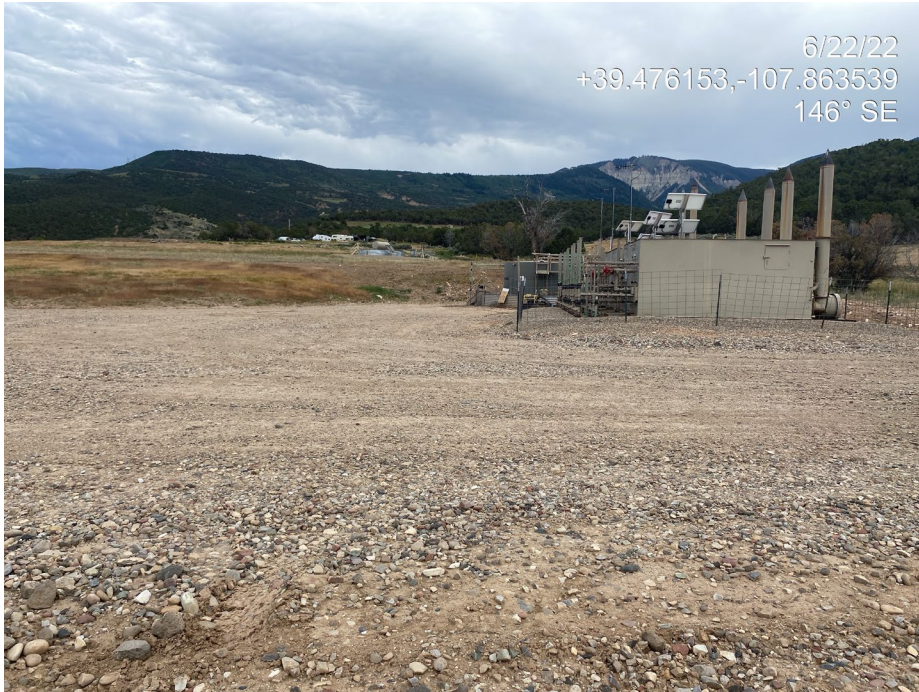
Photo 1. Photo taken from the west of the Location shows an overview of the western production area.

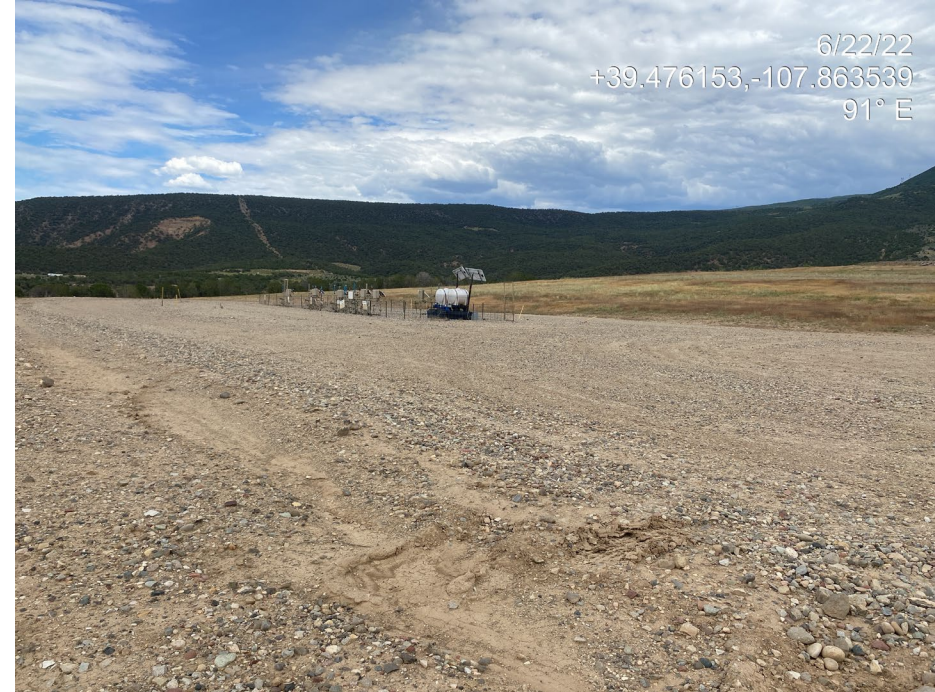
Photo 2. Photo taken from the west of the Location shows an overview of the eastern production area.

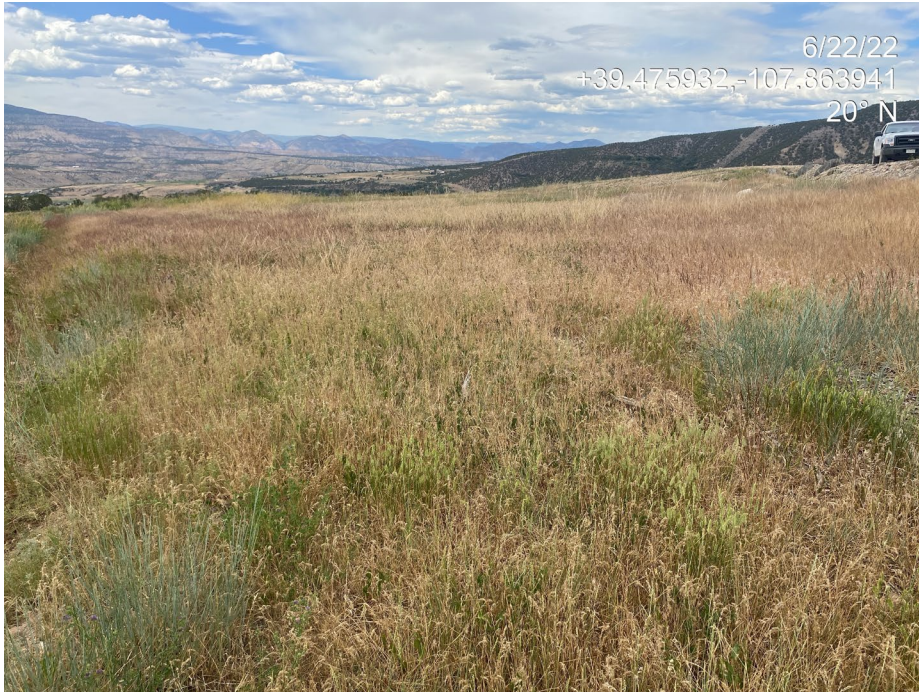
Photo 3. Photo taken from the northwestern interim area of the Location shows a dense patch of bulbous bluegrass (List C Noxious).

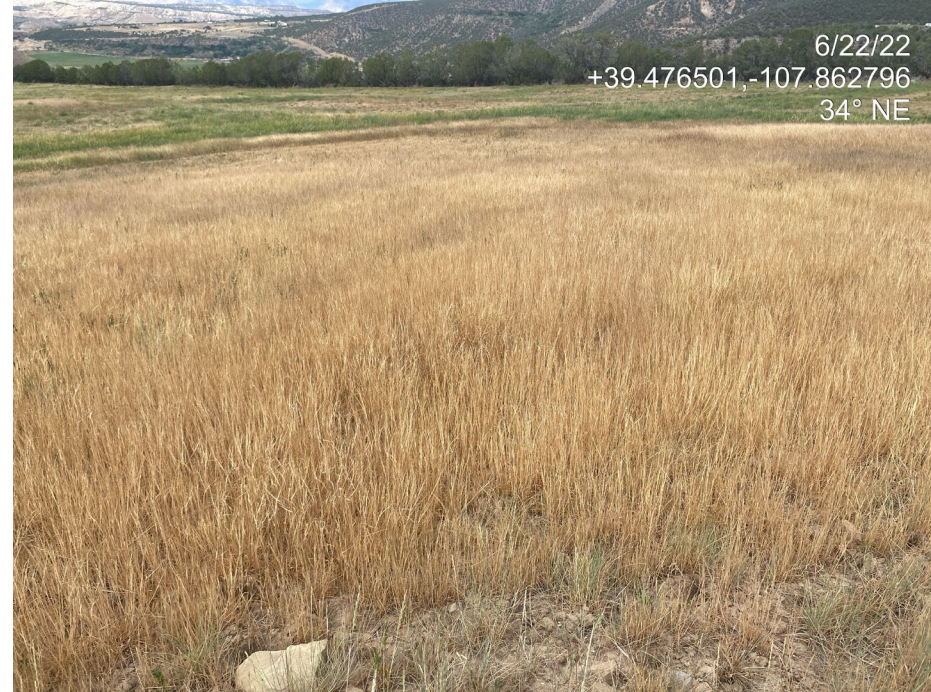
Photo 4. Photo taken from the northern interim area of the Location shows a dense patch of jointed goatgrass (List B Noxious)

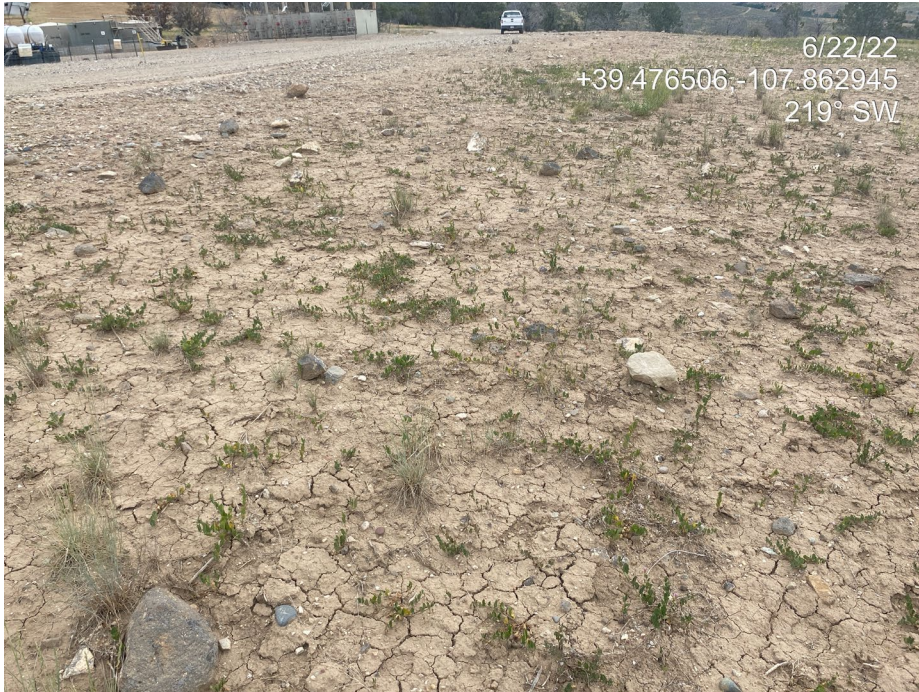
Photo 5. Photo taken from the northern interim area of the Location, directly adjacent to the working pad area shows where revegetation has completely failed. Vegetation in the photo is field bindweed (List C Noxious).

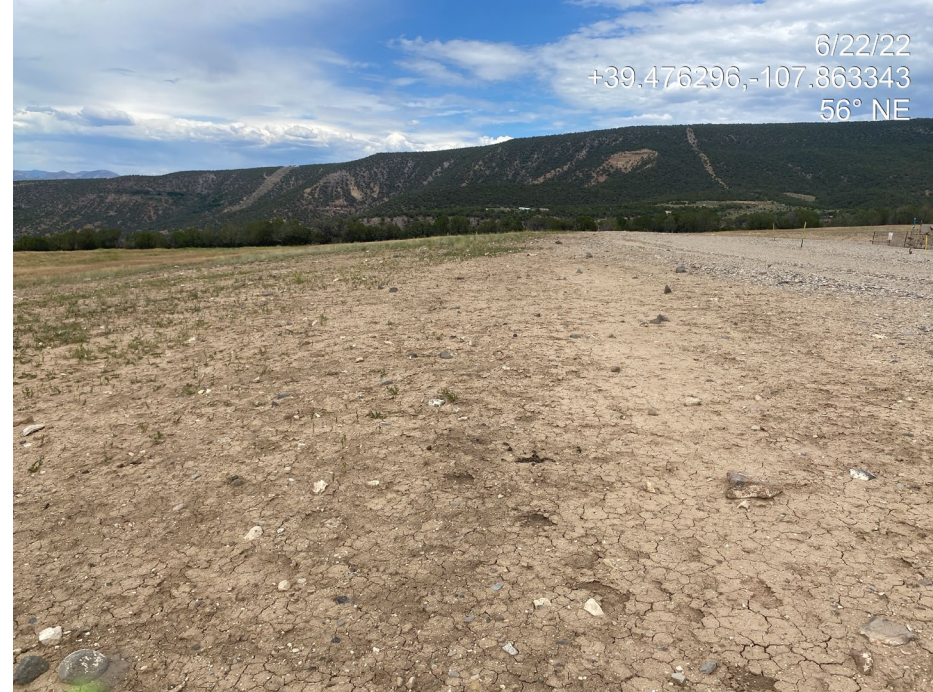
Photo 6. Photo taken from the northern interim area of the Location, directly adjacent to the working pad area shows where revegetation has completely failed.

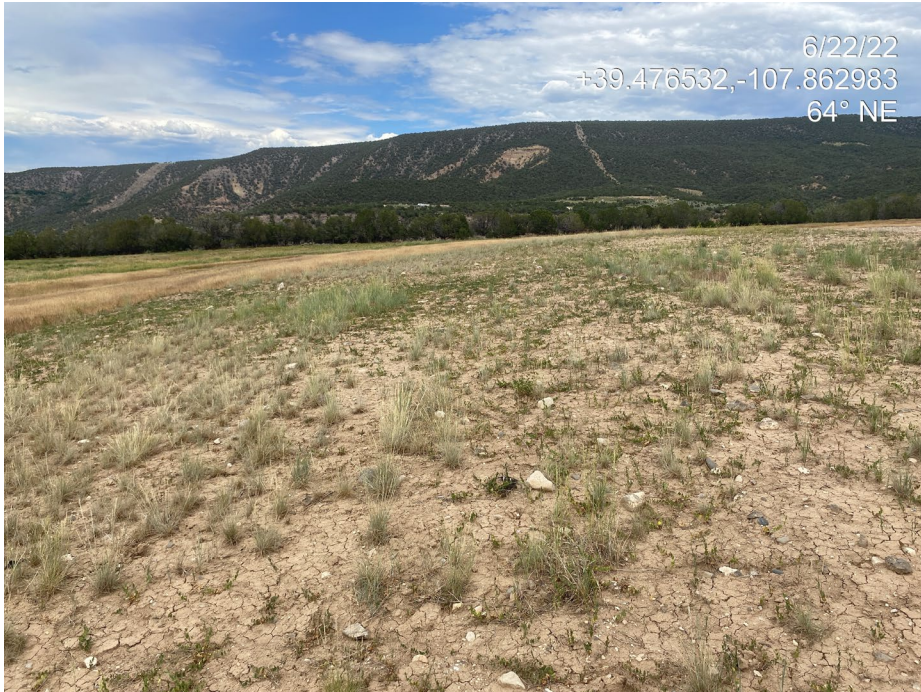
Photo 7. Photo taken from the northern interim area of the Location shows sporadic cover of seeded native perennial grasses.

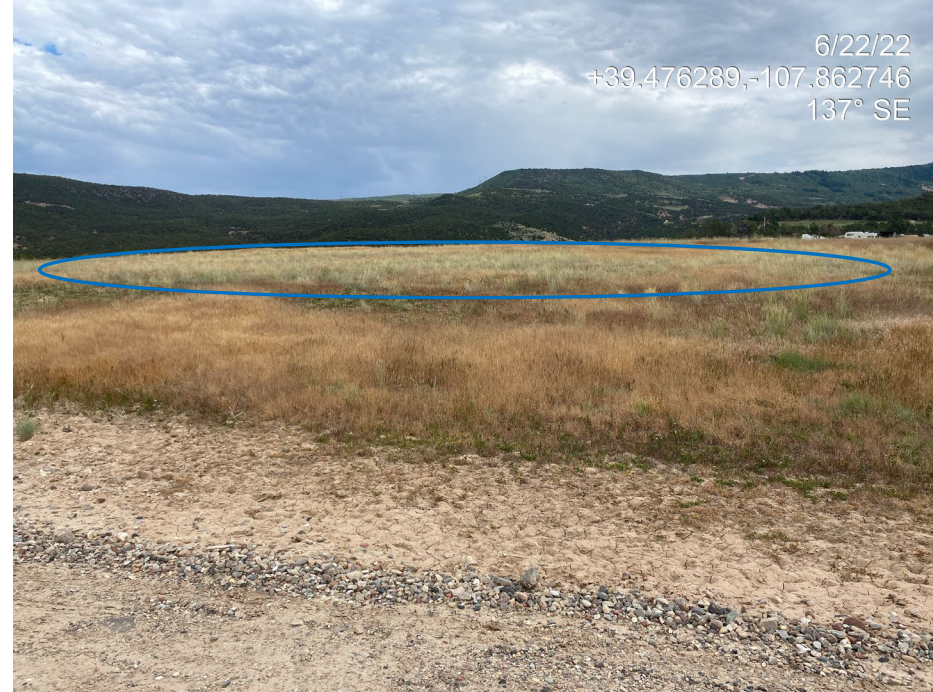
Photo 8. Photo taken from the south of the Location shows an area where seeding of native perennial grasses has been somewhat successful (blue circle), and a dense patch of jointed goatgrass, where seeding has failed.

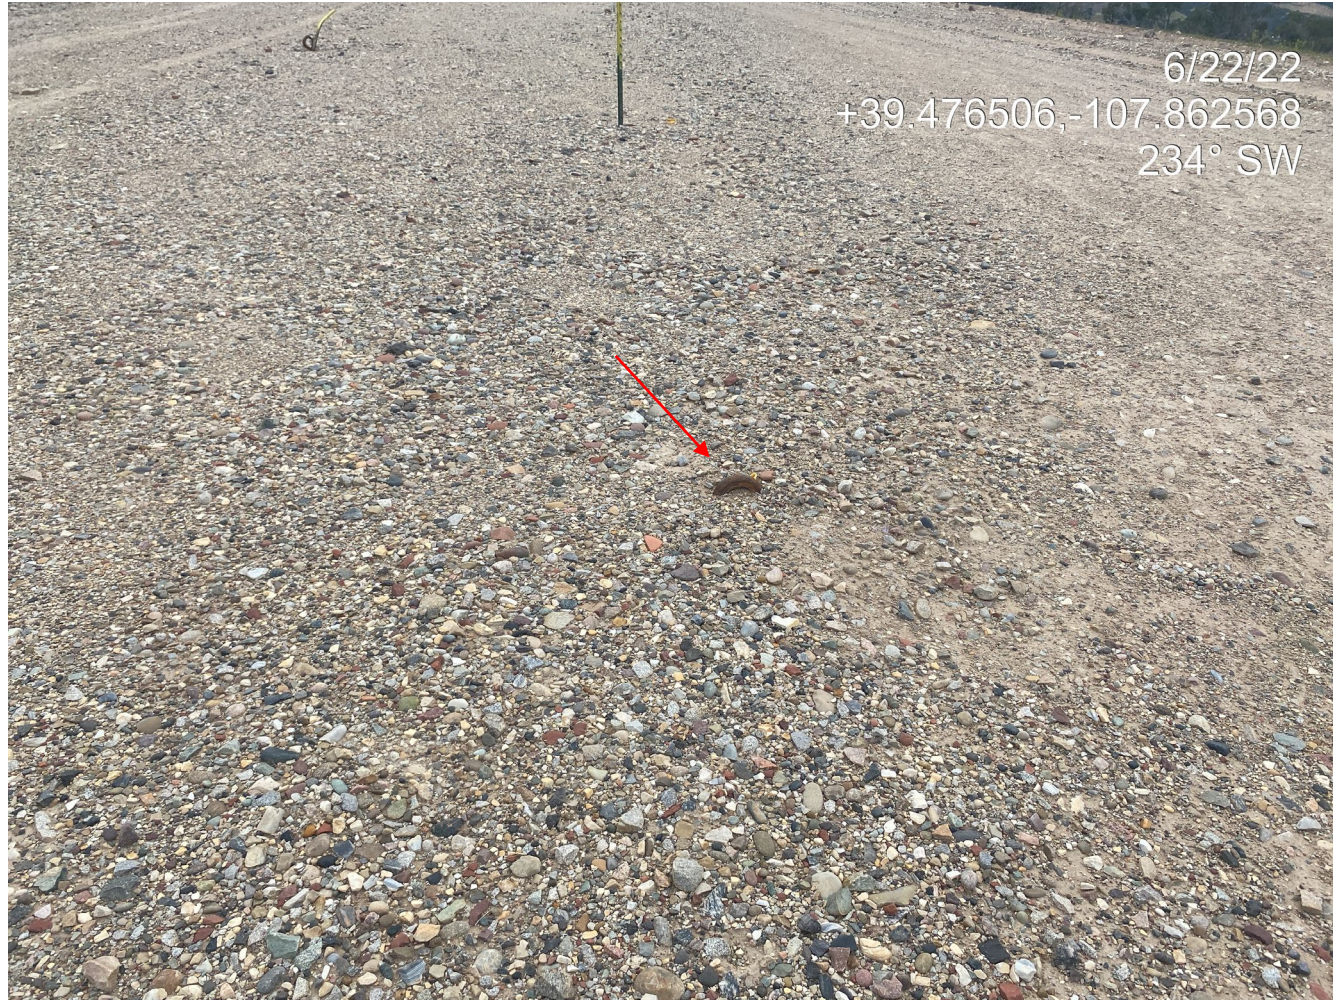
Photo 9. Photo taken from the northern production area shows an unmarked guy line anchor.

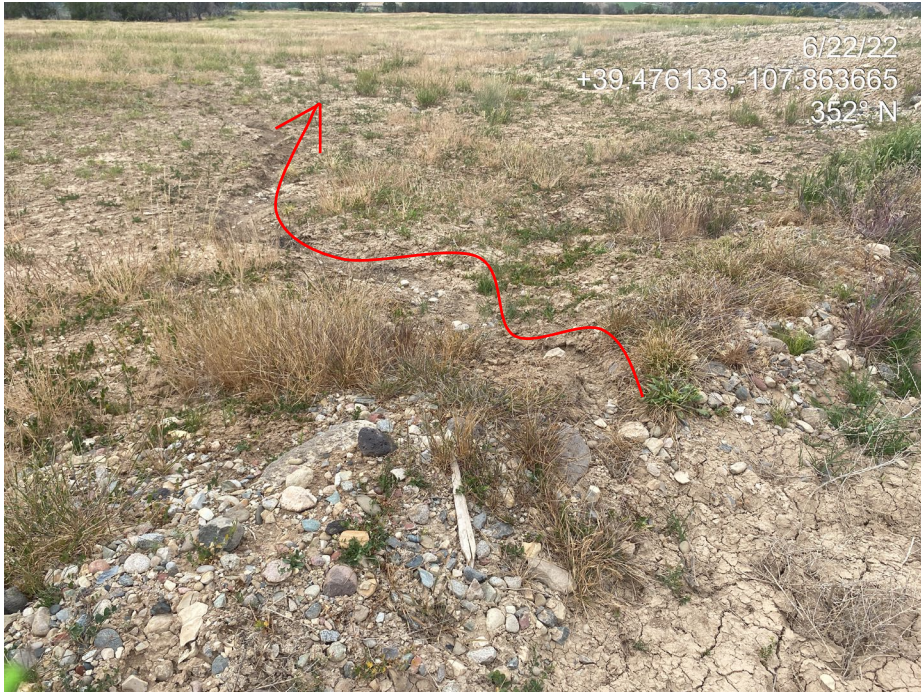
Photo 10. Photo taken from the west of the Location shows where stormwater has broken through a stormwater diversion ditch and is degrading adjacent interim areas.

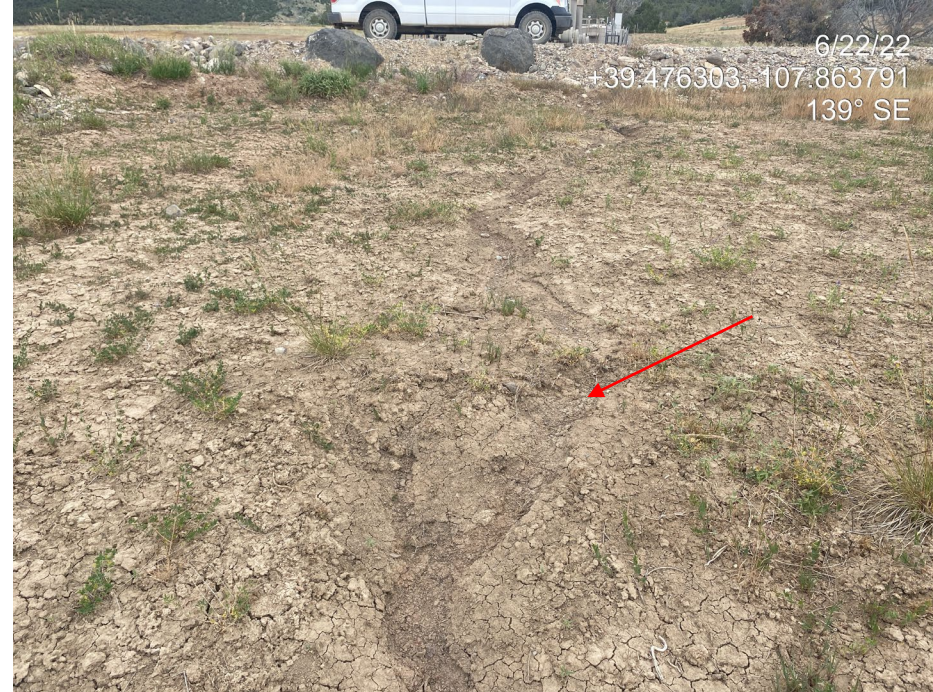
Photo 11. Refer to Photo 10 comment.
