Inspection Photos

Operator: Foundation Energy Management LLC - #10112
Quicksilver Resources Inc. - #10255

Location Name: Donald-67N93W /11NWNE

Inspection Document #: 702800366

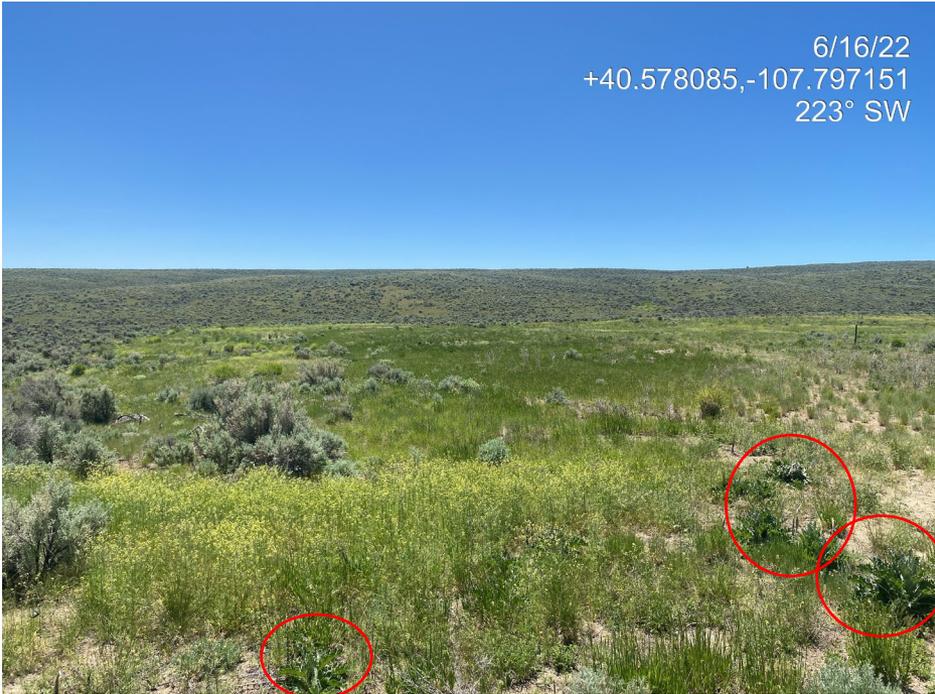
Photo 1. Photo taken from the east, at the Location entrance shows an overview of the southern portion of the Location. Photo also shows Scotch thistle, a List B Noxious Weed.

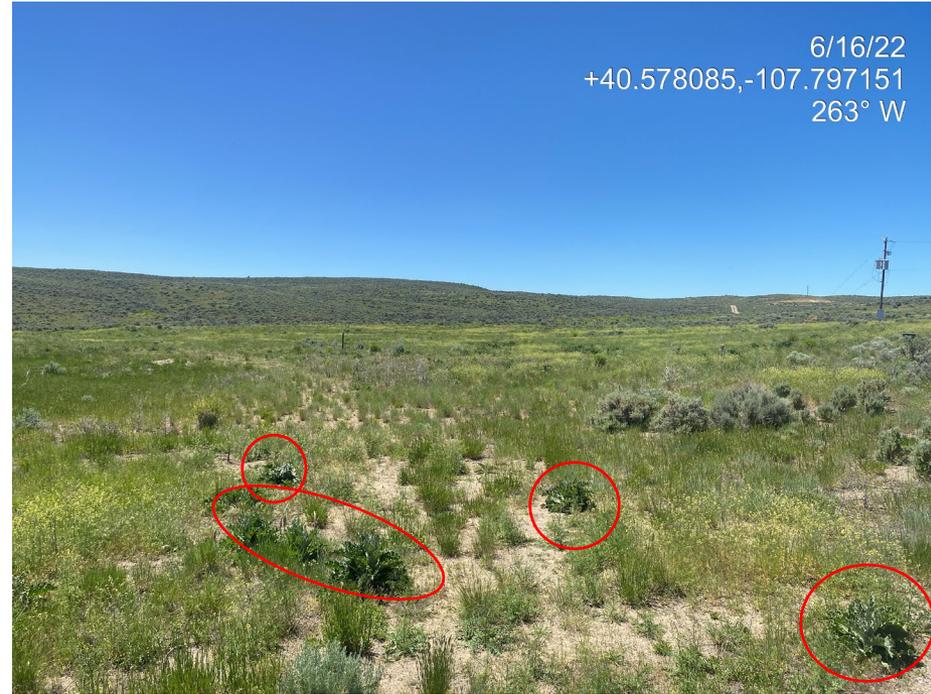
Photo 2. Photo taken from the east, at the Location entrance shows an overview of the northern portion of the Location. Photo also shows Scotch thistle, a List B Noxious Weed.

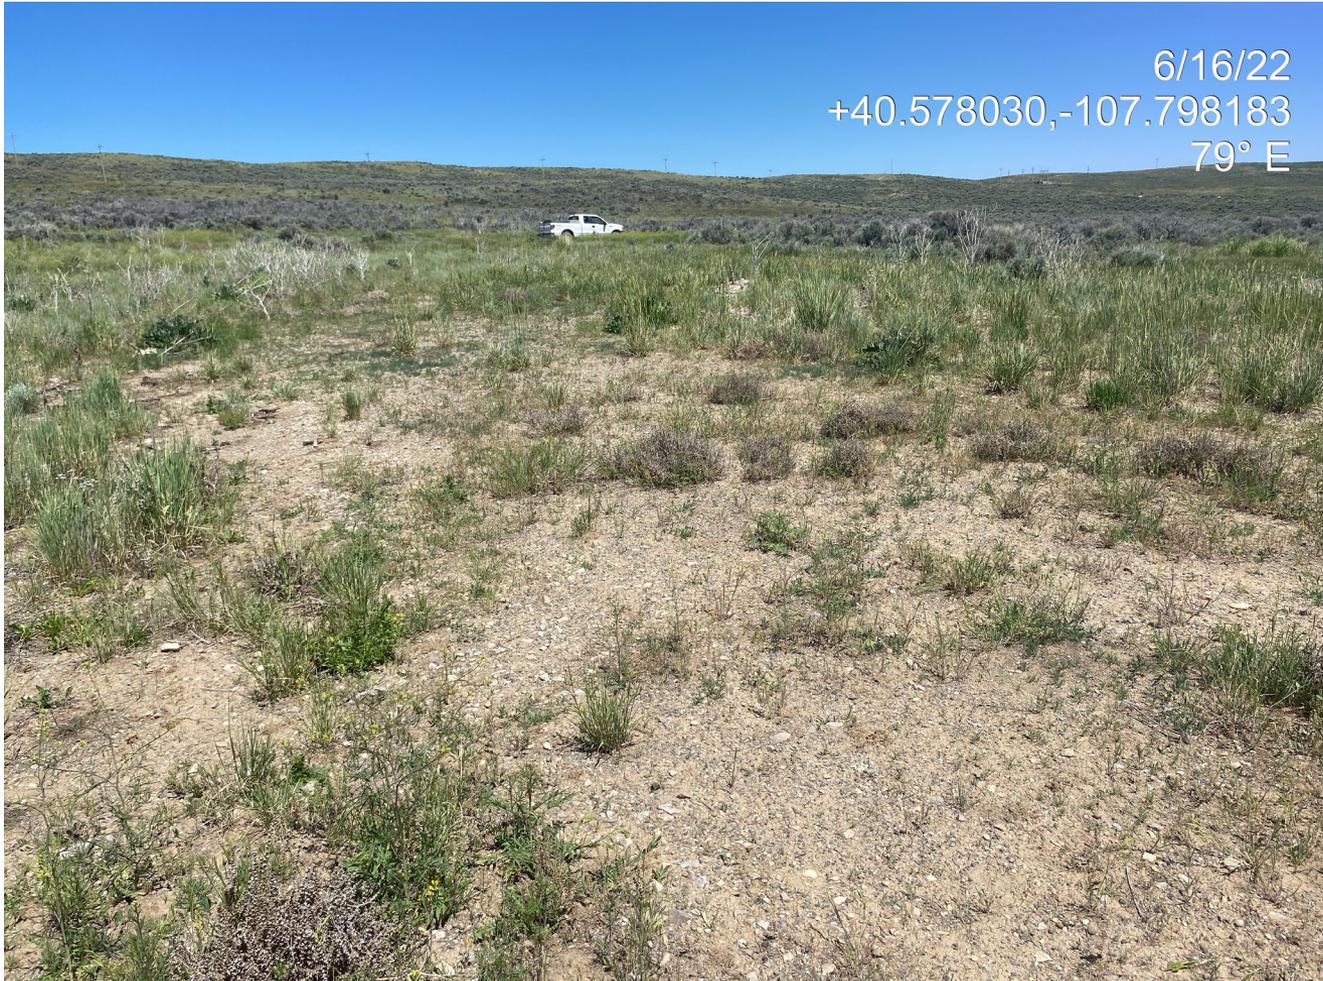
Photo 3. Photo taken from the east of the Location shows areas of the Location which do not appear to have been decompacted, and gravel from the pad surface remains. Vegetation establishment is sparse.

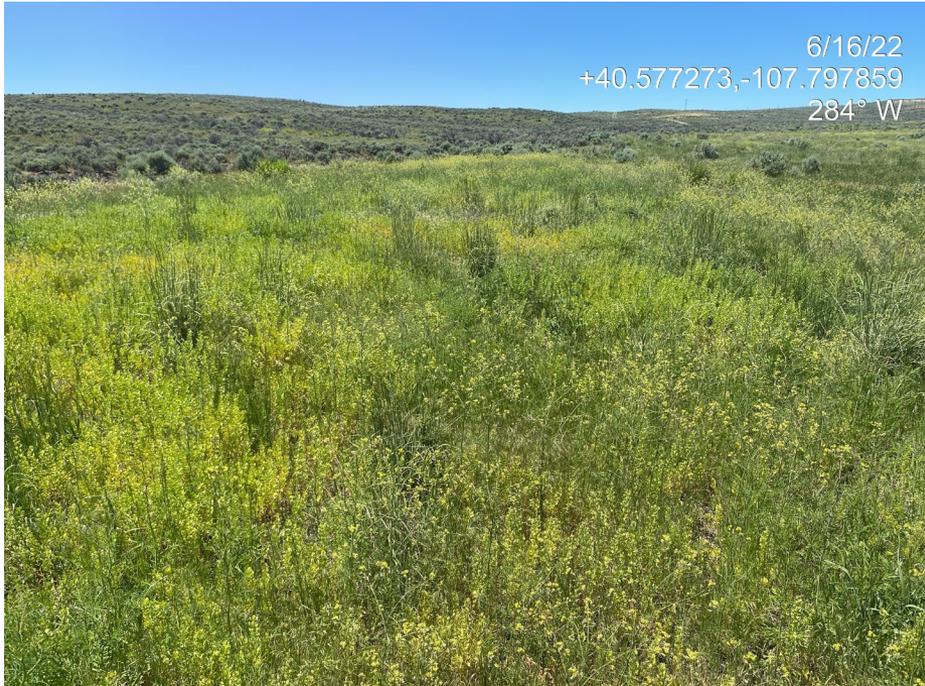
Photo 4. Photo taken from the south of the Location shows an area where perennial plant establishment has failed and the vegetation community is dominated by undesirable plant species/annual weeds.

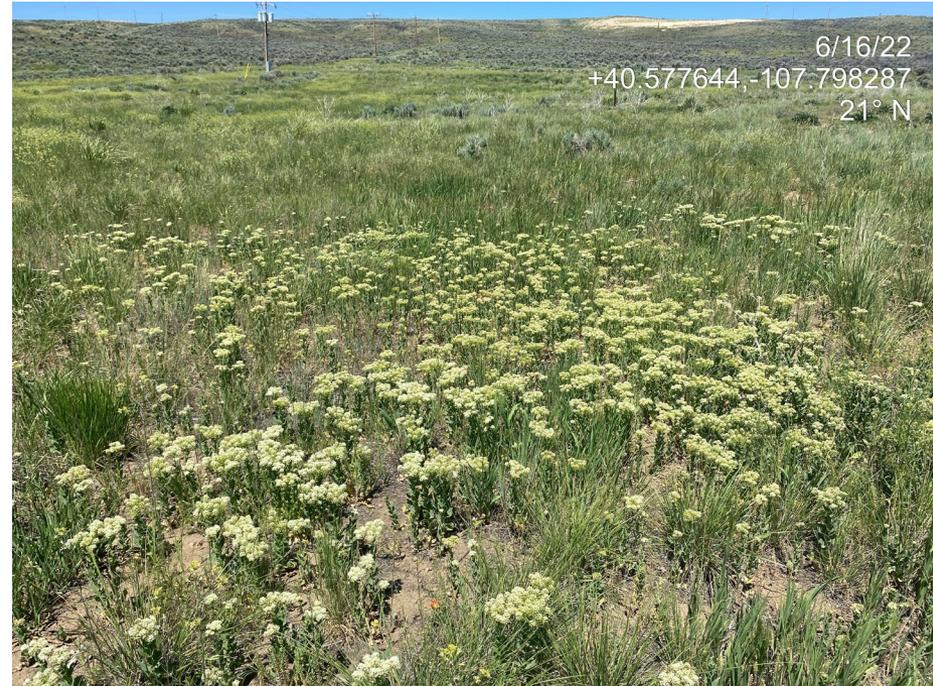
Photo 5. Photo taken from the southwest of the Location shows whitetop, a CO List B Noxious Weed.

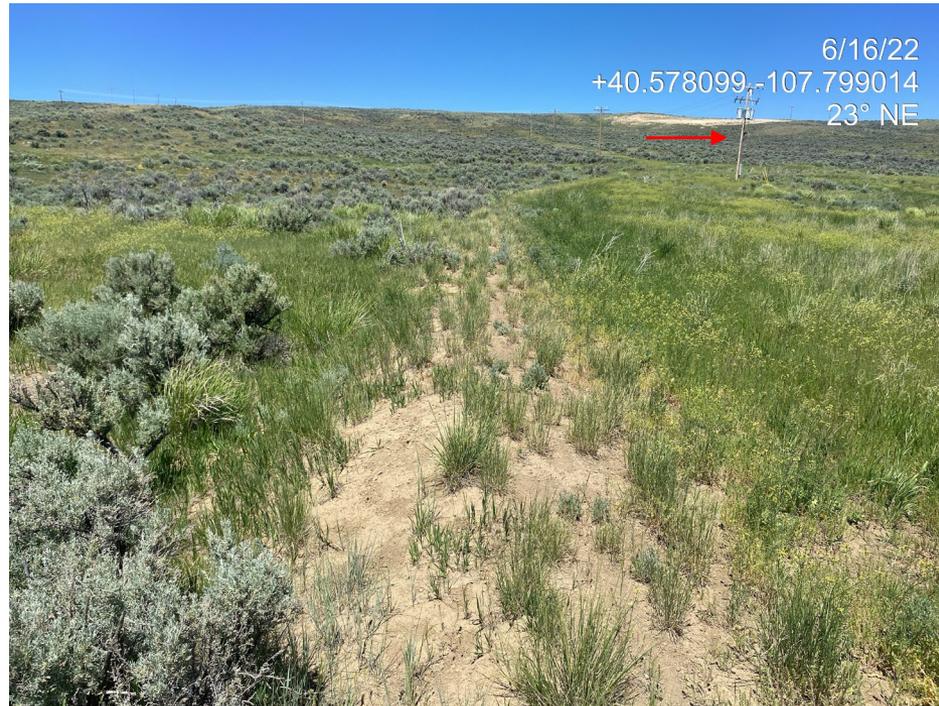
Photo 6. Photo taken from the west of the Location shows the Location has not been recontoured; the Location perimeter berm remains. Note also the power line (red arrow) associated with the Location which must be removed per Rule 1004.a.

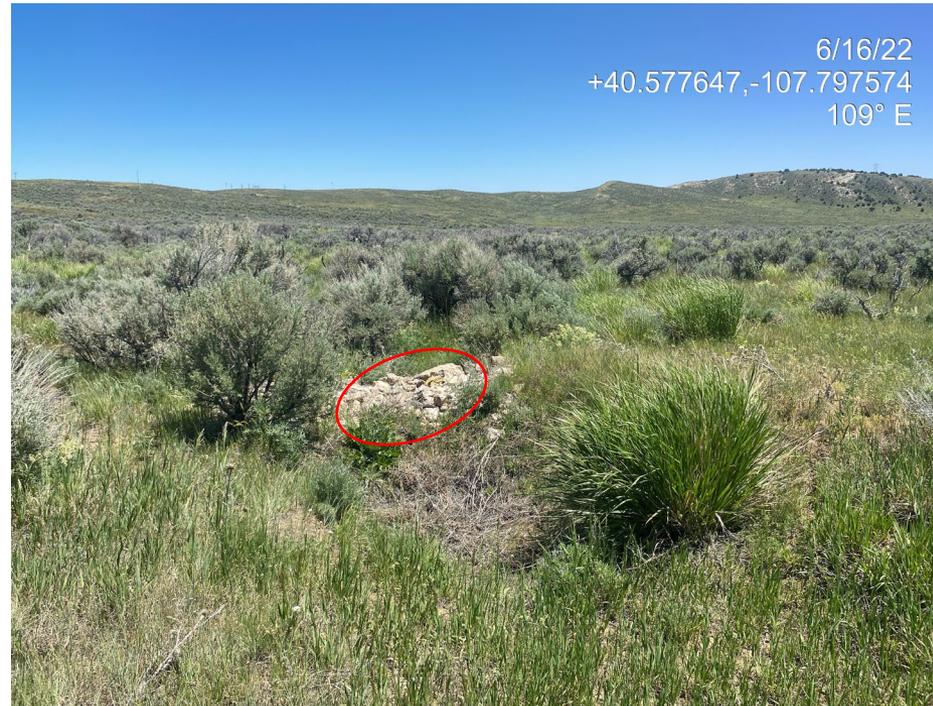
Photo 7. Photo taken from the east of the Location shows a rip-rap lined stormwater outlet with a ditch and berm which must be removed and recontoured per Rule 1004.a.

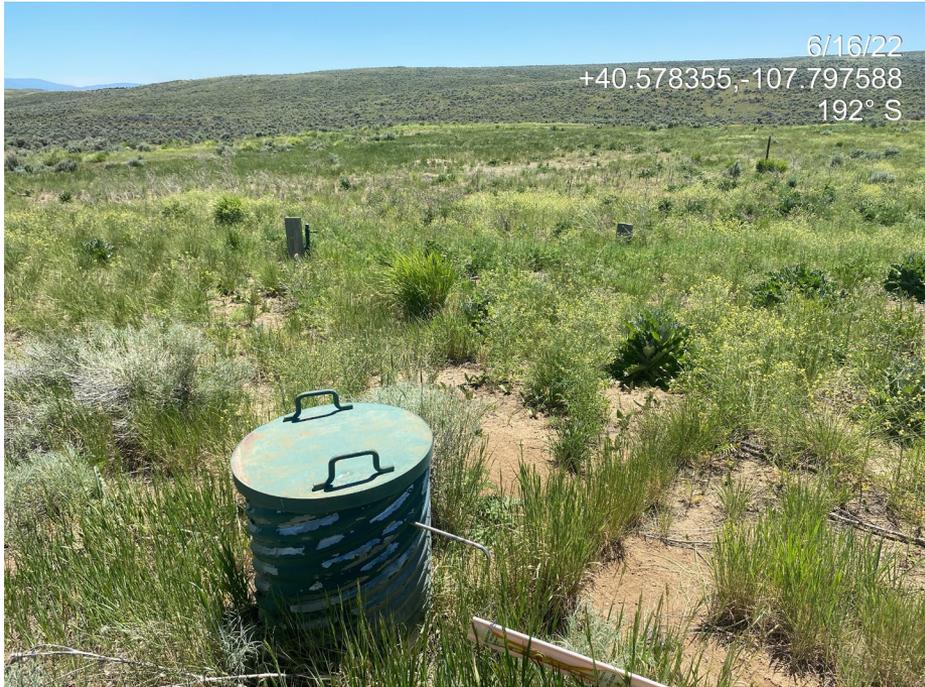
Photo 8. Photo taken from the northeast of the Location shows equipment which must be removed per Rule 1004.a.

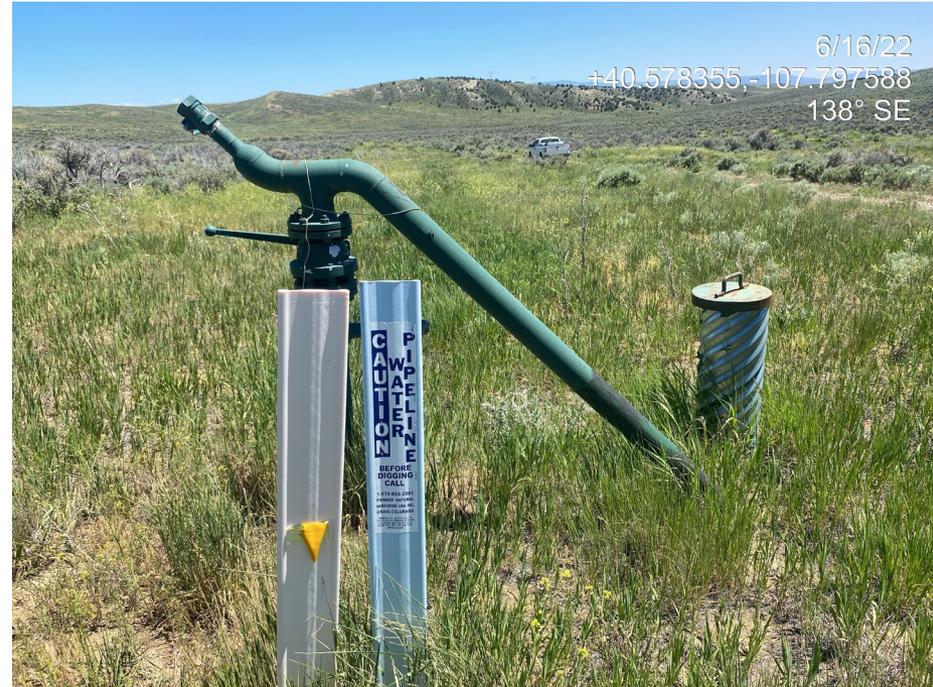
Photo 9. Photo taken from the northeast of the Location shows off-Location equipment associated with the Location which must be removed per Rule 1004.a.

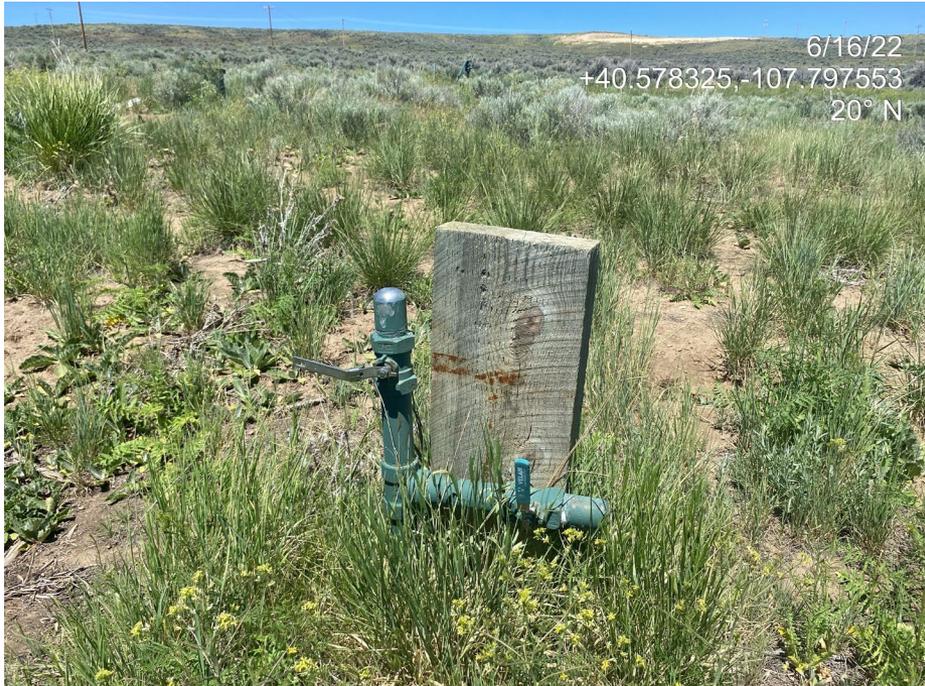
Photo 10. Photo taken from the northeast of the Location shows equipment which must be removed per Rule 1004.a.

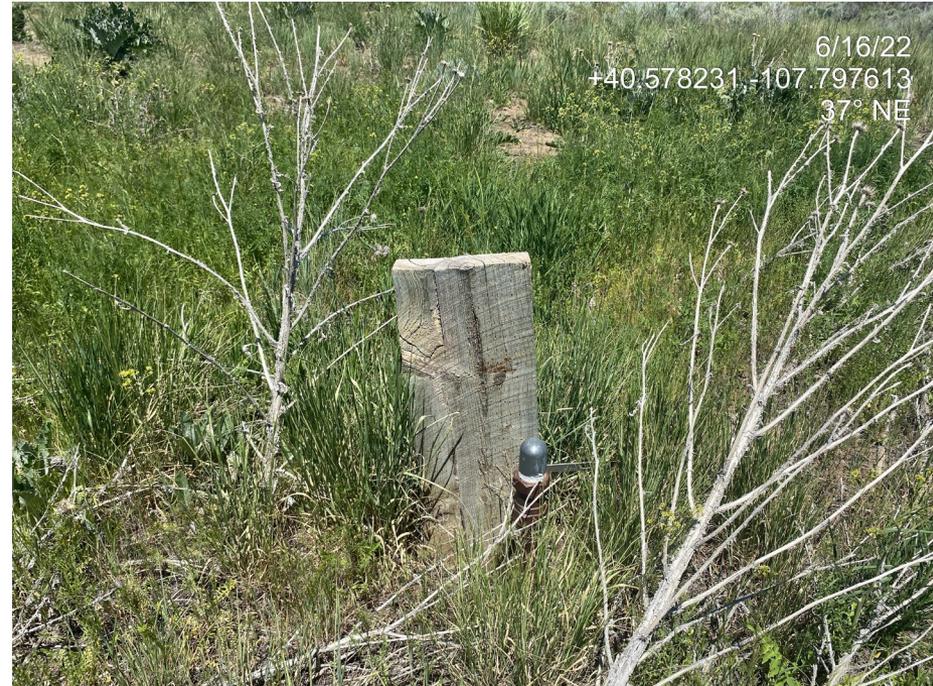
Photo 11. Refer to Photo 10 comment.

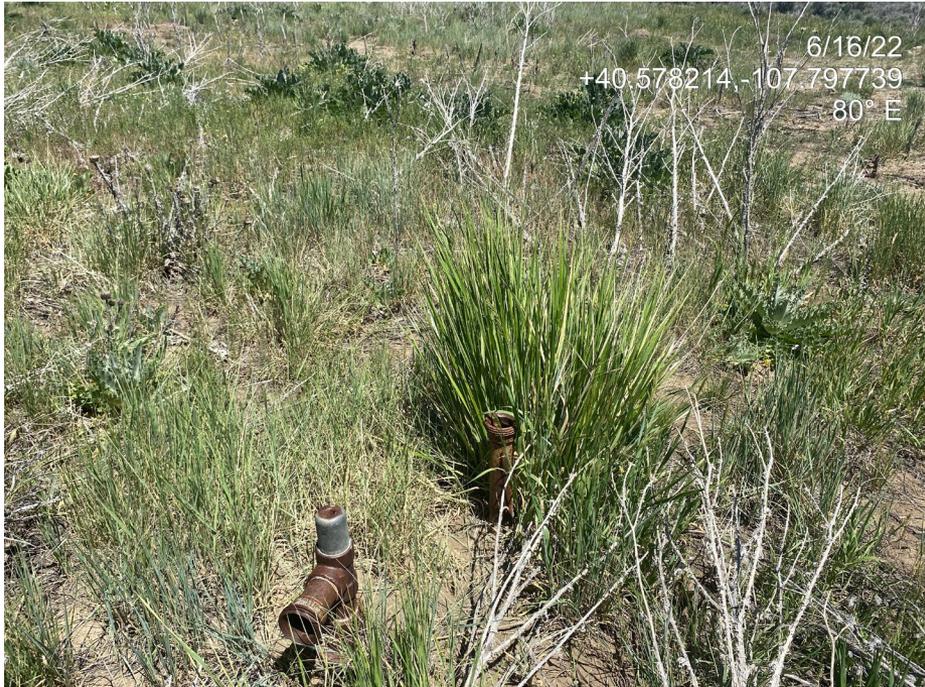
Photo 12. Refer to Photo 10 comment.

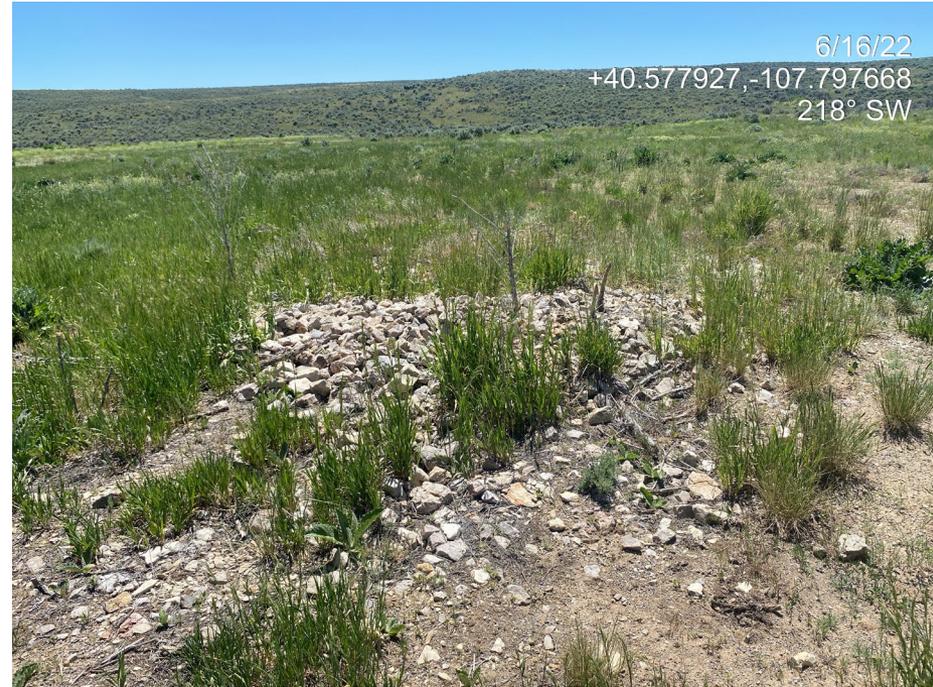
Photo 13. Photo taken from the northeast of the Location shows a pile of rock which must be removed per Rule 1004.a.

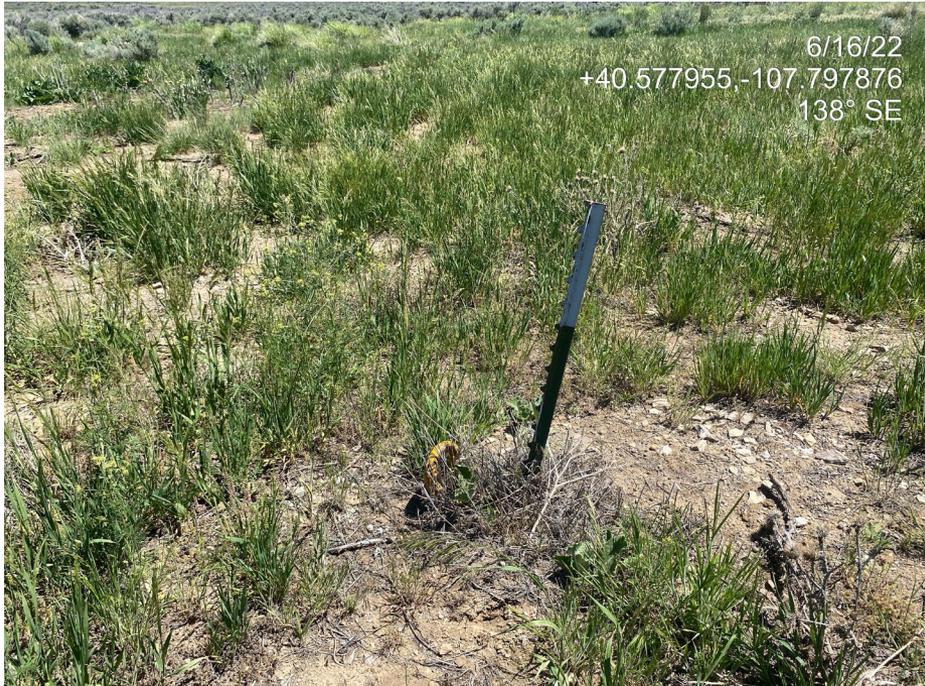
Photo 14. Photo taken from the southeast of the Location shows a guy line anchor which must be removed per Rule 1004.a.

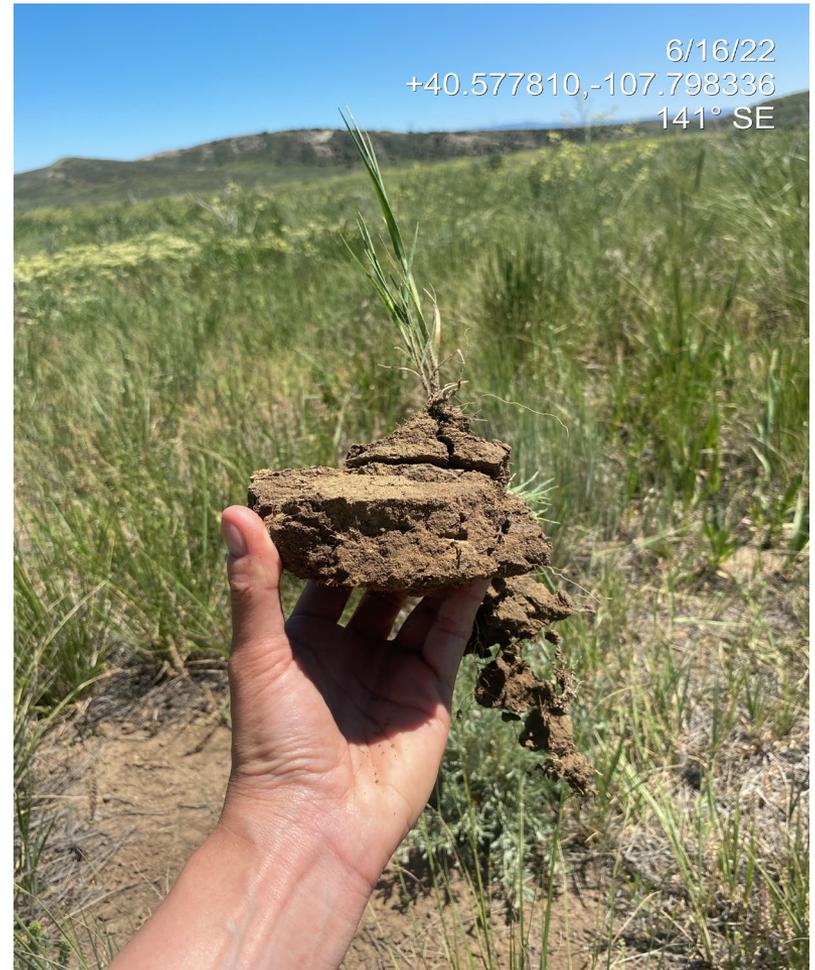
Photo 15. Photo taken from the center of the Location shows a compacted soil layer.

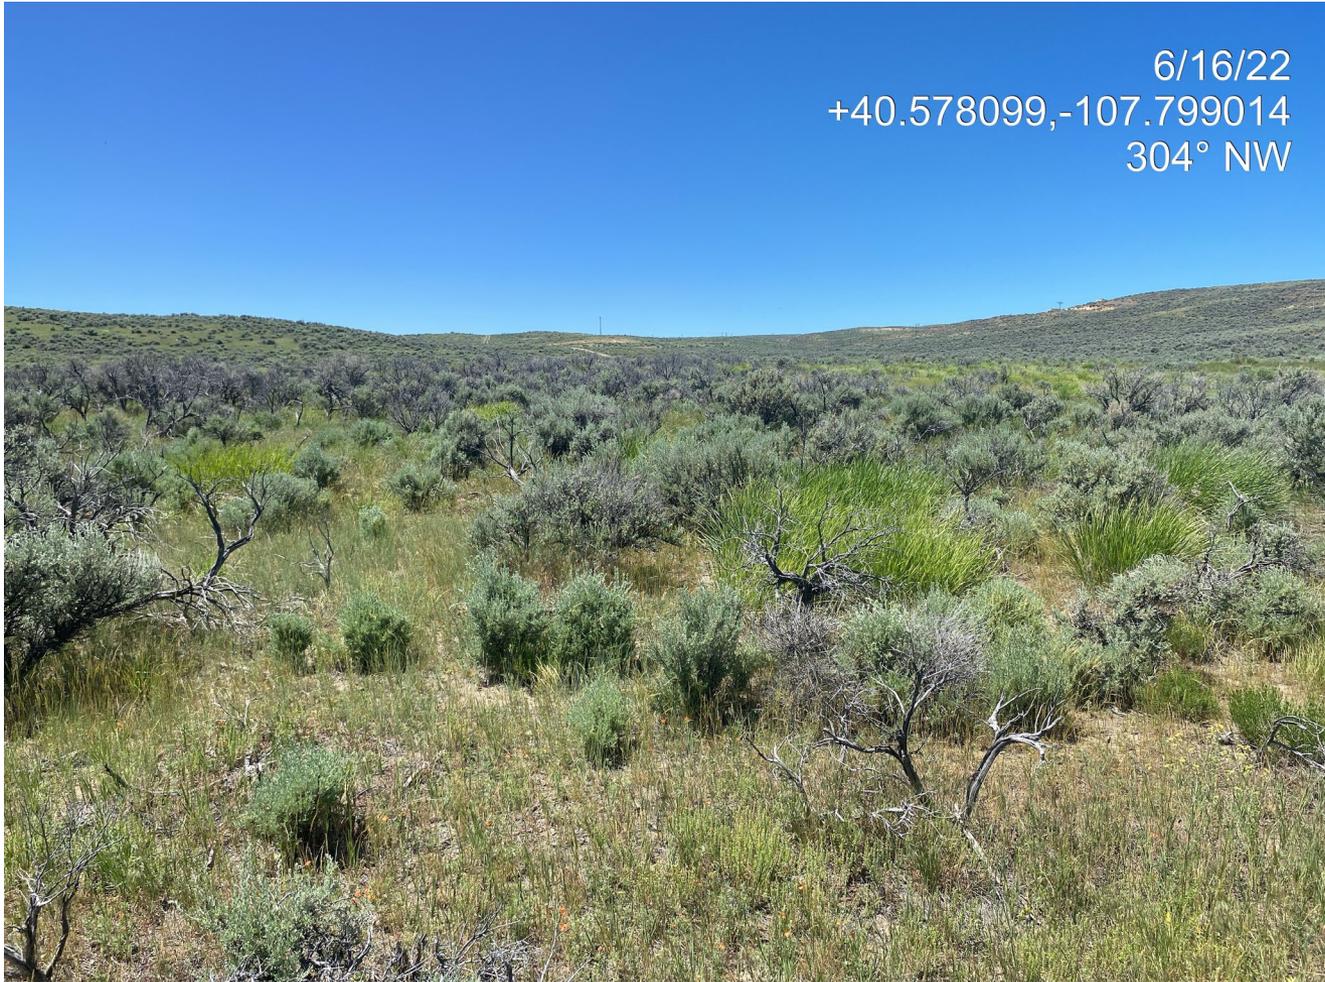
Photo 16. Photo taken from the south of the Location shows reference area vegetation is native rangeland.
