Final Reclamation Inspection

Operator: PDC ENERGY INC - 69175

Location ID: 323096

Inspection Photos
Location Name: Frank 1-21C
Location ID: 323096

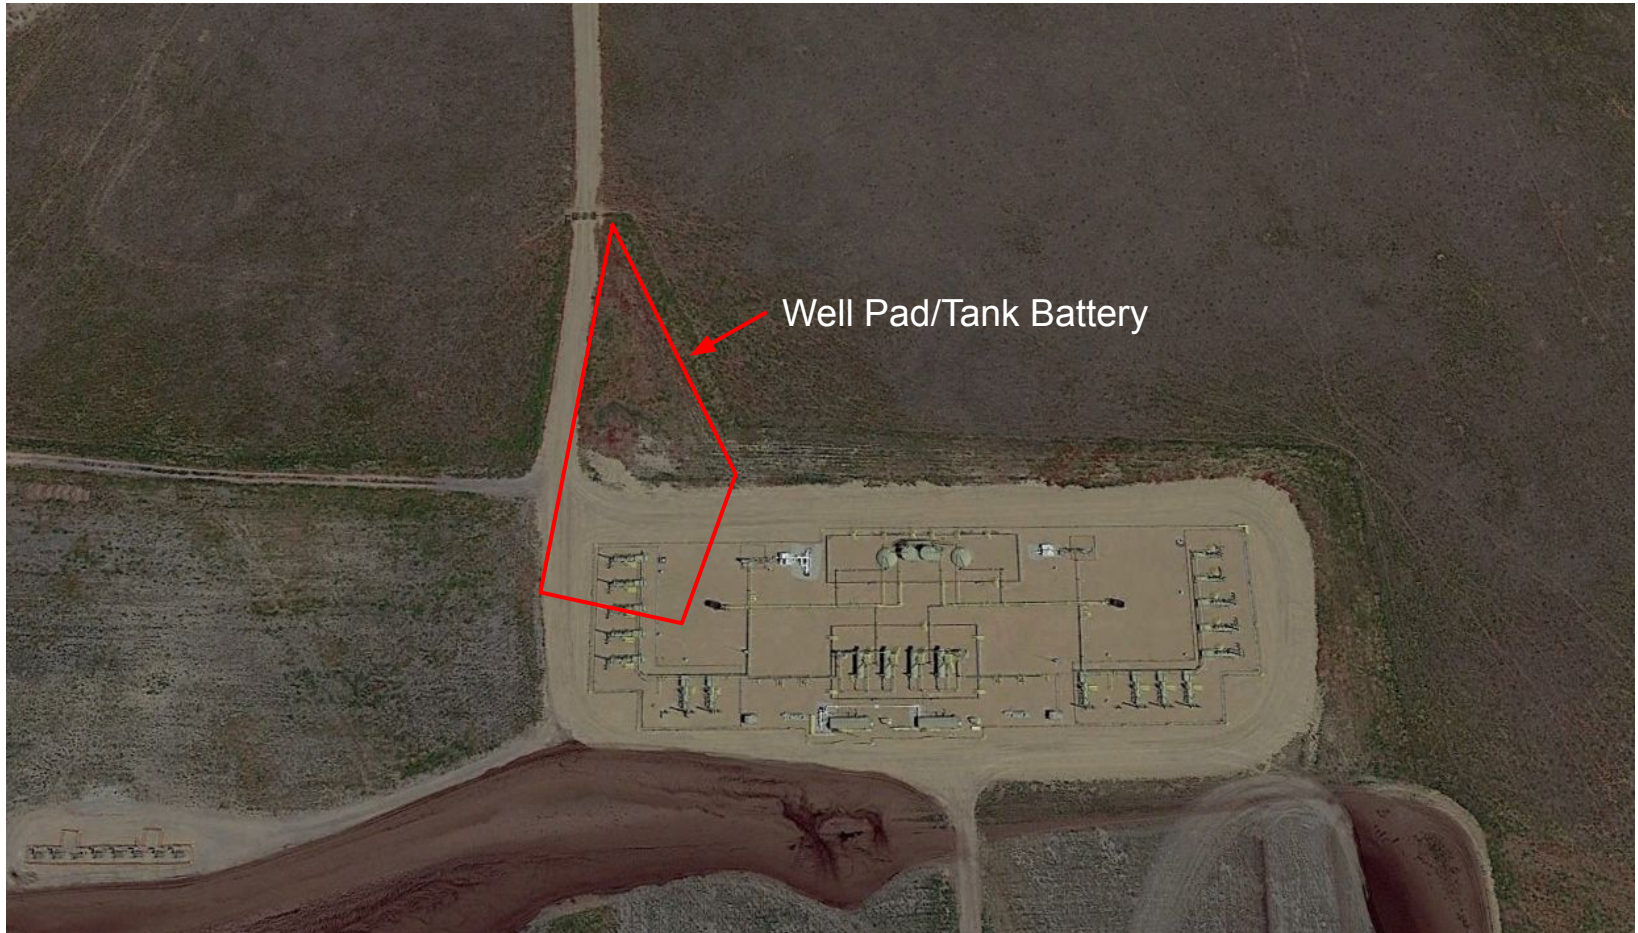
Photo 1. 2021 aerial imagery of the well pad and tank battery. Note: well pad and tank battery shared a disturbance pad. Historical imagery confirms that the tank battery was on the southern end of the disturbance and has been completely absorbed by the new Kerr McGee production facility, location ID 464149.

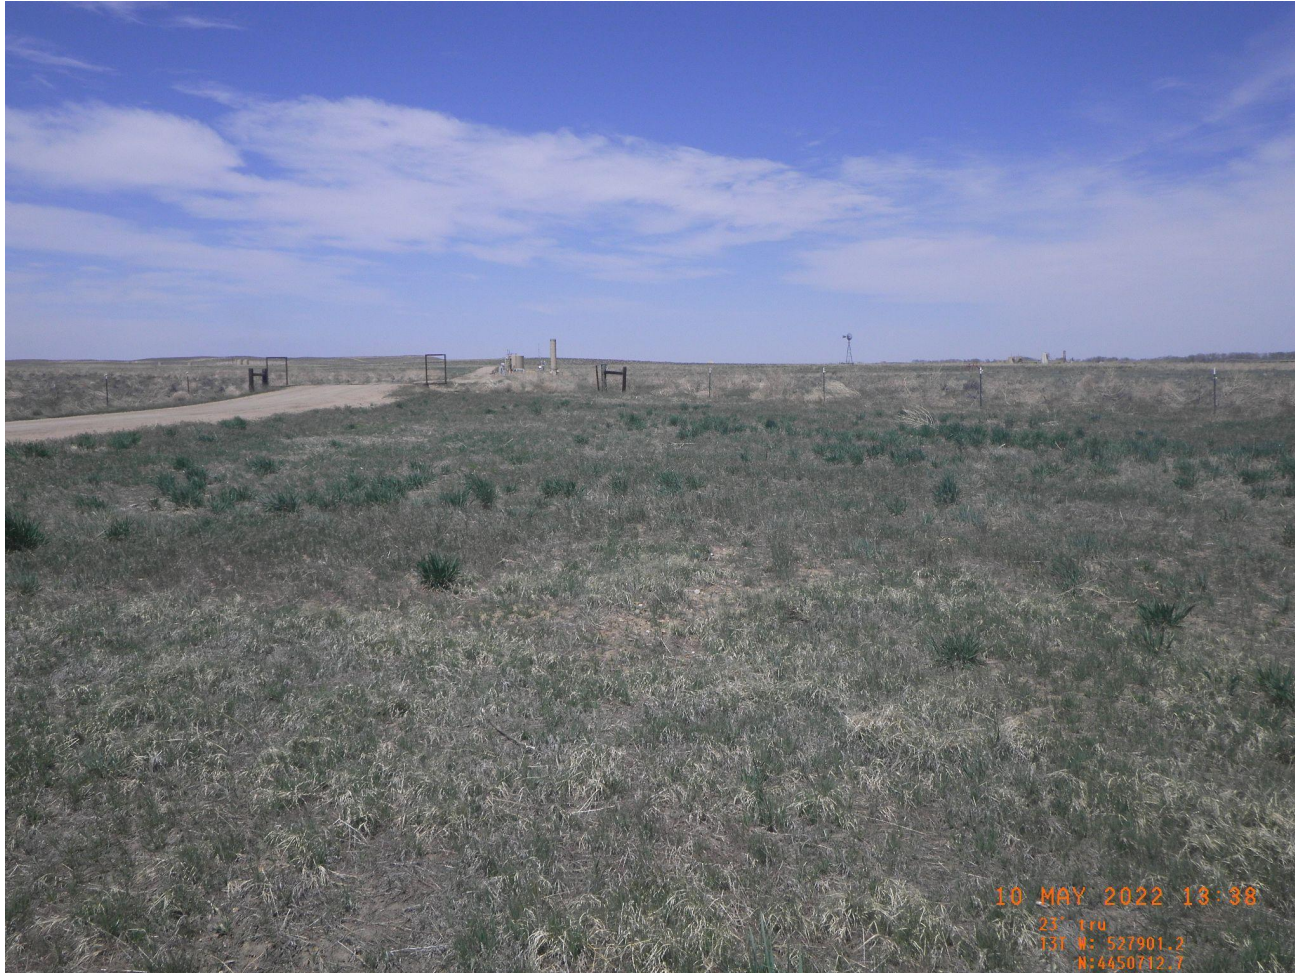
Photo 2. Overview photo of the well pad taken at ground level from the southern edge looking north.

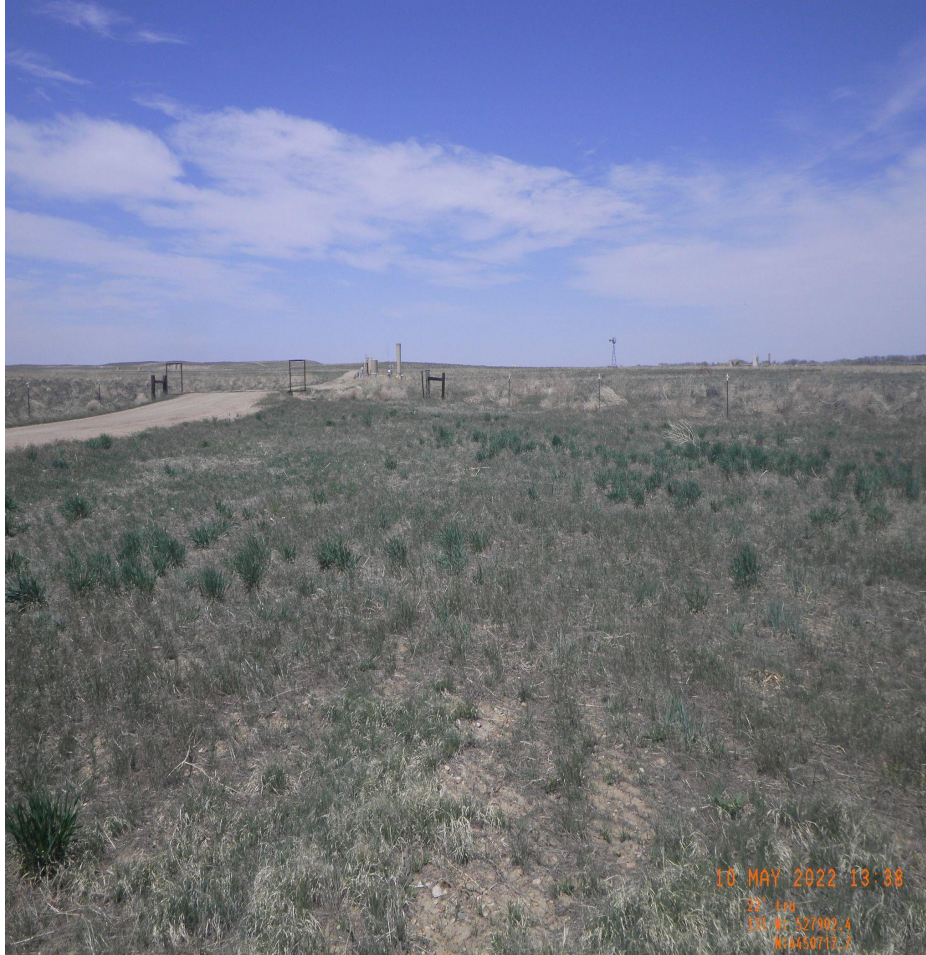
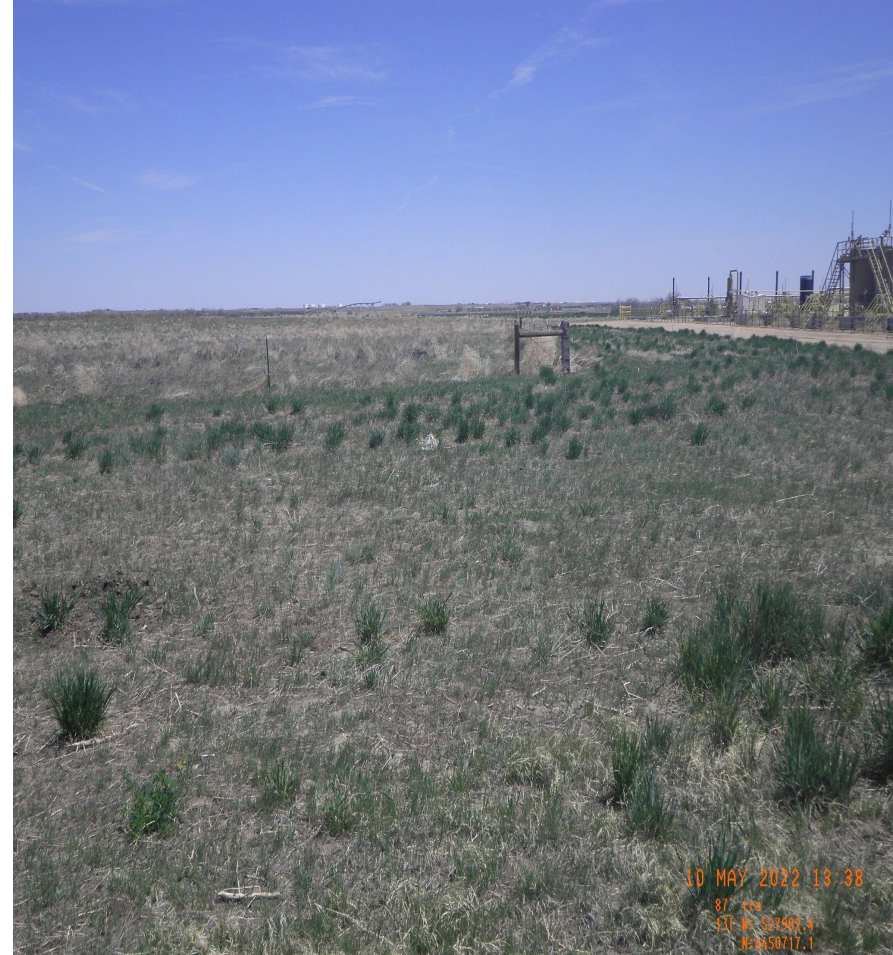
Photo 3. Cardinal overview photos of the well pad. Left photo facing north and right photo facing east.

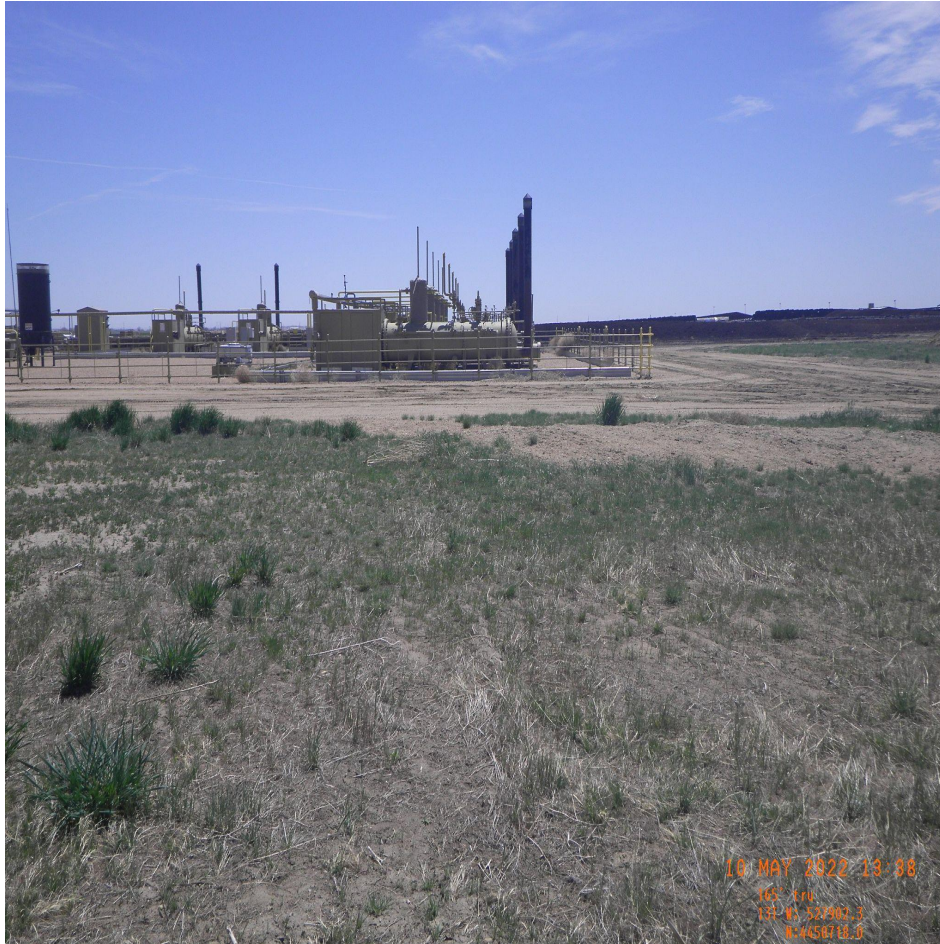
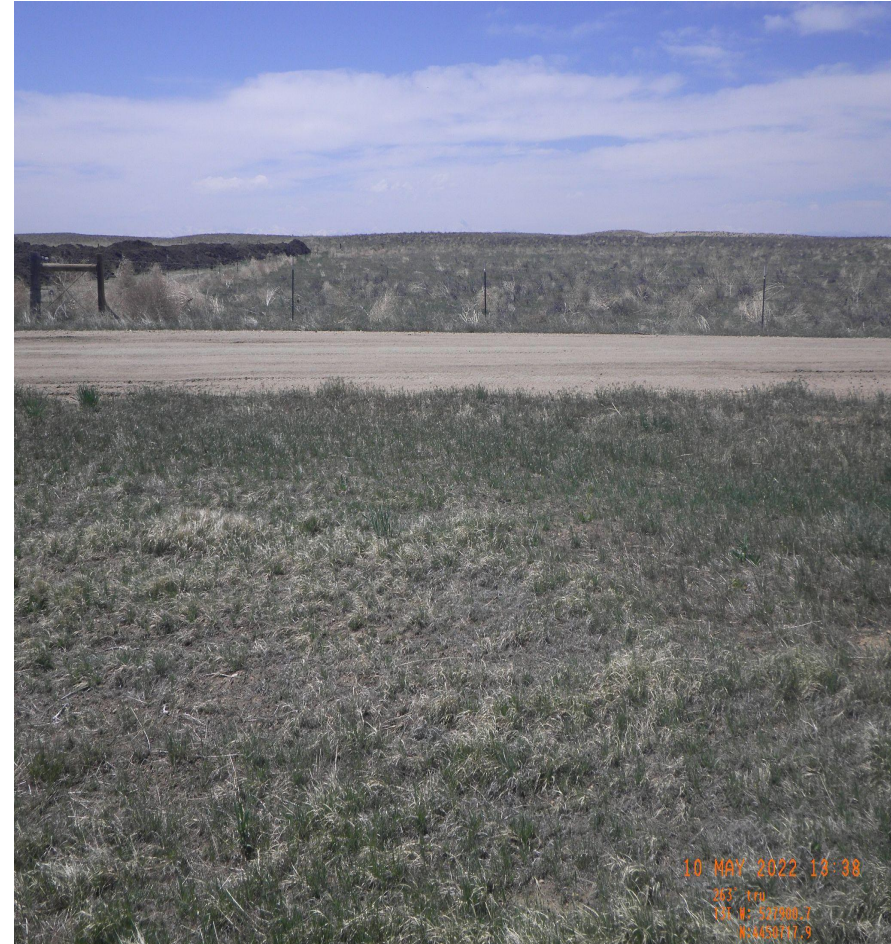
Photo 4. Cardinal overview photos of the well pad. Left photo facing south and right photo facing west. Note: well pad shows minimal perennial plant establishment for stormwater control. Large pile of gravel in southwest corner of well pad. (see photo 5).

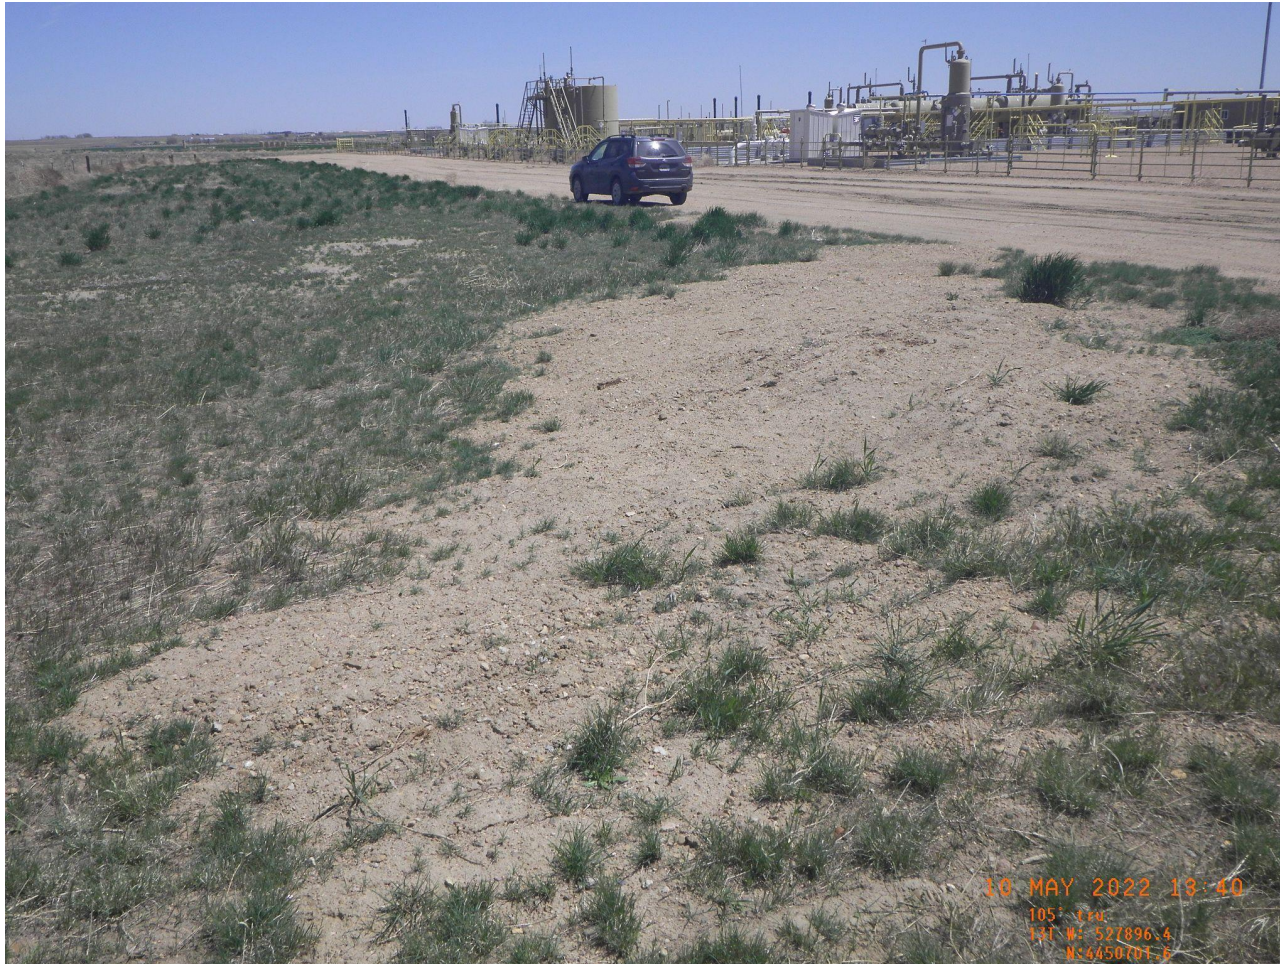
Photo 5. gravel in southwest corner of well pad.
