Final Reclamation Inspection

Operator: PDC ENERGY INC - 69175

Location ID: 322607

Inspection Document #: 701900401

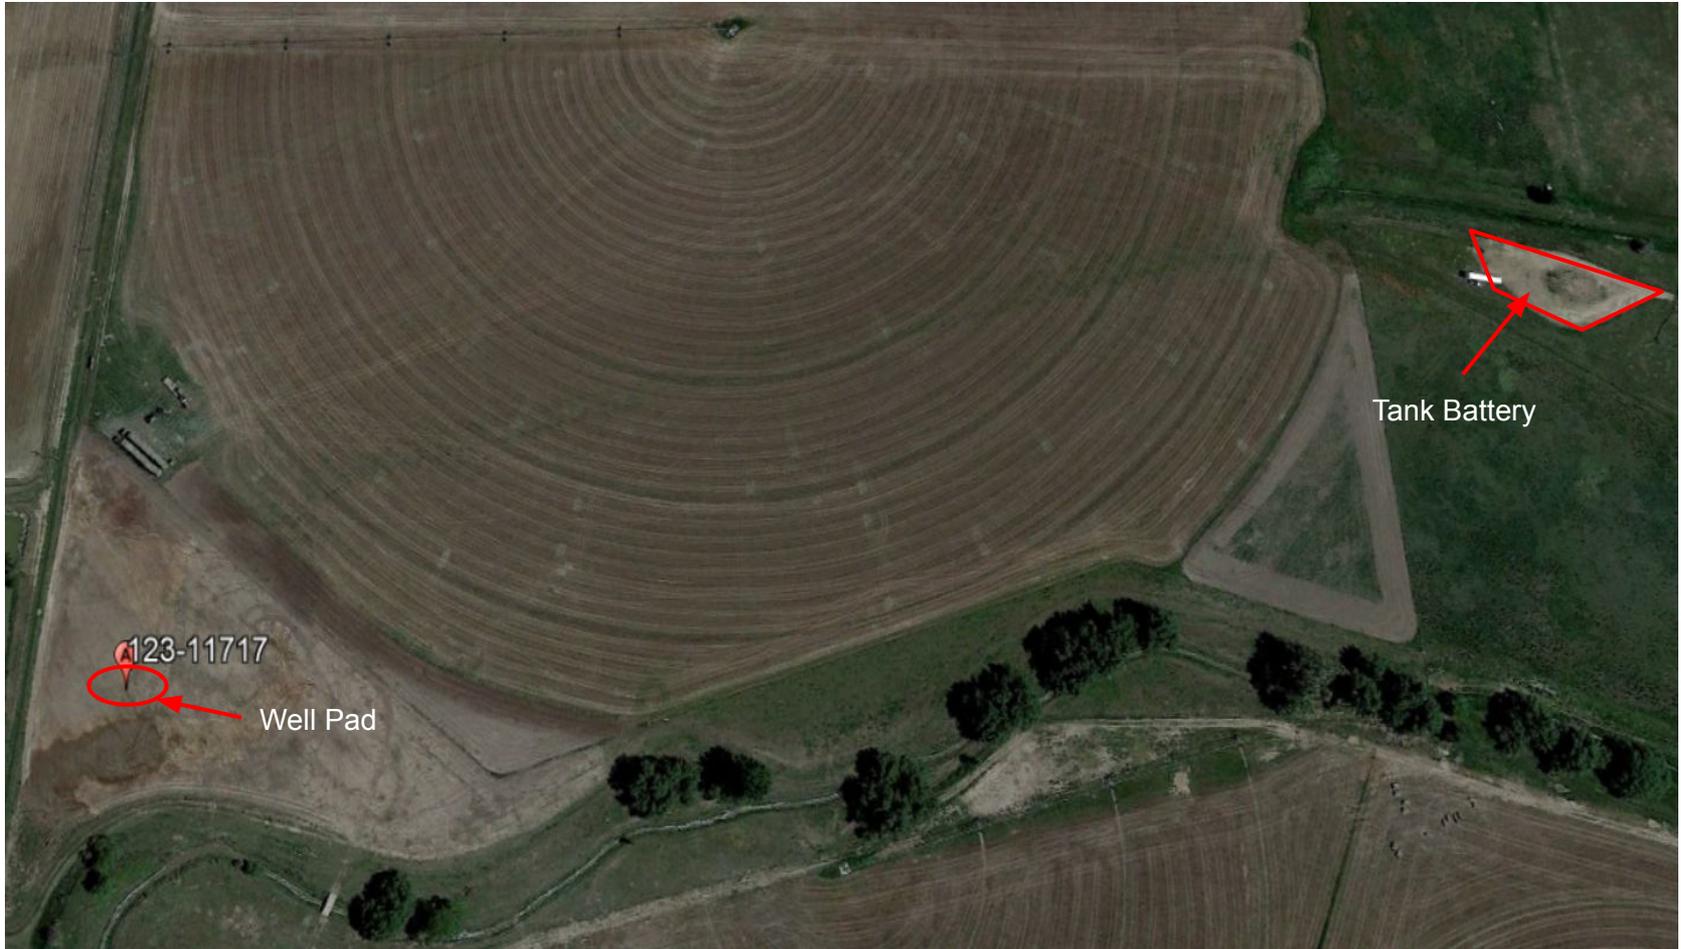
Photo 1. 2021 aerial imagery of the well pad and tank battery.

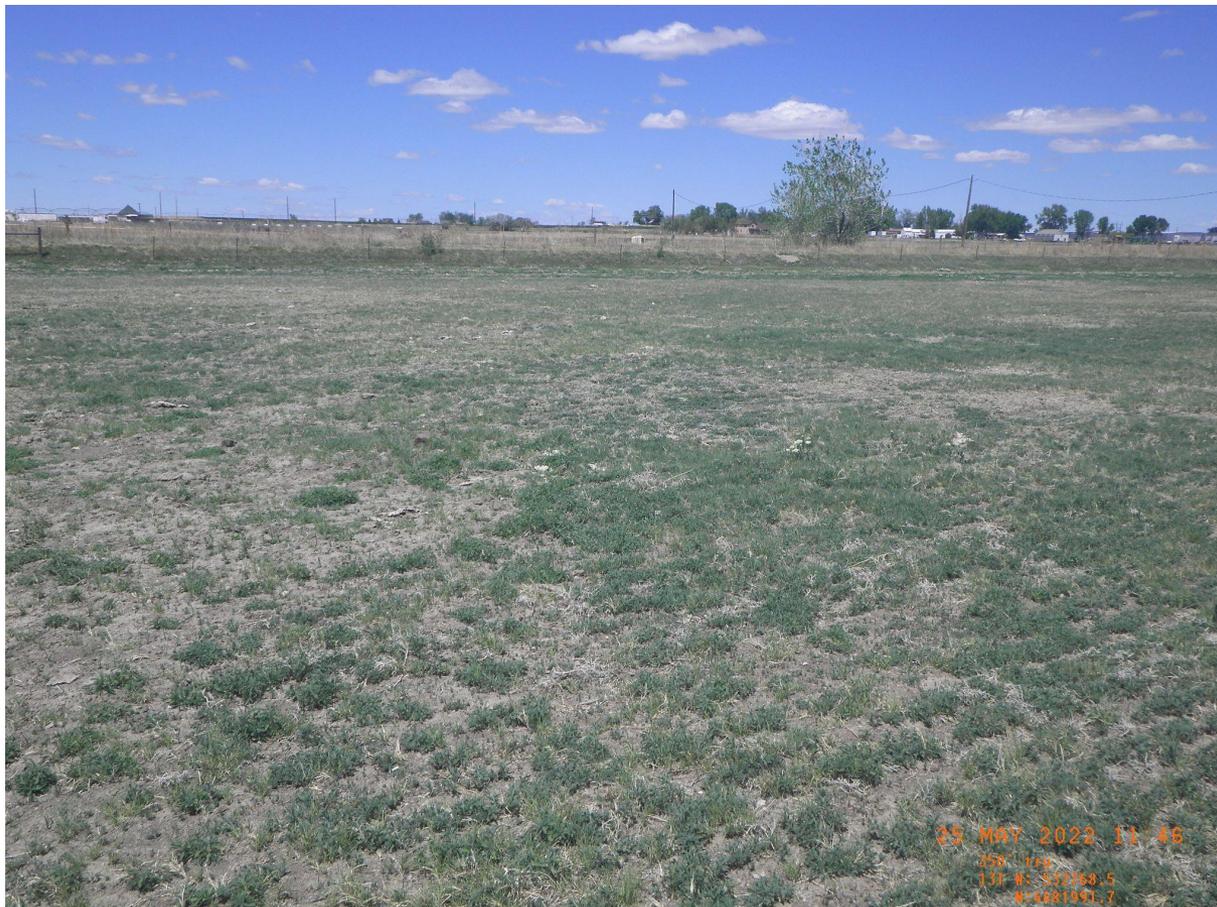
Photo 2. Overview photo of the well pad taken at ground level from the southern edge looking north. Note: well pad falls within a pasture that is actively being grazed by cattle.

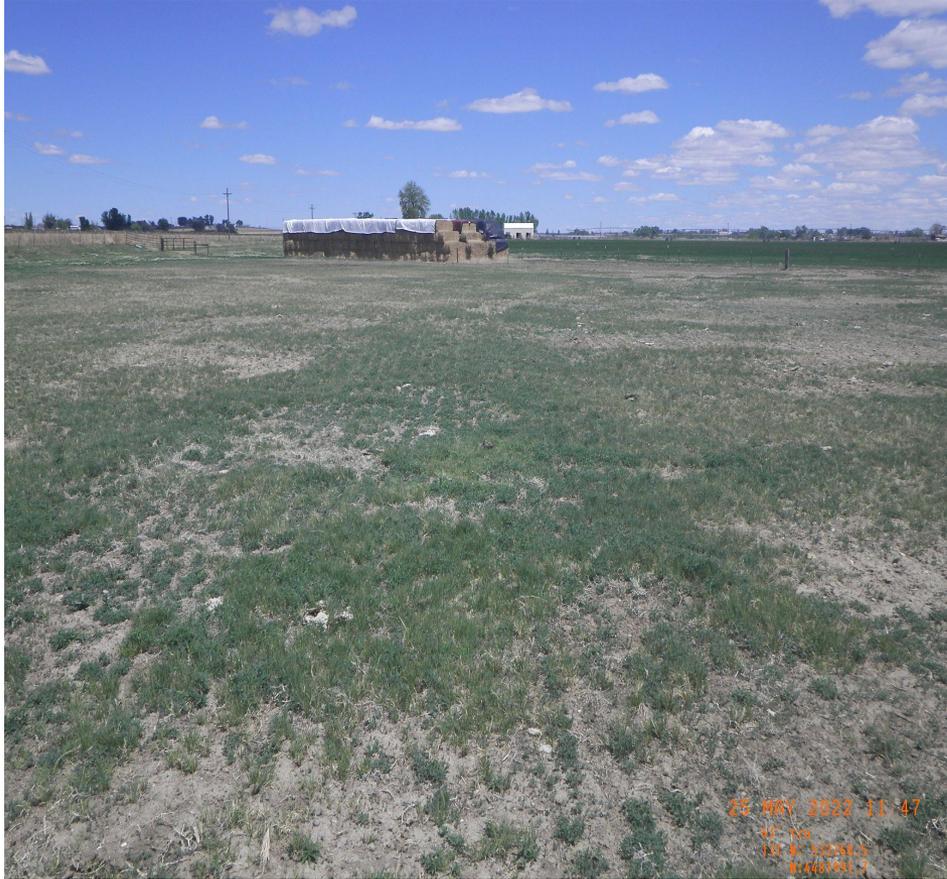
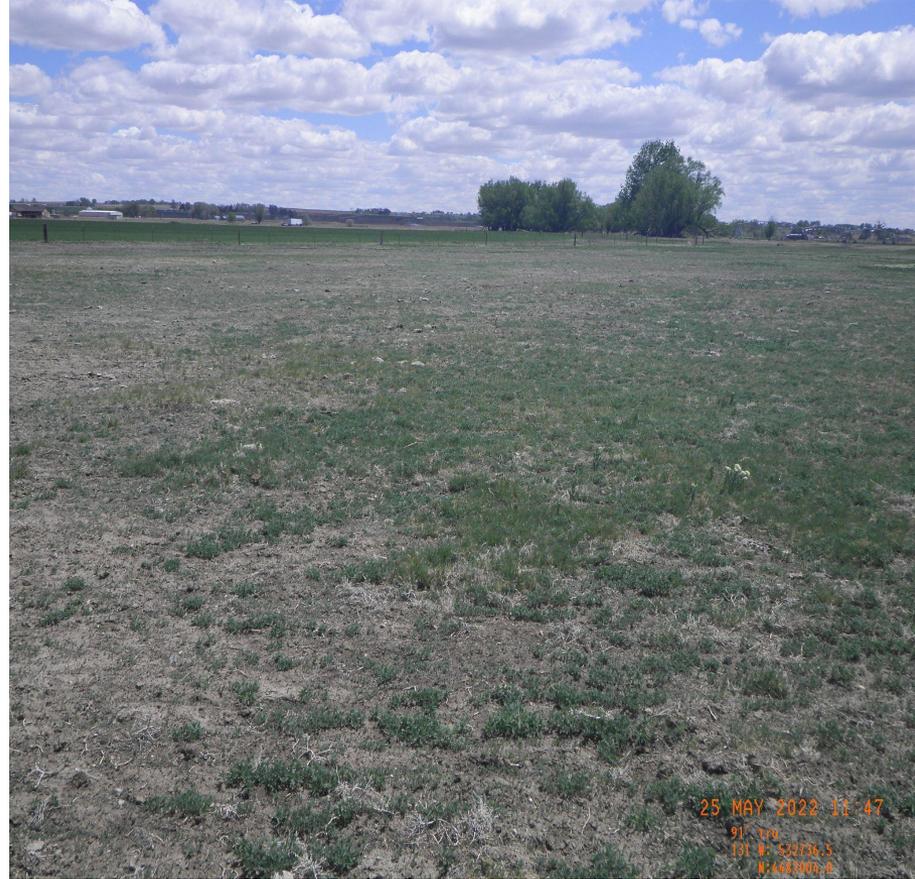
Photo 3. Cardinal photos taken from the middle of the well pad. Left photo facing north, right photo facing east.

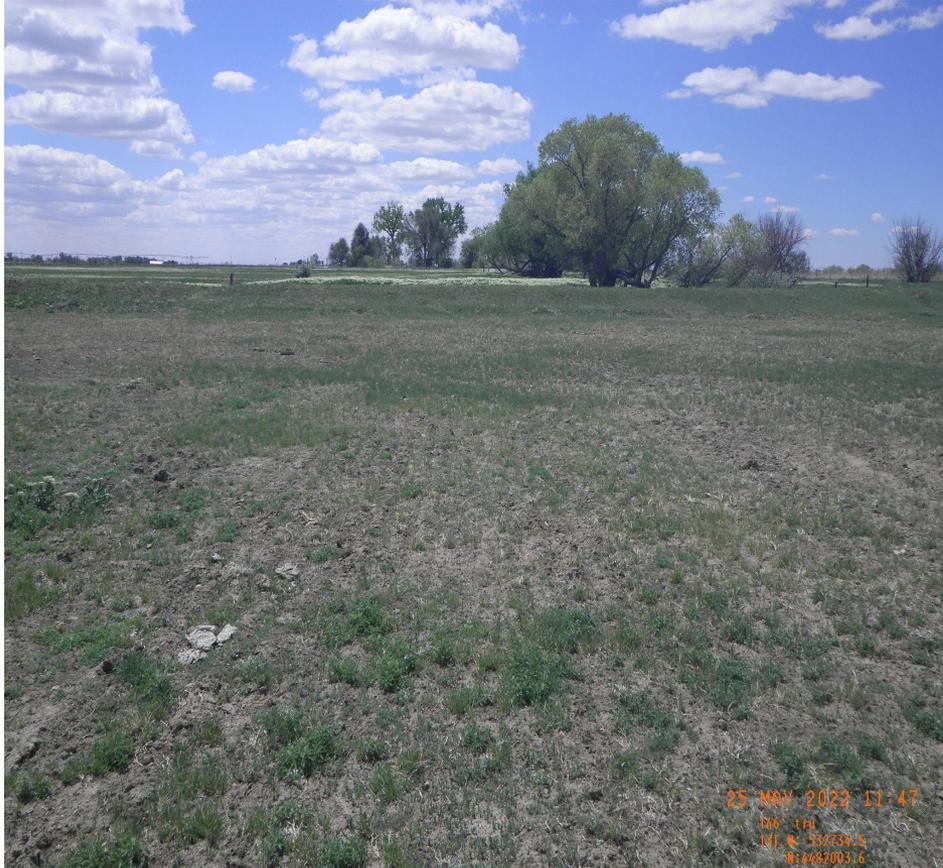
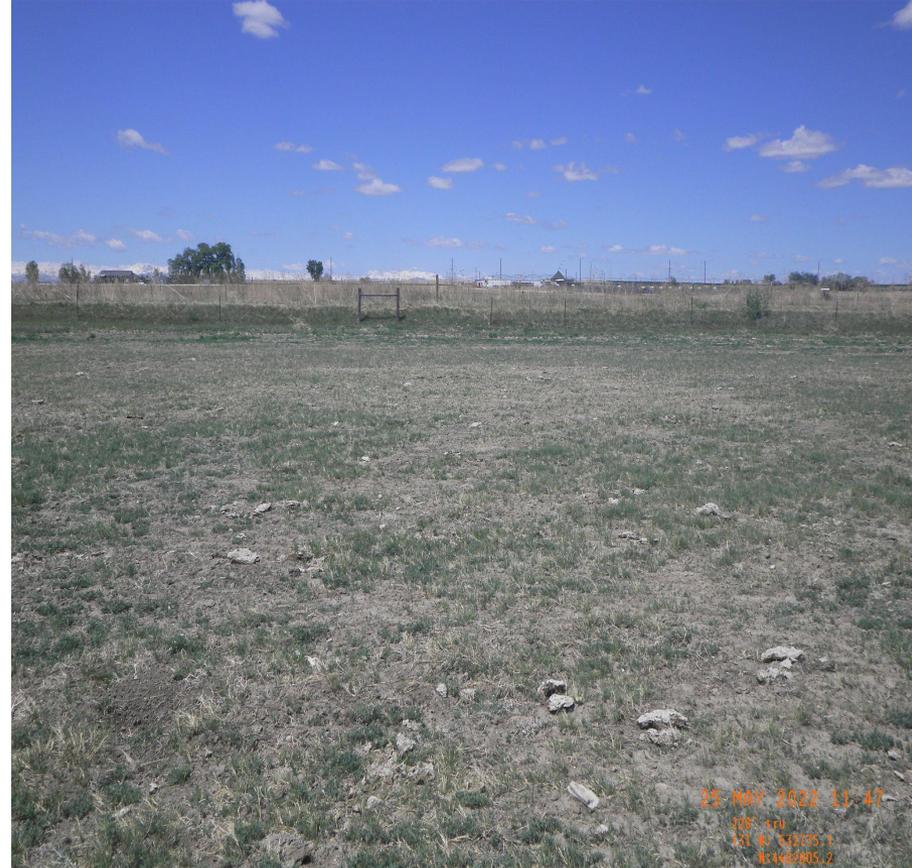
Photo 4. Cardinal photos taken from the middle of the well pad. Left photo facing south, right photo facing west. Note: well pad has a lower density of the dominant grass species (salt grass) compared to the reference area. (see photo 5). Weedy kochia is present within the site.

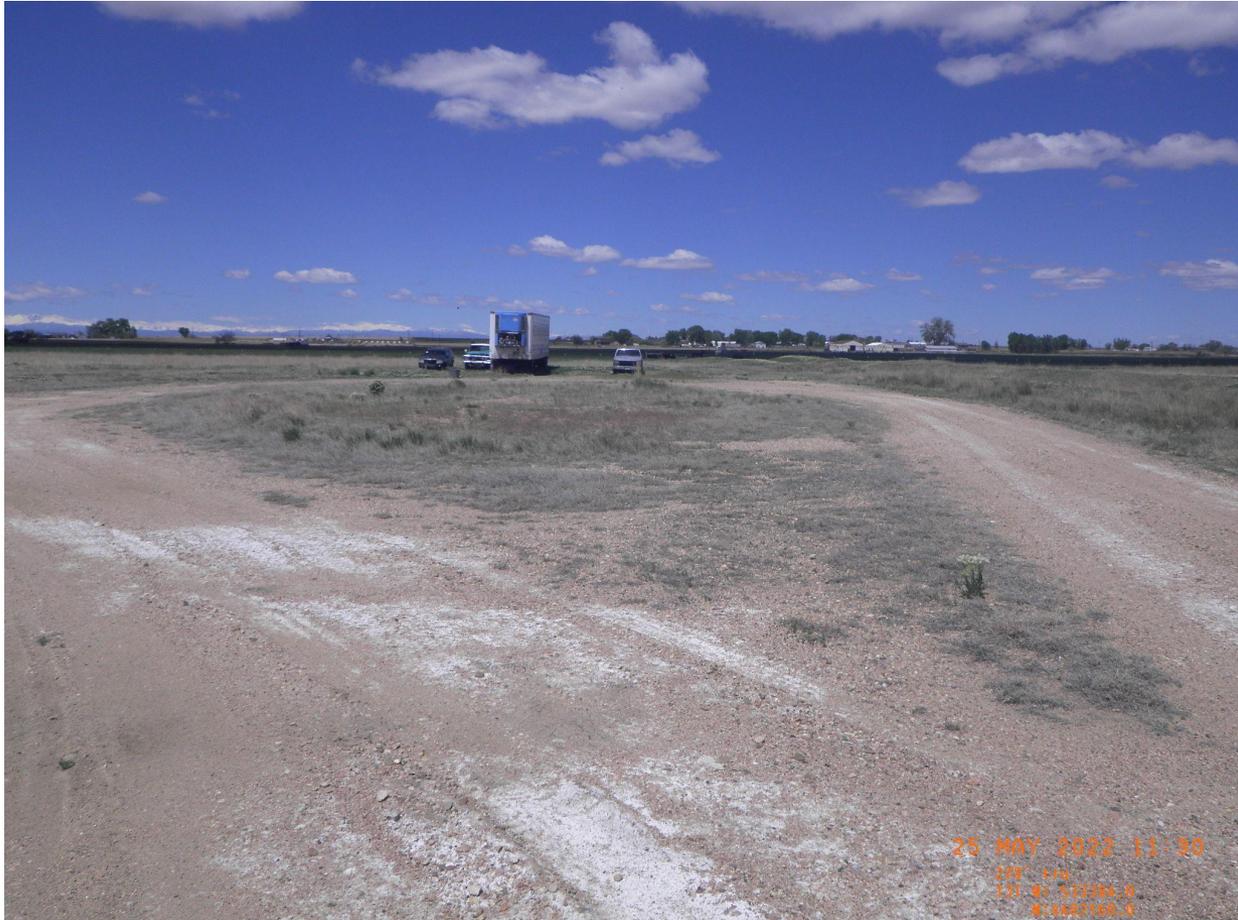
Photo 6. Overview photo of the tank battery taken at ground level from the eastern edge looking west. Note: the tank battery disturbance still remains and a variance form is in process.

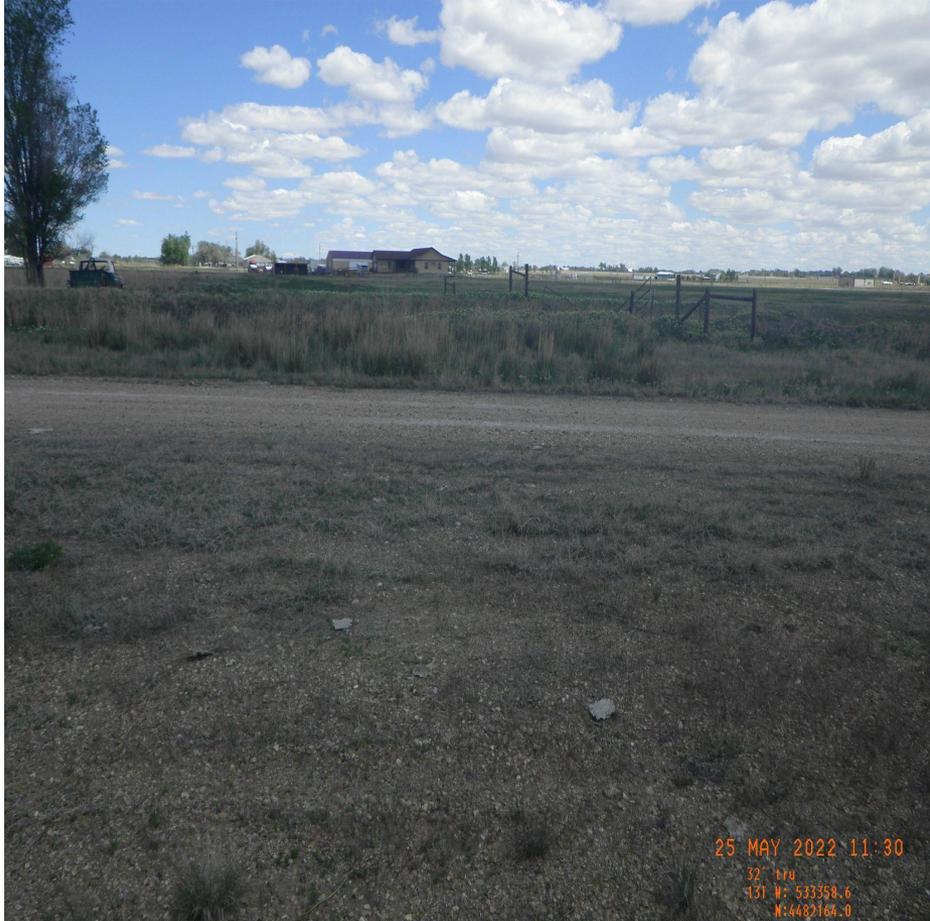
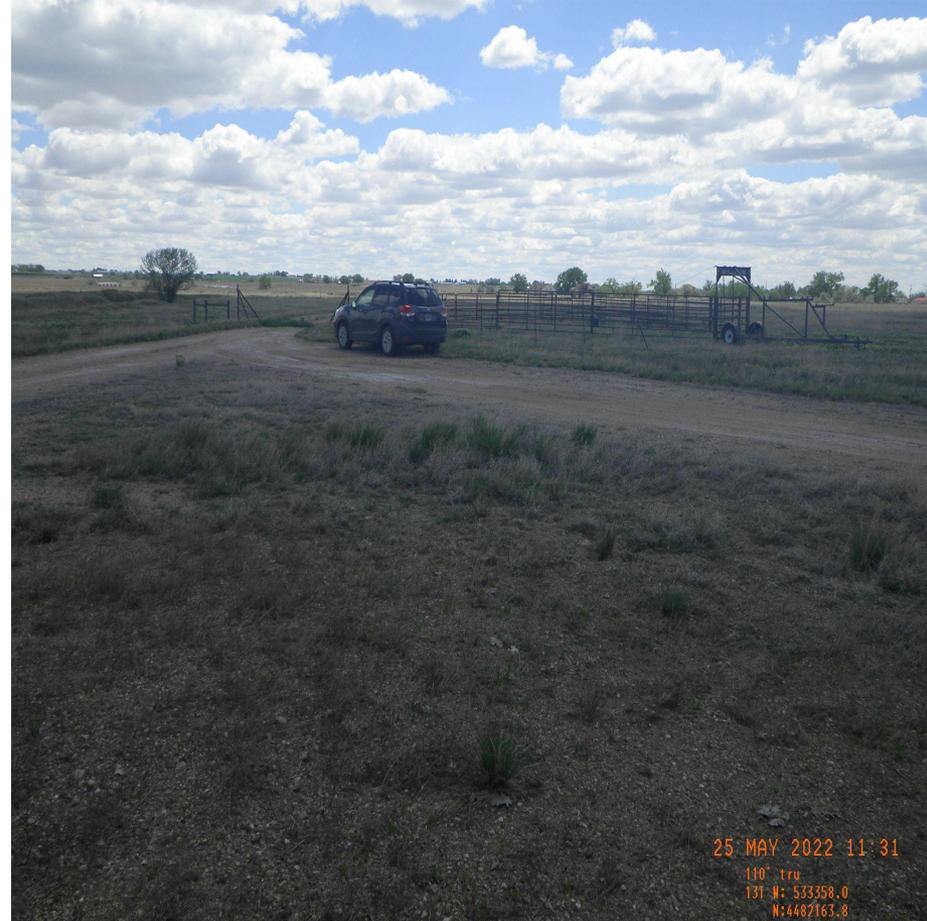
Photo 7. Cardinal photos taken from the middle of the tank battery. Left photo facing north, right facing east.

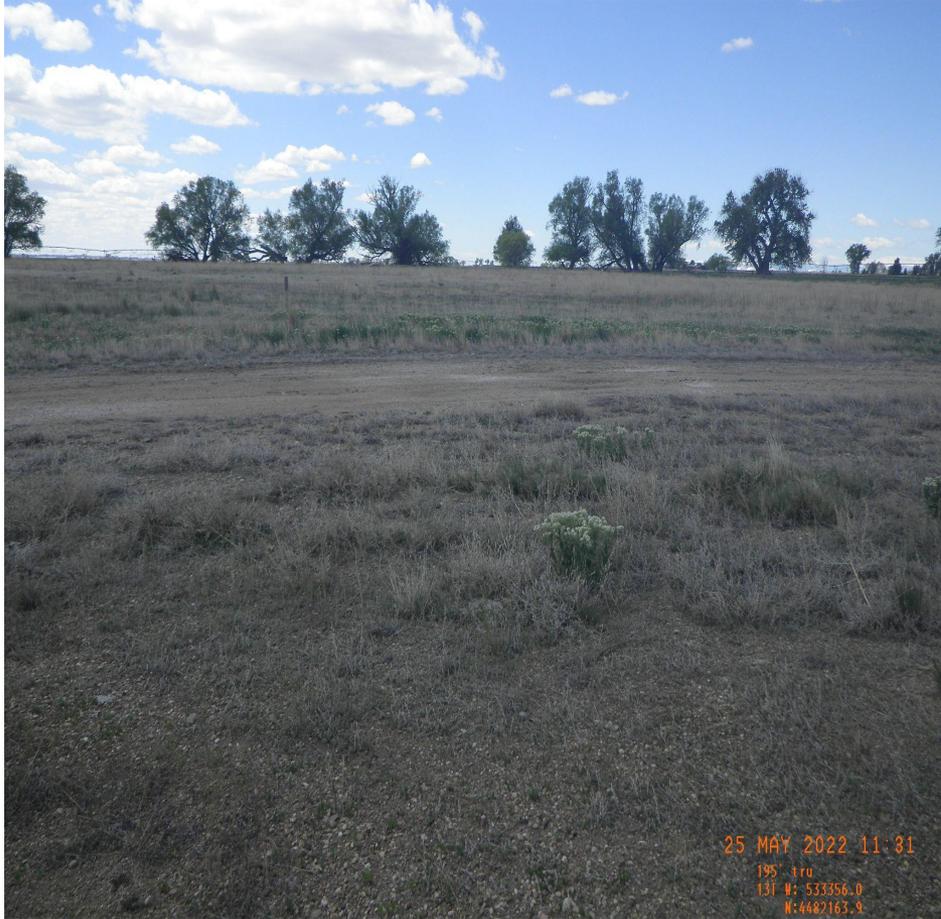
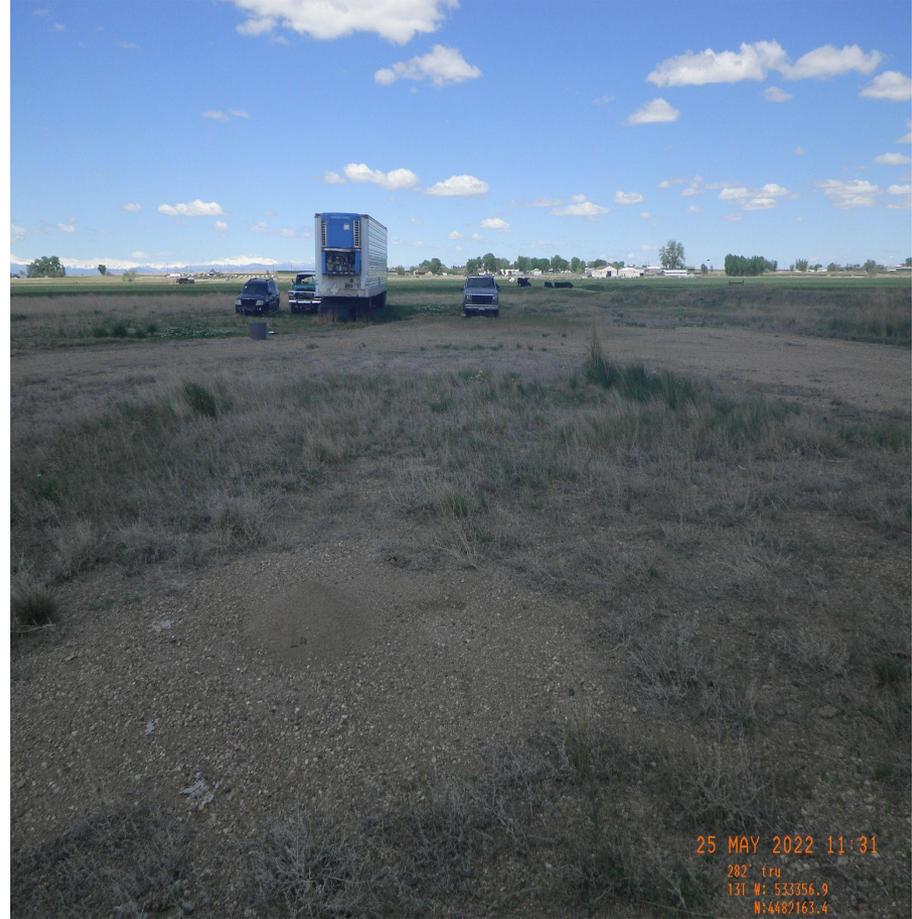
Photo 8. Cardinal photos taken from the middle of the tank battery. Left photo facing south, right facing west.
