Resolved Photos – DAVIS 2-5

05.067.08150

| Well Name: | DAVIS 2-5 | Location: | Sec: 05 | Twn: 034N | Rng: 008W | UL: G |
| INC Number: | 702500087 | Agency: | COGCC | Inspector: | Alex Klink | |

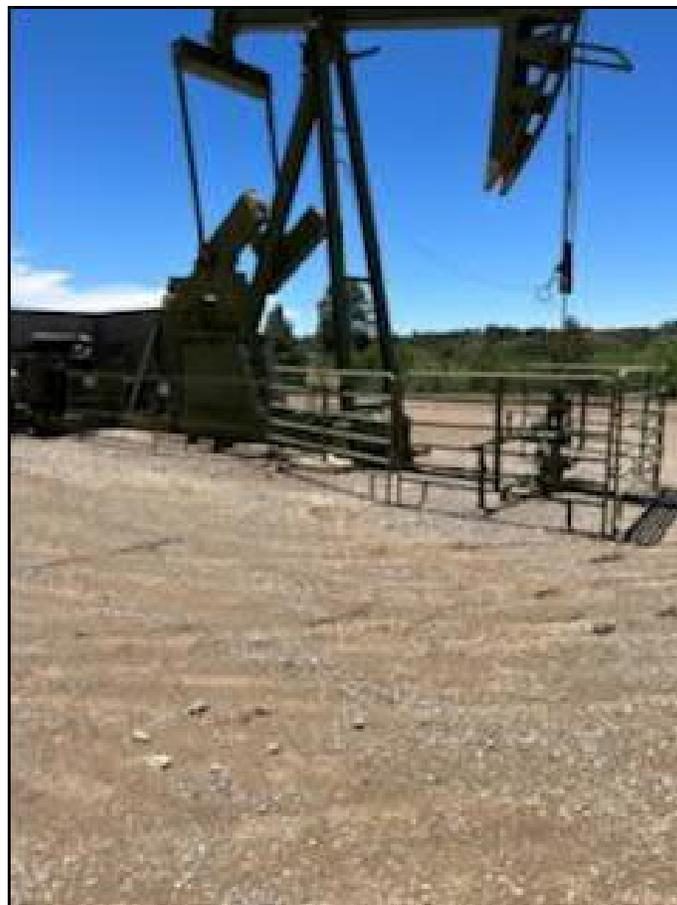
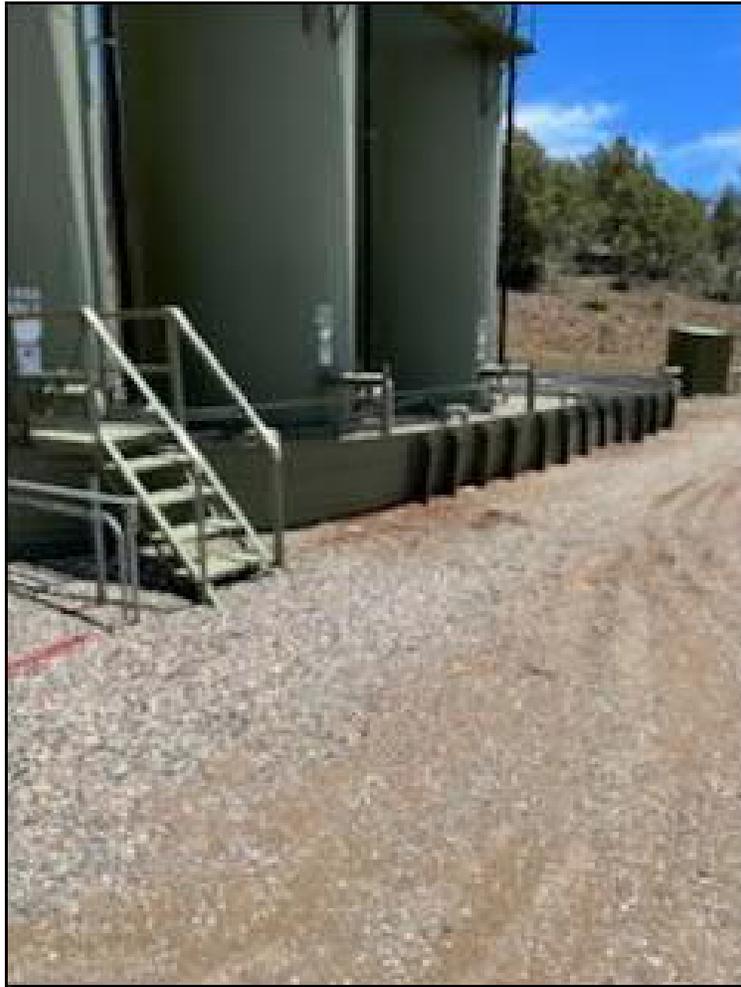
| Issue of Concern: | <p>Comment: Last gas meter calibration was 4/13/21 (IMG 05). Corrective Action: Calibrate gas metering equipment annually to comply with rule 430.d.(1).</p> <p>Comment: Unused stock panels near produced water tank (IMG 06). Corrective Action: Use or remove unused equipment per rule 606.</p> <p>Comment: Tarp near pump jack (IMG 04) and poly tubing near compressor house (IMG 09). Corrective Action: Remove trash to comply with rule 606.</p> <p>Comment: Not in use: 1" flow line uncapped near separator (IMG 08), 1" flow line uncapped near pump jack (IMG 03). Corrective Action: Apply Out of Service Locked and Tagged on unused flow line per rule 1101.(3)</p> <p>Comment: 1 rig anchor with marker, 3 rig anchors with markers not secured properly (IMG 10, IMG 11, IMG 12). Corrective Action: Install proper guy line markers per Rule 1003.a</p> | | | | | |

Stock panels near produced water tank as shown in photo are put back up around the well head.
