Inspection Photos

API: 071-09521

Operator: EVERGREEN NATURAL RESOURCES

Inspection Date: 6/28/2022

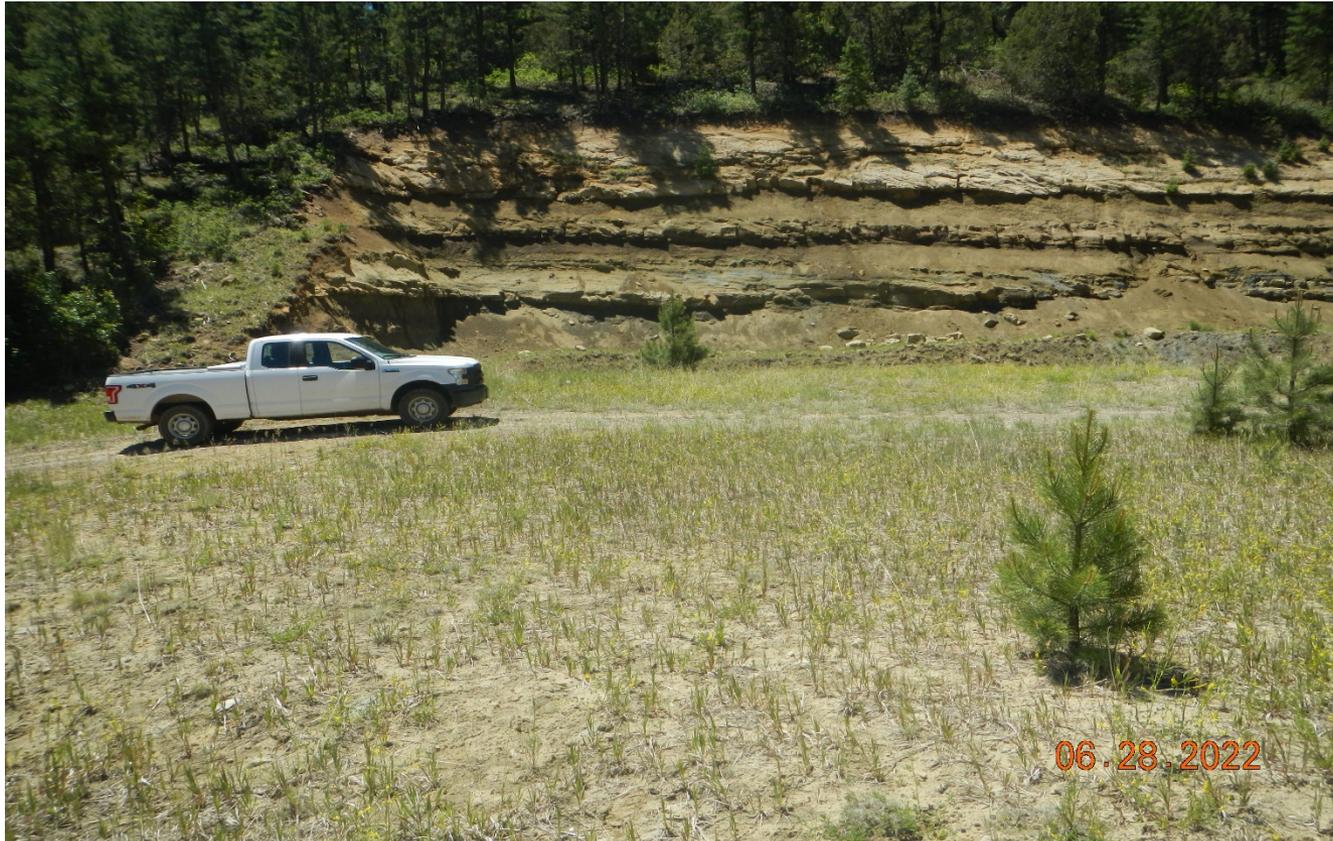
Photo 1. Facing southwest at the location. The location has not been recontoured and a steep cut slope remains. Previous corrective action not completed.

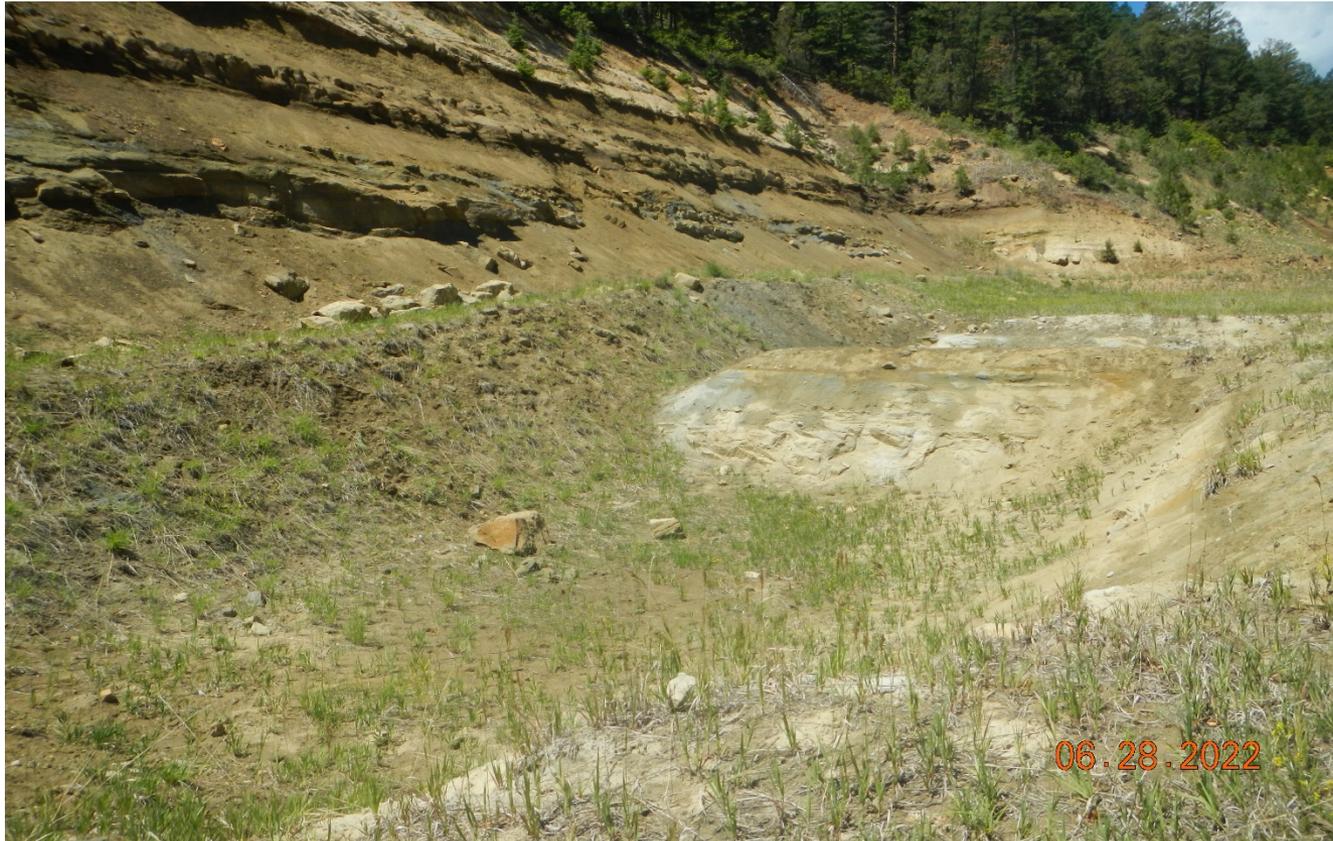
Photo 2. There is a pit that remains along the base of the cut slope at the location.

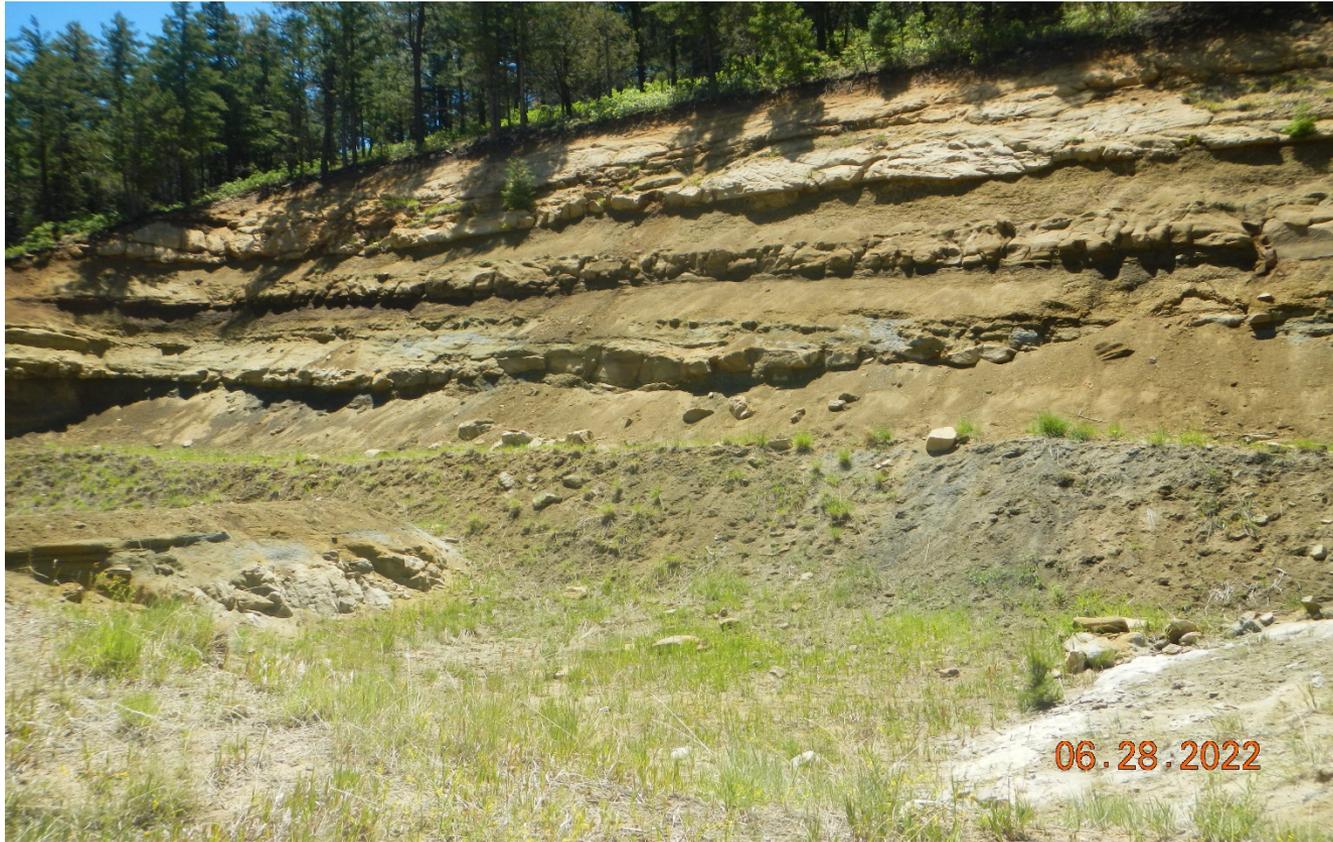
Photo 3. Facing southeast toward the pit at the base of the cut slope.

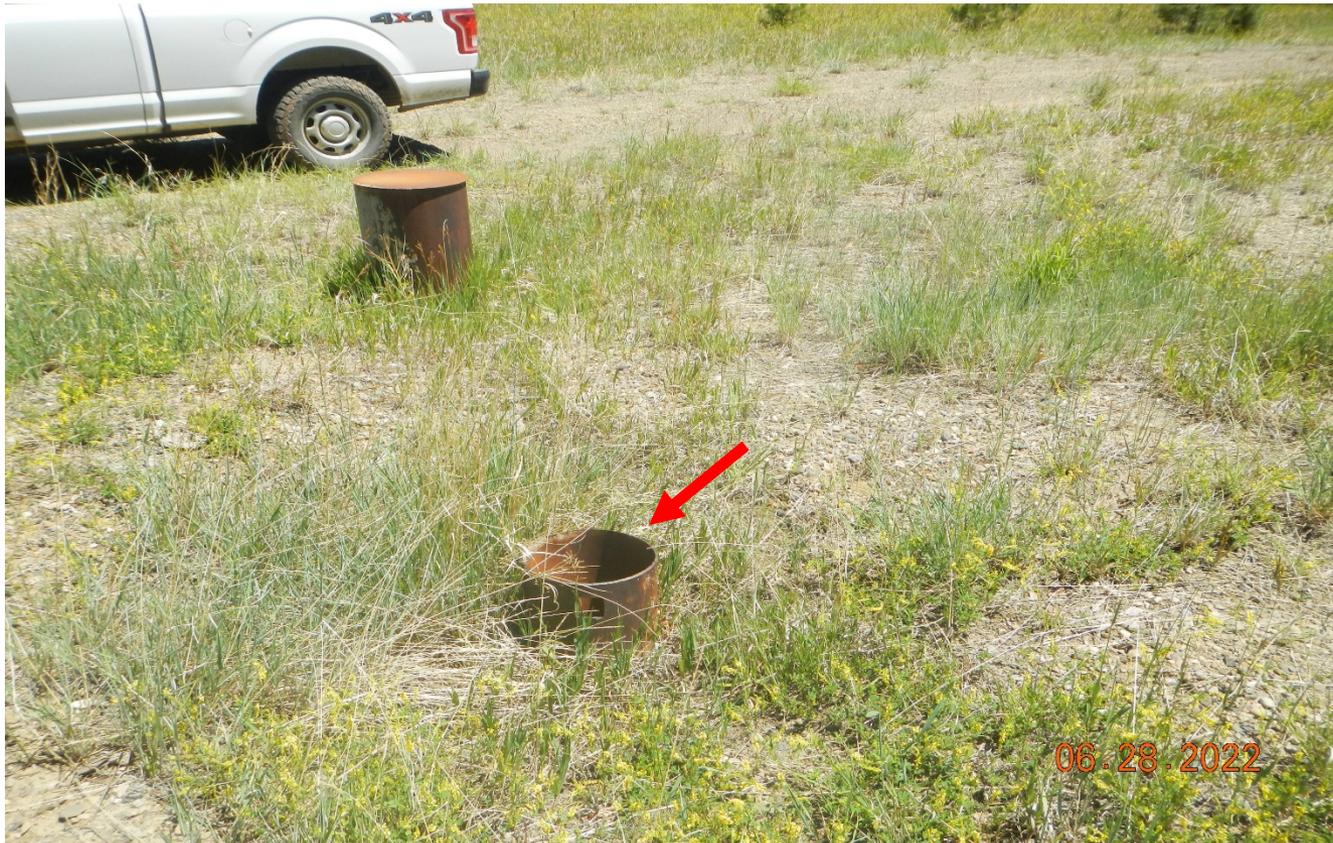
Photo 4. There are 3 steel casings that remain at center of the location. The casing shown at red arrow is not covered to prevent entry. The steel casings need to be removed.

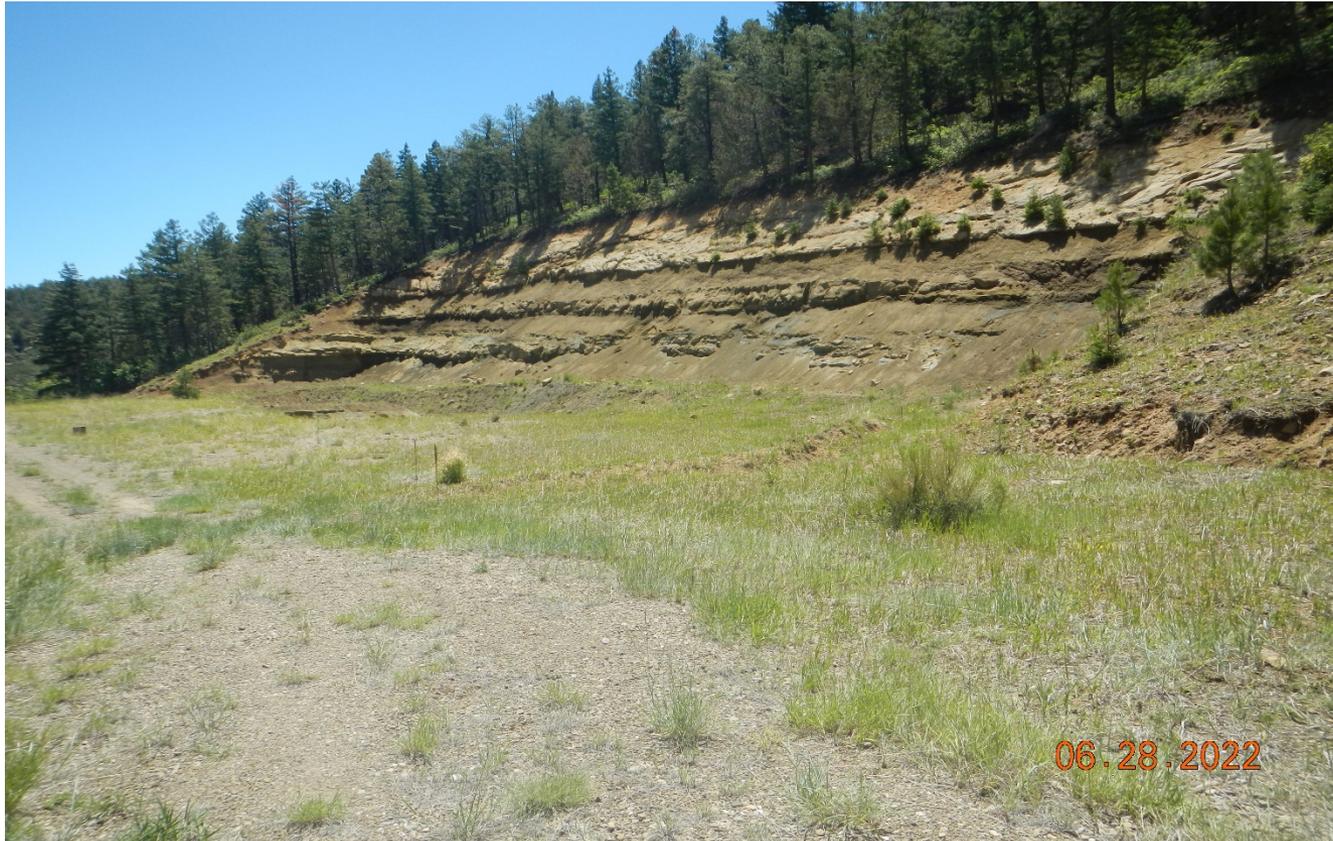
Photo 5. Facing southeast toward the location. The abandoned location needs to be recontoured and reclaimed.

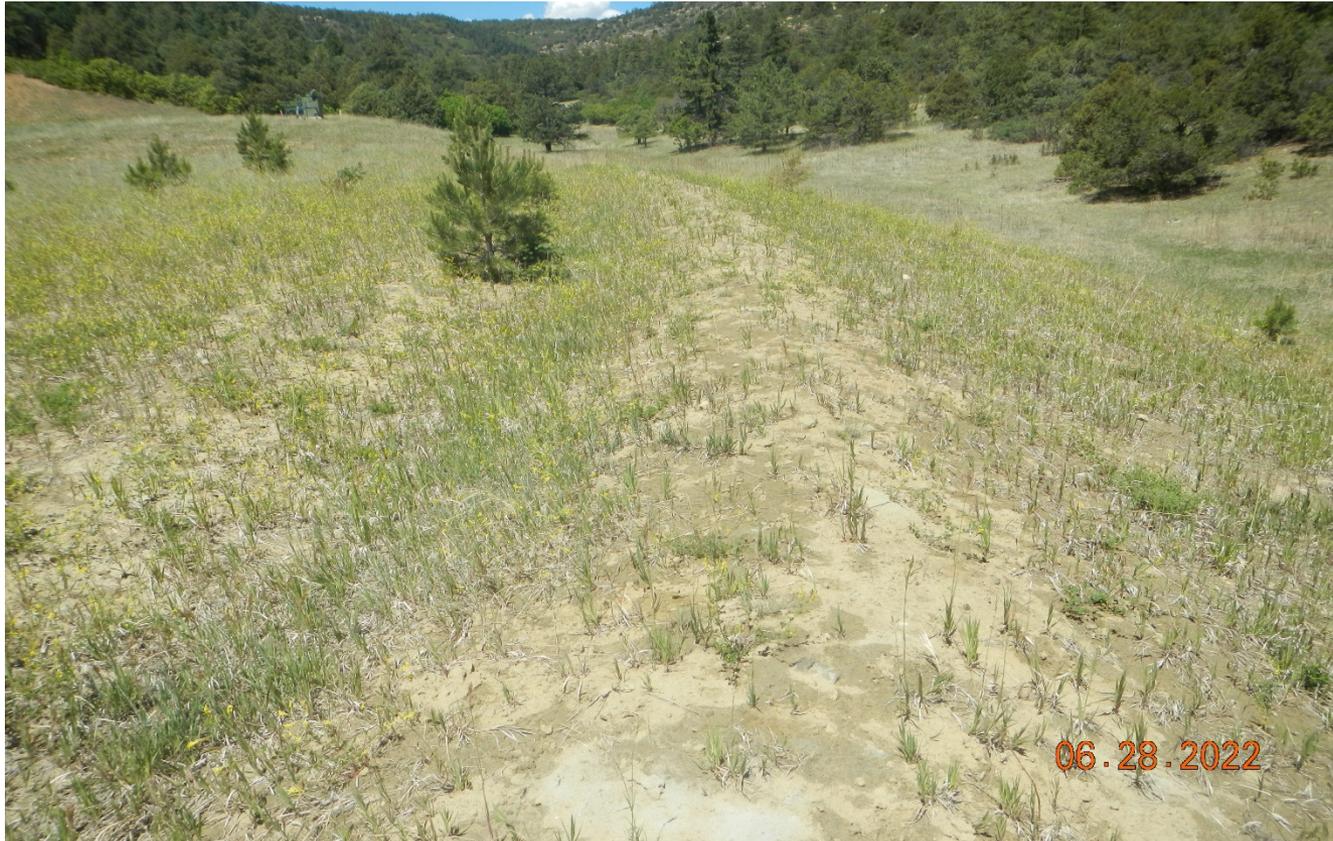
Photo 6. Facing west along the fill slope of the location which will need to be recontoured back into the cut slope.

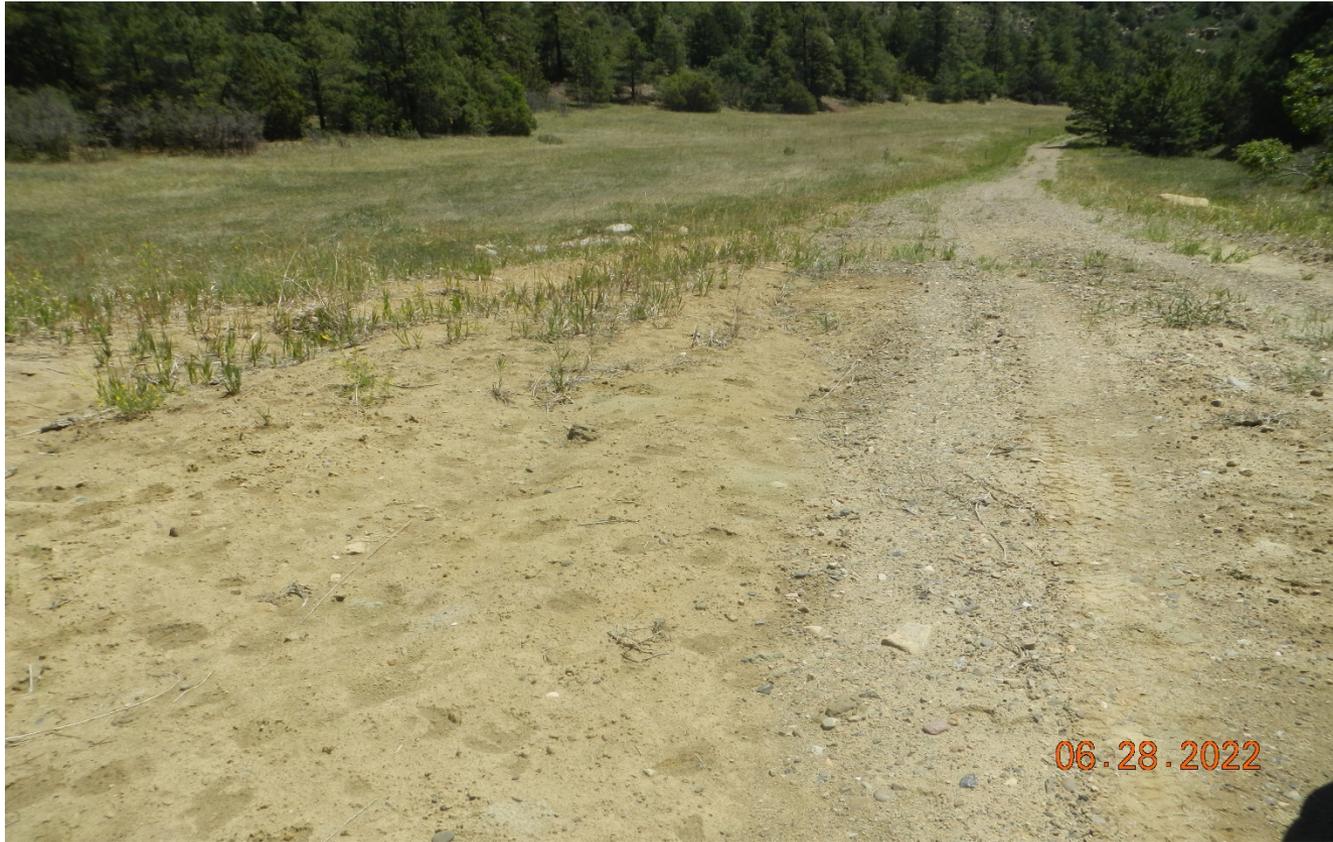
Photo 7. There are some signs of erosion at the east side of the location.
