**Inspection Photos June 22, 2022**  
**Location Name: Isle Dome Pit ID: 116587; Spill ID: 482343**

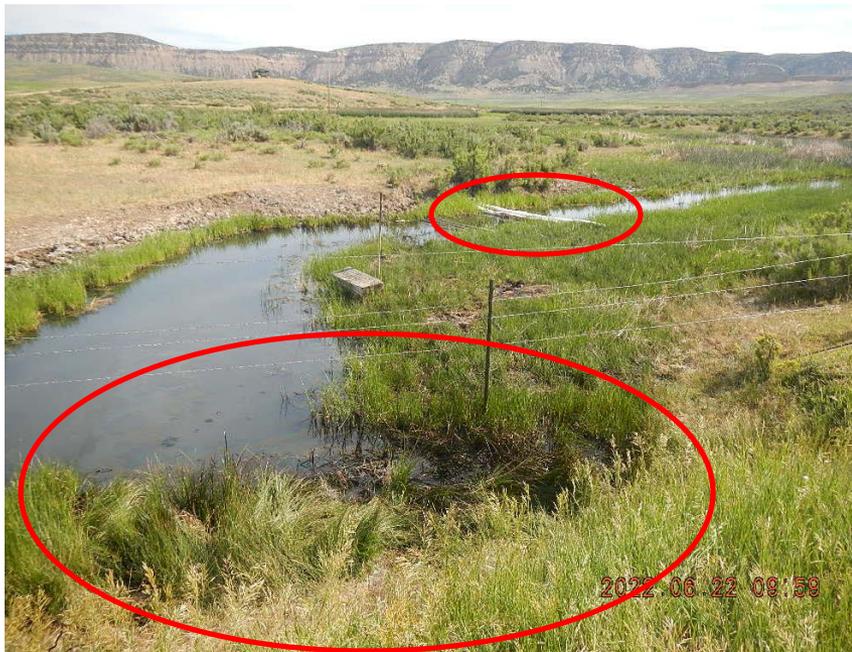
**Outfall of culvert beneath County Road LY5. Oily impacted vegetation and oil observed on the water surface. Booms are placed down gradient.**

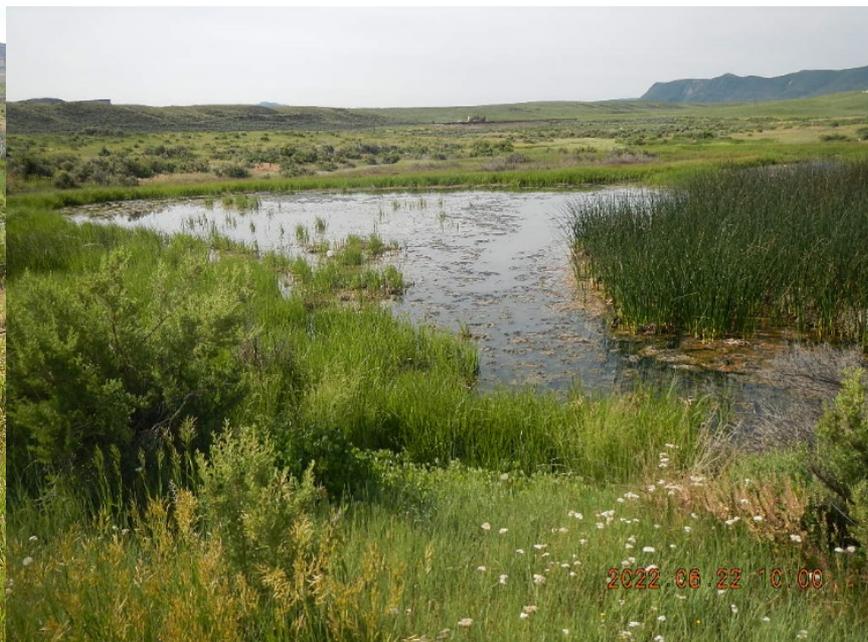
**Up gradient of culvert beneath County Road LY5. Oily impacted vegetation and oil observed on the water surface.**

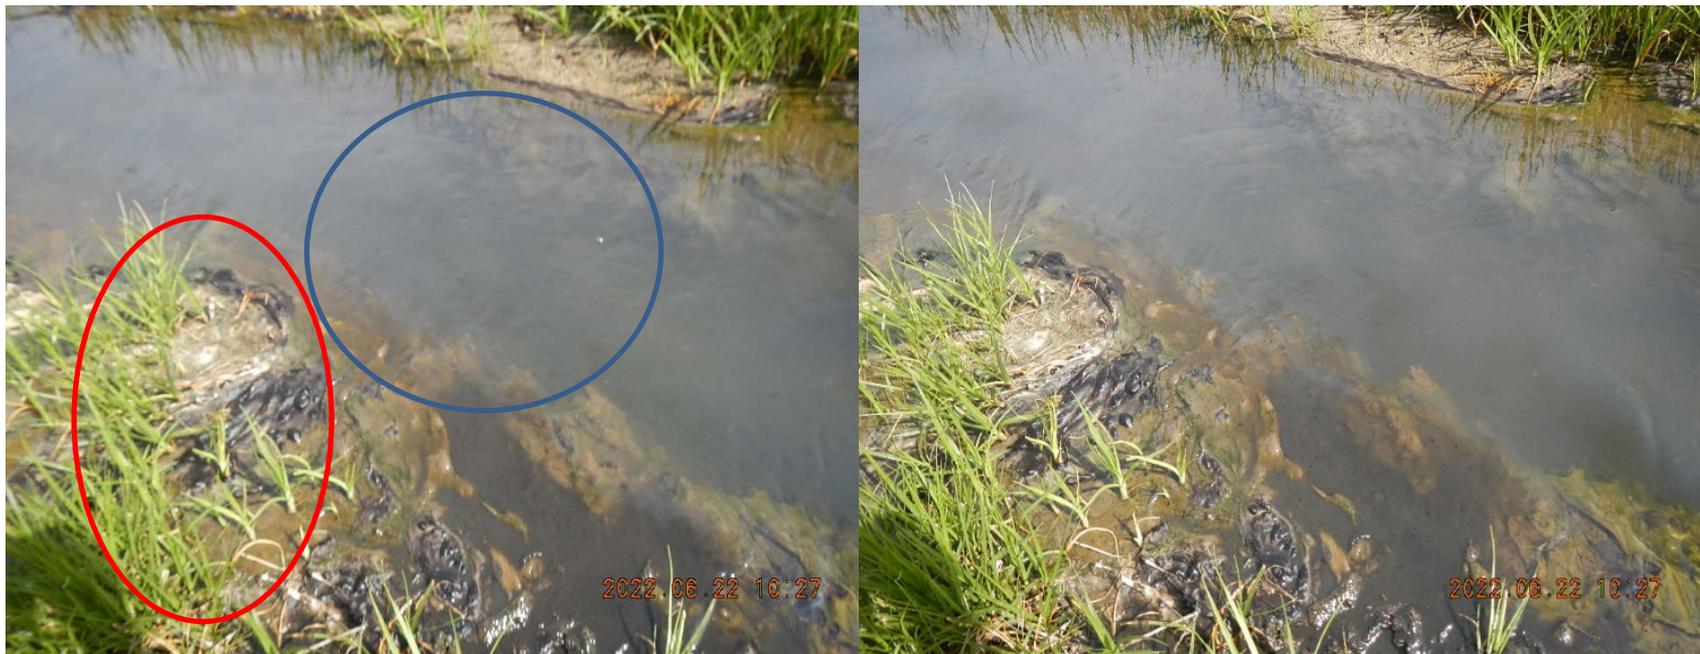
**Up gradient of culvert. Note the oily algae mat and hydrocarbon sheen on the water surface.**

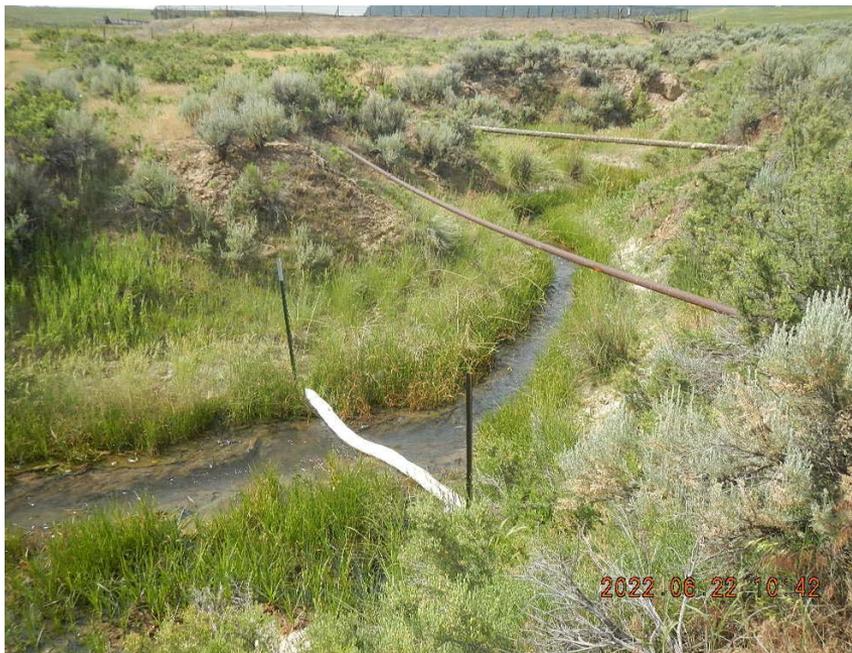
**Boom down gradient of Pit Facility ID: 116587 discharge.**

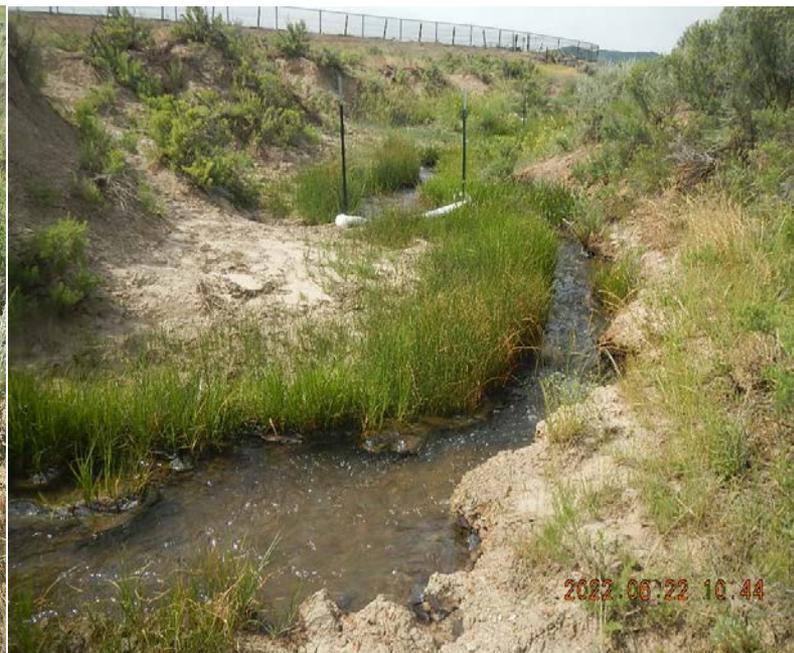
**Boom approximately 100 feet down gradient of Pit Facility ID: 116587 discharge. Oily stained vegetation observed and hydrocarbon odor noted.**

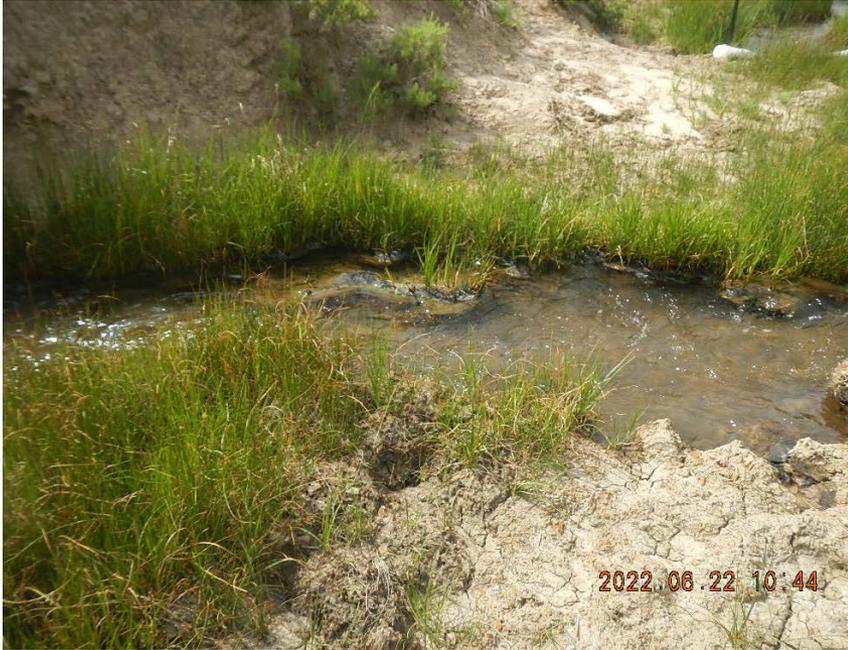
**Boom approximately 100 feet down gradient of Pit Facility ID: 116587 discharge. Oily stained vegetation observed and hydrocarbon odor noted.**

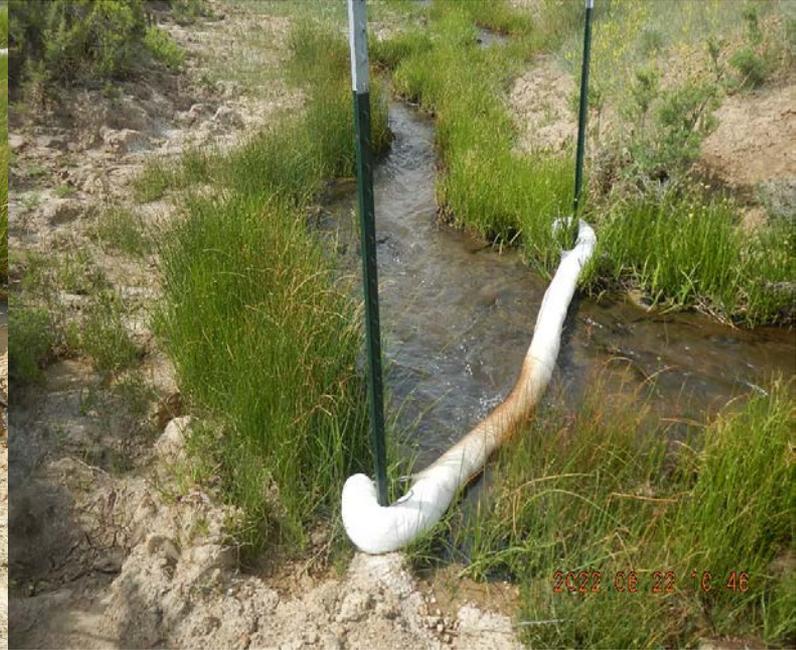
**Boom approximately 100 feet down gradient of Pit Facility ID: 116587 discharge. Oily stained vegetation observed and hydrocarbon odor noted.**

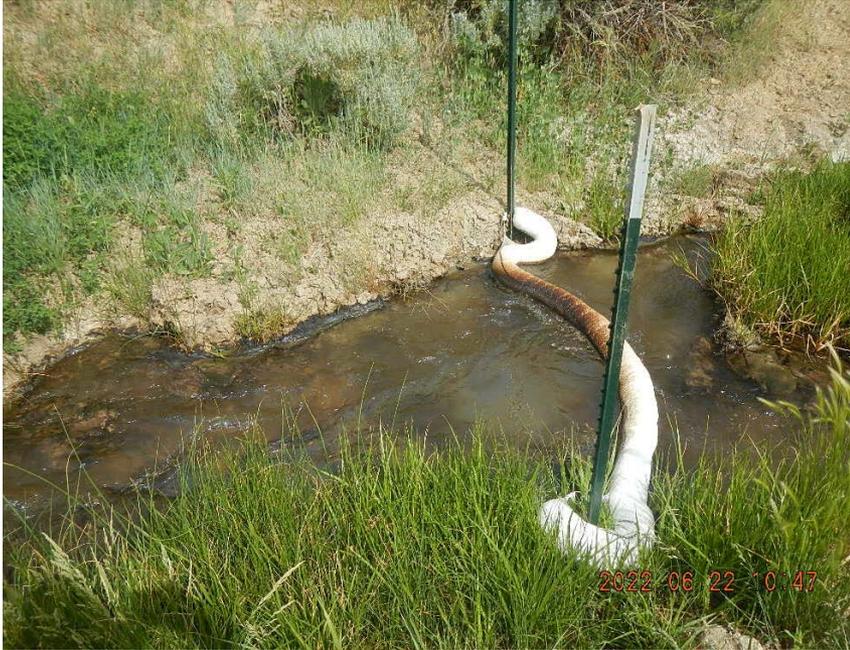
**Boom approximately 70 feet down gradient of Pit Facility ID: 116587 discharge. Oily stained vegetation observed and hydrocarbon odor noted.**

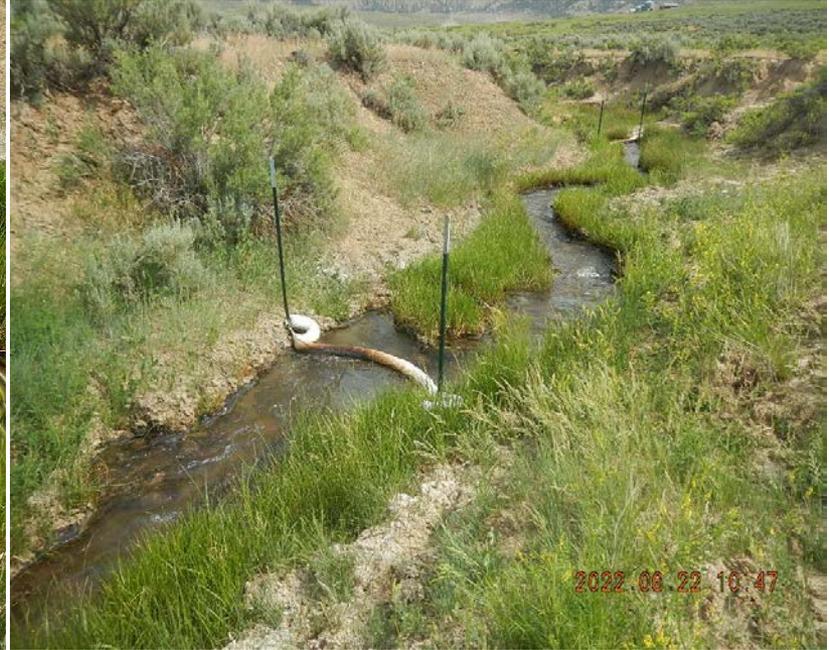
**Boom approximately 70 feet down gradient of Pit Facility ID: 116587 discharge. Oily stained vegetation observed and hydrocarbon odor noted.**

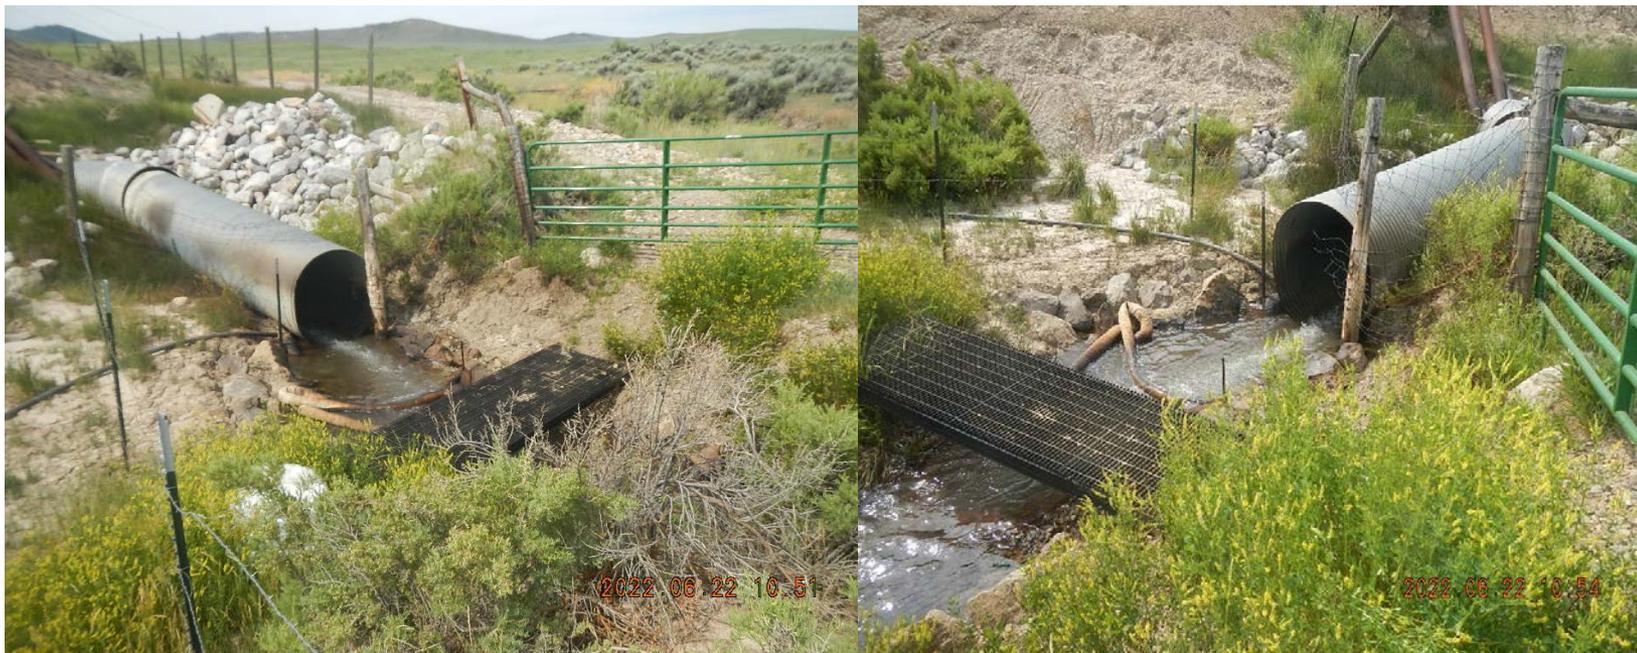
**Boom at Pit Facility ID: 116587 discharge. Oily stained vegetation observed and hydrocarbon odor noted.**
