Inspection Photos
Location Name: Keating 2
Location ID: 306900

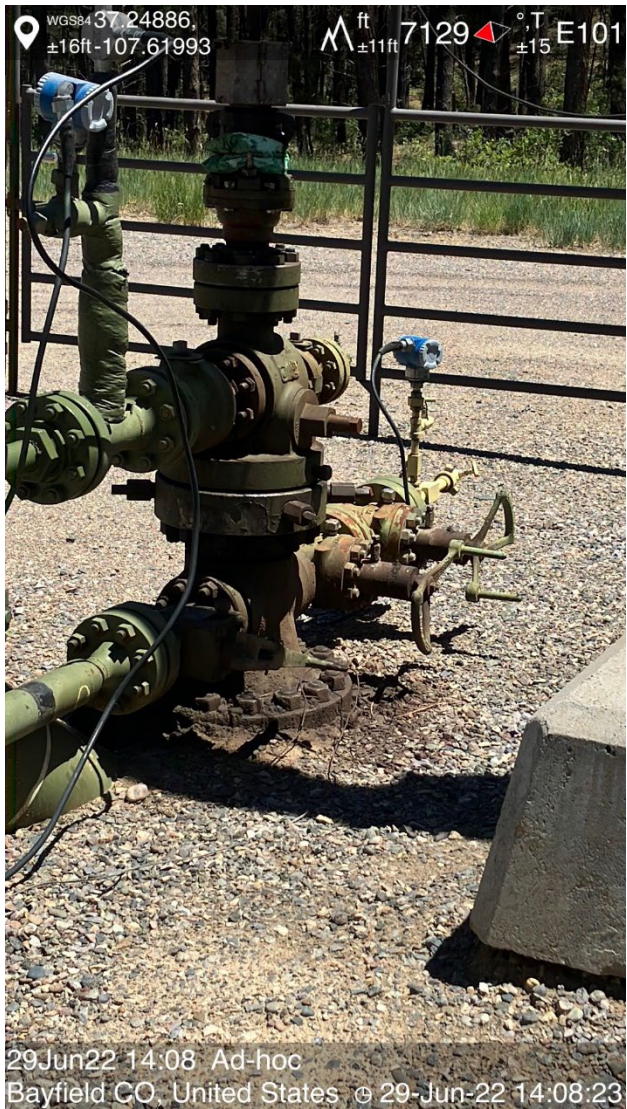
IMG 03

Lube oil has begun to impact material
