Inspection Photos

Location Name: TEP ROCKY MOUNTAIN LLC T & T Assoc. LTD /PA 21-7

Location ID: 420224

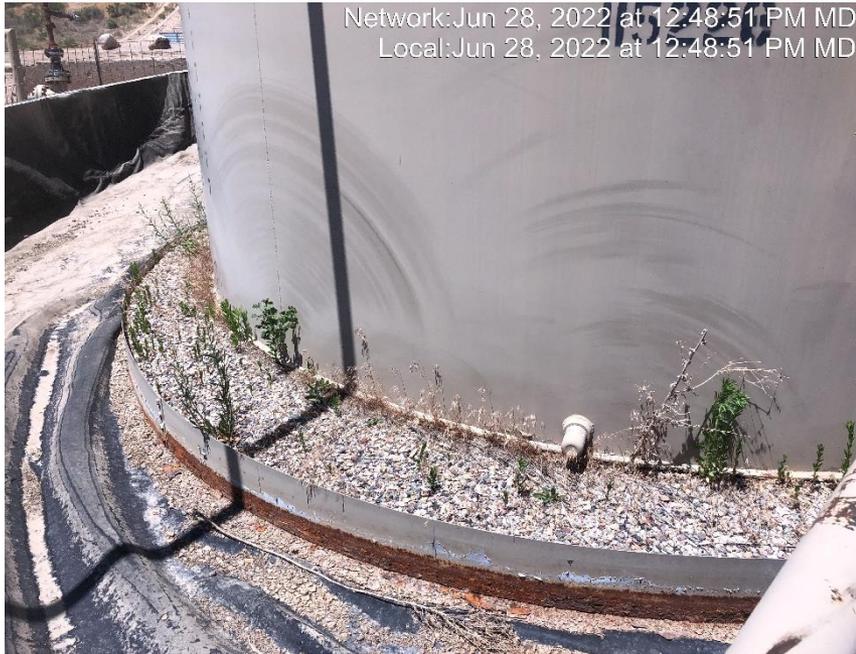
Photo #6992 Undesirable plant species in tank containment.

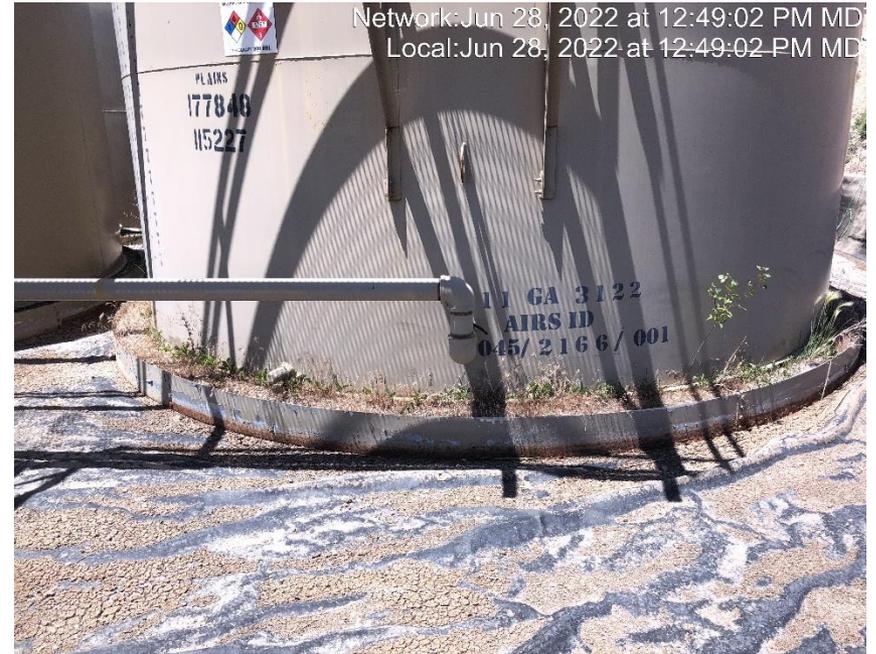
Photo #6993 Undesirable plant species in tank containment

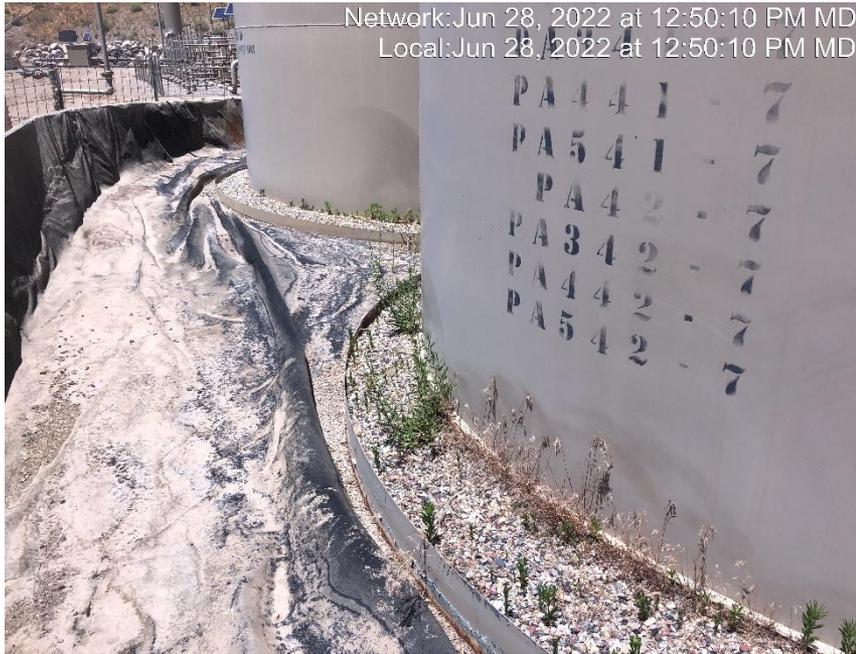
Photo #6994 Undesirable plant species in tank containment

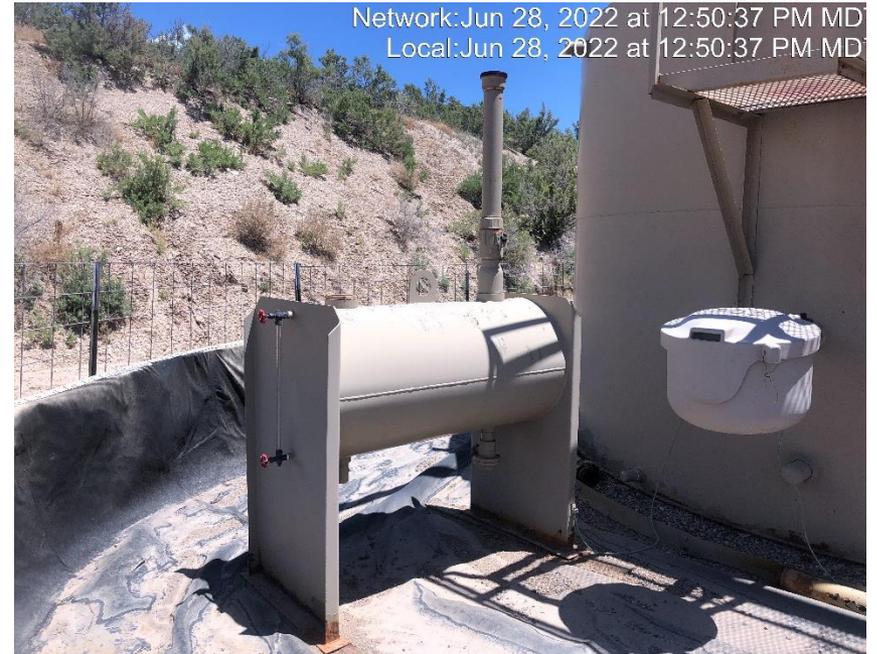
Photo #6995 Unused equipment.

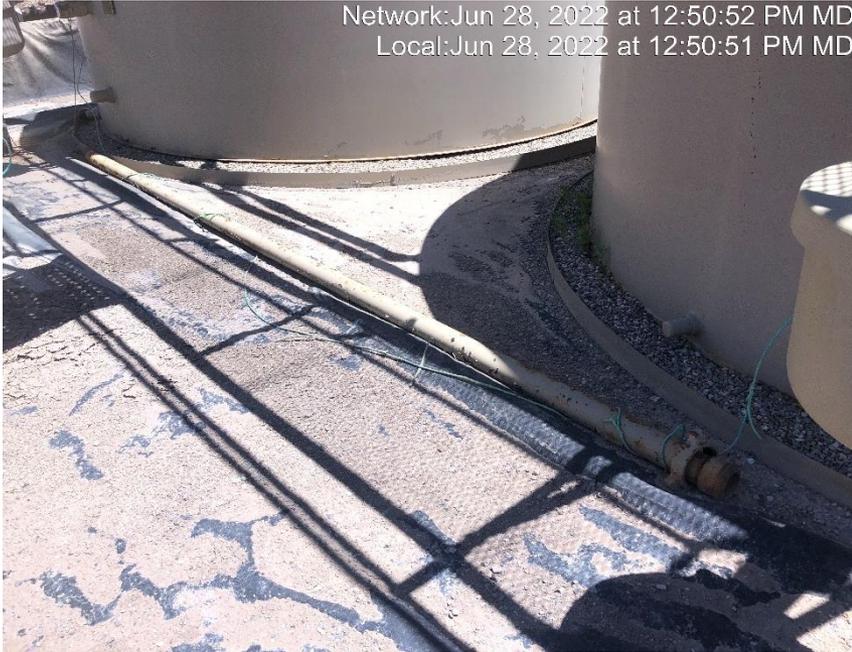
Photo #6996 Unused supplies.

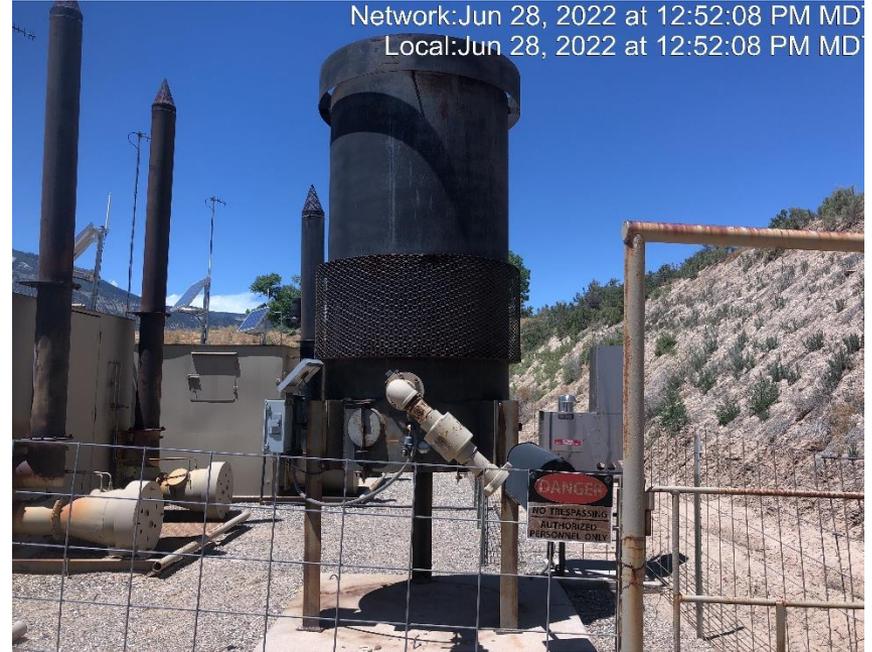
Photo #6997 Unused equipment.

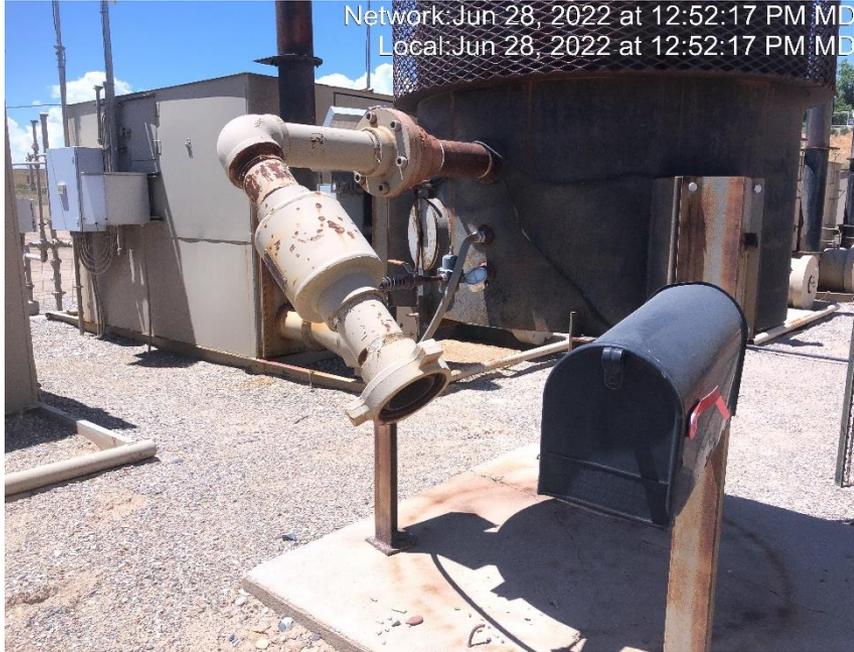
Photo #6998 Unused equipment.

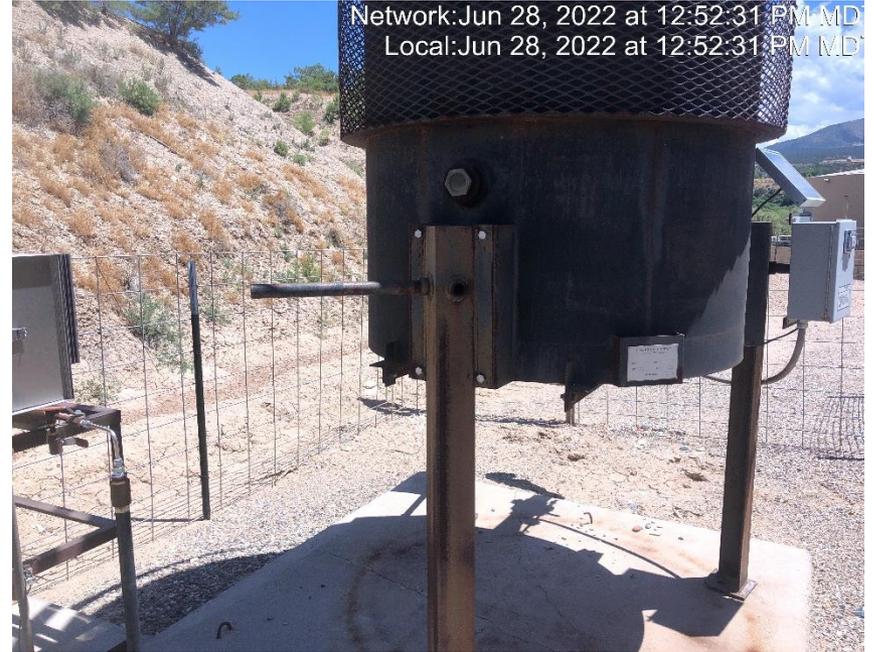
Photo #6999 Unused equipment.

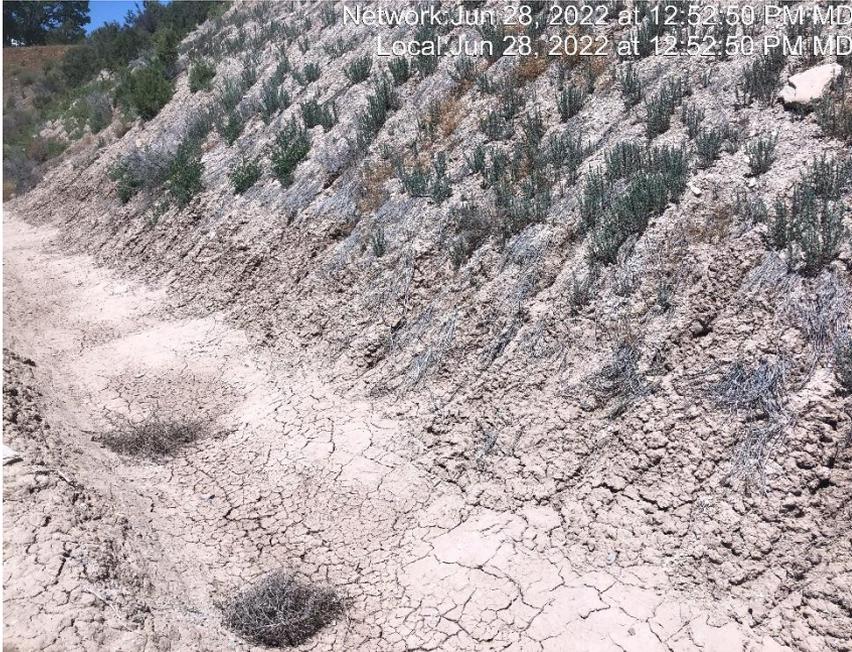
Photo #7001 Rill erosion occurring on cut slope.

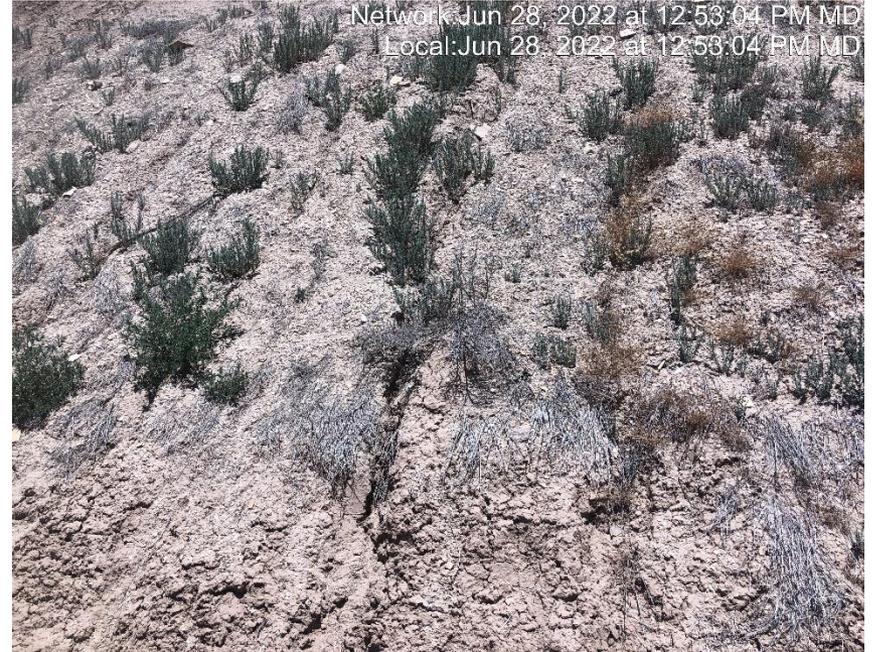
Photo #7002 Rill erosion occurring on cut slope.

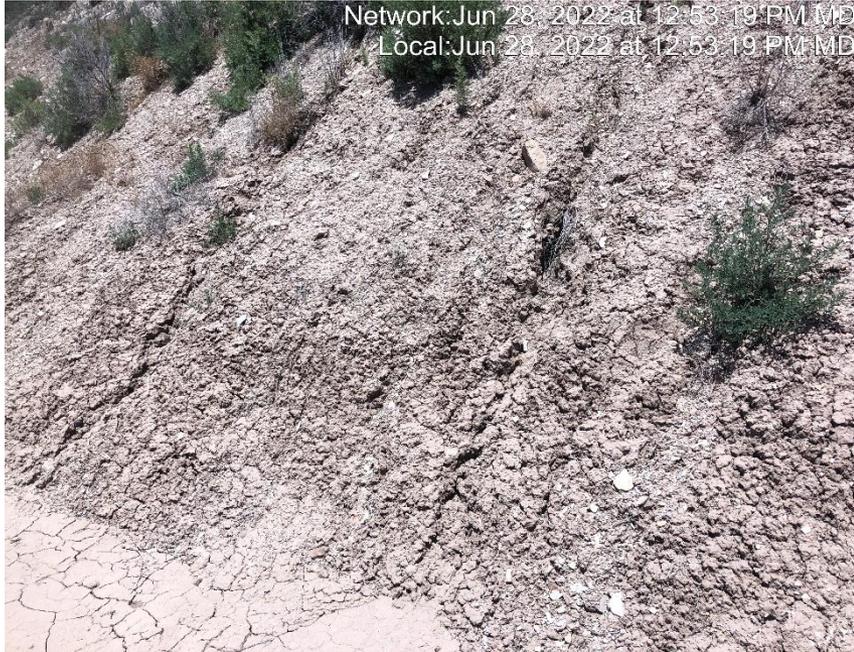
Photo #7003 Rill erosion occurring on cut slope.

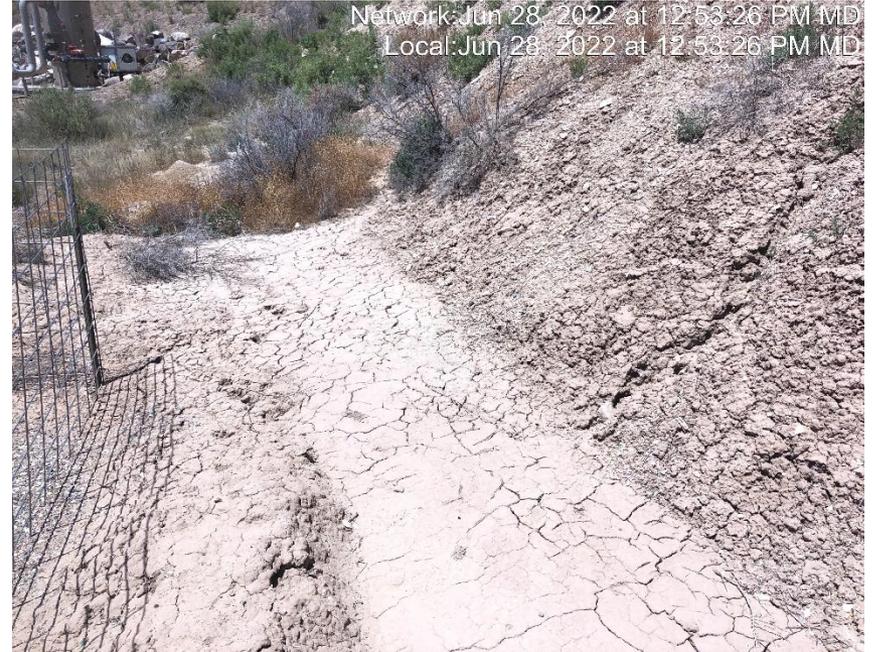
Photo #7004 Sediment migrating into ditch.

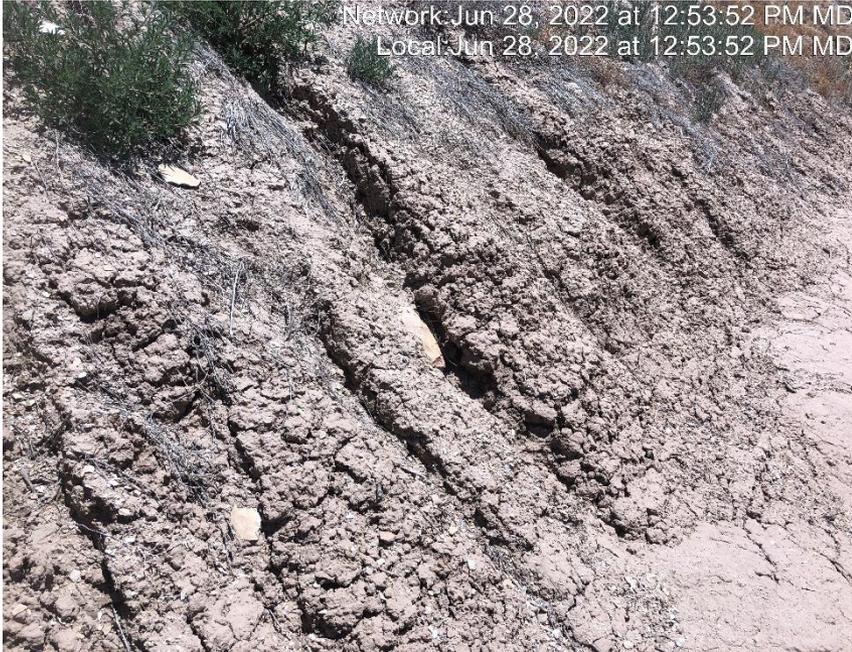
Photo #7006 Rill erosion occurring on cut slope.

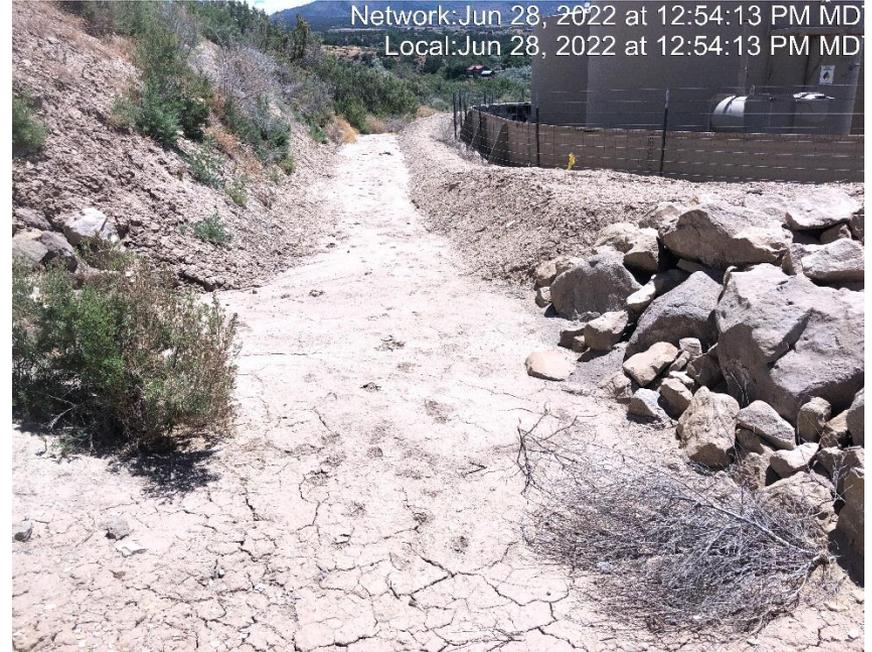
Photo #7007 Sediment migrating into ditch.

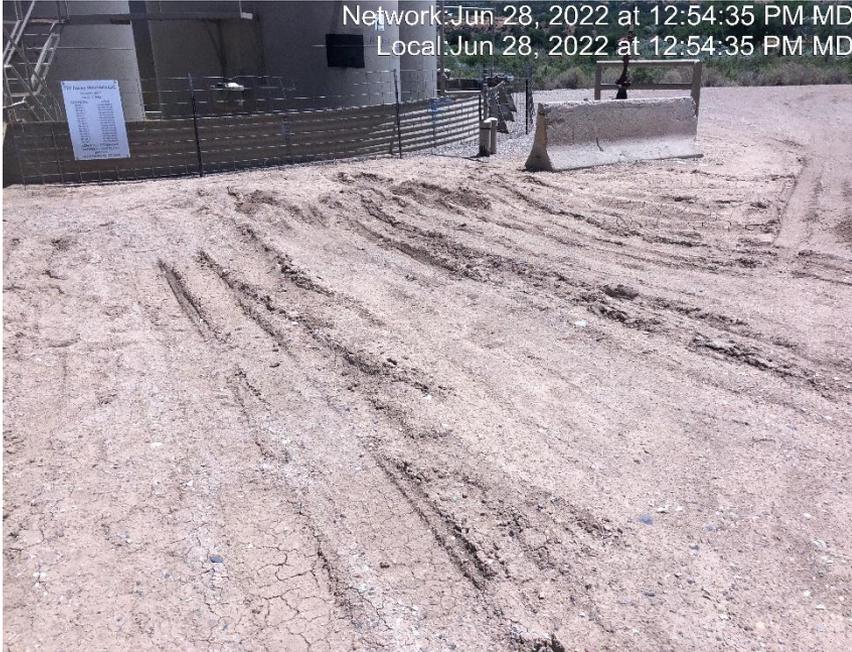
Photo #7008 Location lacks stabilization.

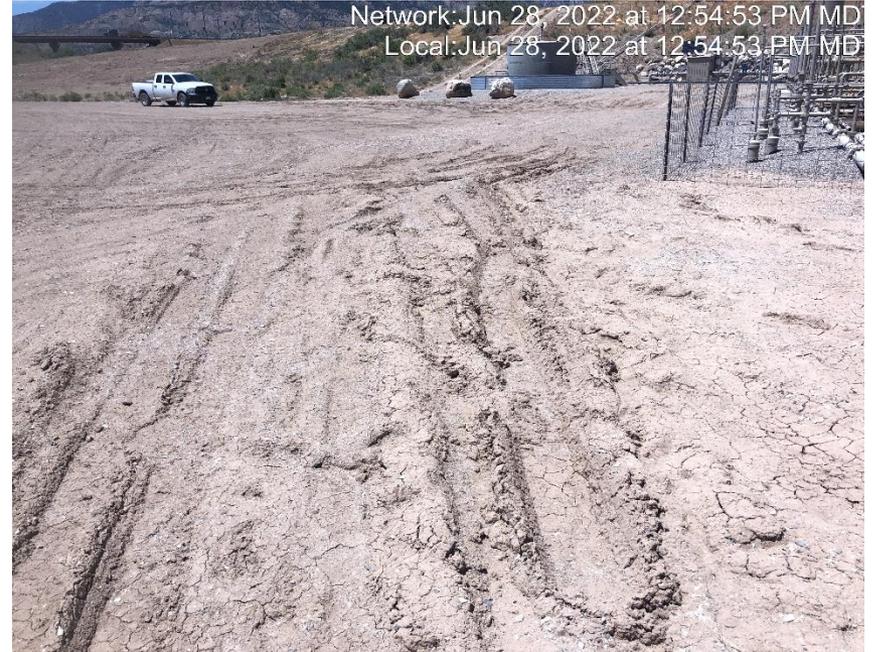
Photo #7009 Location lacks stabilization.

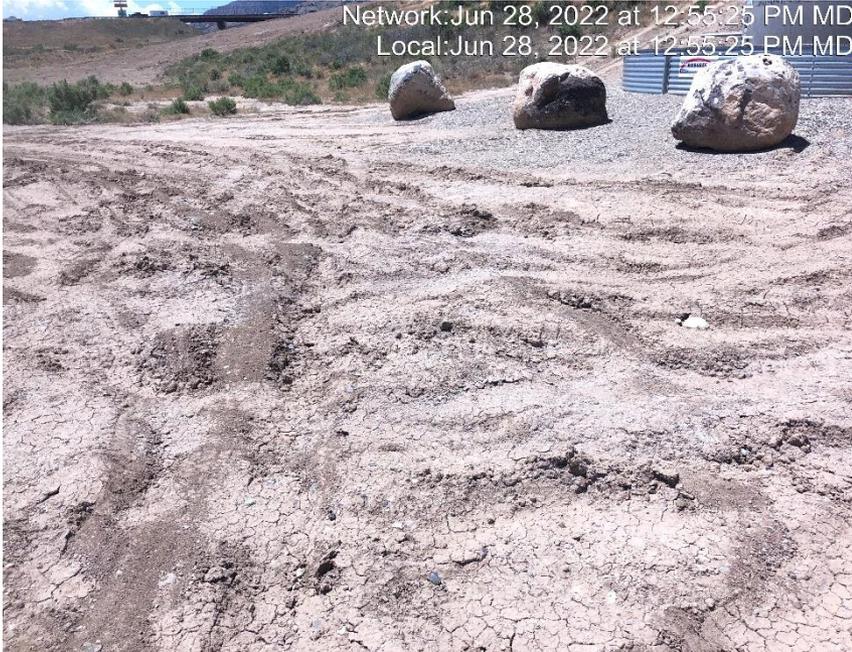
Photo #7010 Location lacks stabilization.
