Construction and Stormwater Inspection

June 16, 2022

Operator: CCRP OPERATING INC- 10665

Location ID: 455554

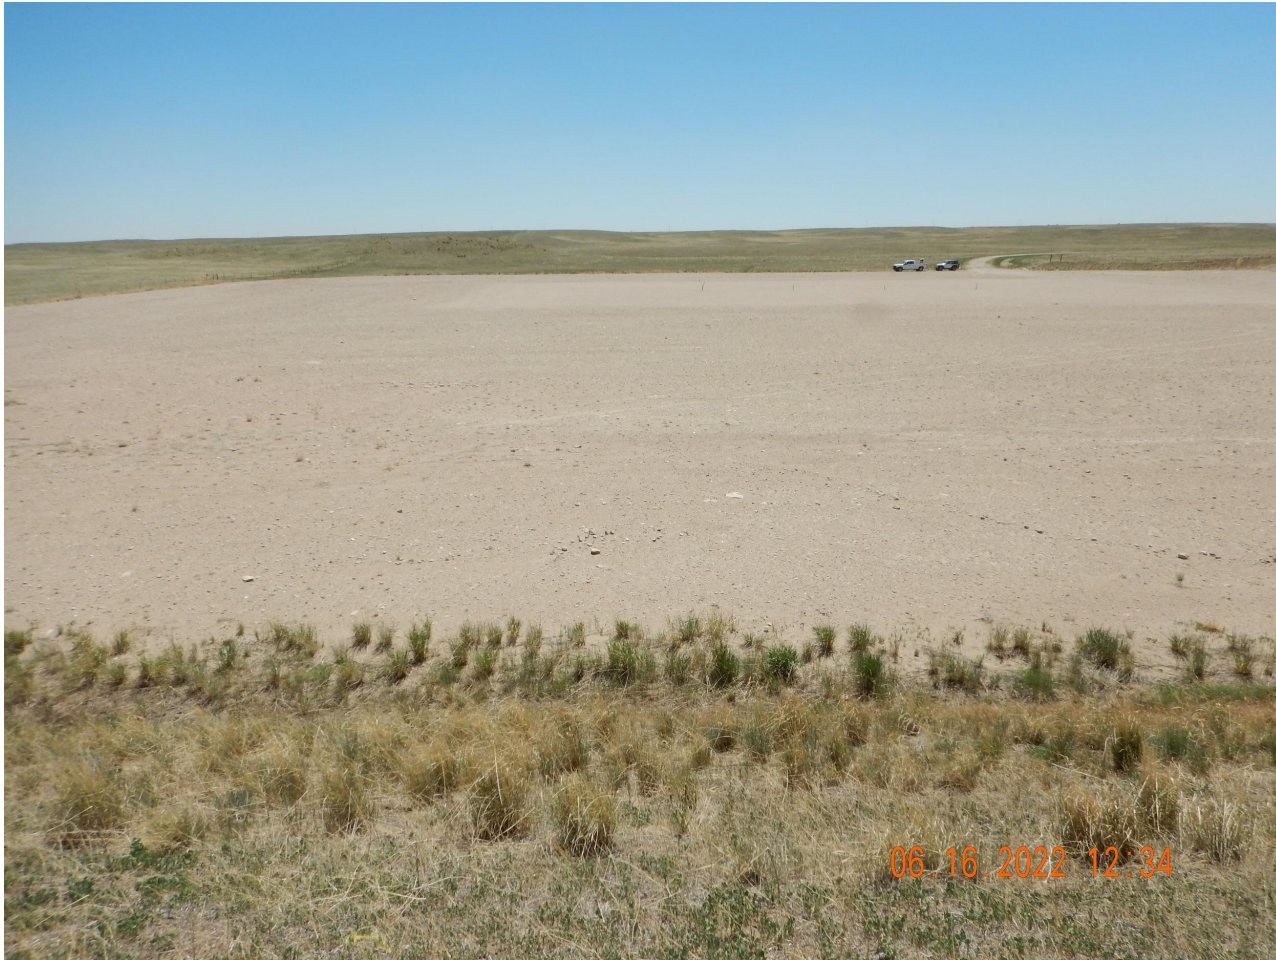
Photo 1. Photo taken from the northern location on the topsoil stockpile, facing South. Photo illustrates the Operator has not performed drilling operations.

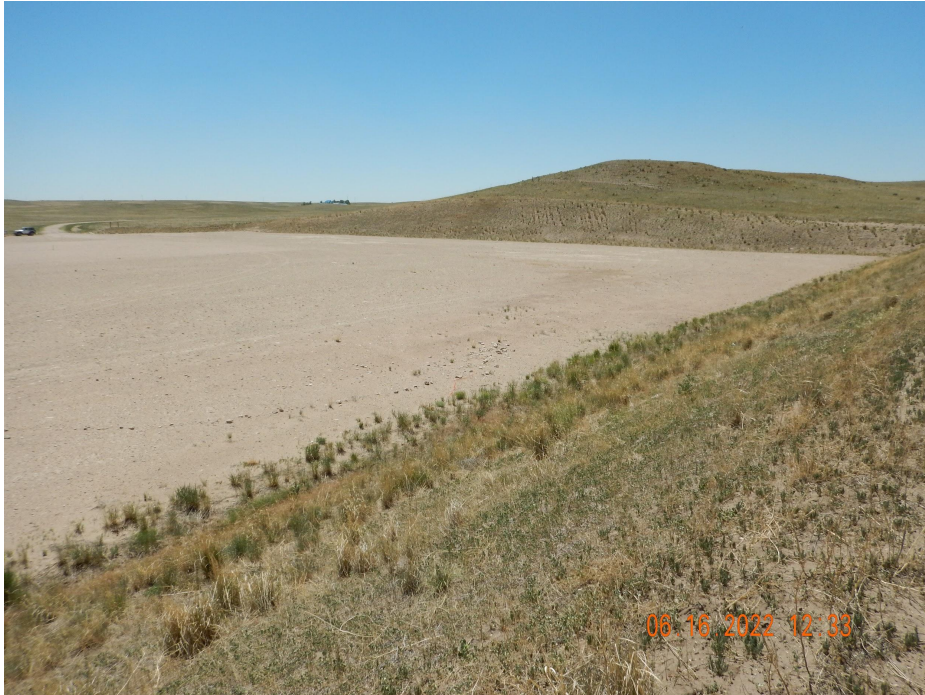
Photo 2. Photo taken from the northern location on the topsoil stockpile, facing Southwest. See comments under Photo 1.

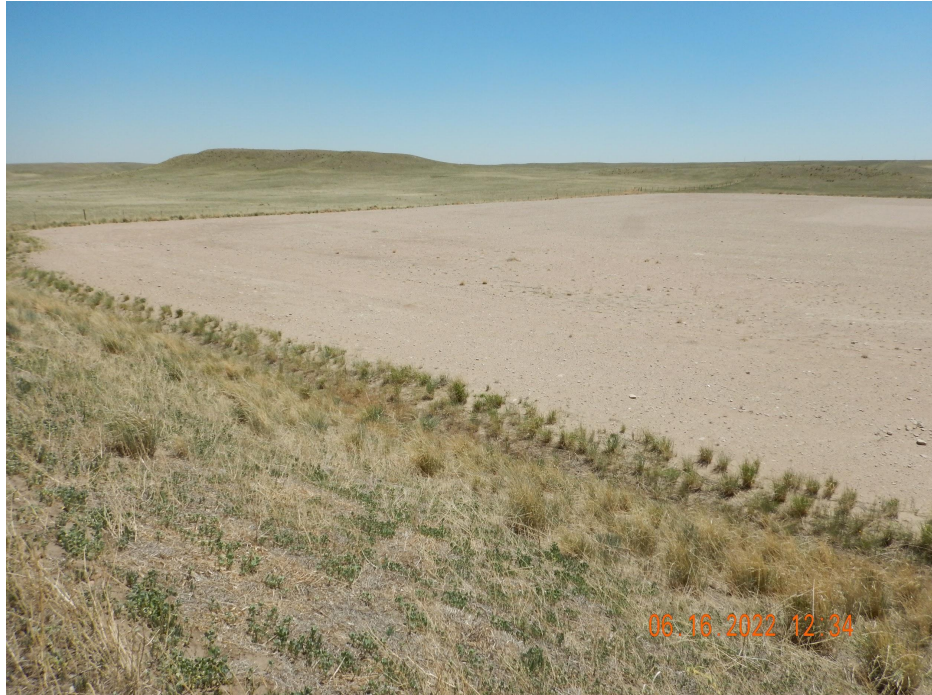
Photo 3. Photo taken from the northern location on the topsoil stockpile, facing Southeast. See comments under Photo 1.

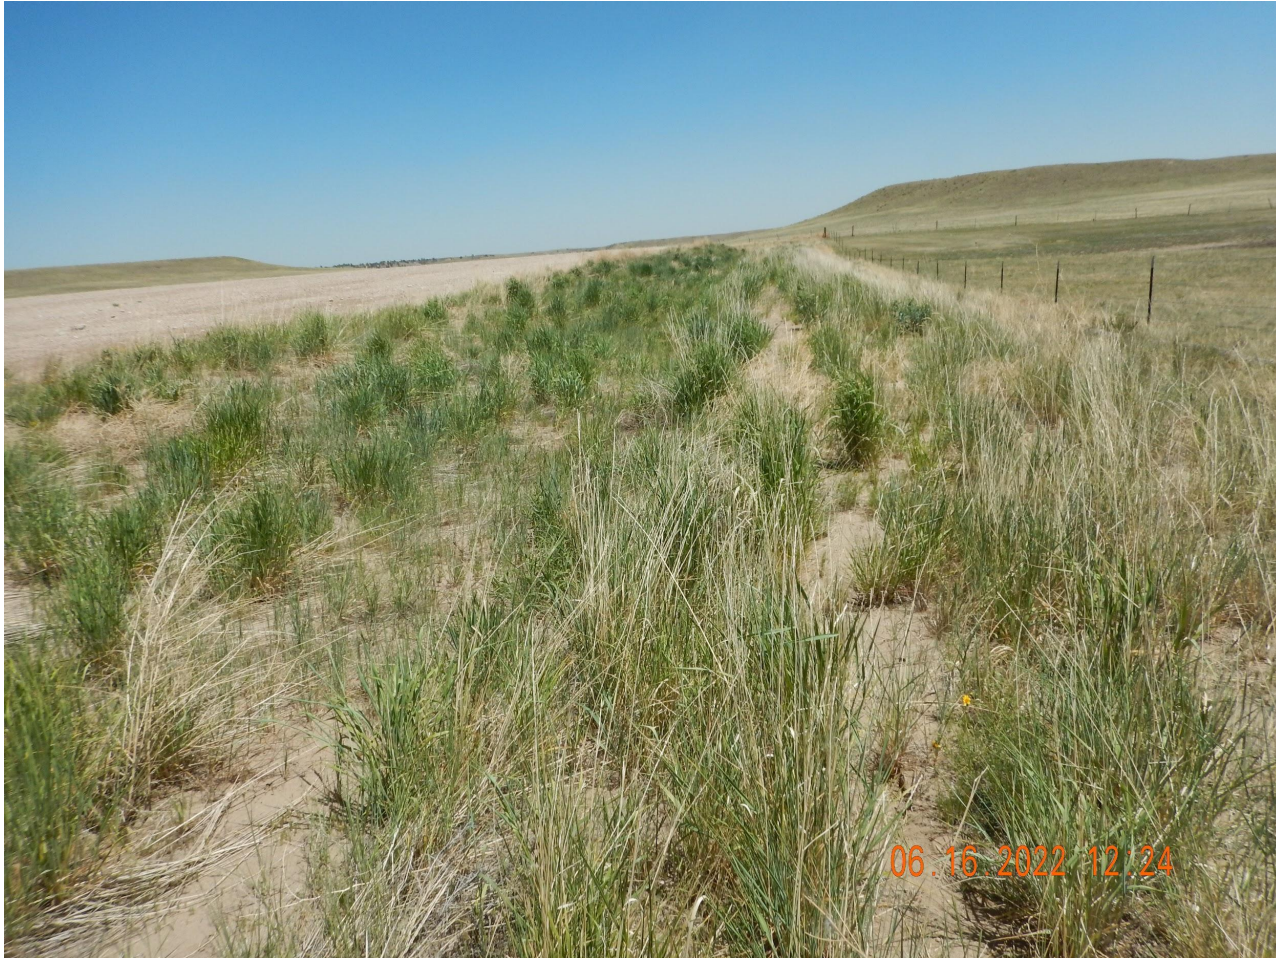
Photo 4. Photo taken from the southern location, facing East. Photo illustrates the vegetative growth that is both native and introduced plant species.

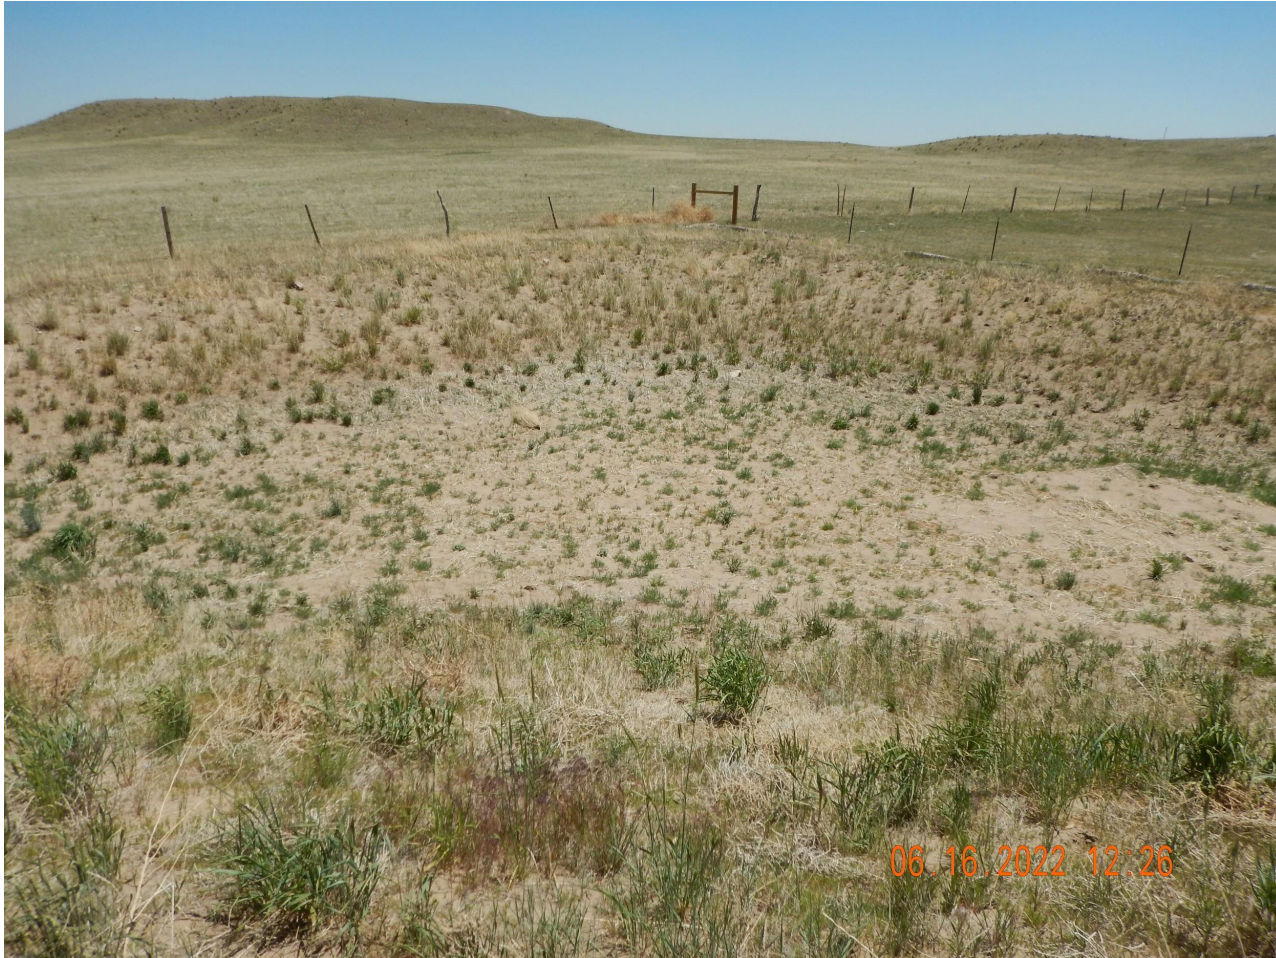
Photo 5. Photo taken from the southeastern location, facing East. Photo illustrates the detention pond that is in proper functioning condition.

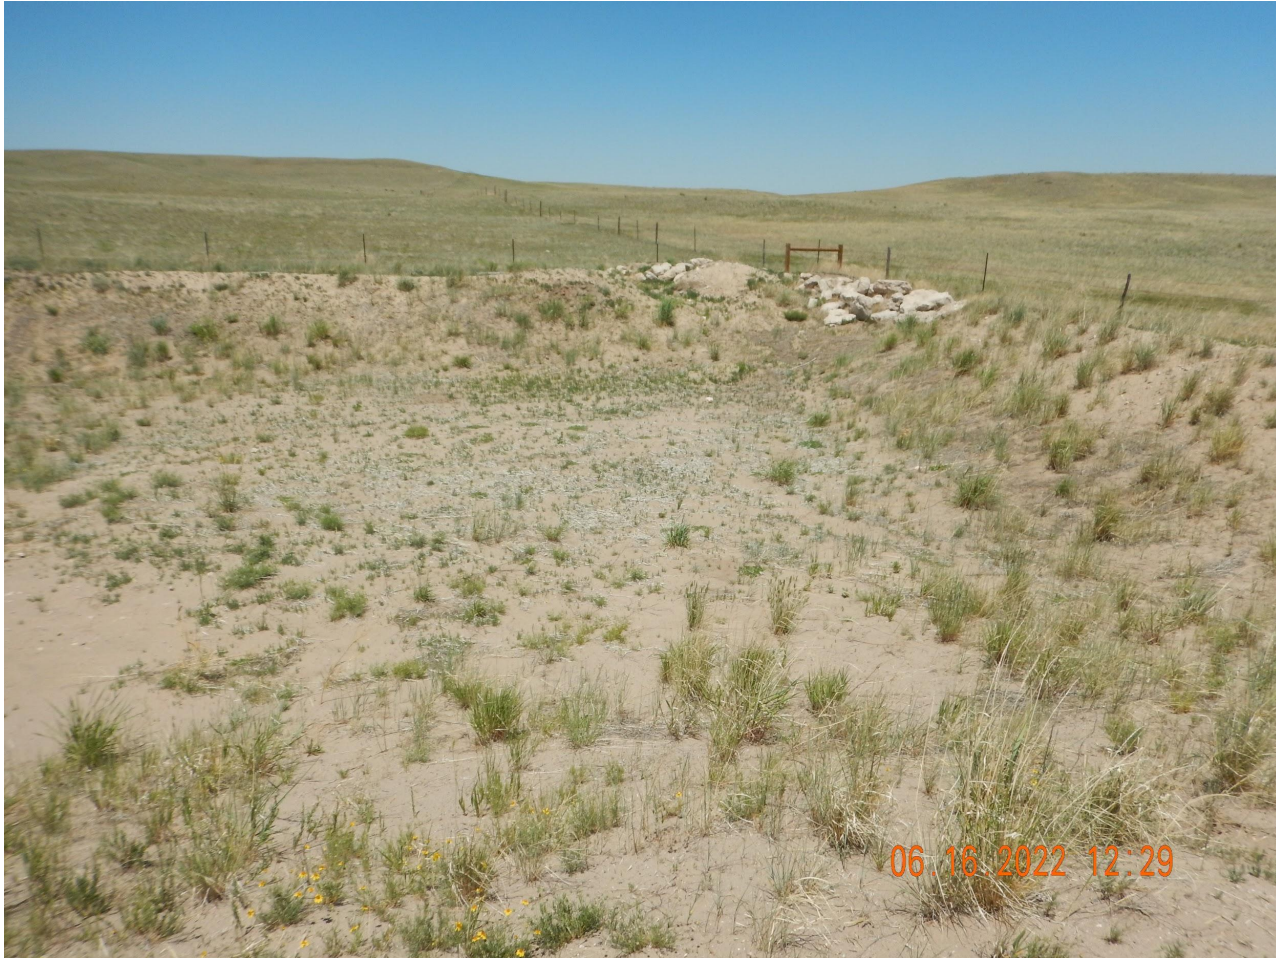
Photo 6. Photo taken from the northeastern location, facing Northeast. Photo illustrates the detention pond that is in proper functioning condition.

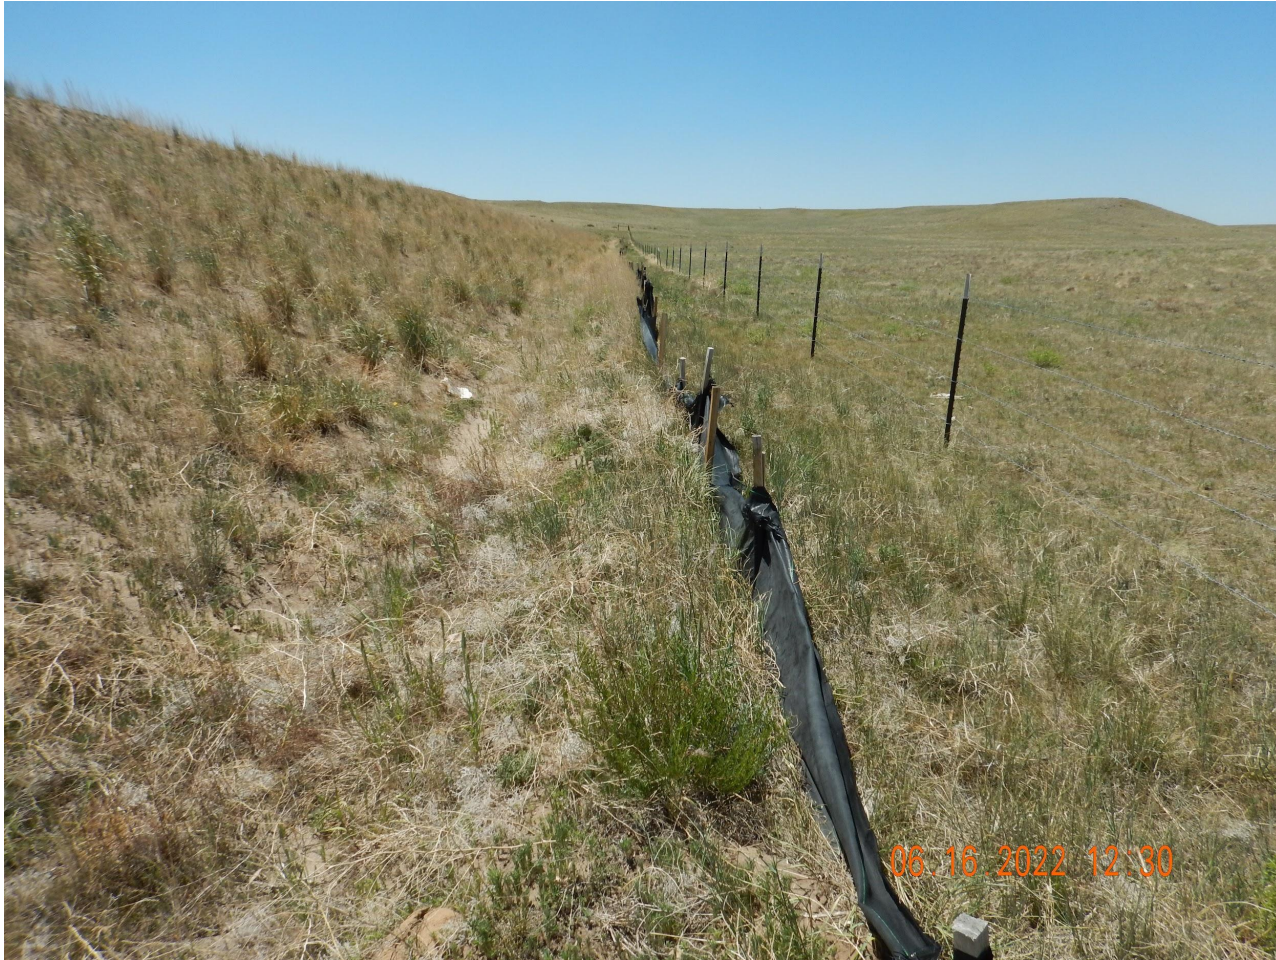
Photo 7. Photo taken from the northeastern location, facing West. Photo illustrates a silt fence BMP is disrepair. There appears to be sufficient vegetative growth that the silt fence may not be needed any further since there is a ditch BMP to the interior that is directed to a detention area.

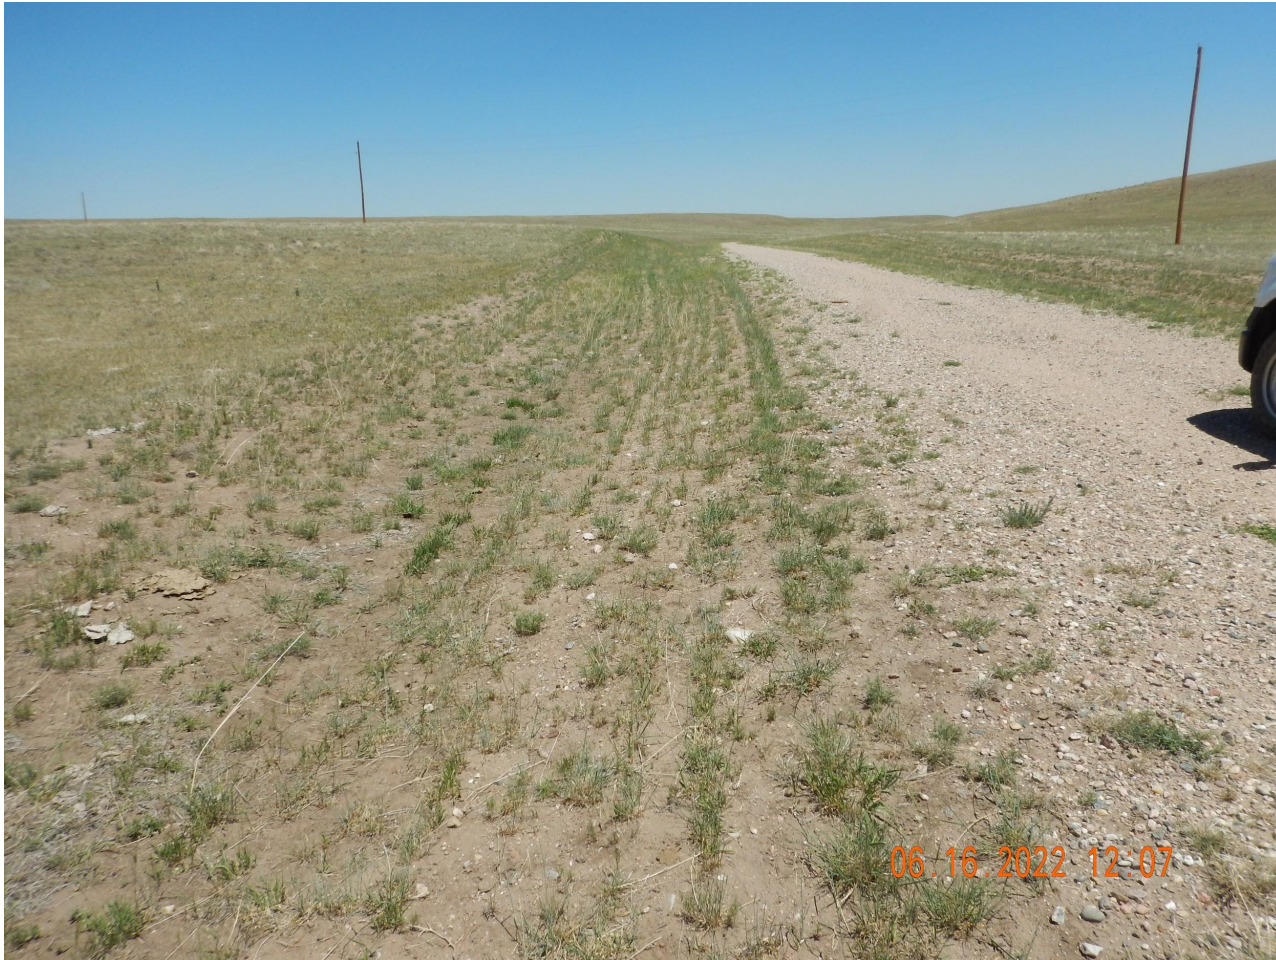
Photo 8. Photo taken from a portion of the main lease road, facing East. Photo illustrates desirable vegetation is observed but cheatgrass is starting to establish along areas of the access road.

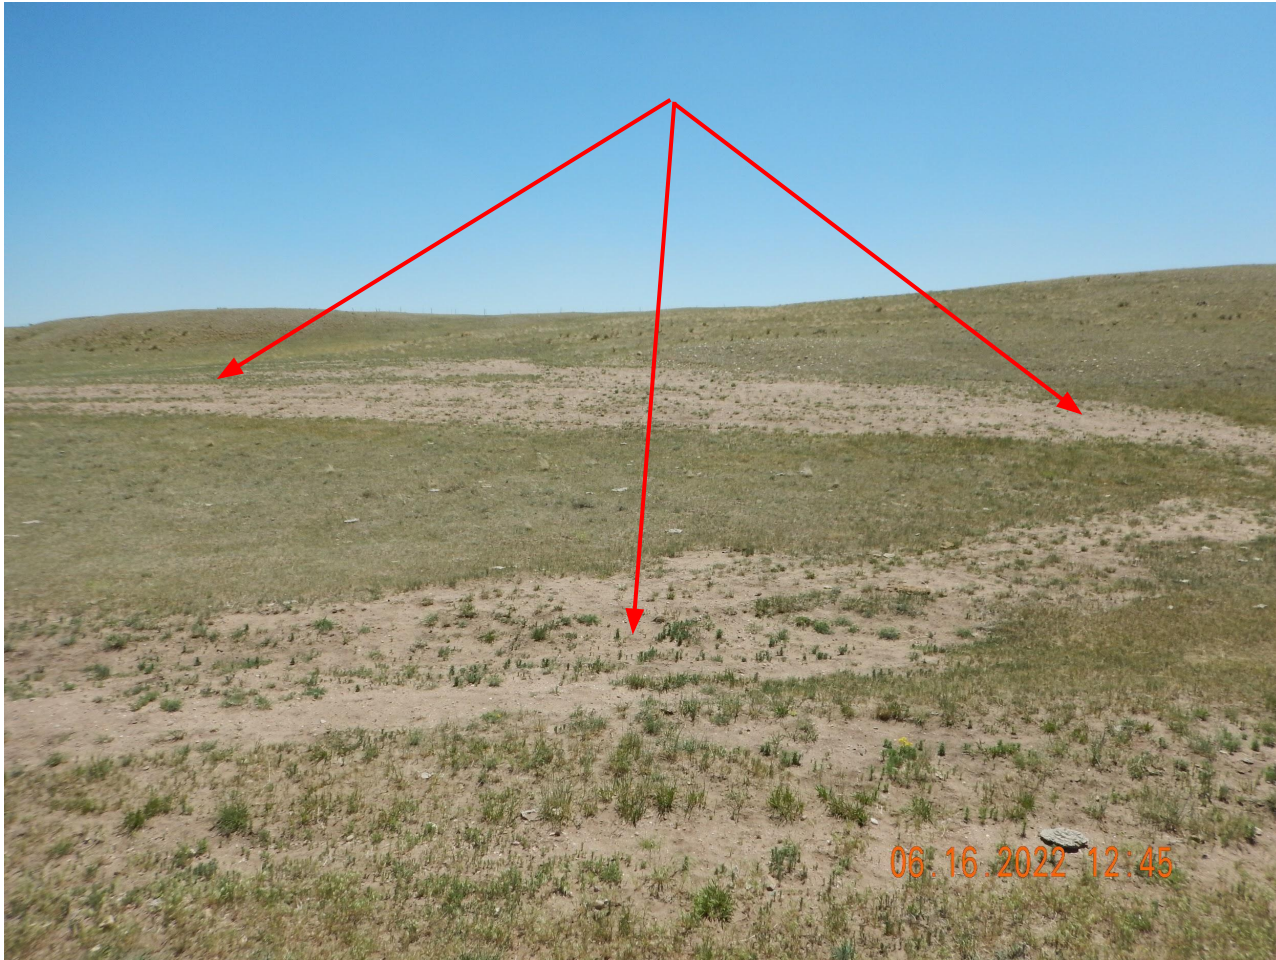
Photo 9. Photo taken from a portion of the main lease road (approximately halfway), facing Southeast. Photo illustrates an area where topsoil was stockpiled from the access road. This area will need to meet Rule 1004 vegetative standards.
