Inspection Photos

API: 055-06142

Operator: CAPTUREPOINT LLC

Inspection Date: 7/1/2022

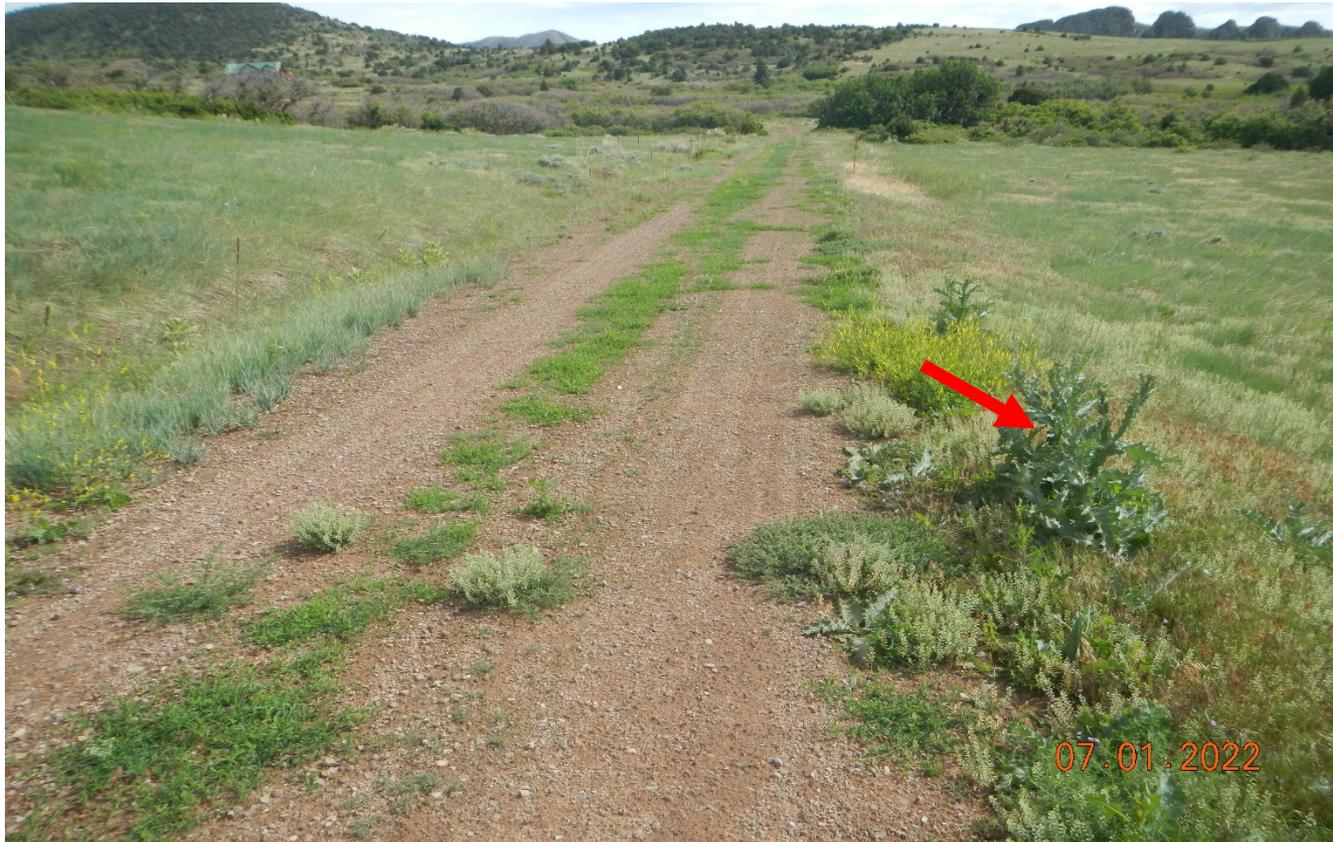
Photo 1. Facing north along the access road. There are noxious weeds along the road that need to be controlled. Red arrow → Scotch thistle

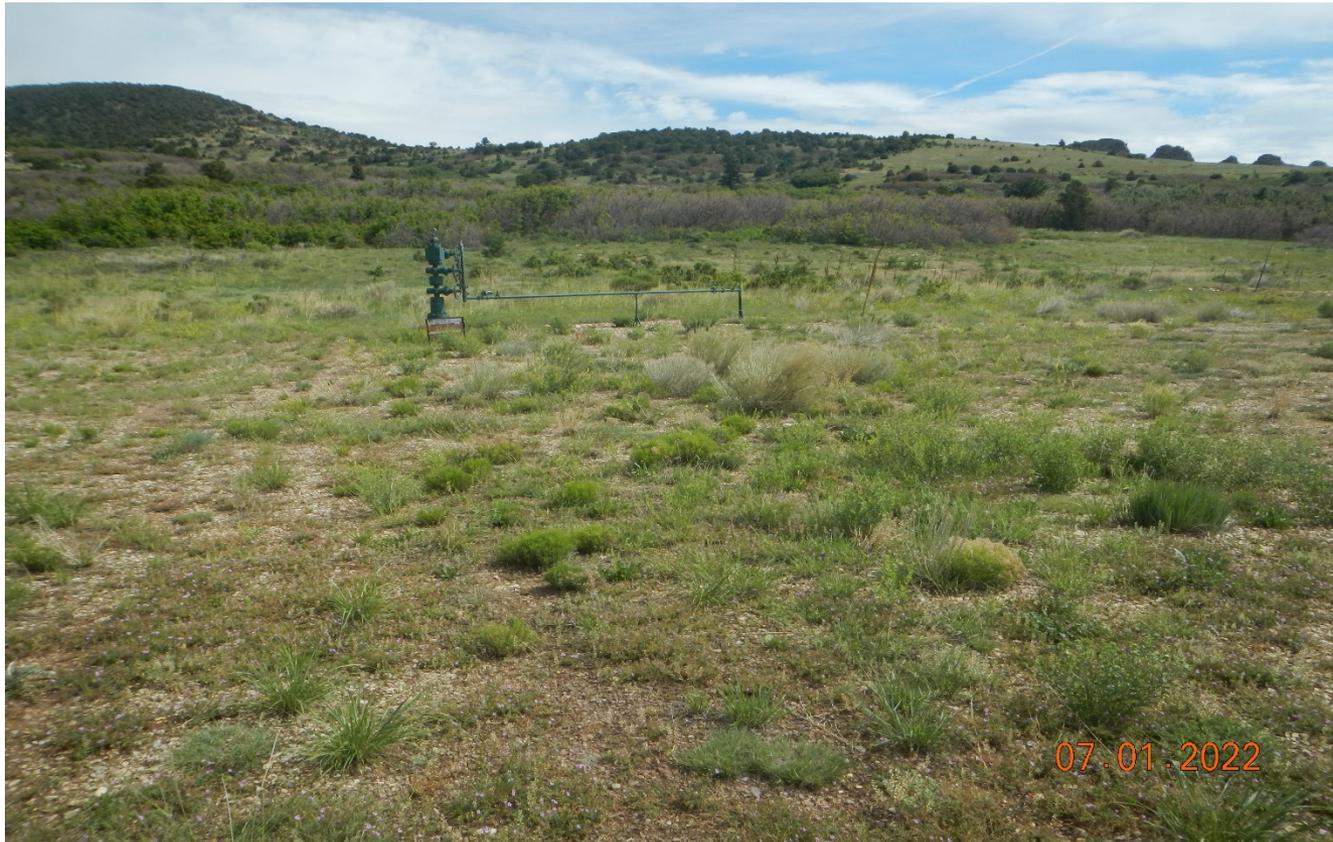
Photo 2. Facing northeast toward the multi well site.

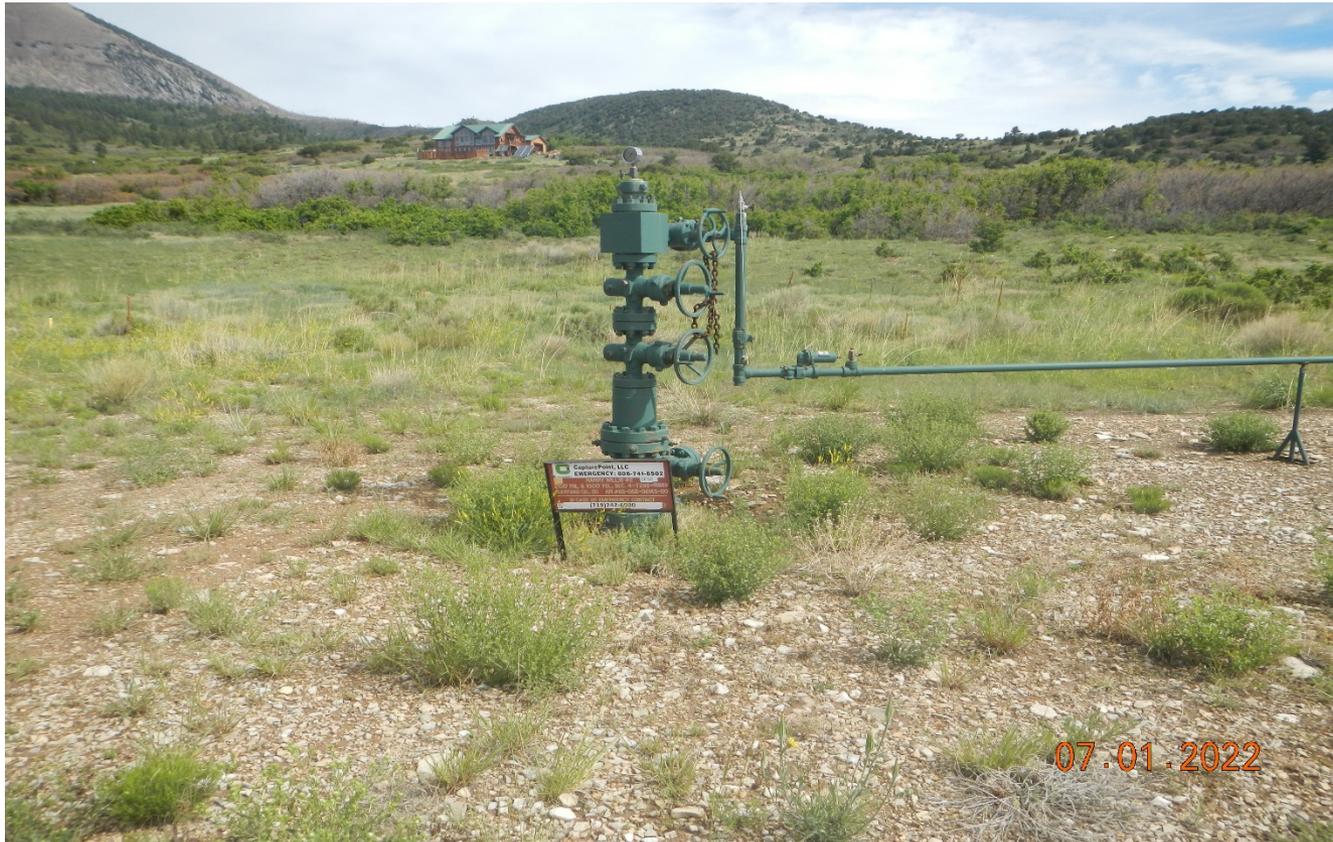
Photo 3. Well sign is posted at the well head and has been updated with current operator INFO.

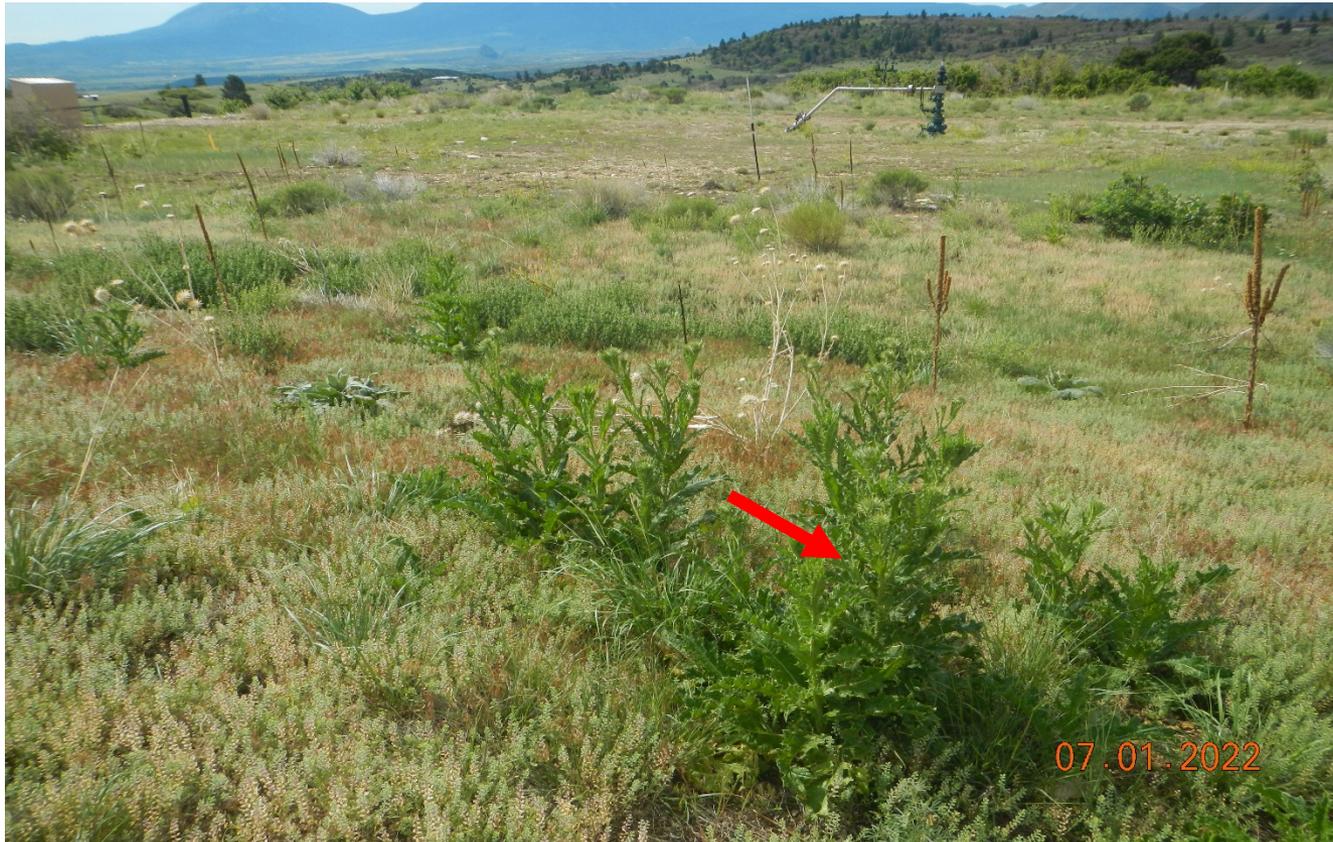
Photo 4. Facing toward the north side of the location. There are noxious weeds along the north side of the location that need to be controlled. Red arrow → Musk thistle
