Inspection Photos
Location Name: Huber Crook 4-26
Location ID: 326530

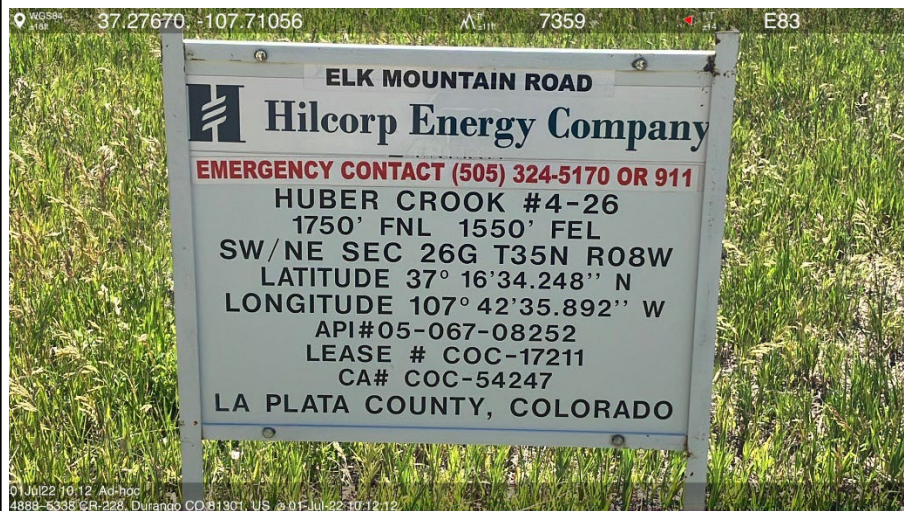
IMG 01
Well sign

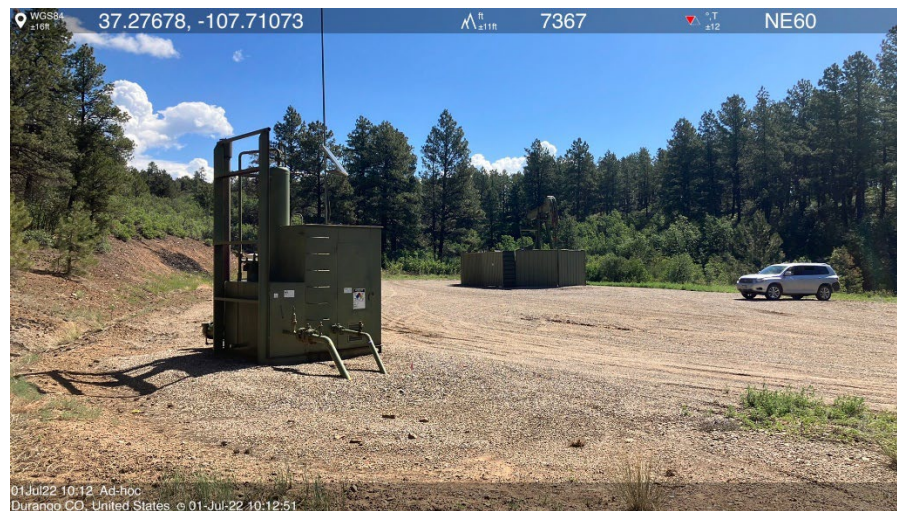
IMG 02
Location overview

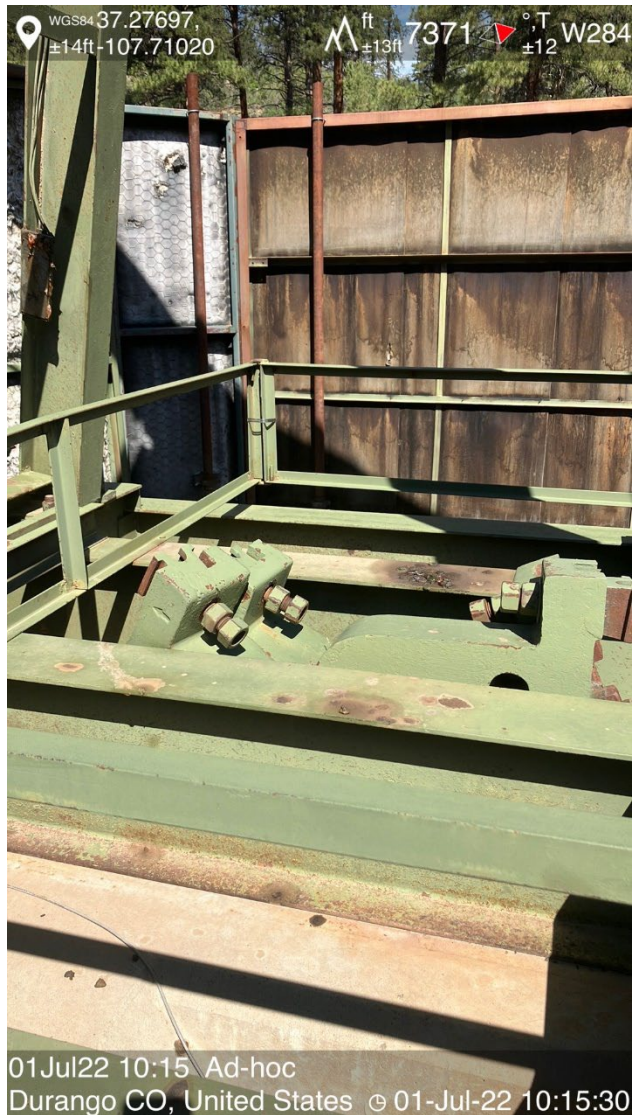
IMG 03

Unused equipment

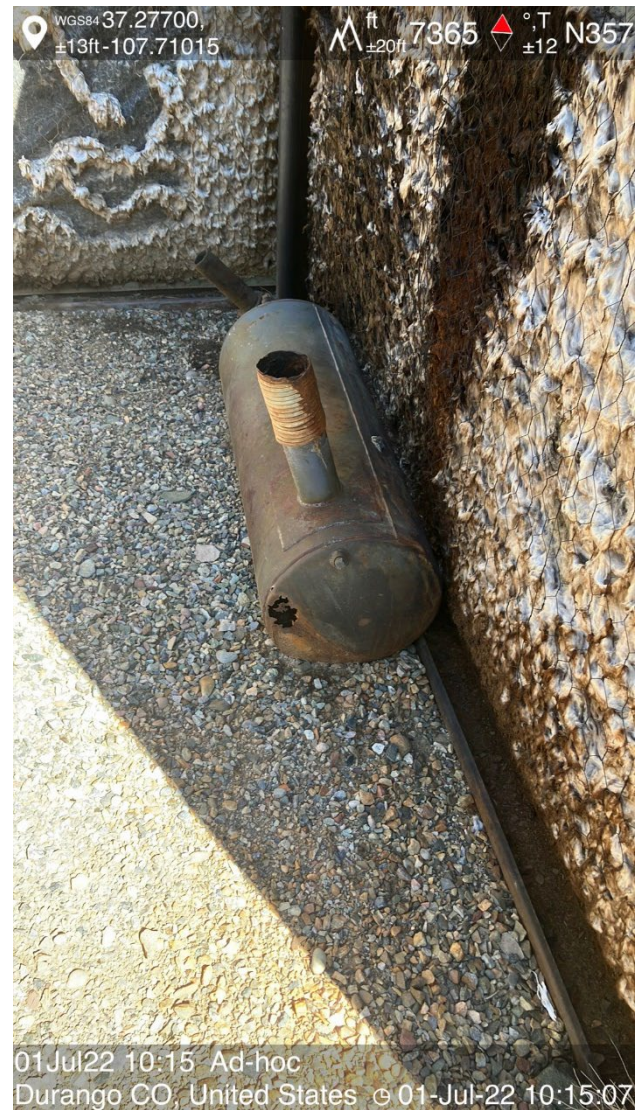
IMG 04

Unused equipment

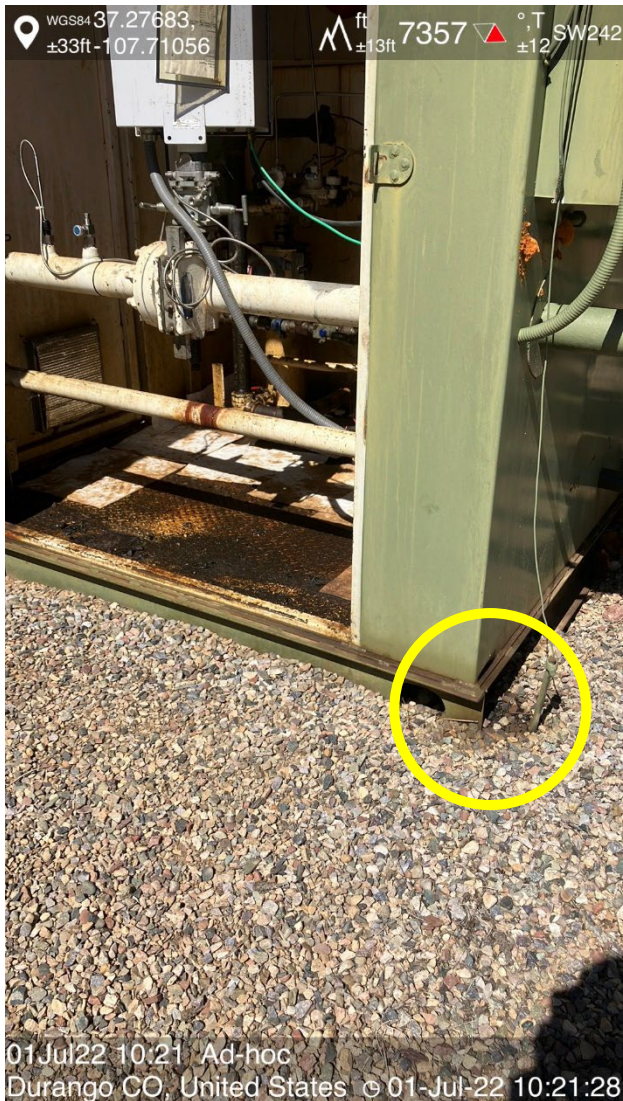
IMG 05

Lube oil on gas meter run/separator house floor has begun to impact surface material

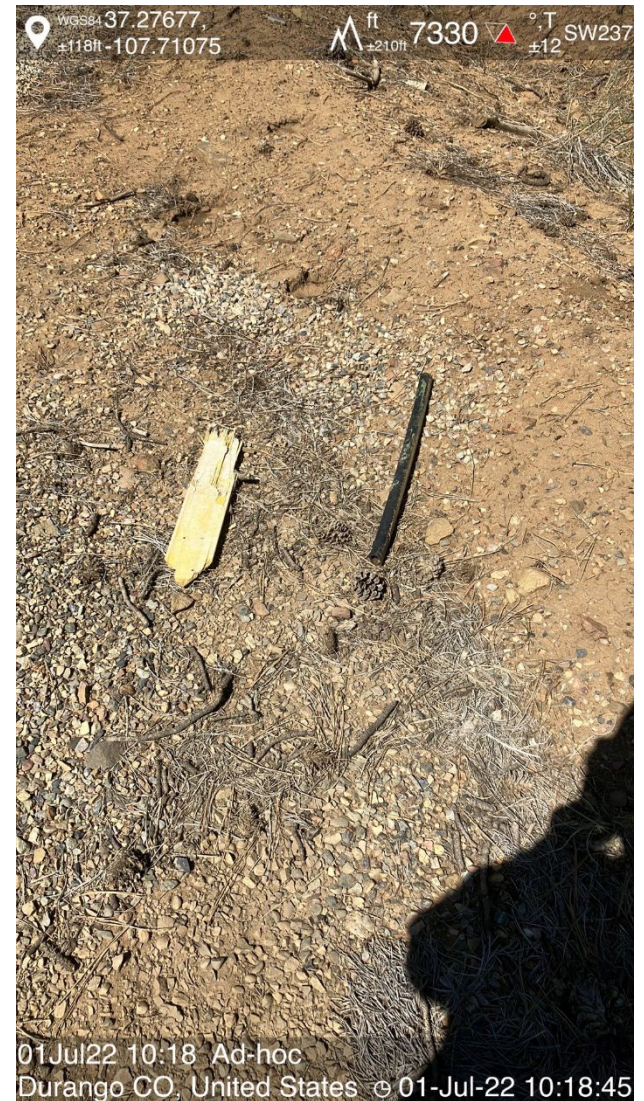
IMG 06

Trash near separator house

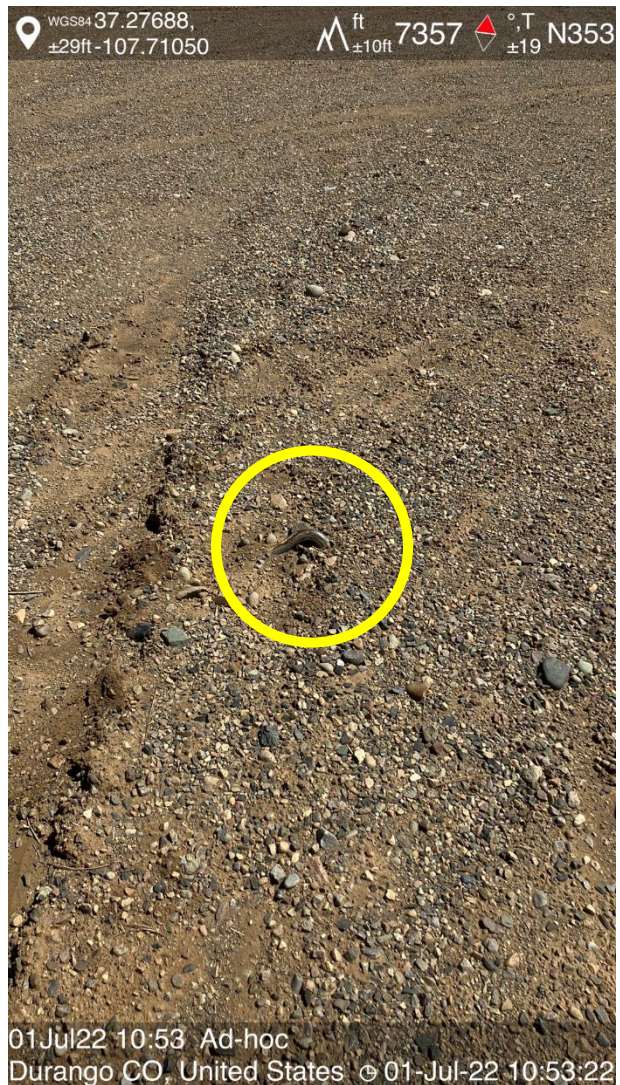
IMG 07

Rig anchor not marked
