Inspection Photos

API: 055-06301

Operator: CAPTUREPOINT LLC

Inspection Date: 7/1/2022

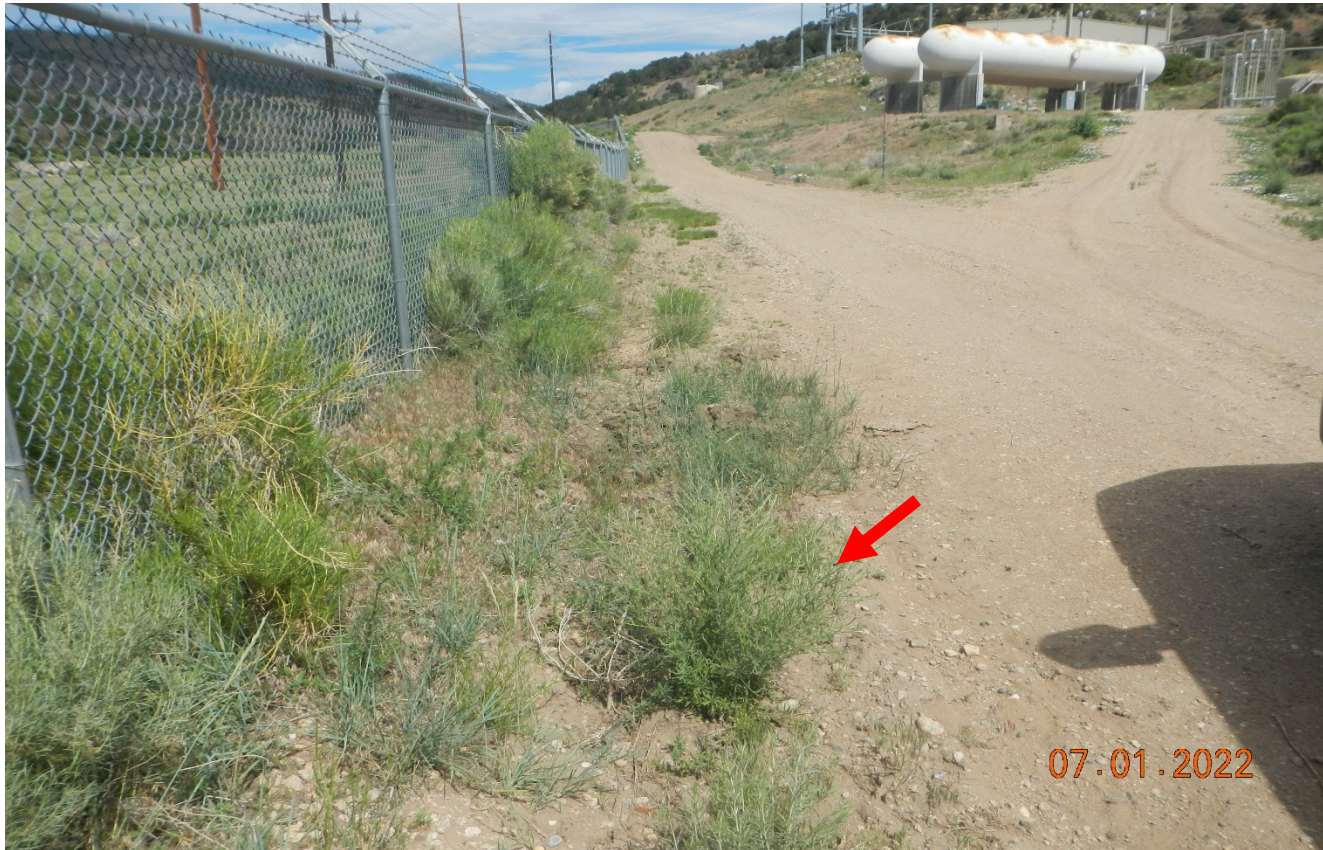
Photo 1. Facing west at the entrance of the Gas Plant. There are noxious weeds along the road that need to be controlled. Red arrow → Diffuse knapweed.

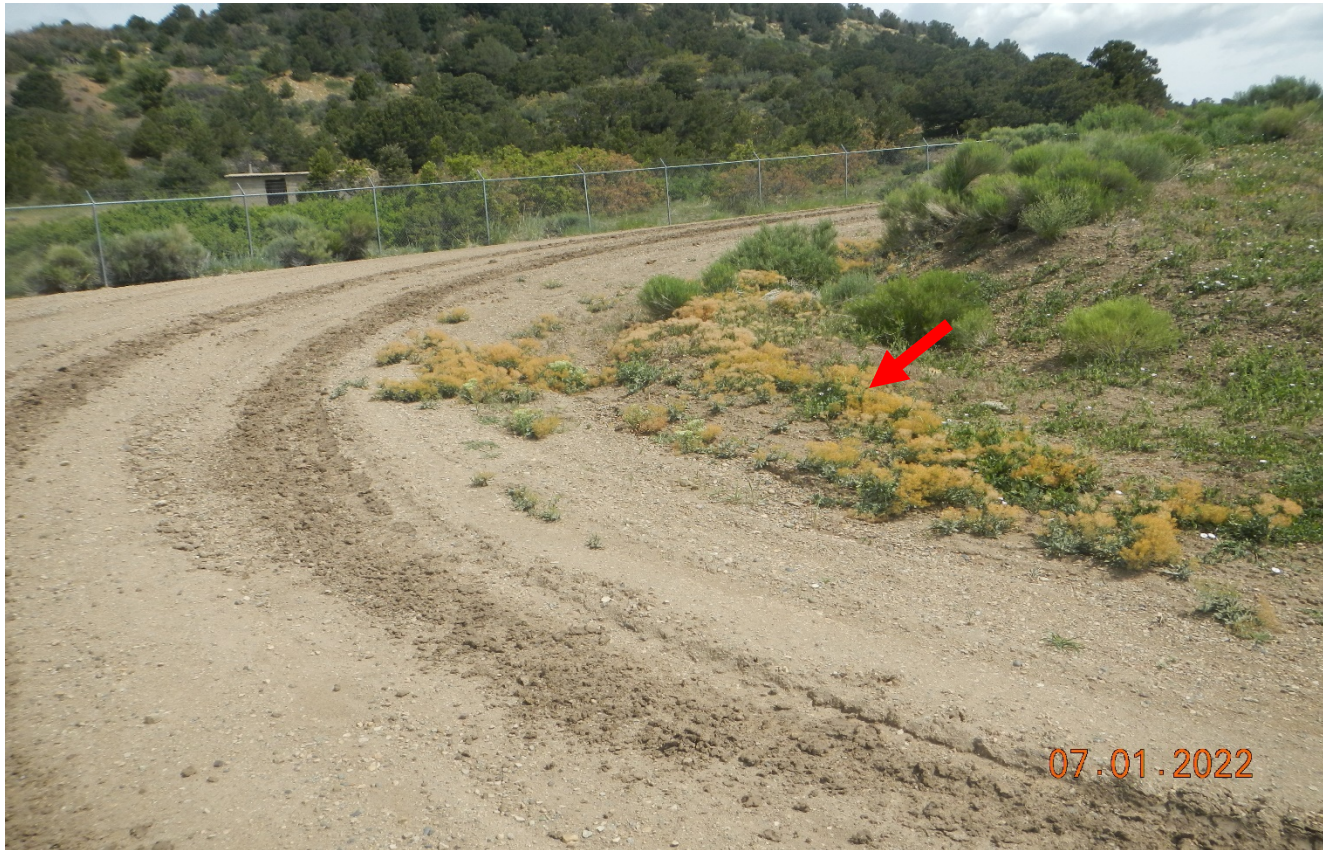
Photo 2. Facing west at the entrance of the Gas Plant. There are noxious weeds along the road that need to be controlled. Red arrow → Hoary Crest.

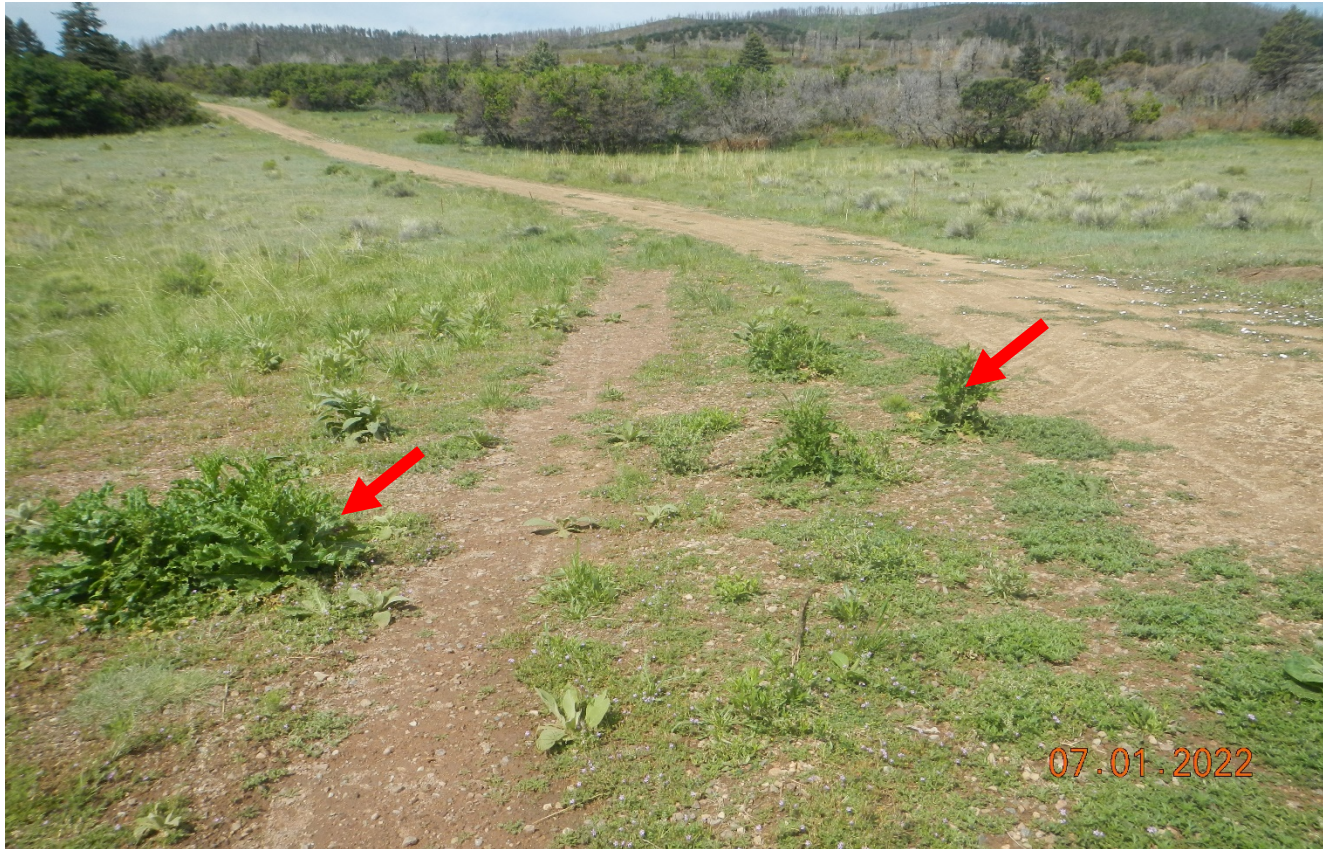
Photo 3. Facing southwest along the access road. There are noxious weeds that need to be controlled. Red arrow → Musk thistle.

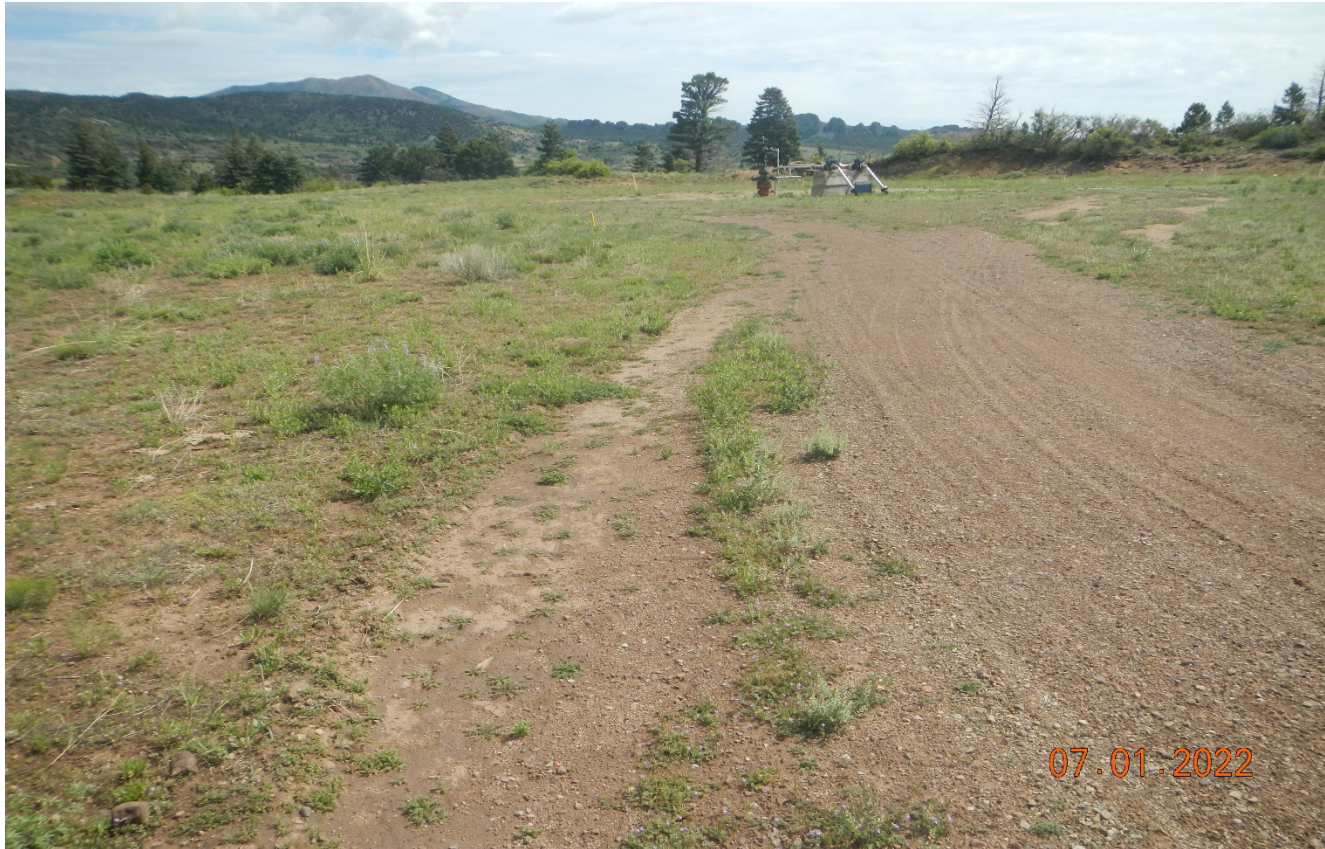
Photo 4. Facing northeast toward the well site.

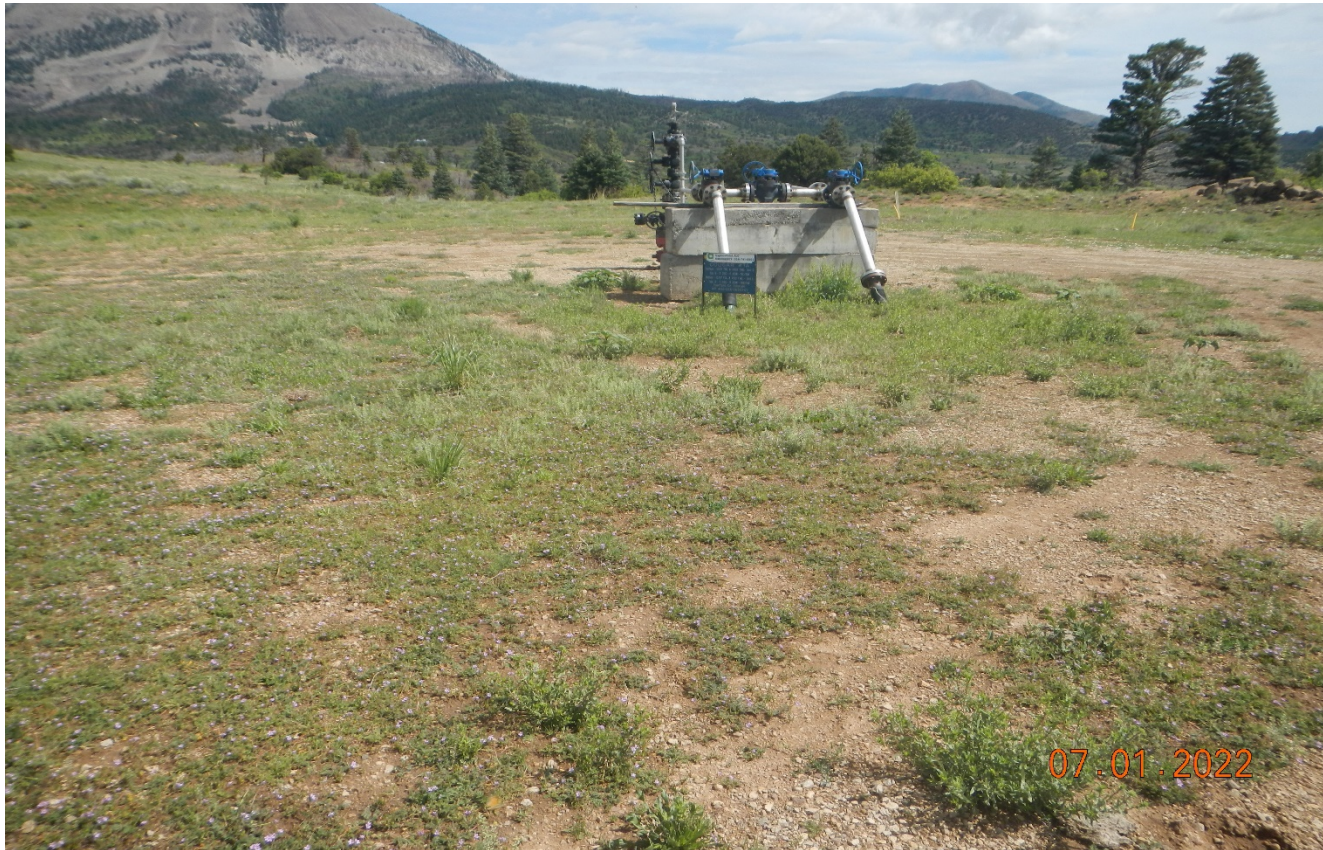
Photo 5. Well sign is posted at the well head and has been updated with current operator INFO.

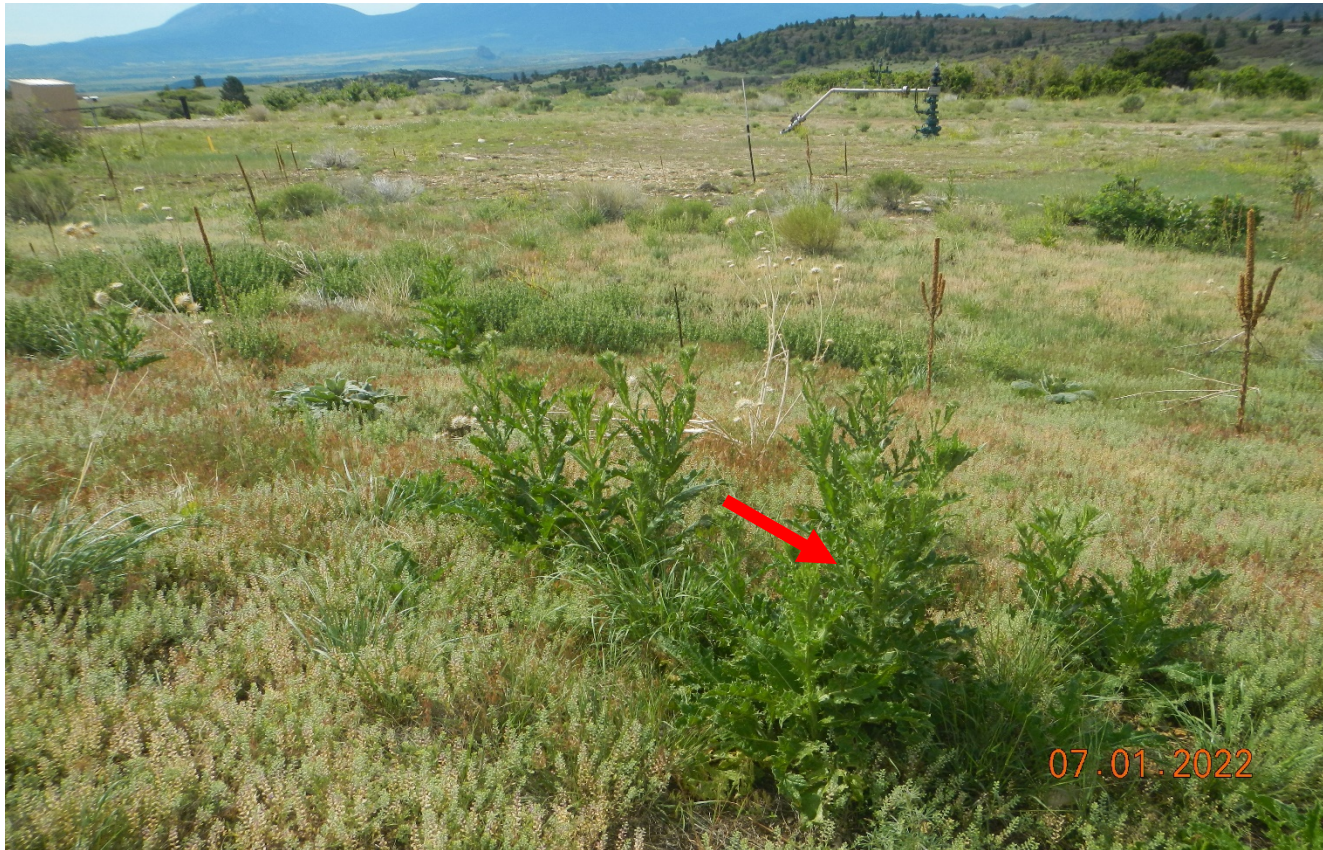
Photo 4. Facing toward the north side of the location. There are noxious weeds along the north side of the location that need to be controlled. Red arrow → Musk thistle
