Inspection Photos
Kern UPPR 41-5 1 O SA Facility
Spill ID 482122 (CL) /Remediation Project No 22664

Inspection Photos
Boulter Tank Battery Spills
Spill ID 481624 (CL) & 481638 (CL)/Remediation Project No 21306

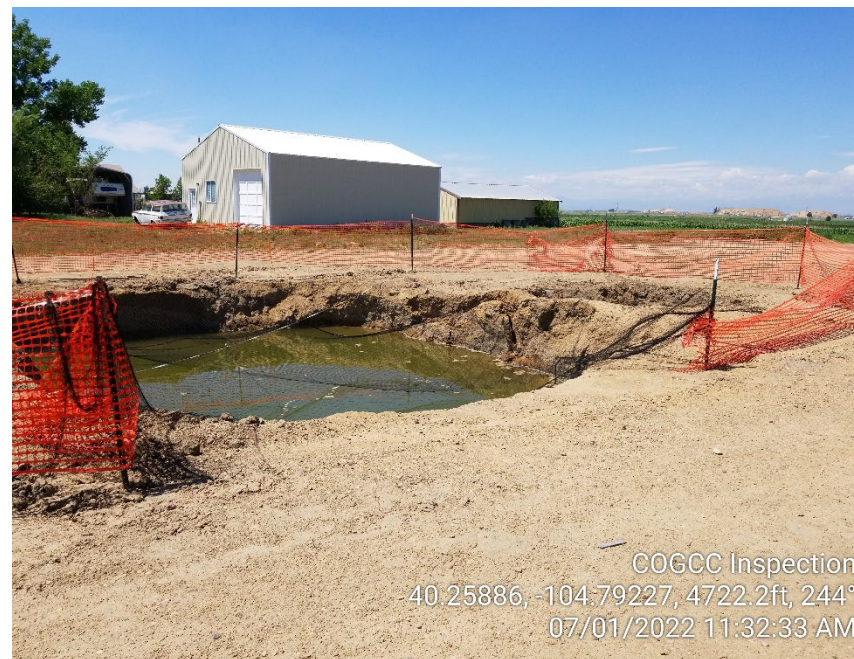
**Photo 2 – Location photo. Fencing is down.
Groundwater observed in open excavation.
Groundwater is covered with bird netting.**

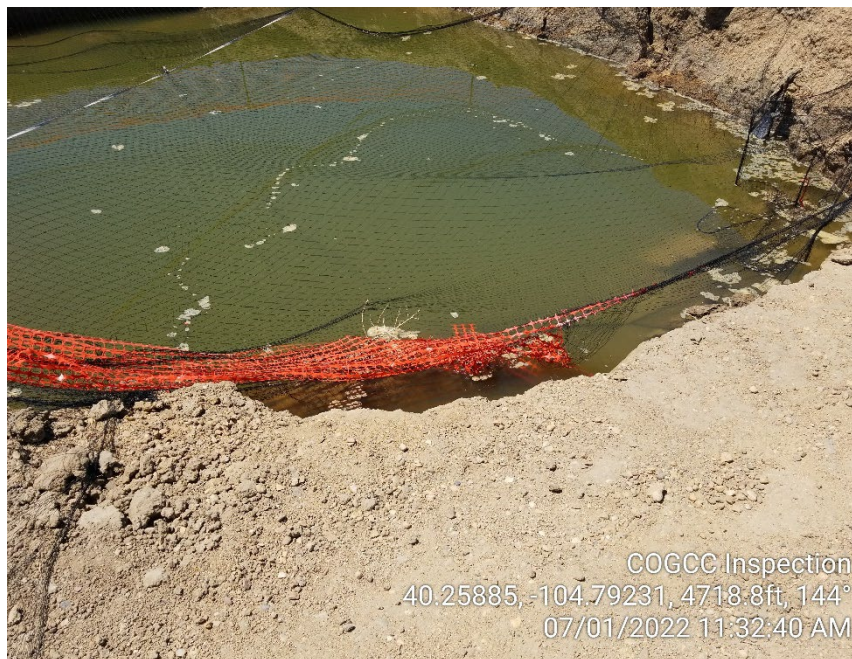
Photo 3 – Downed fencing in open excavation.

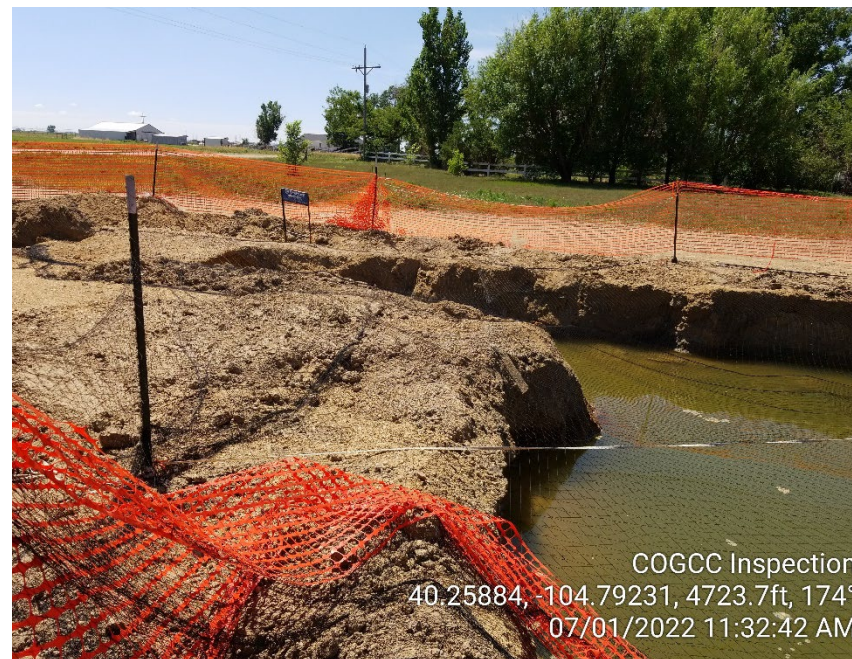
Photo 4 – Open excavation.

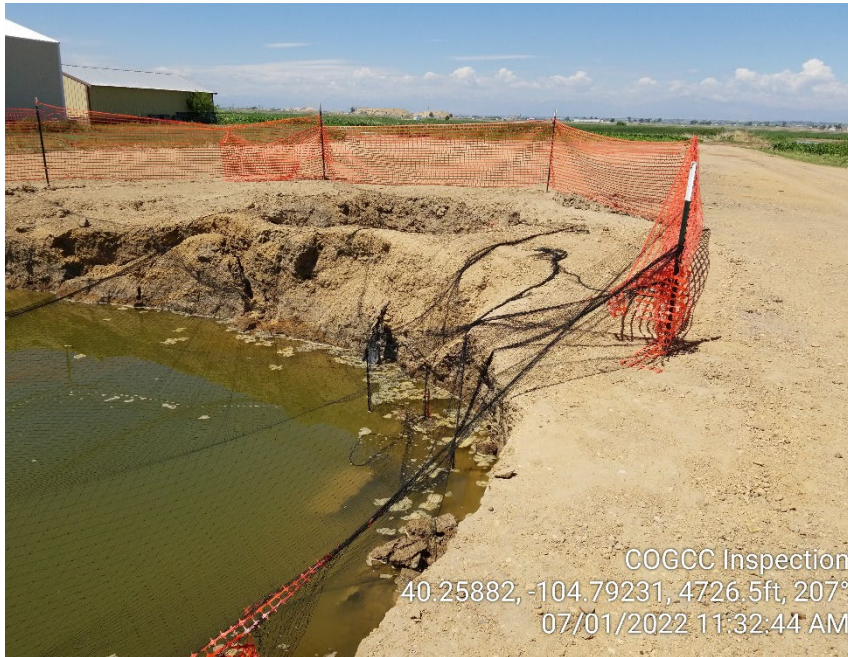
Photo 5 – Open excavation

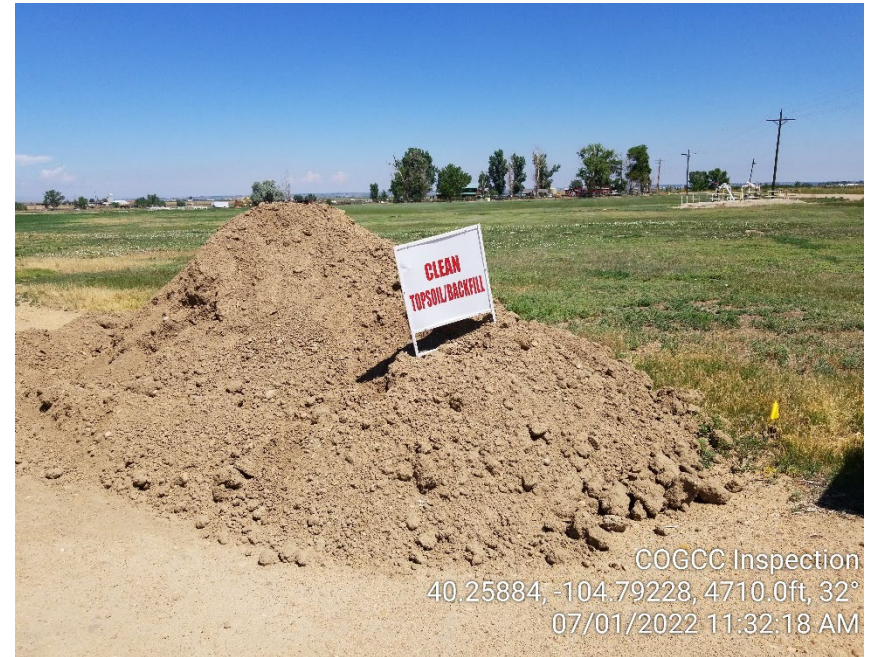
Photo 6 – Clean stockpiled soils on location.
