| Well Name: | SEVER 1 | Location: | Sec: 13 | Twn: 032N | Rng: 010W | UL: H |
| INC Number: | 702500134 | Agency: | COGCC | Inspector: | Alex Klink | |

Subject: RE: SEVER 1 - INC - 702500134

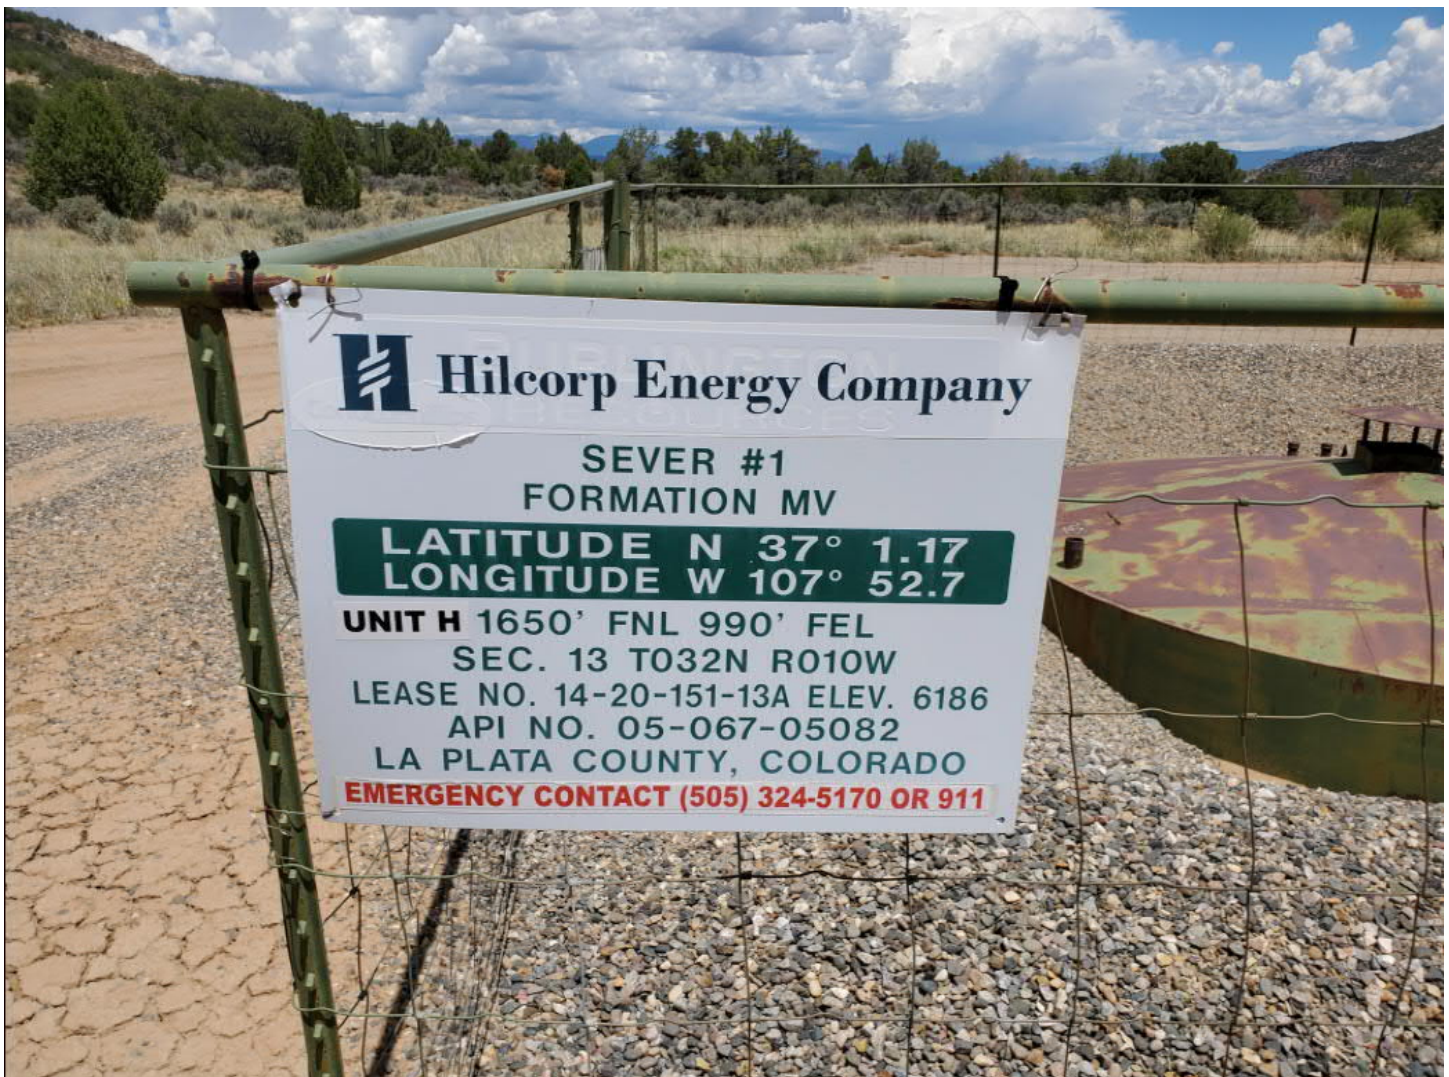
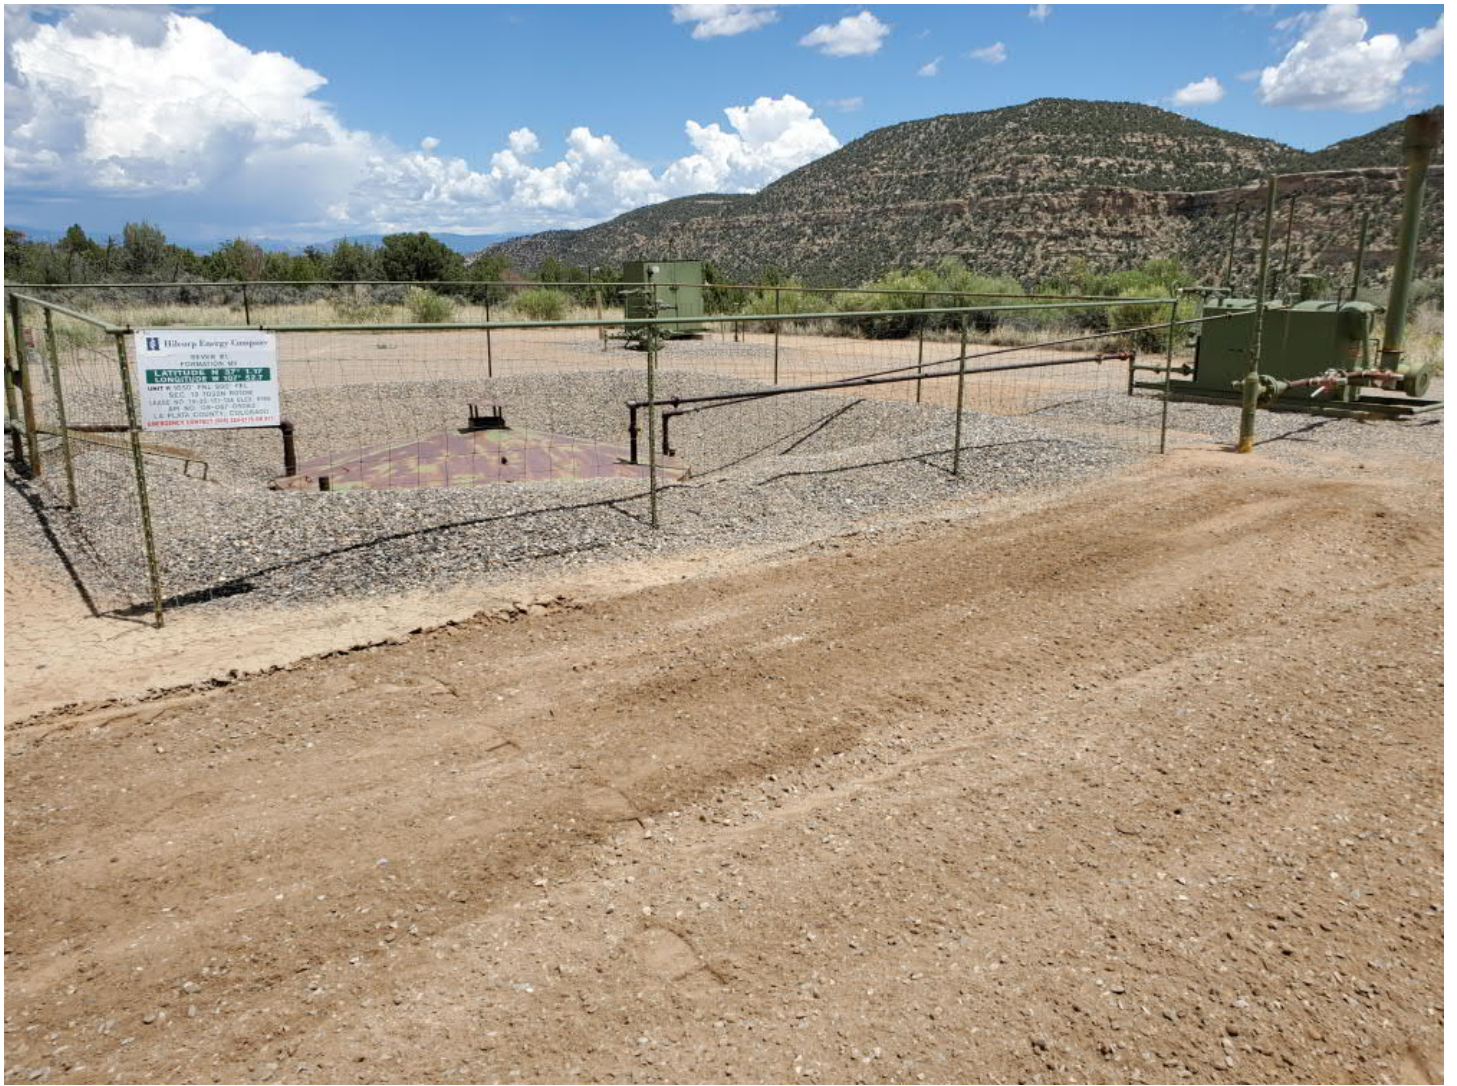
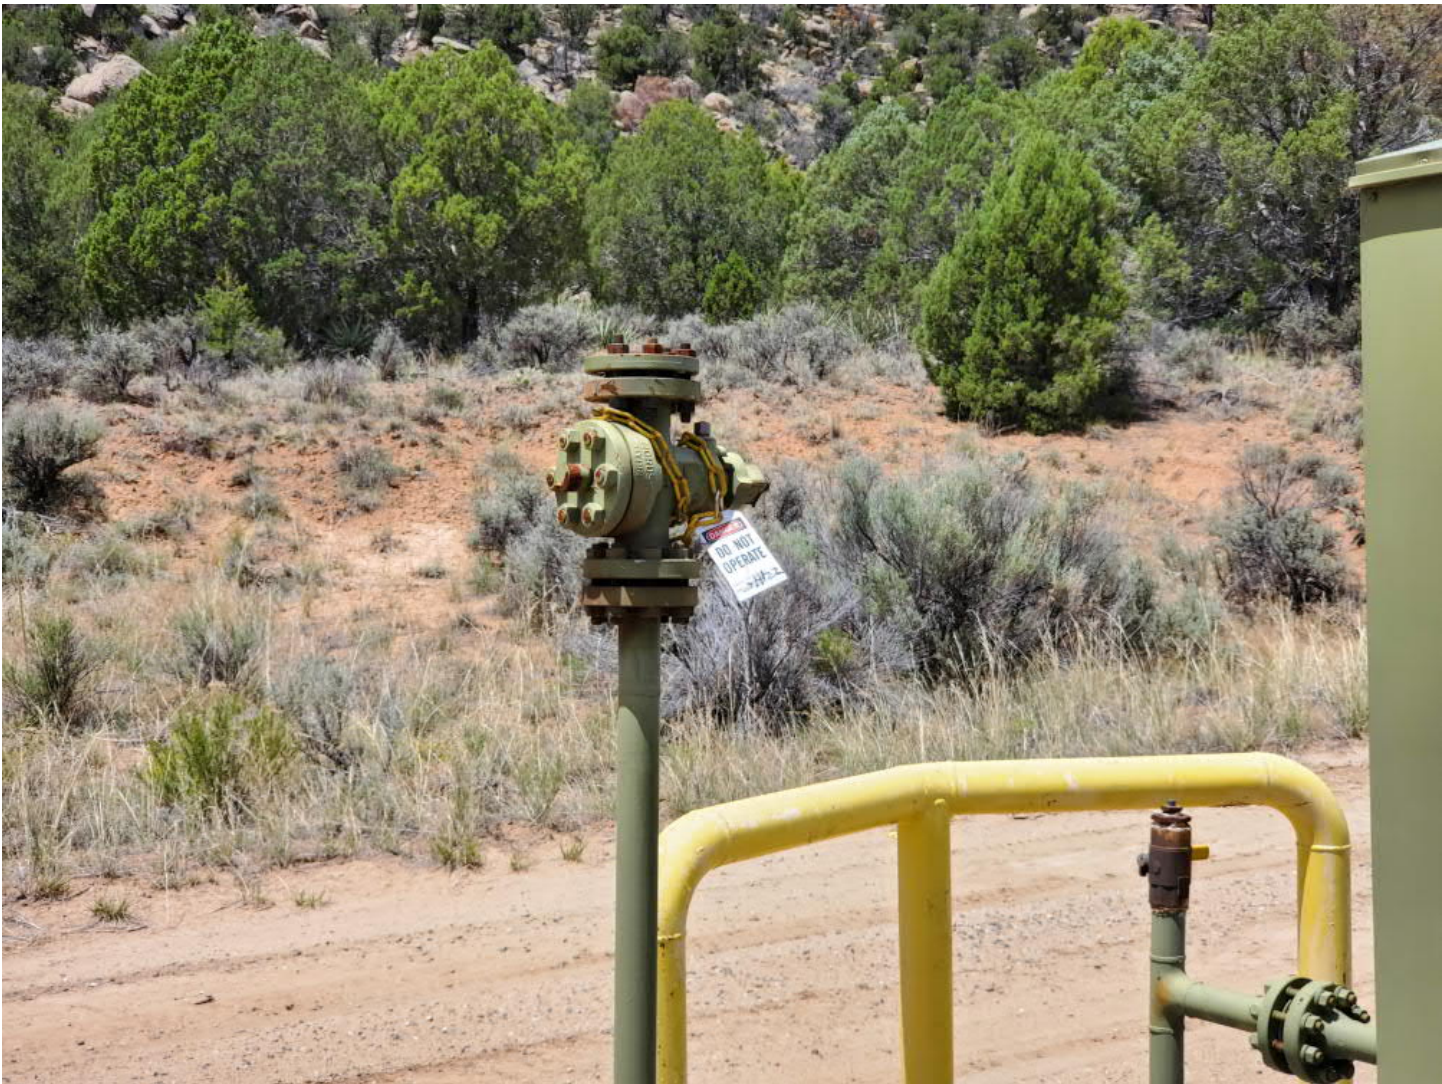
| Issue of Concern: | <p>Comment: Access road is both dirt and washed rock. Some sections of dirt road are developing ruts. Partially buried produced water tank.</p> <p>Comment: Unused equipment and trash in spill prevention for oil container (IMG 03).</p> <p>Corrective Action: Use or remove unused equipment per rule 606. Remove trash per rule 606.</p> <p>Comment: Not in use: 2" line stubbed up near gas meter run is not locked out/tagged out (IMG 04).</p> <p>Corrective Action: Apply Out of Service Locked and Tagged on unused flow line per rule 1101.(3)</p> | | | | | |

I got all unused equipment and trash off location and the two inch valve locked and tagged out.
