**Inspection Photos**  
**Location Name: UPRR 43 Pan AM I #30**  
**Location ID: 318749**

Location Name: UPRR 43 Pan AM I #30

Location ID: 318749

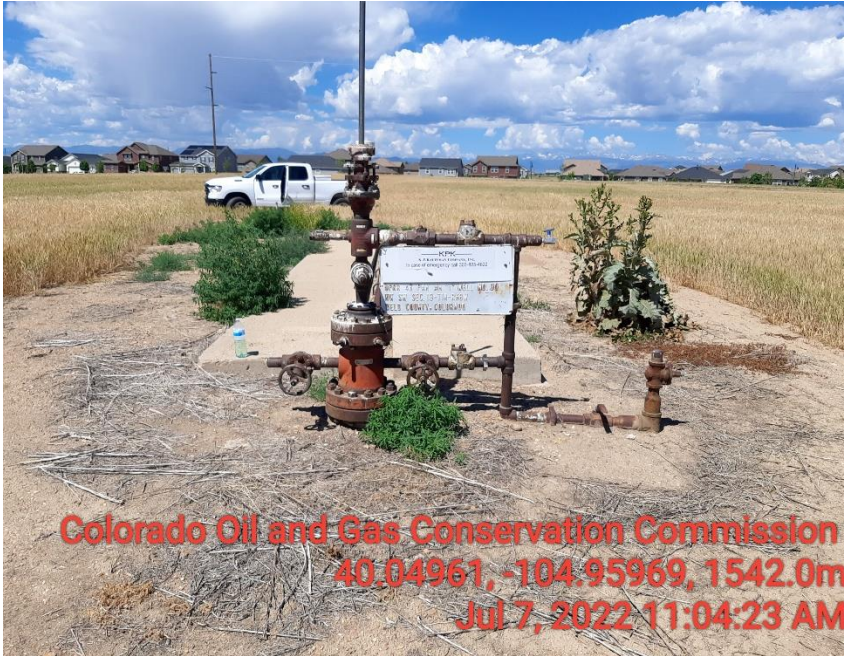
**Photo 1 Well head**

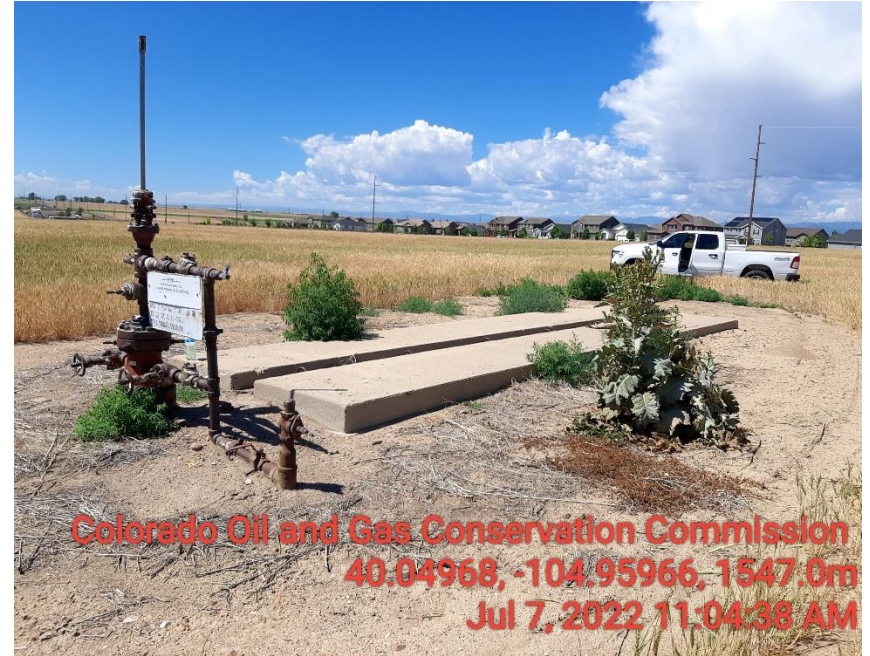
**Photo 2 Weeds, unused equipment (cement base) Sign faded not legible.**

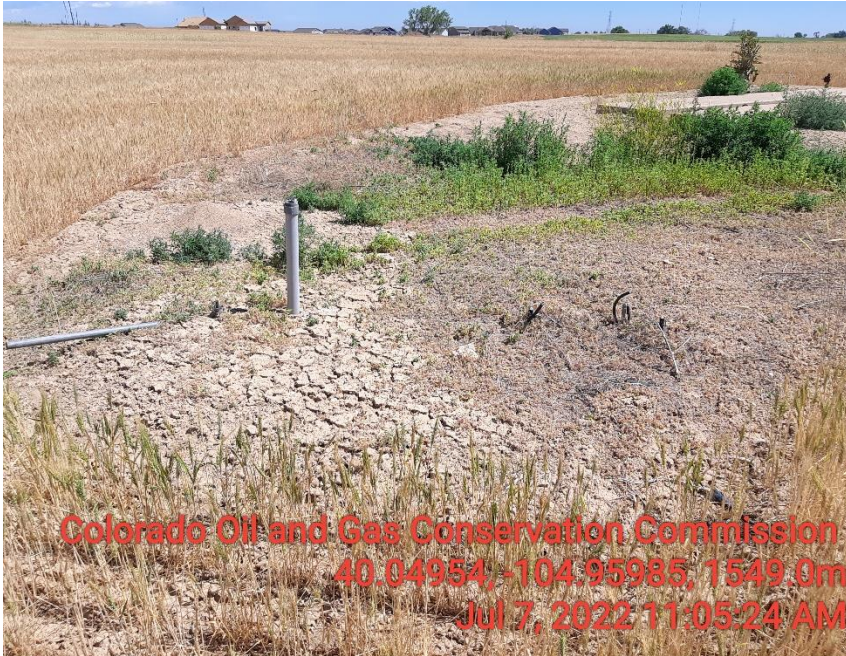
**Photo 3 unused electric lines**

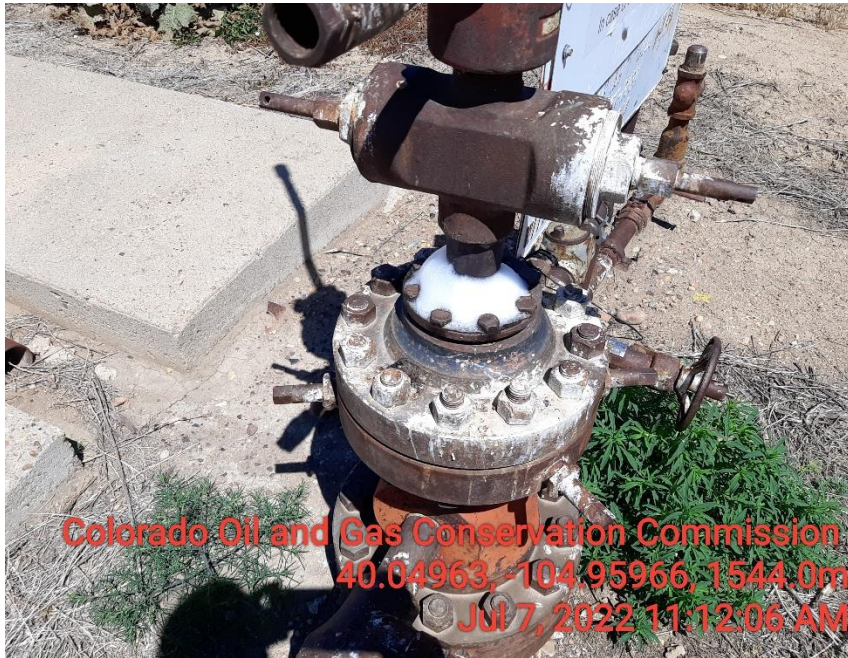
Photo 5 Small leak on well head around tubing.
