Inspection Photos

API: 061-06179

Operator: ENERVEST OPERATING LLC

Inspection Date: 7/7/2022

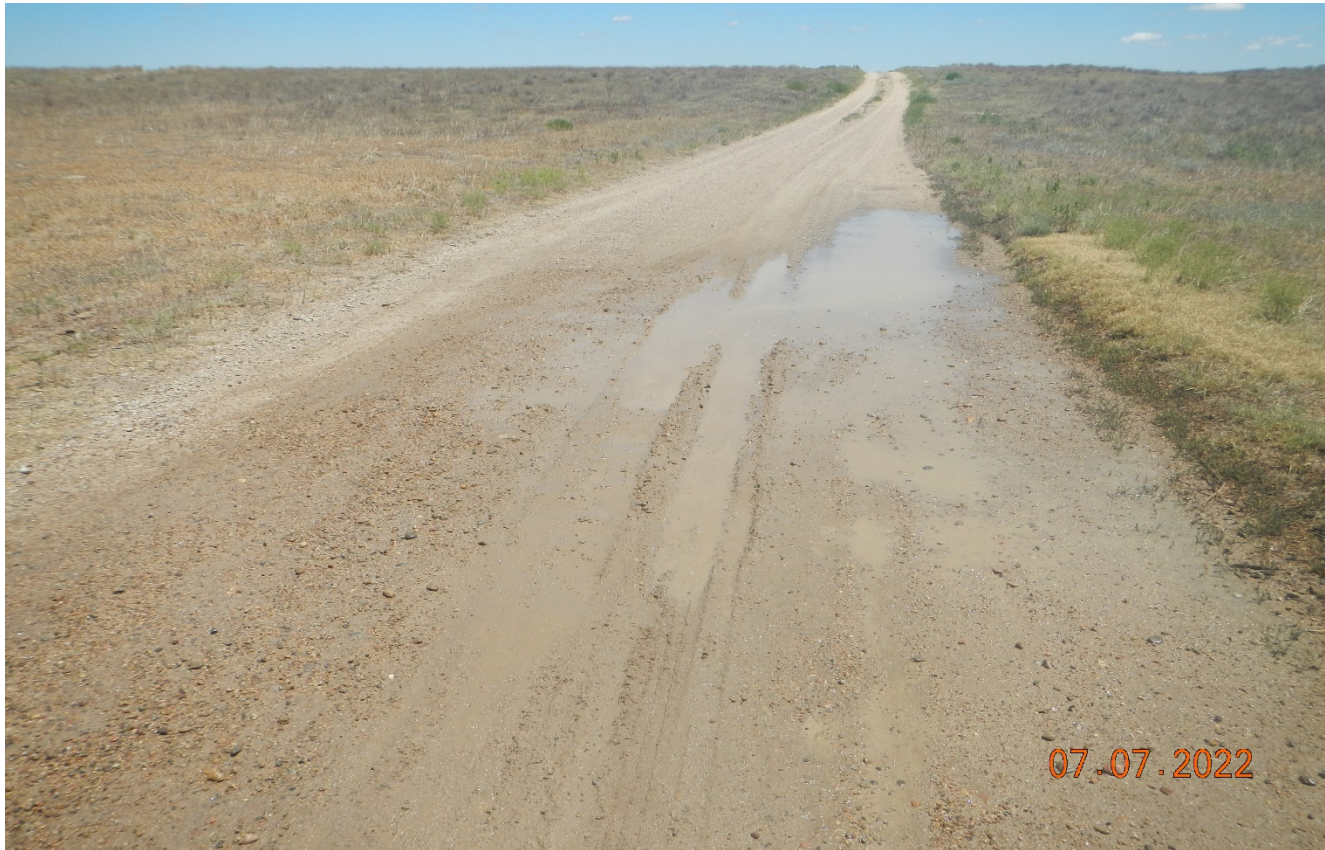
Photo 1. Facing northeast along the access road. There are areas where stormwater is pooling on the road causing vehicles to drive around and widen the road. This area needs to be stabilized with BMP's such as gravel. Stormwater should be diverted off the road.

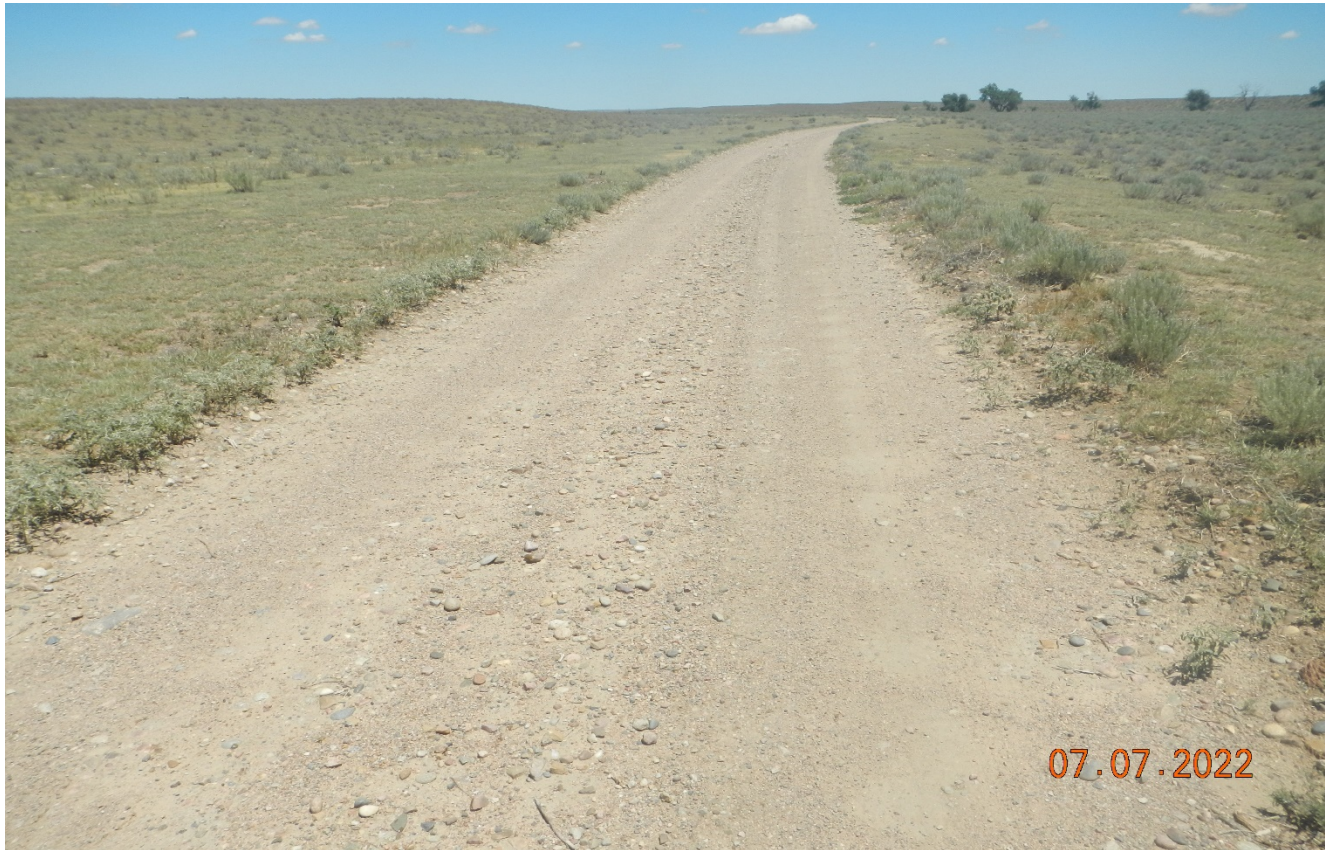
Photo 2. Facing northeast along the access road. This area along the road is stabilized with gravel.

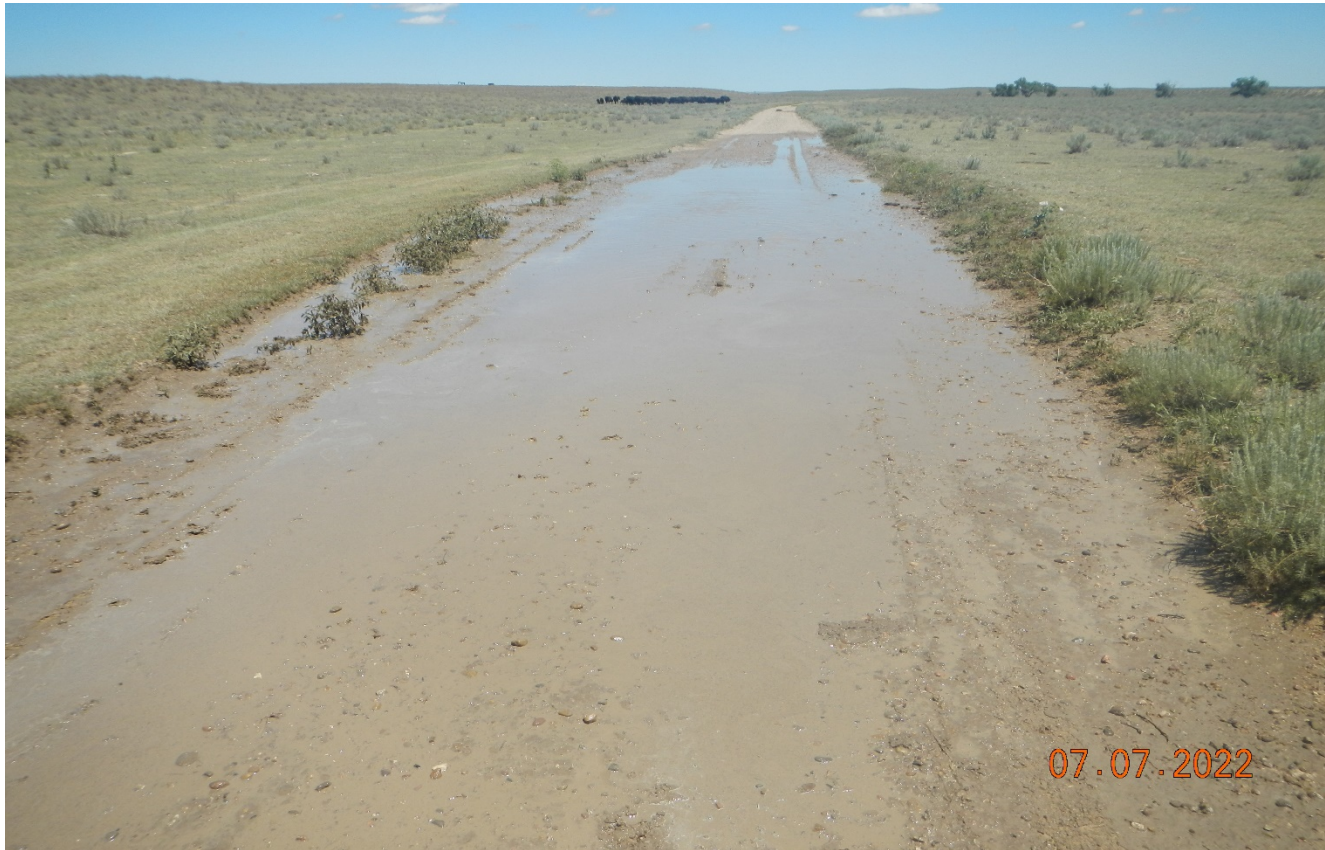
Photo 3. Facing northeast along the access road. There are areas where stormwater is pooling on the road causing vehicles to drive around and widen the road. This area needs to be stabilized with BMP's such as gravel. Stormwater should be diverted off the road.

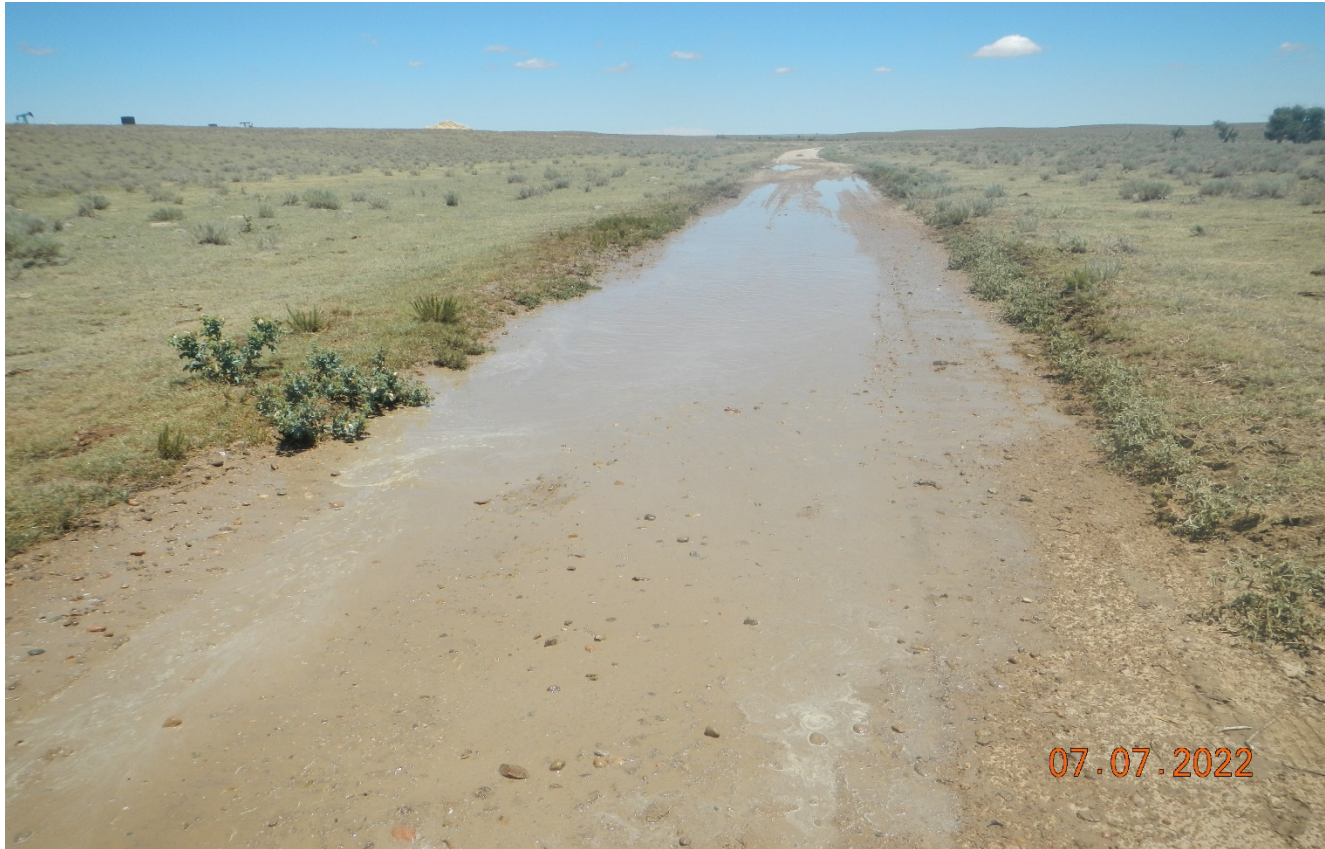
Photo 4. Facing northeast along the access road. There are areas where stormwater is pooling on the road causing vehicles to drive around and widen the road. This area needs to be stabilized with BMP's such as gravel. Stormwater should be diverted off the road.

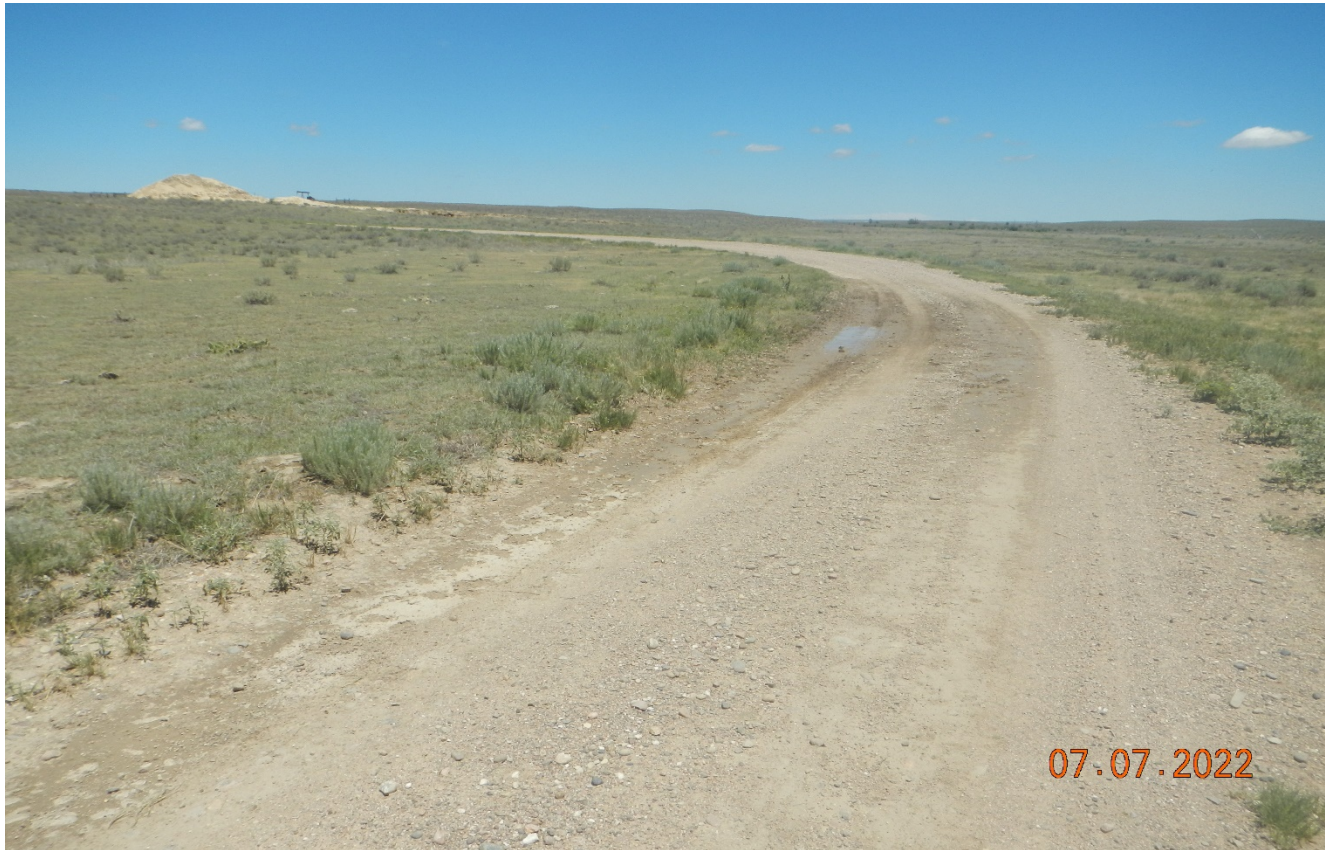
Photo 5. Facing north along the access road.

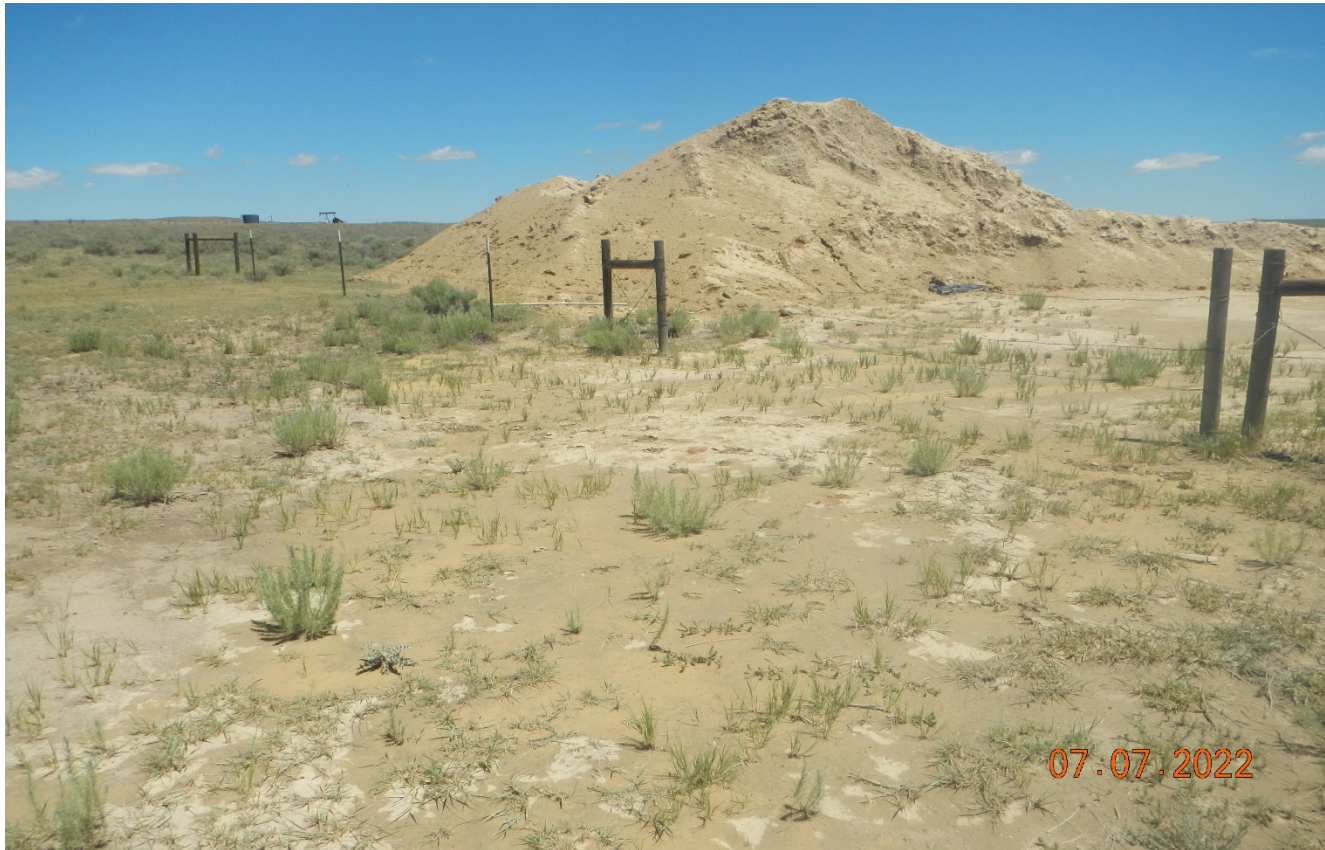
Photo 6. Facing north toward the location. There is a remediation project # 19874 in process with excavated material stored onsite. There are no perimeter BMP's around the excavated material to prevent sediment transport offsite.

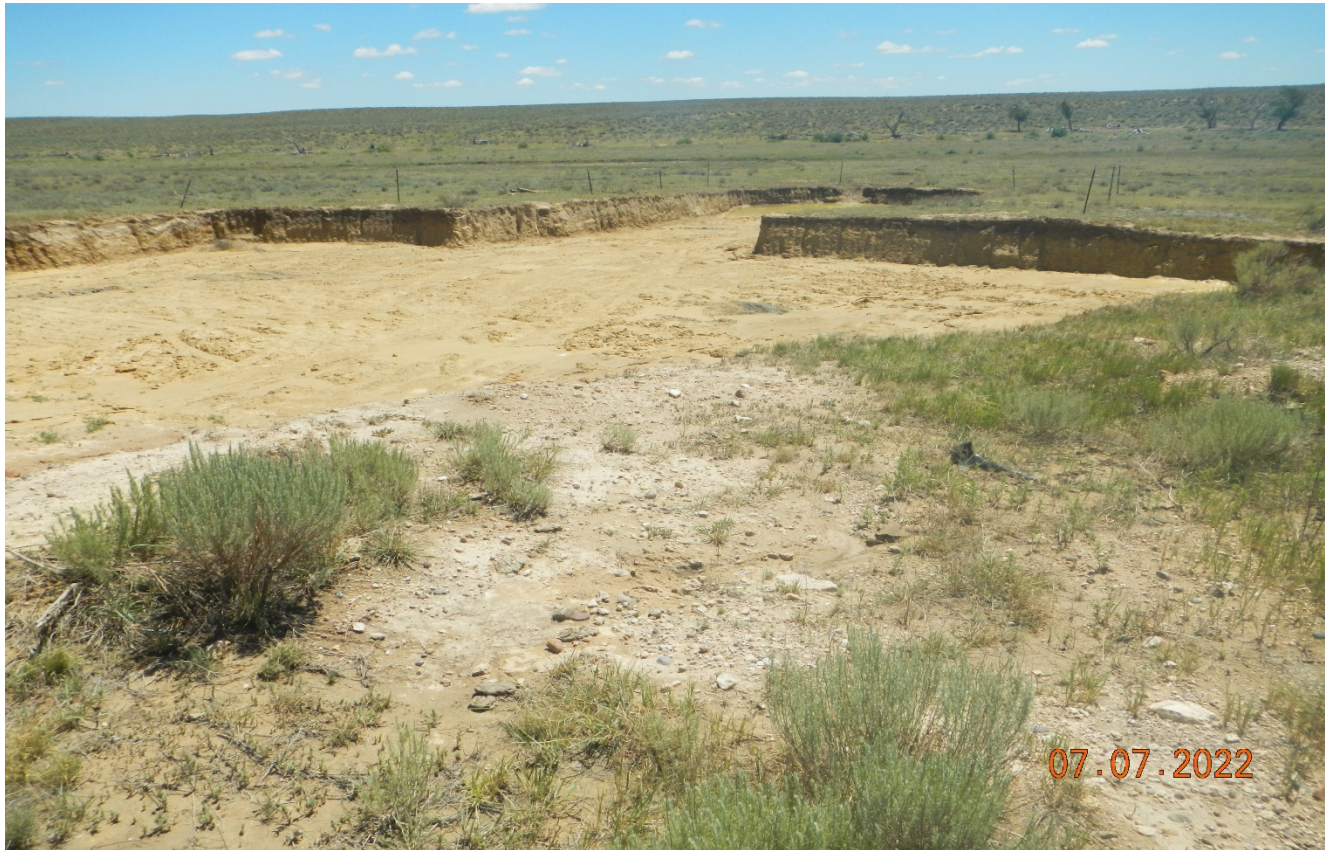
Photo 7. Facing northeast toward the excavated area.

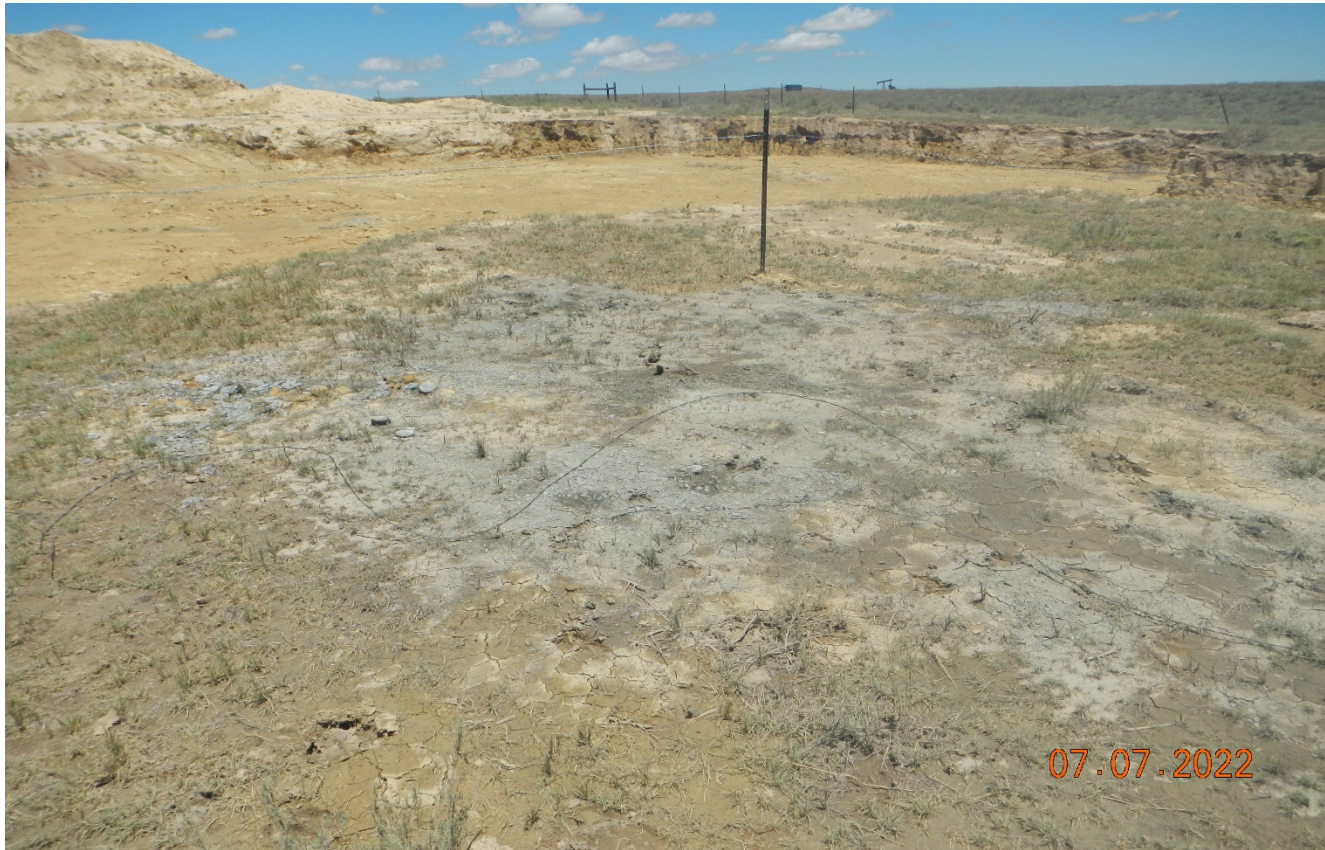
Photo 8. Facing northwest toward the excavated area. The fence around the location is inadequate to prevent livestock entry and is not maintained. There is grey sampling soil material in this area that was put on the vegetation.

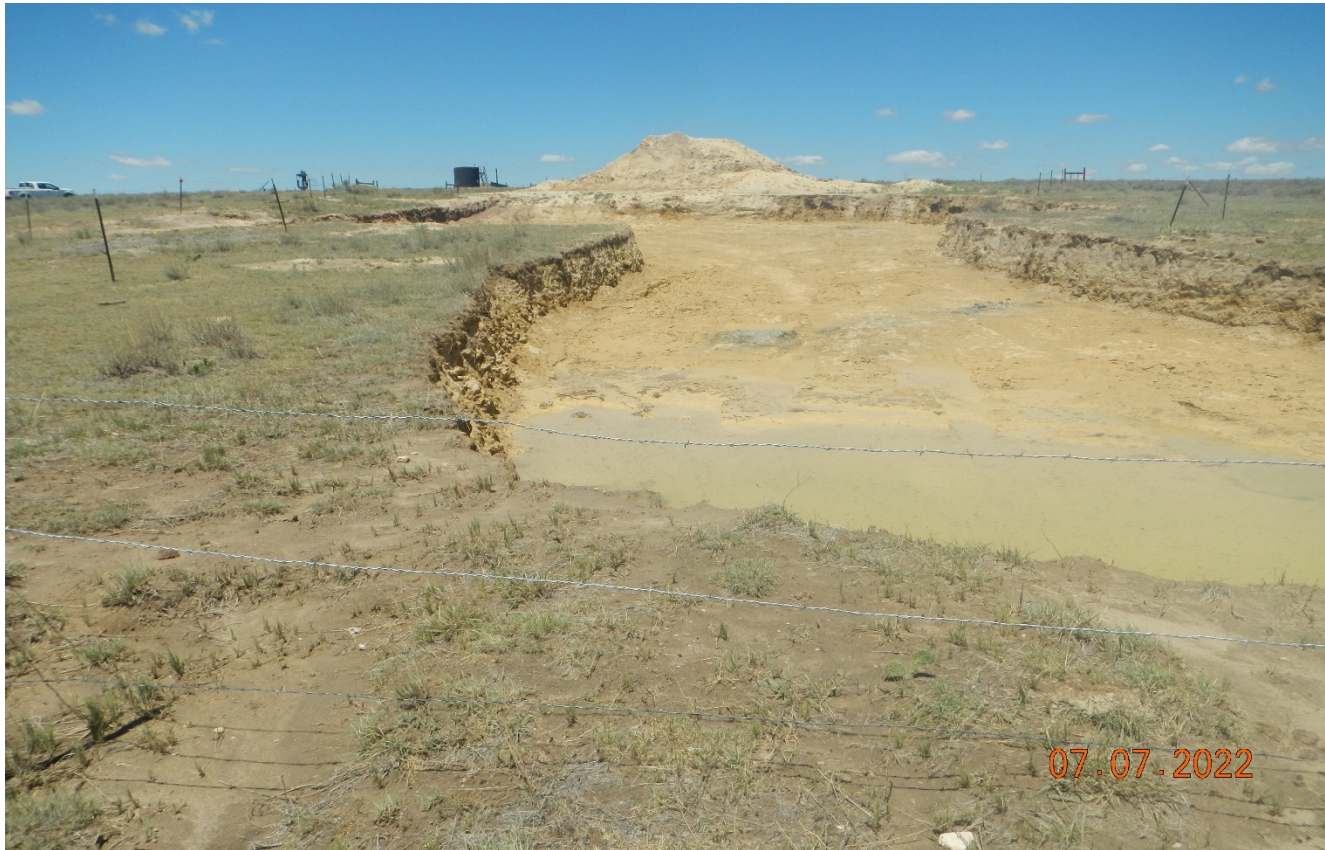
Photo 9. Facing west toward the excavated area which is pooling water from recent rain storm.

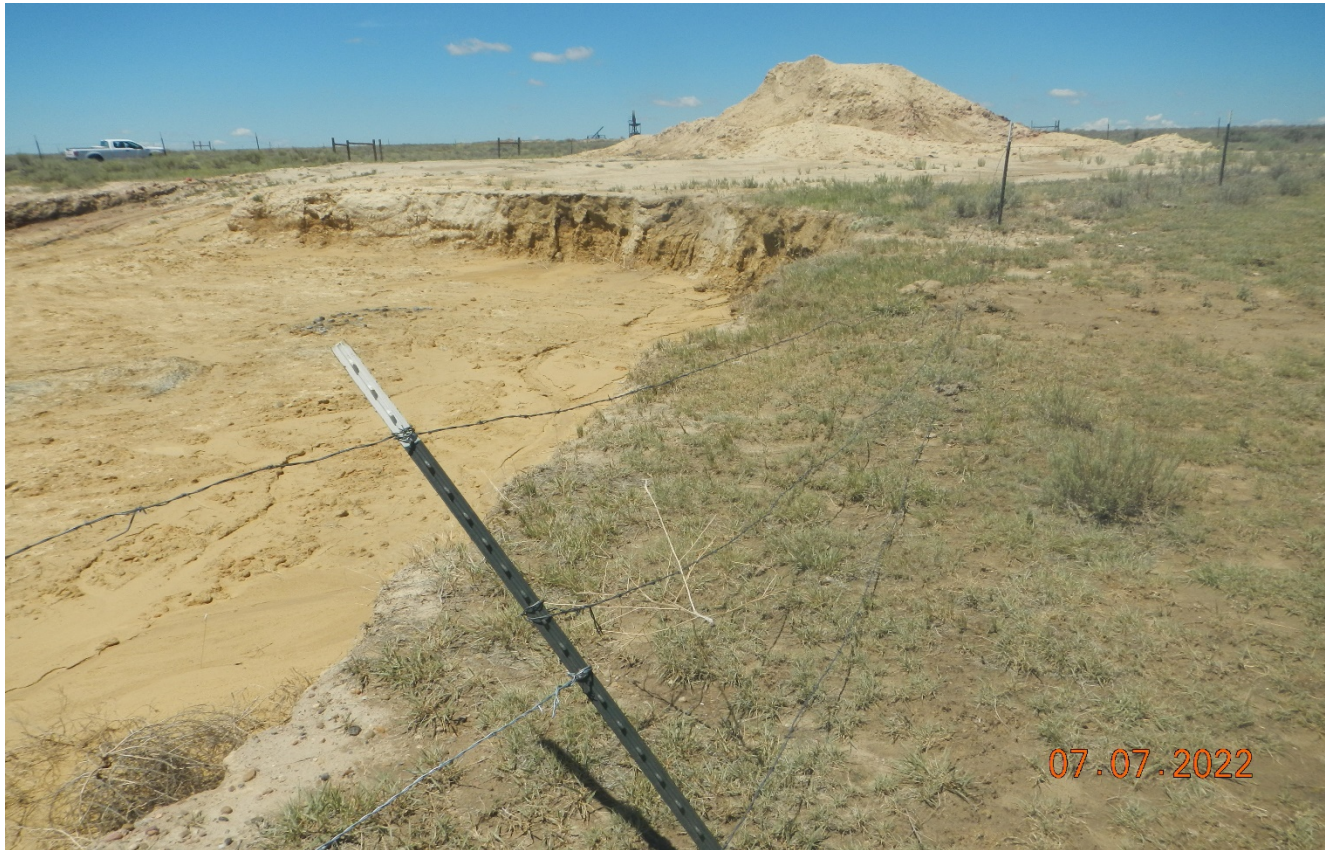
Photo 10. Facing west toward the excavated area. The fence around the location is inadequate to prevent livestock entry and is not maintained.

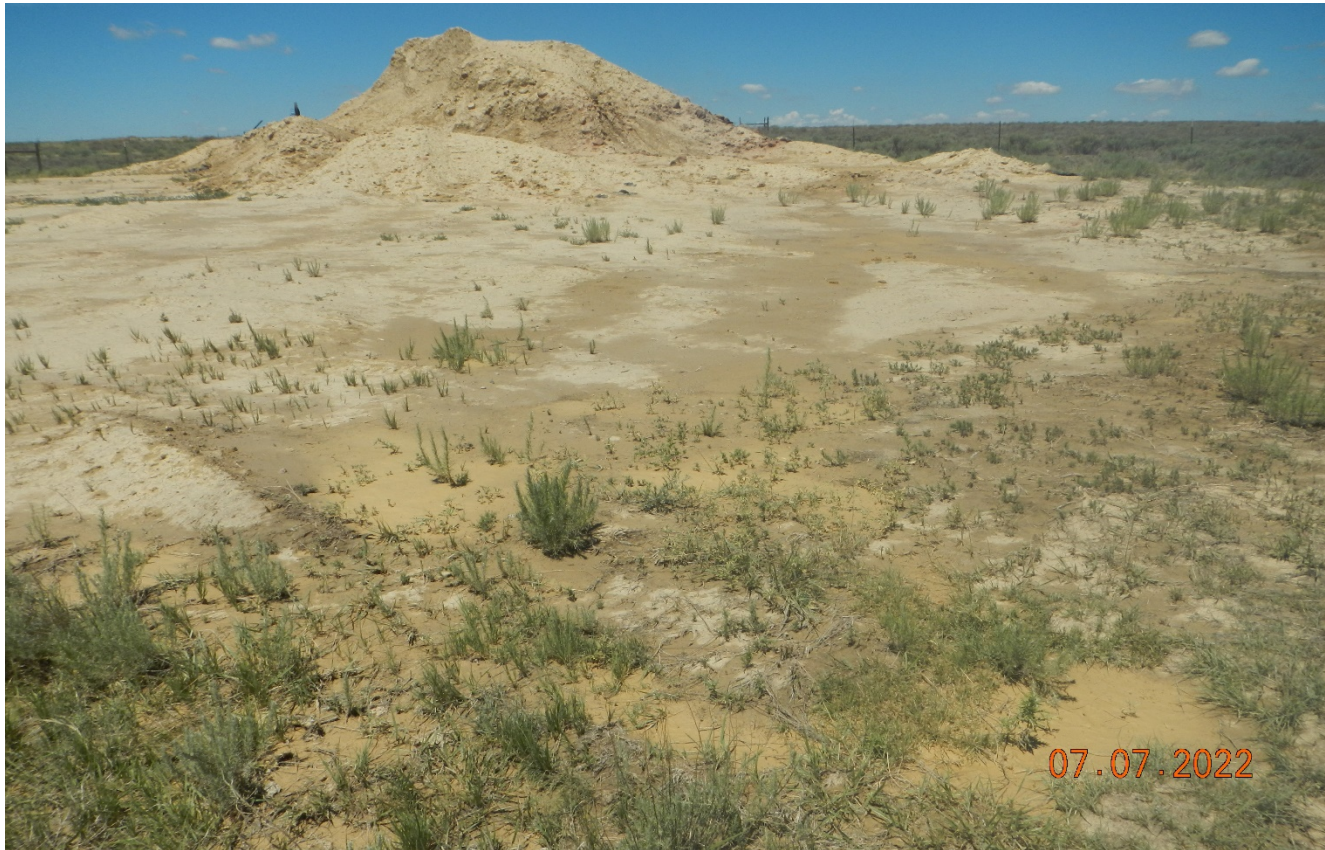
Photo 11. Facing west toward the excavated material stored onsite. There are no perimeter BMP's around the excavated material to prevent sediment transport offsite. There are signs this material has eroded offsite from recent precipitation.

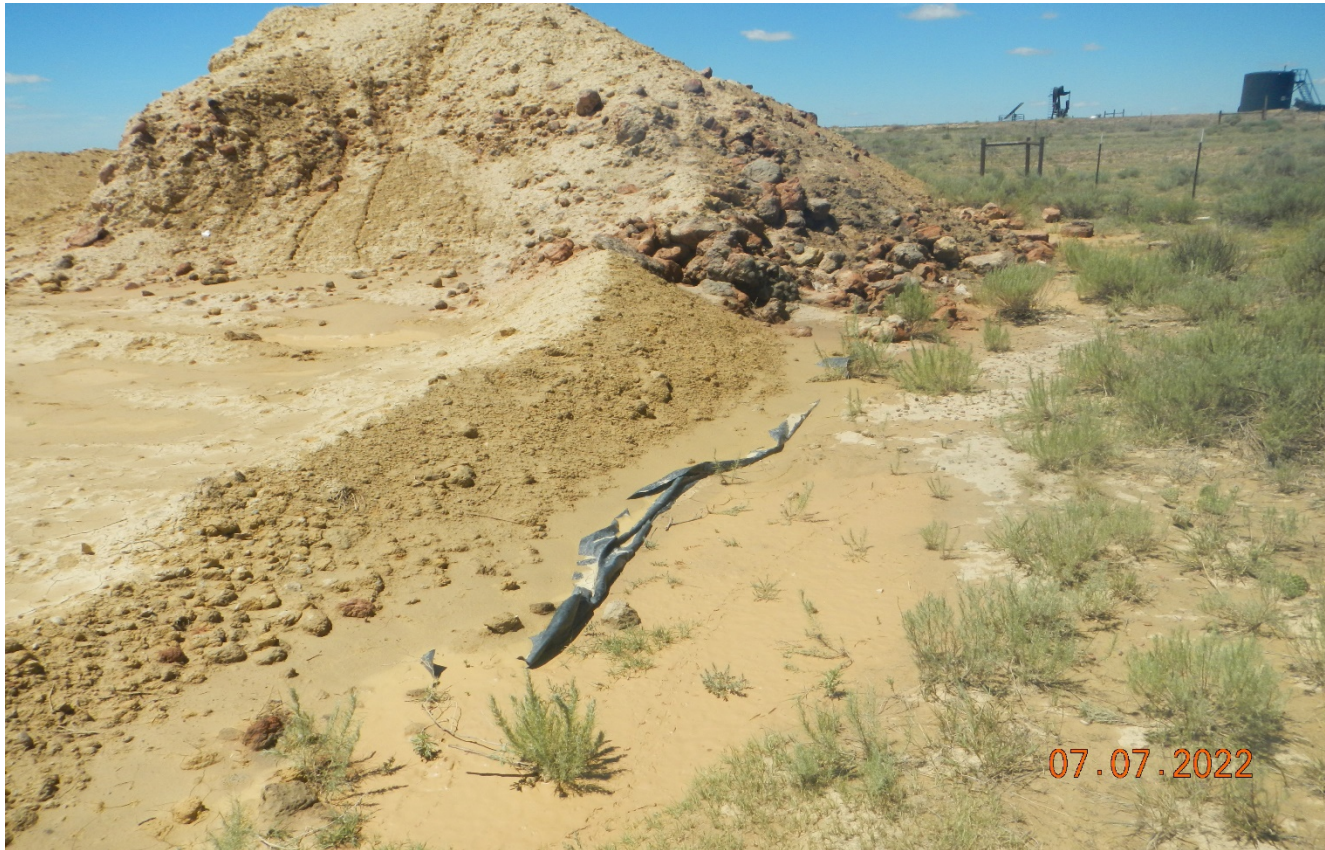
Photo 12. Facing west toward the excavated material stored onsite. There are no perimeter BMP's around the excavated material to prevent sediment transport offsite. There are signs this material has eroded offsite from recent precipitation.

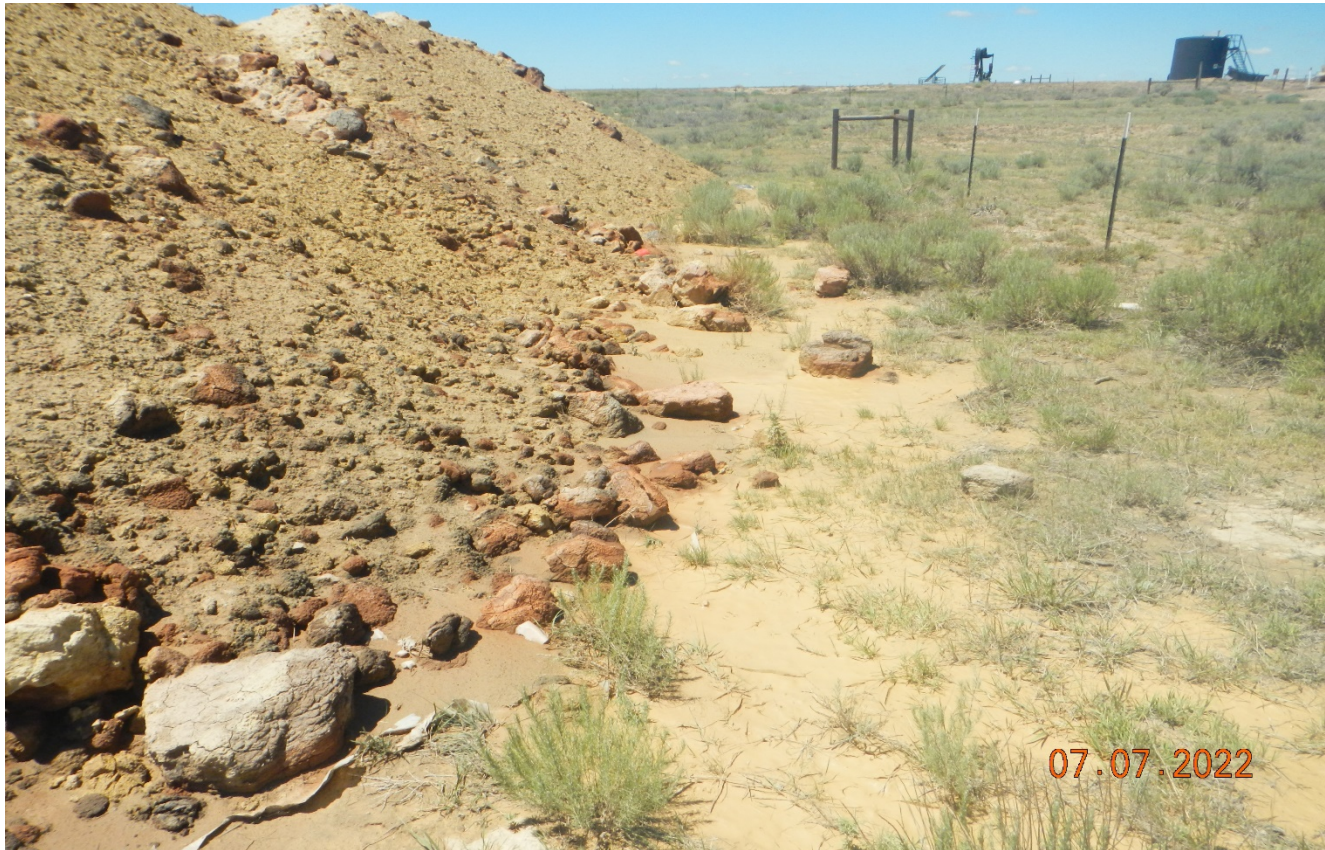
Photo 13. Facing west toward the excavated material stored onsite. There are no perimeter BMP's around the excavated material to prevent sediment transport offsite. There are signs this material has eroded offsite from recent precipitation.
