Inspection Photos and Issue Report

Operator: CHEVRON USA INC - 16700

Location ID: 314945

Rio Blanco County, CO

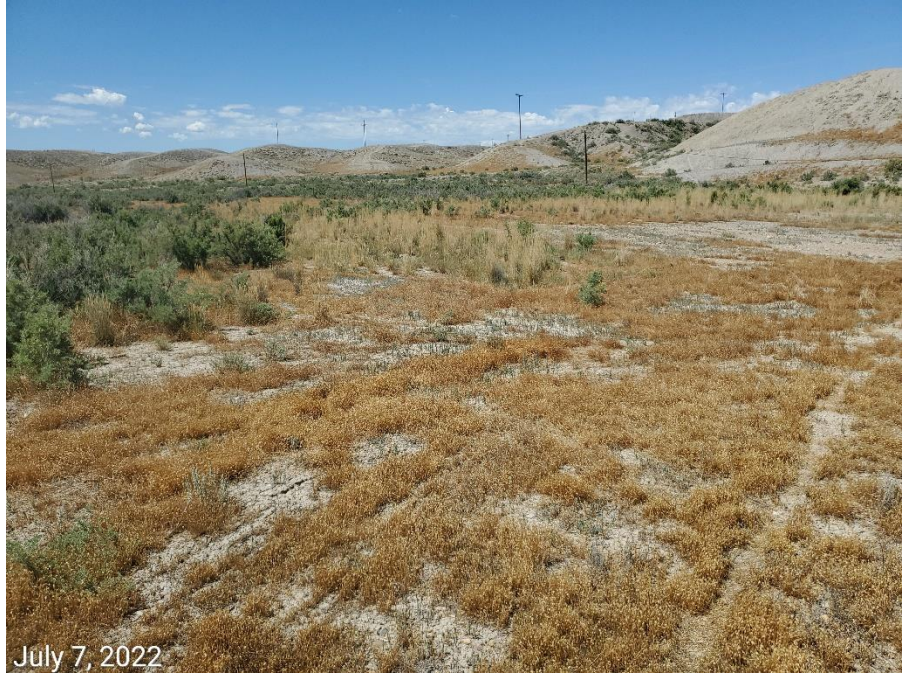
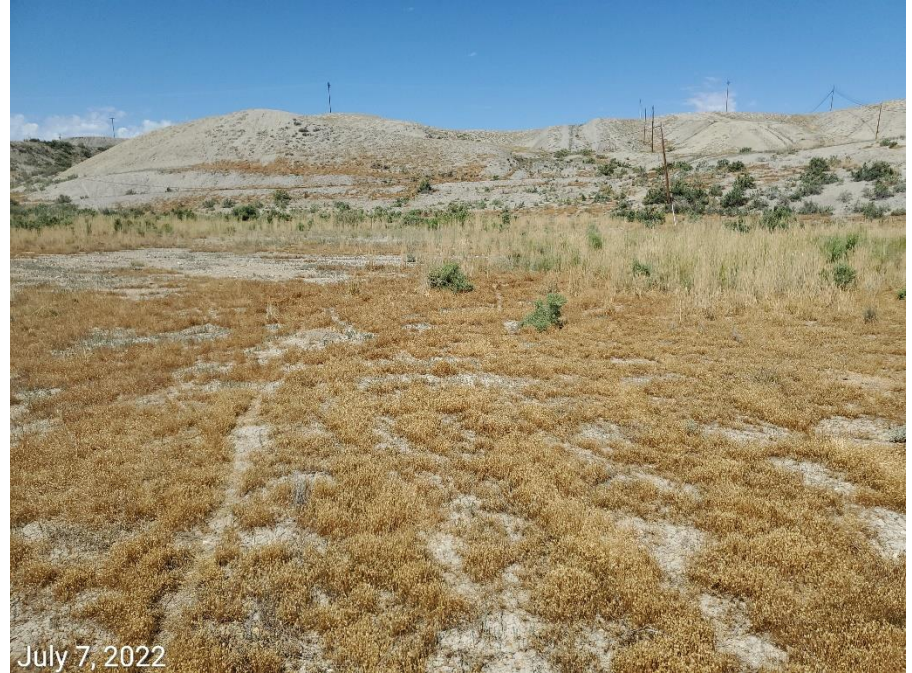
Photo 1: Photos taken from the northeast end of the Location. Photos provide an overview of the Location facing southwest to west. Photos examples showing Location is either bare, or predominantly vegetated by Undesirable and Noxious Plant Species, such as Halogeton, cheatgrass, and annual wheatgrass

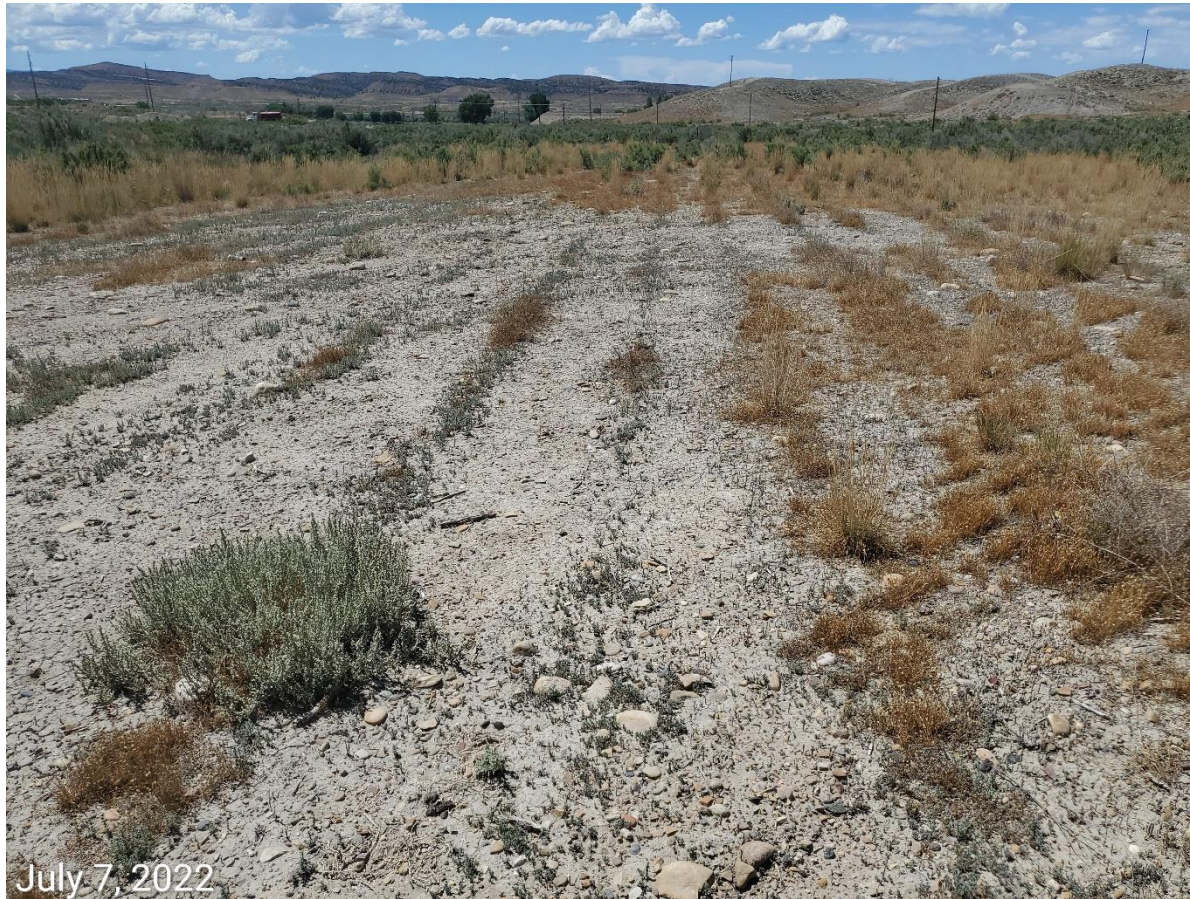
Photo 2: Photo taken from the north end of the Location, facing south. Photo shows Location is either bare, or predominantly vegetated by Undesirable and Noxious Plant Species, such as Halogeton, cheatgrass, and annual wheatgrass

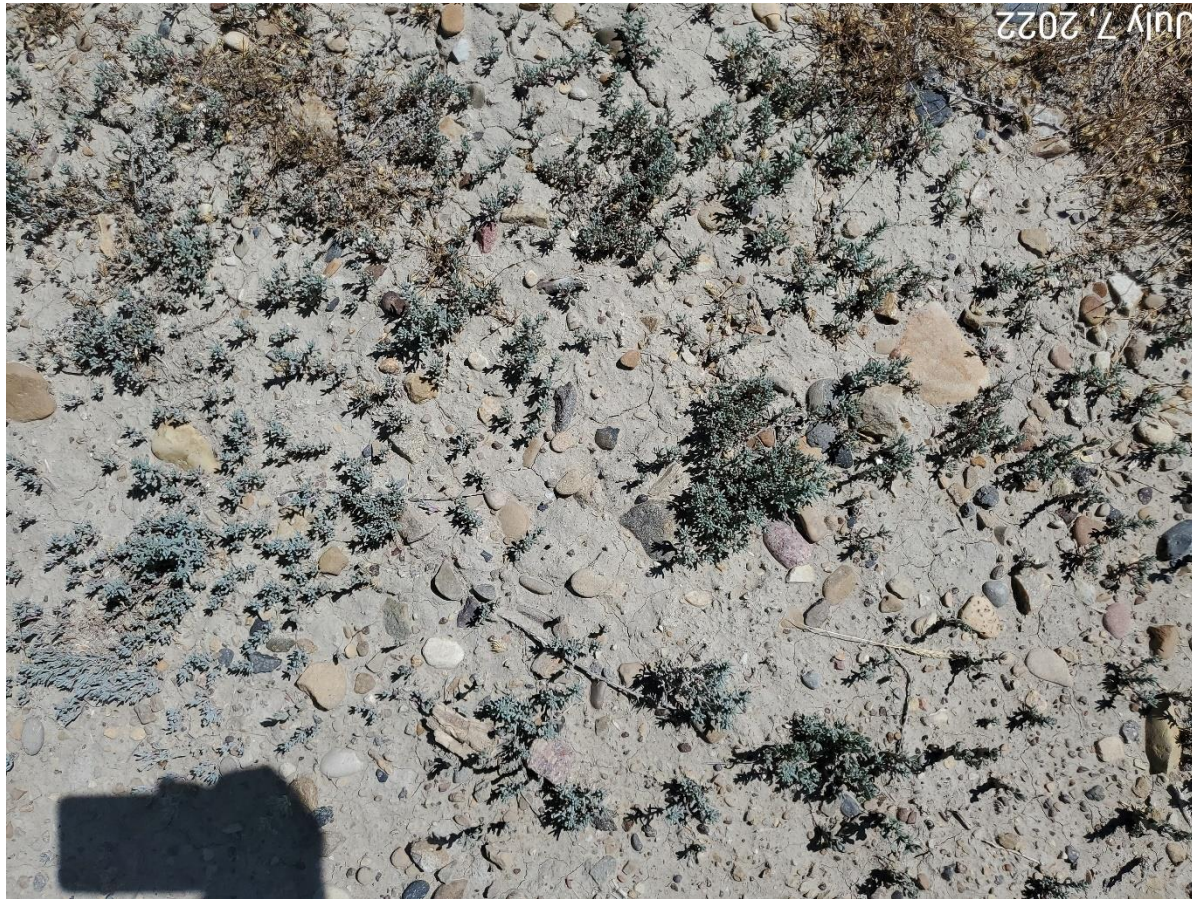
Photo 3: Photo shows Halogeton establishment on the Location.

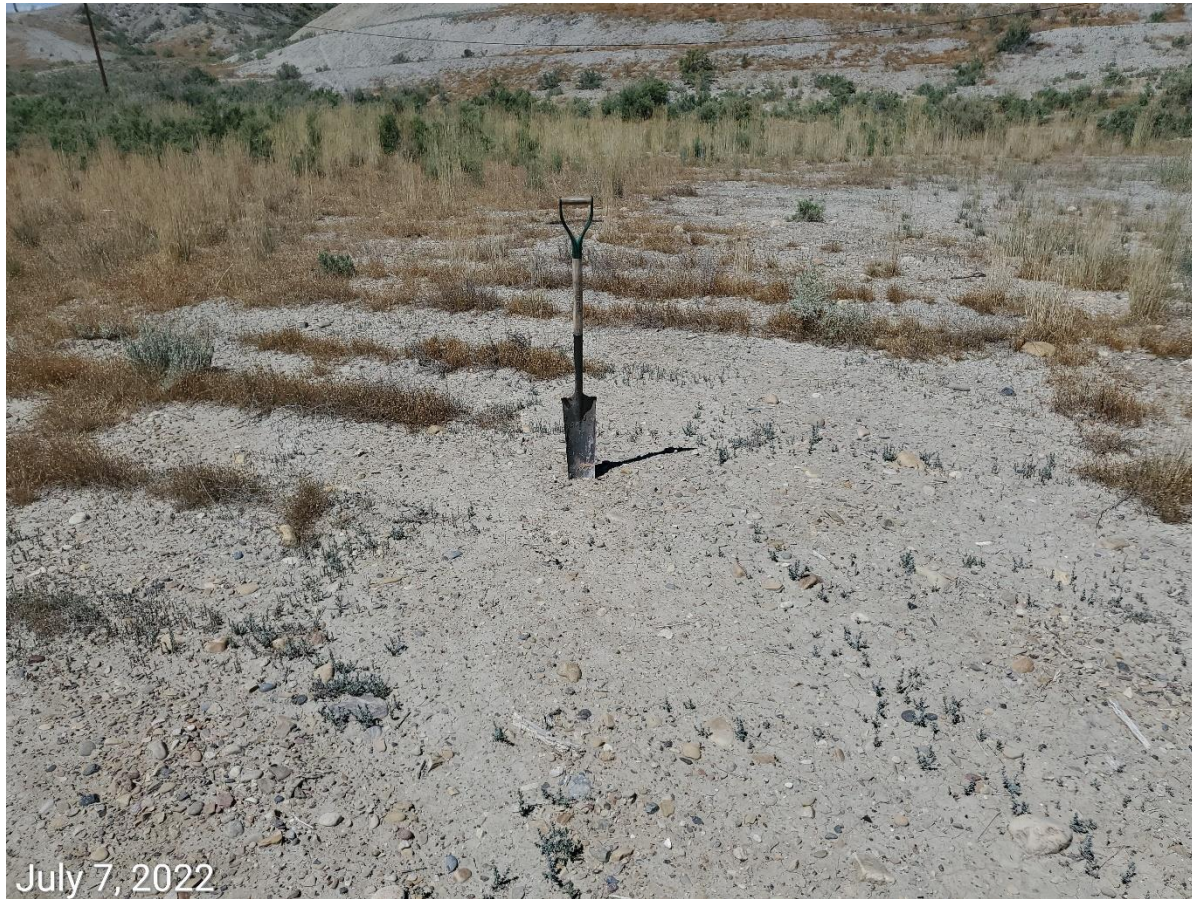
Photo 4: Photo taken from the bare areas of the Location. Photo shows Reclamation Specialist attempted to dig a test pit, but was only able to easily penetrate the first couple inches of soil. Compaction concerns evident at the Location and access road; compaction alleviation inadequate and does not appear to have been conducted.

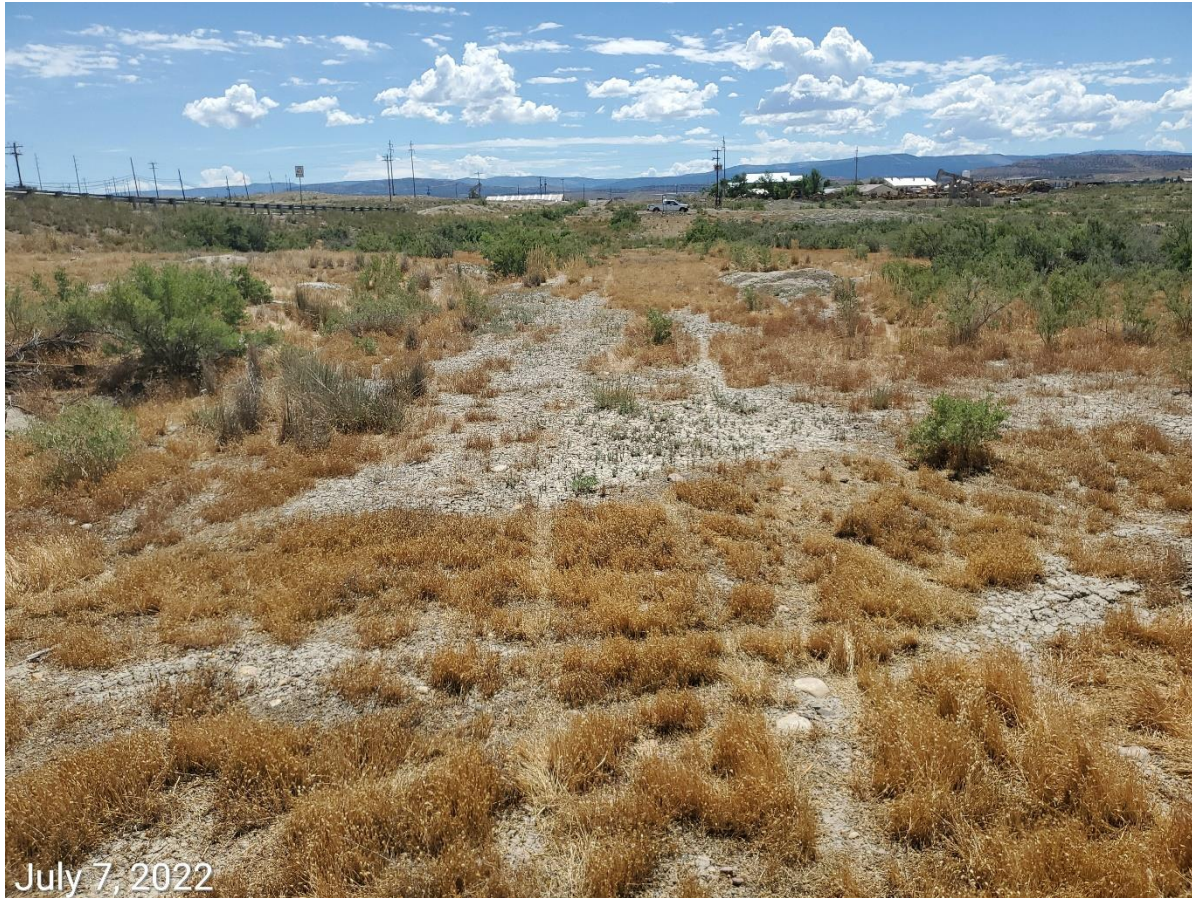
Photo 5: Photos of access road. Access road is either bare, or predominantly vegetated by Undesirable and Noxious Plant Species, such as Halogeton, cheatgrass, and annual wheatgrass

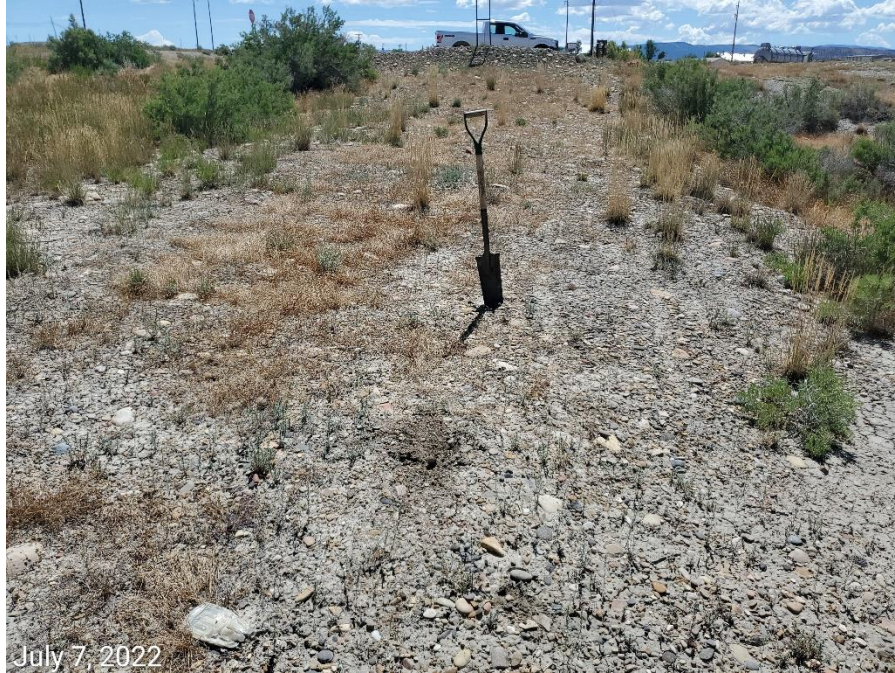
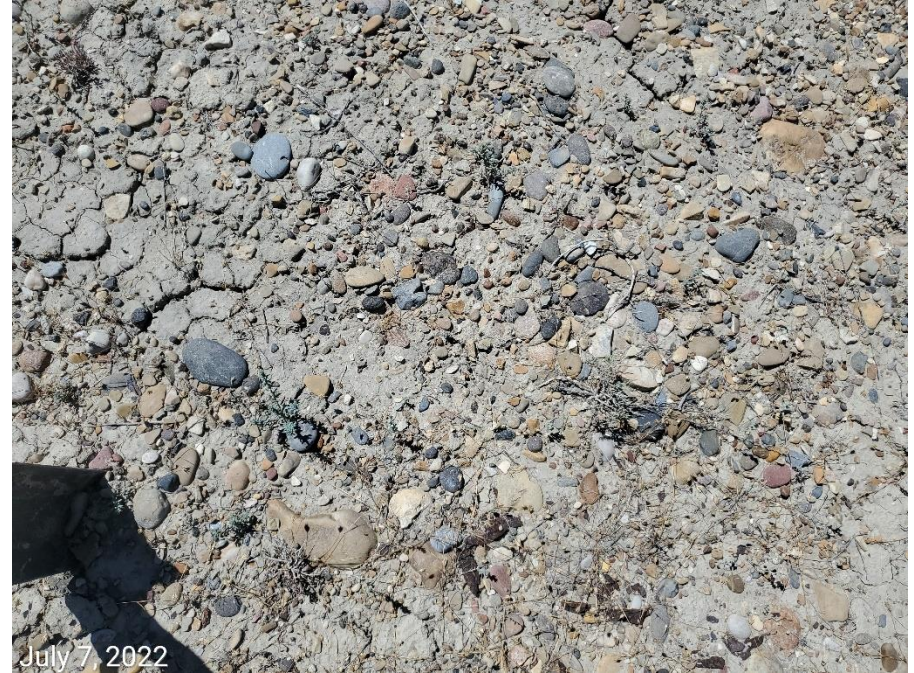
Photo 6: Photos taken from the bare areas of the Access Road. Photo shows Reclamation Specialist attempted to dig a test pit, but was only able to easily penetrate the first couple inches of soil. Compaction concerns evident at the Location and access road; compaction alleviation inadequate and does not appear to have been conducted. Photo also shows gravel/road base remaining.
