Inspection Photos

API: 017-06051

Operator: KUENZLER & FLORA RESERVE COMPANY

Inspection Date: 7/6/2022

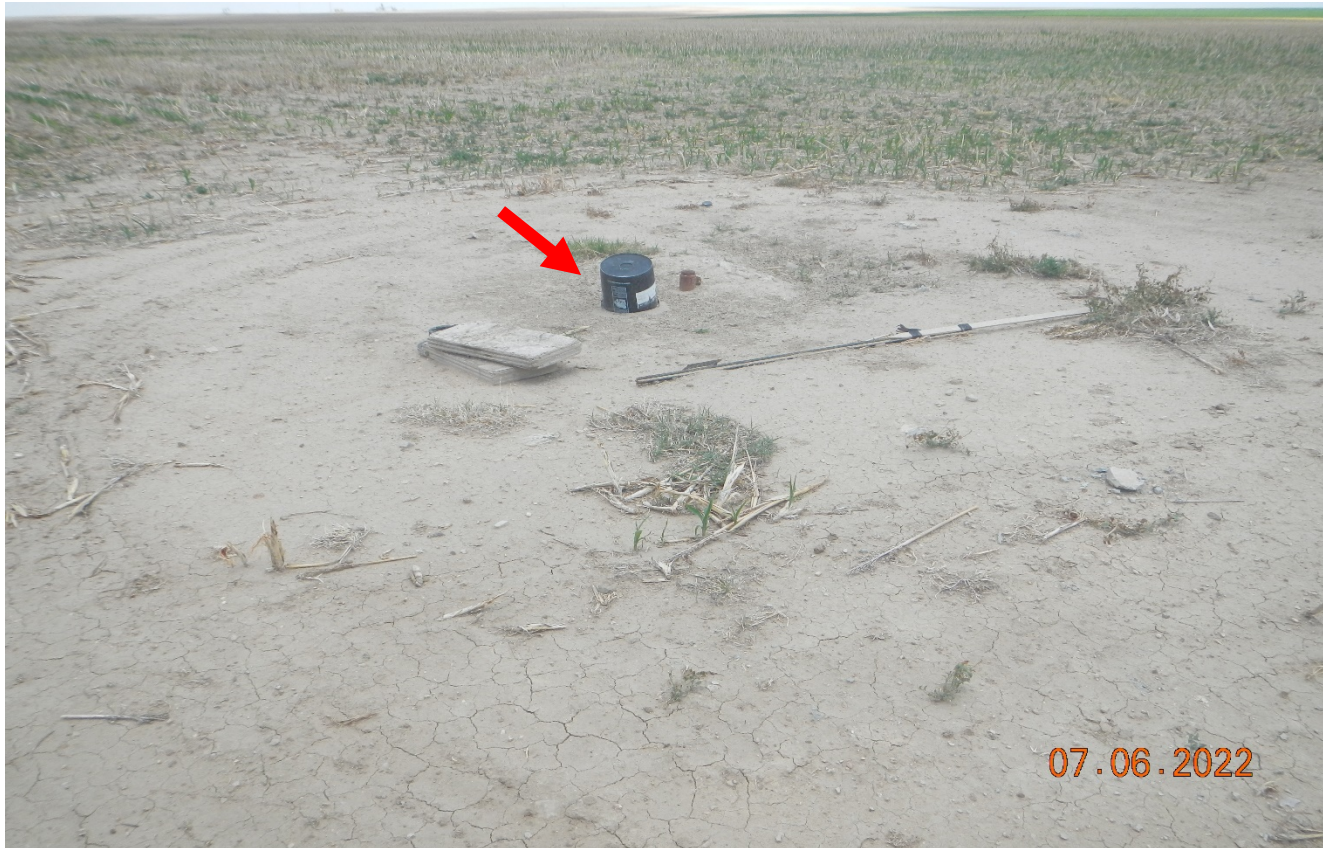
Photo 1. Facing toward the well site. There is a bucket pipe riser at the wellhead area. It is unknown if the well has plugged per the 6N.

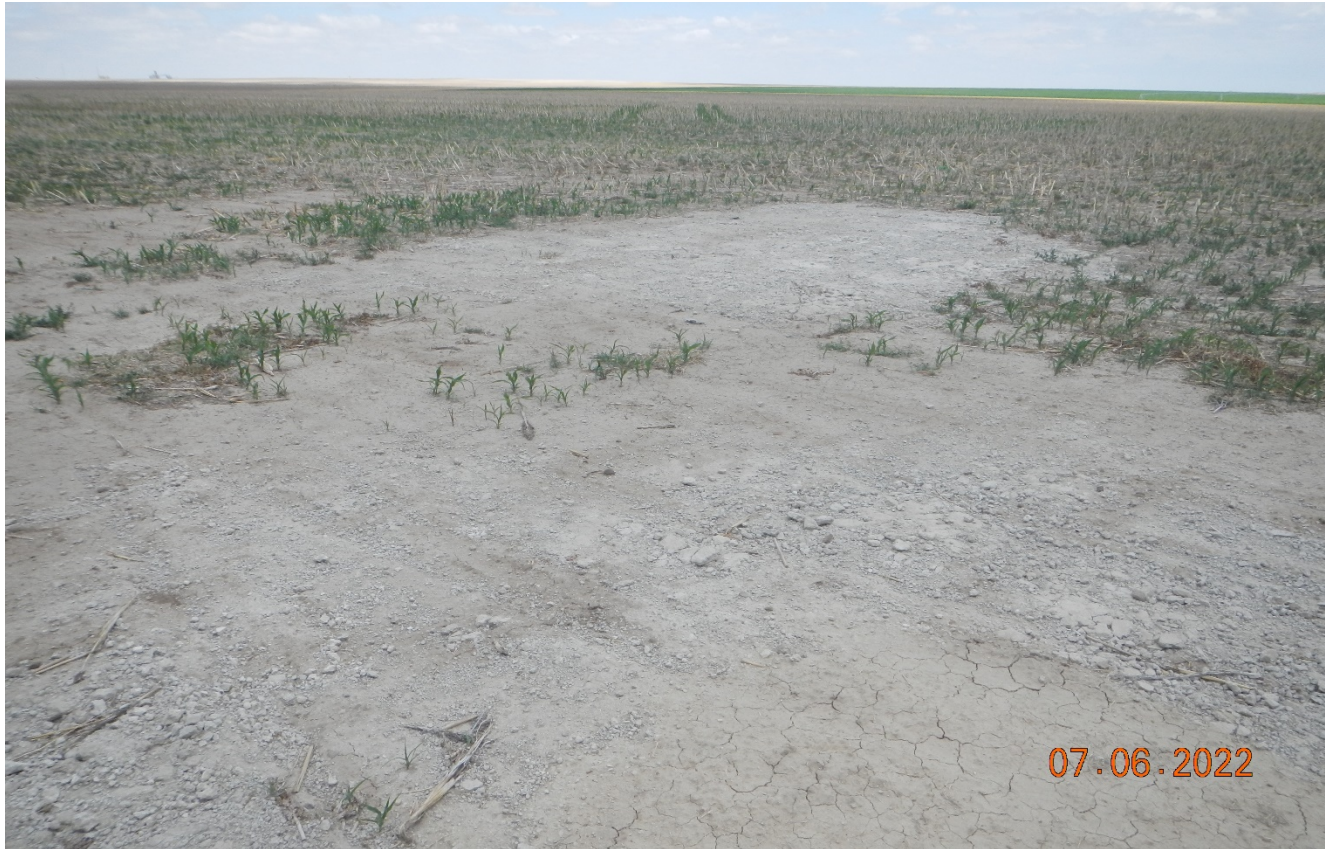
Photo 2. There is some cement waste left near the well head. This needs to be cleaned up and removed.
